**ST AIDAN'S PARISH CHURCH
CHILTON**

QUINQUENNIAL INSPECTION 2017

DATE OF INSPECTION : 20 June 2017

**Malcolm R Cundick Dip.Arch.(Oxford) RIBA
ADG Architects
6 Pioneer Court
Morton Palms Business Park
DARLINGTON
DL1 4WD**

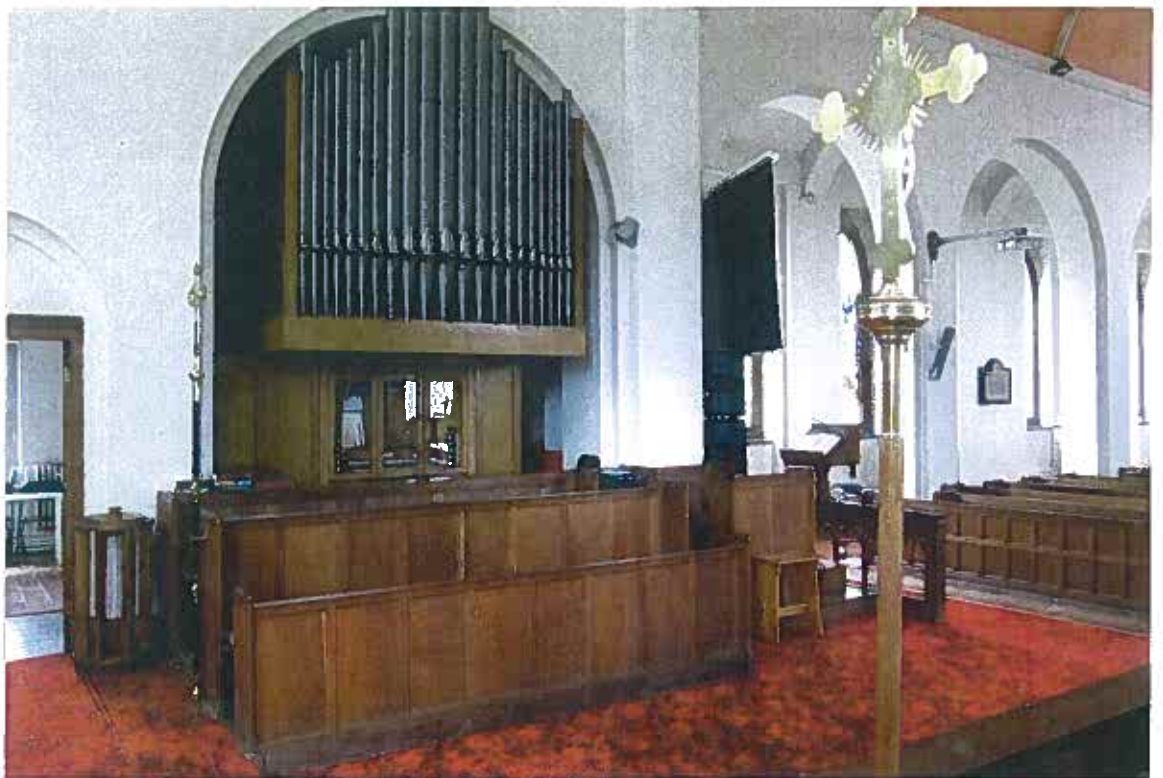
23

23. Organ and Choir pews

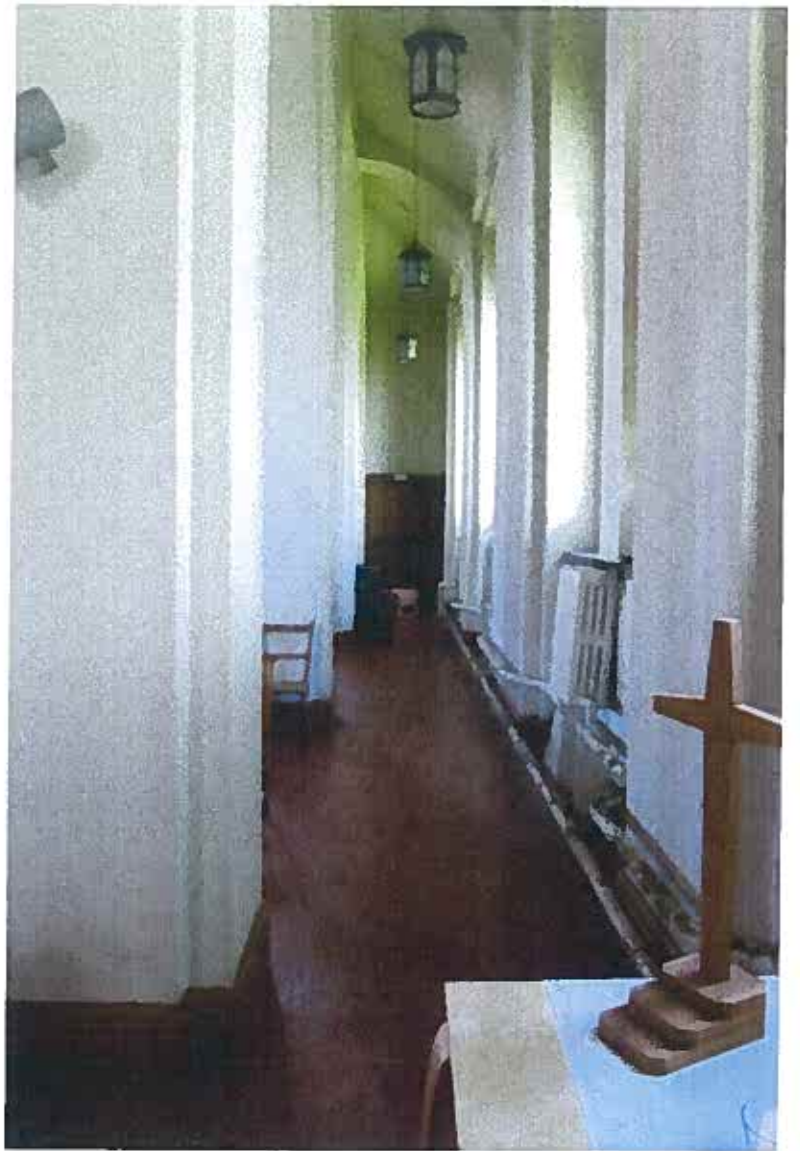
24. North Aisle. Note spalling decoration to central heating pipework and painted concrete floor.
25. North aisle looking West
26. Aisle radiator and pipework detail
27. Baptistry looking North West
28. Baptistry gable wall
29. Baptistry/ South Porch wall with historic efflorescence plaster/decoration defect above new rendered dado.
30. Baptistry looking toward South Porch. Note plaster/decoration defects per 29.
31. Clergy Vestry
32. South Aisle. See notes per 24
33. Choir Vestry
34. Clergy Vestry
