## ST HELEN'S CHURCH, AUCKLAND

### REPORT ON QUINQUENNIAL INSPECTION March 2021

This report summarises the findings of an inspection of St Helen's Church, Auckland. Carried out on Tuesday 9<sup>th</sup> March 2021 by Inspecting Architect Ulrike Knox RIBA AABC and Stephen McConnell ARB.

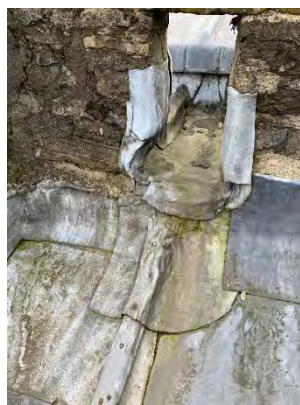
To the west end bays appear to have slipped towards the gutter indicating poor fixings. Many of the nails into the rolls have corroded. This is a poor detail. There are areas of flash band repair which should be properly repaired. There is a small area at the west end which requires pointing over the flashing.

To the back face of the parapet at the north, a silicone mastic has been used instead of mortar and this is in good condition.

The coping does not sit on a DPM and this is recommended.

- C**      • Properly repair flashing with lead.
- B**      • Reset coping on lead DPM and extend flashing to new extension roof.
- B**      • Refix slipped lead sheet. Patch nail holes with lead.

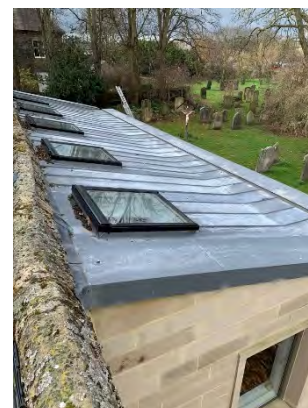
- 1.5.1. The lean to extension has a zinc roof with standing seams. It has a box gutter behind a parapet to the north.

Condition is good.

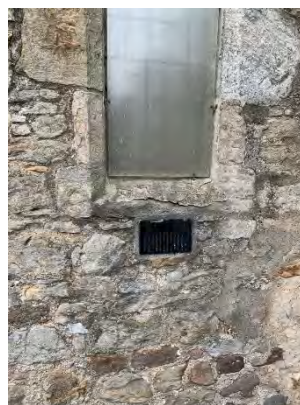
The pointing appears to be in reasonable condition however there is a corbeled out flue at the abutment with the Chancel which requires repointing. The window sill also requires repair.

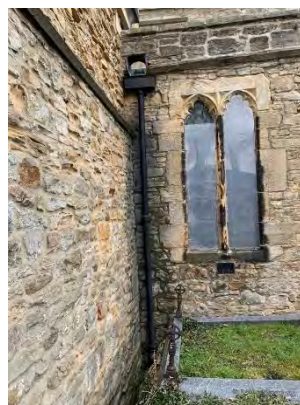
There is a small crack to the right hand side of the eastern most downpipe which should be pointed and monitored.

The west pipe may be blocked and there is green build up on the wall. This needs to be checked.

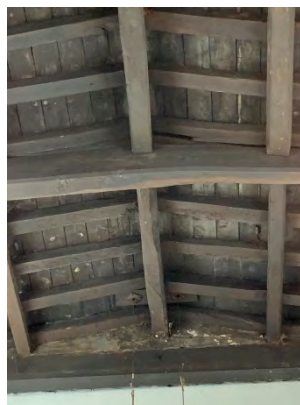
Apart from some flaking of the finish to the west end timbers, it appears to be in reasonable condition from the floor level. This is likely due to poor pointing of the bellcote, but there have been some recent leaks reported corresponding to defects in the lead.

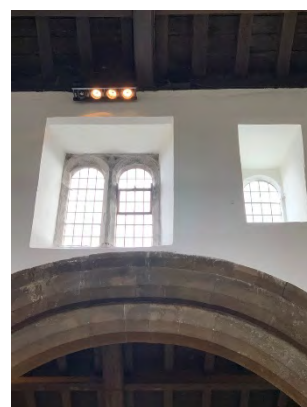
First window from the west there is a small arched window. Appears to be in reasonable condition.

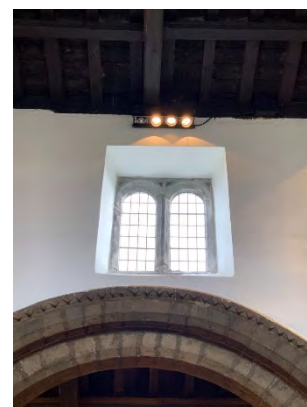
This has two fixed lights and appears to be in fine condition

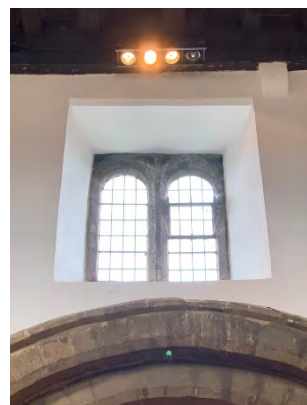
This appears to be in a reasonable condition.

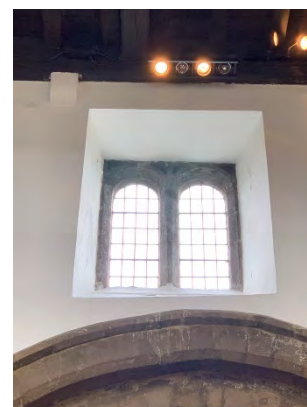
- 2.3.6. **North 2nd from west:**  
In reasonable condition.

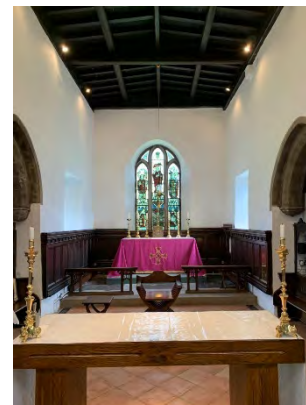
At low level close to the Sanctuary step there is some evidence of damp where the decorations have come away from the wall. It does not appear to be damp at the moment and redecoration should be undertaken after brushing back carefully. One crack over the east window which should be filled and decorated and monitored.

The stone work appears to be in good condition, if rather dirty. Particularly the joints of the Chancel Arch have been filled with a rather unattractive mortar as have a number of the Arches in the Nave. If the stone was cleaned, then these would become very obtrusive.

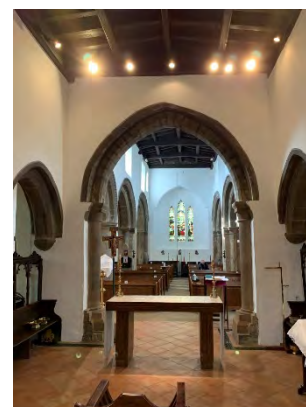
There is a slight indication of dis-colouration towards the west end of the Chancel roof and a closer inspection may be required or rather vigilance over whether there is any dampness or water coming through at that point.

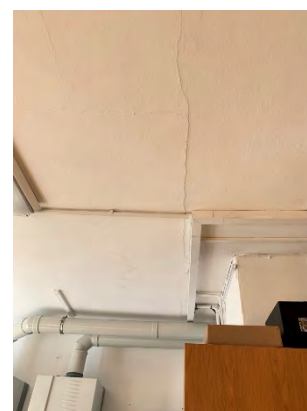
There is a crack running east –west to the ceiling which was mentioned in the previous report. This should be filled and monitored in time for the report in five years' time.

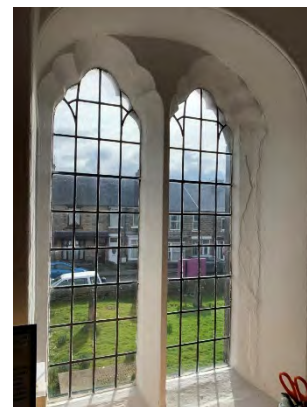
There are two light windows facing south with their stone reveals painted.

Both in good condition.

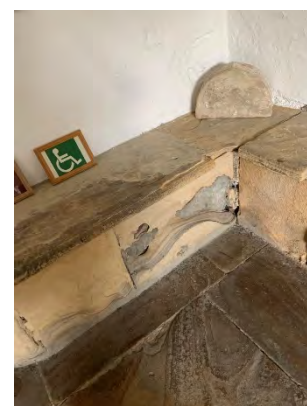
- 2.8.2. **Walls:**  
 Generally plastered and limewashed as elsewhere. There is a stone seat bench fitted into the wall on the east side and this is deteriorated in a number of places. It has had some very poor repairs in the past and these can be improved substantially.

2.8.6	South Porch Ground Floor Improve poor cement repairs to stone bench.	<b>1</b>
<b>3.6</b>	<b>ROUTINE MAINTENANCE – CATEGORY M</b>		
	<b>ITEM</b>	<b>Comment</b>	<b>Broad Budget Costs Inc above</b>
	2.2.3	Nave Ceiling West end flaking to nave – masonry to be repointed above.	
	2.4.10	South Aisle The Church should continue to be vigilant for any evidence of sawdust which may be due to wood boring insects.	<b>0</b>
	2.4.10	South Aisle Monitor stonework deterioration above 2nd window from west south aisle.	<b>1</b>
	2.5.9	North Aisle The Church should continue to be vigilant for any evidence of sawdust which may be due to wood boring insects.	<b>0</b>
	2.6.8	Chancel The Church should continue to be vigilant for any evidence of sawdust which may be due to wood boring insects in the chancel.	<b>0</b>
	2.8.6	South Porch Ground Floor Maintain door timber.	<b>1</b>

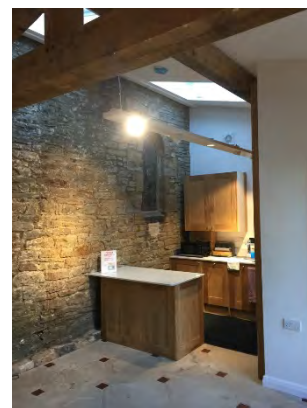
- 2.9.2. **Stonework Condition:** The north wall bows out significantly. The two Victorian buttresses were removed during construction and the wall stabilised. Generally the mortar pointing is in reasonable condition.

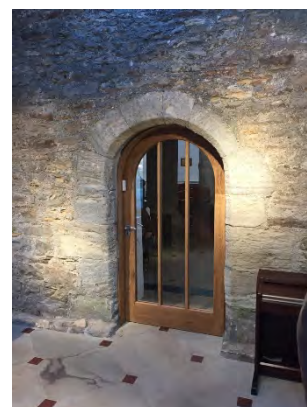
- 2.9.3. **North Door and surround:** In good condition.

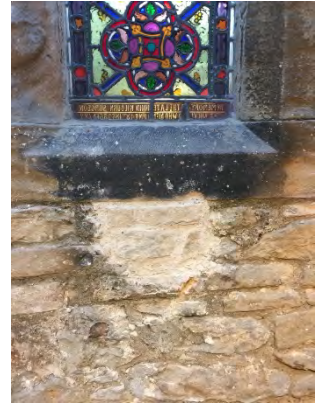
- 2.9.4. First window from the west: The original stonework around the window to the west end showed signs of weathering, however this is now internal and protected.  
Second window from the west: The original stonework is generally in reasonable condition, although the left jamb is weathered. Now internal and protected.
