**ST CHAD'S BENSHAM**  
**QUINQUENNIAL INSPECTION REPORT 2024**

An inspection for this report was carried out on 23 August 2024 by Amy Redman. The previous quinquennial inspection was carried out by Chloe Granger in 2019.

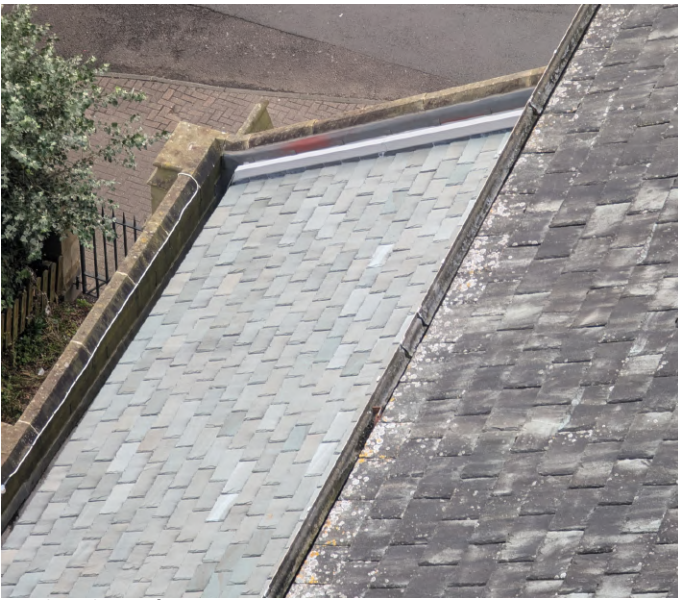
South Aisle Roof - new in 2022

All slates and ridges are in good condition. The lead flashings were replaced in 2015 in code 6 lead and are in good condition.

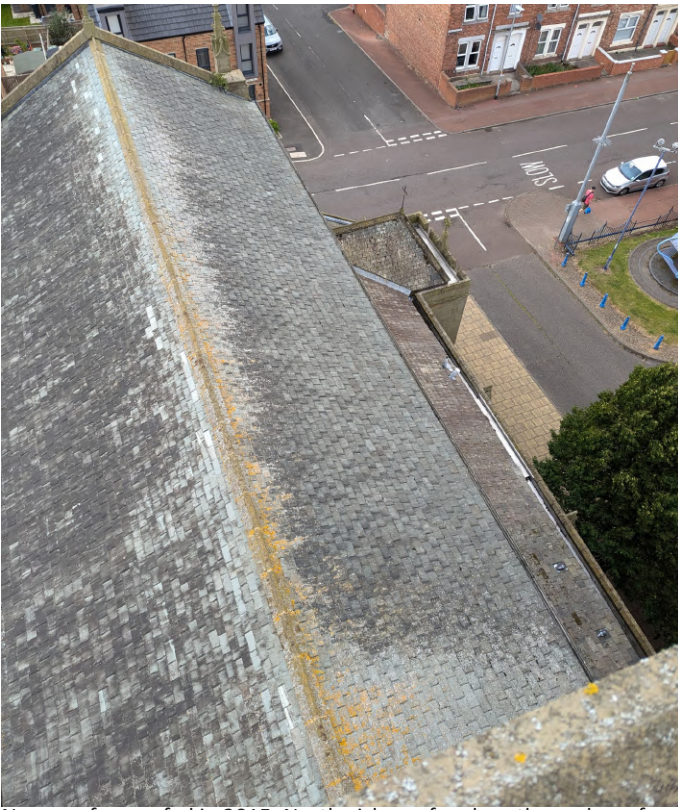
Nave roof re-roofed in 2015. North aisle roof and north porch roof beyond.

To the south pitch the lead-replacement flashings have been pulled away by thieves in search of lead in three areas: at the base of the down pipe on the west end, and two areas where the ambulatory flat roof begins. It would be worth considering a roof alarm as this roof frequently gets climbed on. All flashings here are Ubiflex or equivalent with lead soakers underneath, and all appear in satisfactory condition where not disturbed.

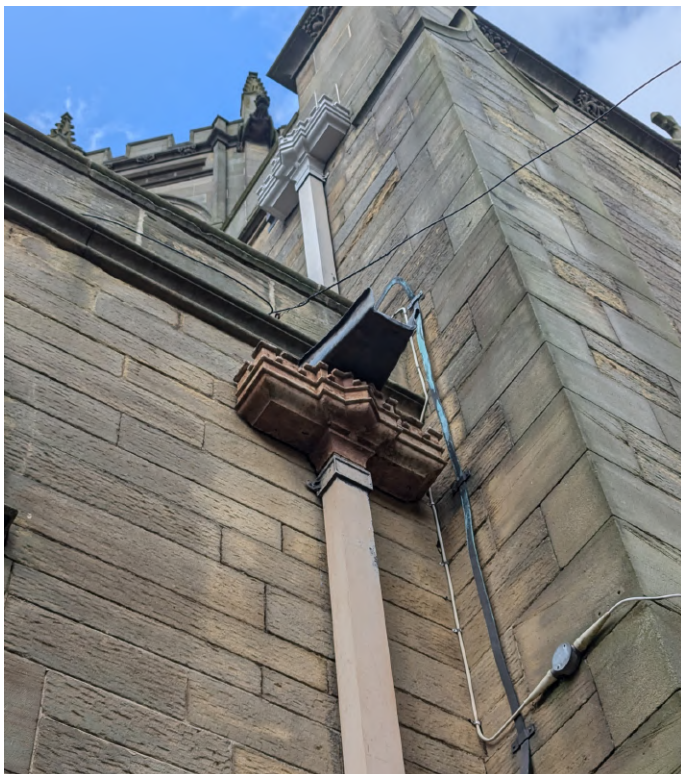
Hopper at south aisle with refurbished hopper of the west side of the north transept (refurbished 2022).

All low level down pipes finish over gullies although many are not visible beneath undergrowth and debris. These should be cleared out and checked that they are all free flowing to maintain rainwater water discharge. *(Outstanding from previous QI report.)*

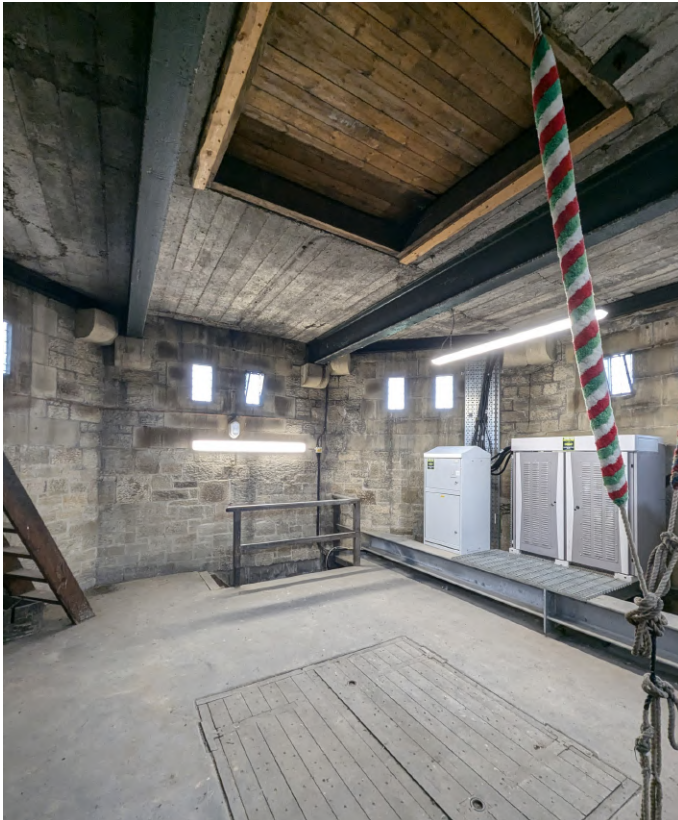
Ringling chamber.

The next level is the louvred belfry, accessed up a timber ladder. The belfry also holds the clock faces. The concrete floor has visible cracks, as seen from below. *(As previous QI report.)*

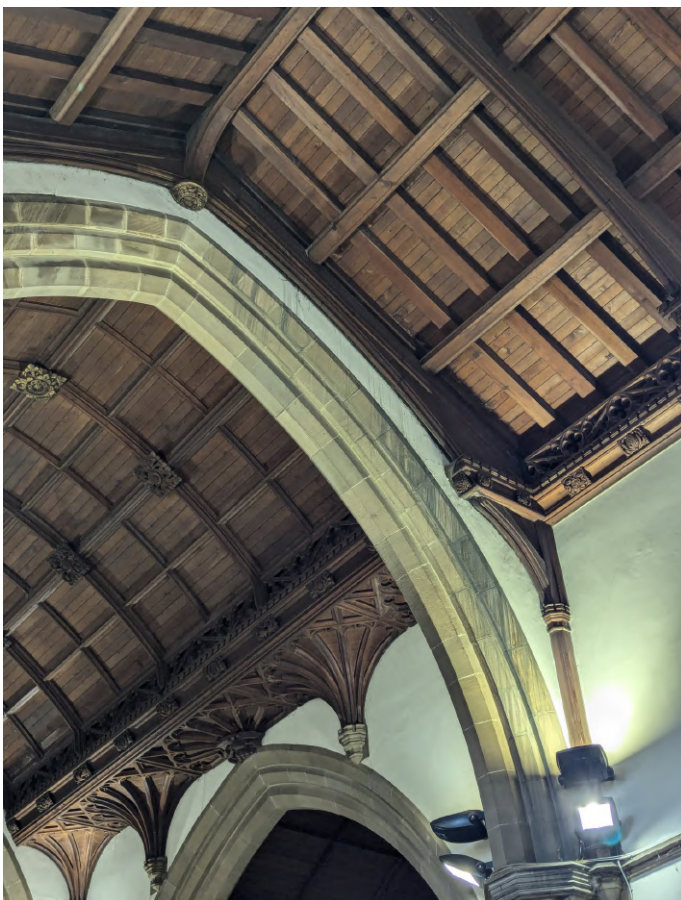
Suspended timber ceilings to nave and chancel. Chancel arch to centre.

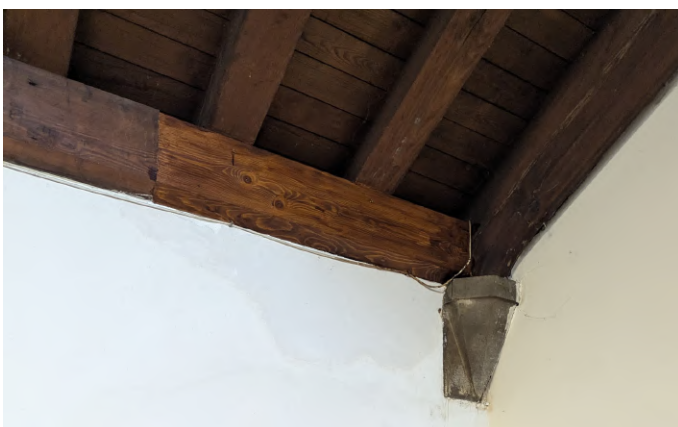
Repairs to previous area of water ingress to south aisle.

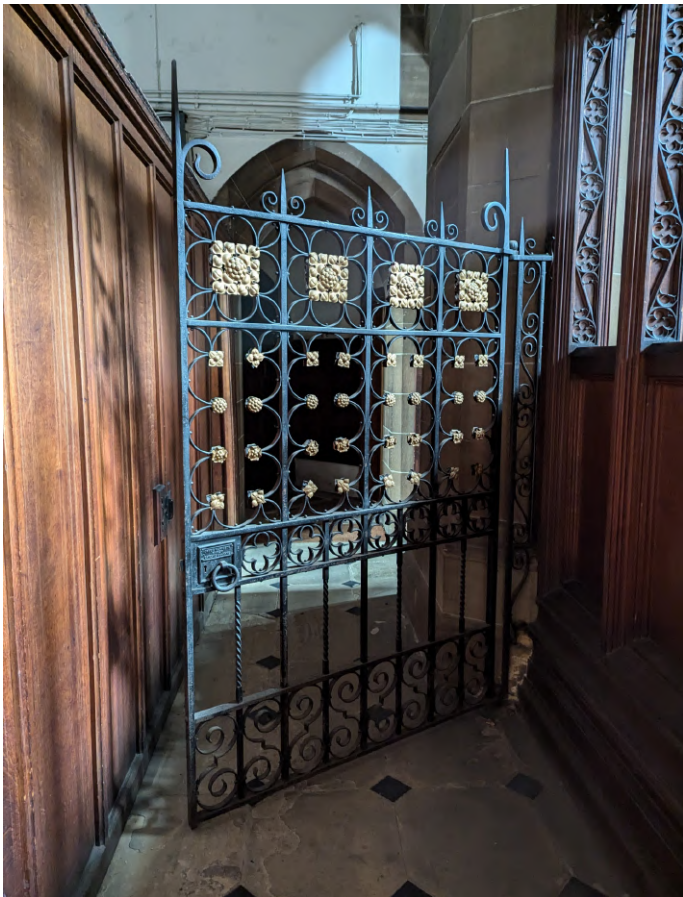
To both the north and south aisles at the far east end, north and south of the chancel, are two large wrought gates that when closed would restrict access to the choir vestry and sacristy, and the Chapel of All Saints beyond. These are original with decorative motifs and of excellent quality. They would benefit from rubbing down and repainting, although the application of gold should be chosen carefully as these would have originally been gold leaf. *(Outstanding from previous QI report.)*

Gate to north ambulatory. Requires some redecoration and refurbishment.

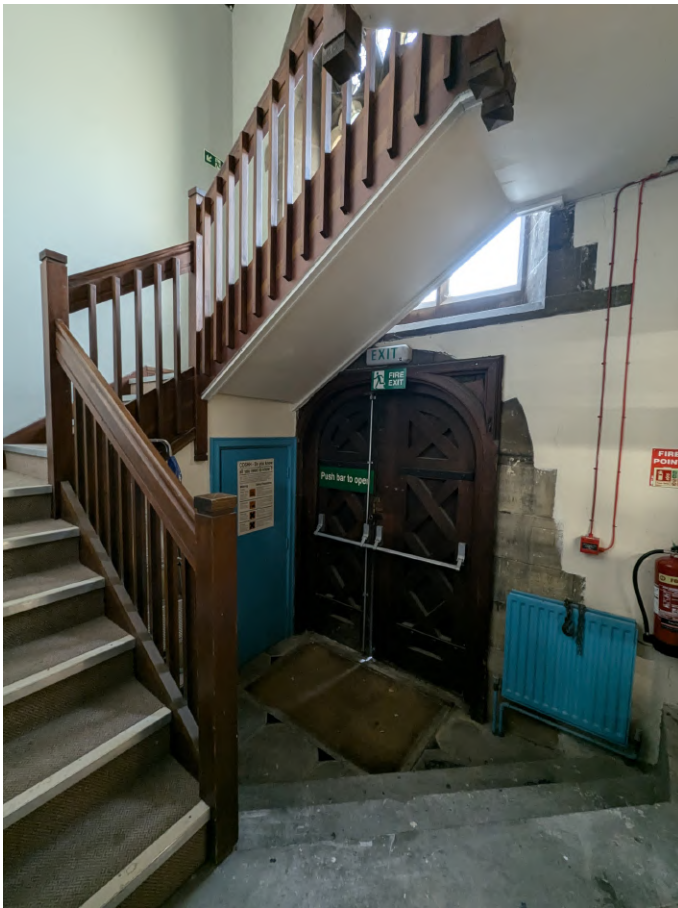
West door entrance space.

The plaster to the external wall has recently been painted but it would appear that there has been historic damp in this area. The previous QI notes vinyl paint in this area which would be preventing the wall behind from breathing. It is unknown whether the plastering that was carried out during

the reordering is of a compatible material or whether this too is contributing to the restrictions of moisture movement within the wall. (*As previous QI report.*) The wall to the stair looked fine at time of survey although it had been recently redecorated. Roofing works are required over this space.

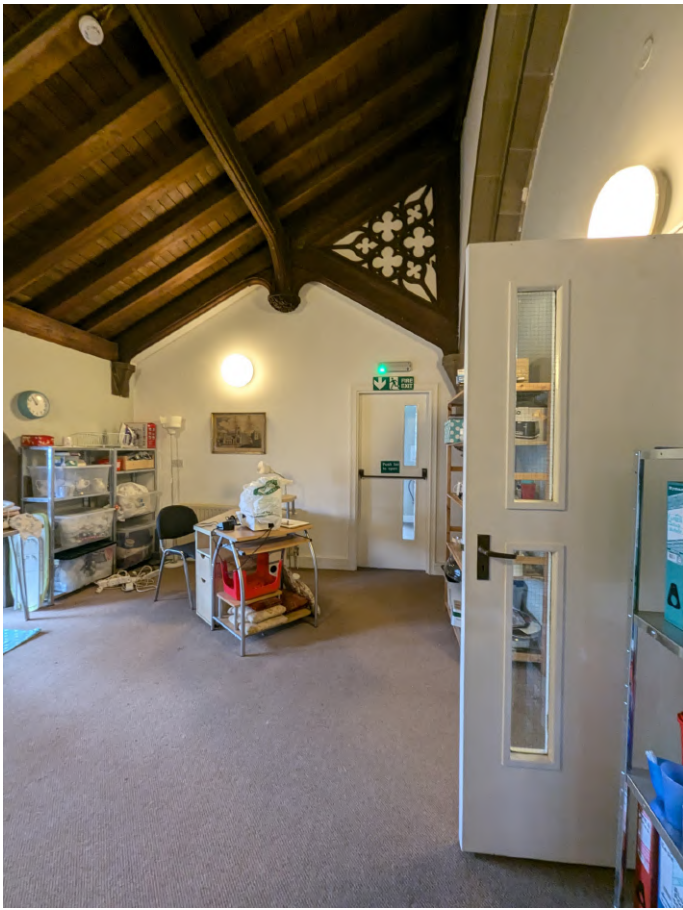
Smaller meeting room on the upper floor at the west end.

movement within the leaded panels and a few cracked pieces, but nothing of concern. (As previous QI report.) Some areas of hollow plaster above window on left side and salts to stone surround of window. Replace hollowed plaster and redecorate.

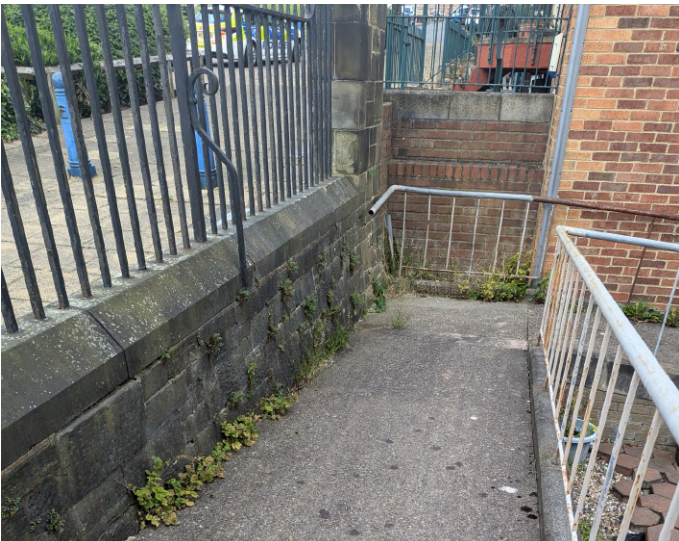
Accessible ramp down to north-east entrance. Railings require some redecoration. Boundary wall requires weeding and repointing.

j)	*Touch up paintwork in chancel, south side, where former light fittings have been removed.	500
k)	*Re-point boundary wall to west, against pavement. Some minor rebuilding and re-setting of copings. Repair gate pier at west boundary wall. Repoint boundary wall to north and re-set copings. Approx.5LM of walling to be rebuilt.	3,000

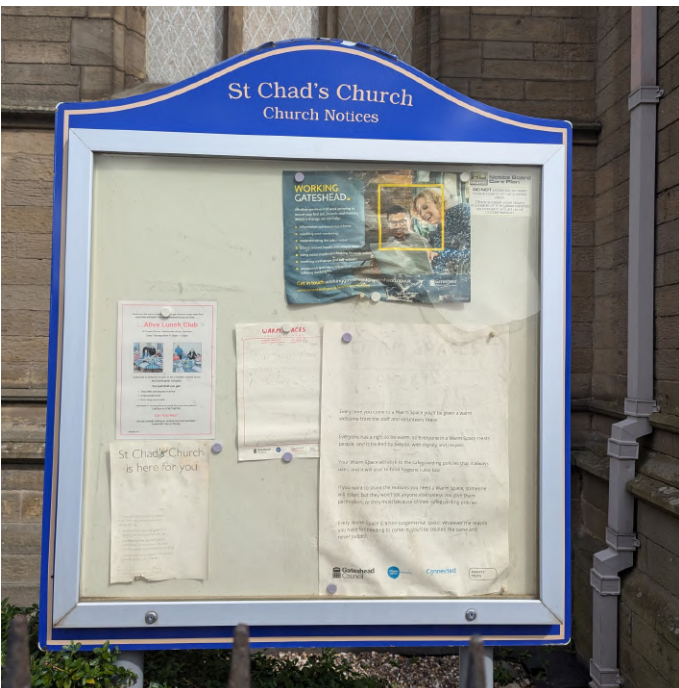
Noticeboard at north-west corner of church.

l)	*Add additional noticeboard to north-west corner of plot, to post community hall notices and events etc.	1,500
m)	Refurbish entrance doors generally. North entrance door leaf and frame, repair threshold area. North-east porch door - overhaul detail to threshold.	5,000

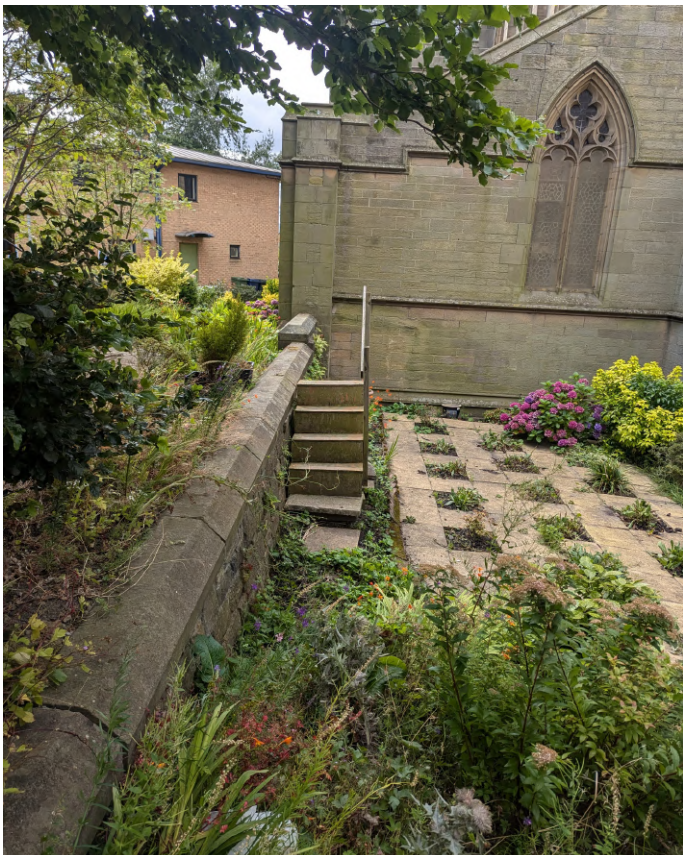
Beds to south walkway are kept beautifully. Garden to south of retro-chapel is neat and well-maintained but access is difficult.

standing but appear to be roughly at ground level. These areas are difficult to keep tidy due to poor access and rubbish and debris frequently builds up. The church keeps on top of the maintenance as best they can but it is hard work. It is suggested that a group of volunteers be set up from the local community to maintain this area, and others around the church of rubbish and vegetation.

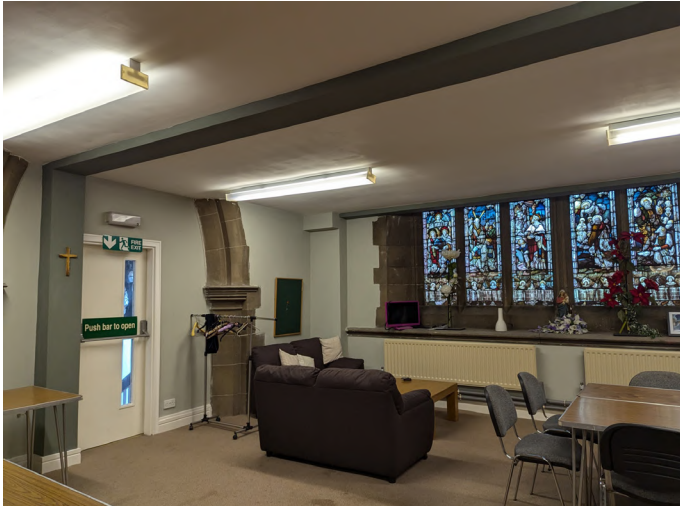
Meeting room 2 at upper floor of west end

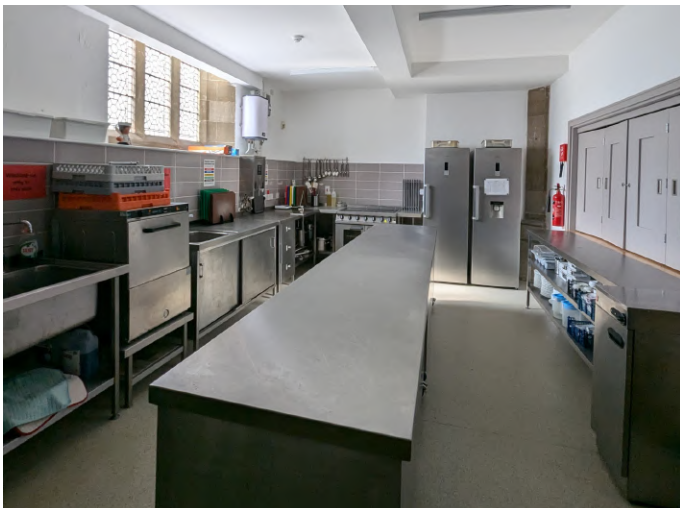
New kitchen installed in 2020/2021.

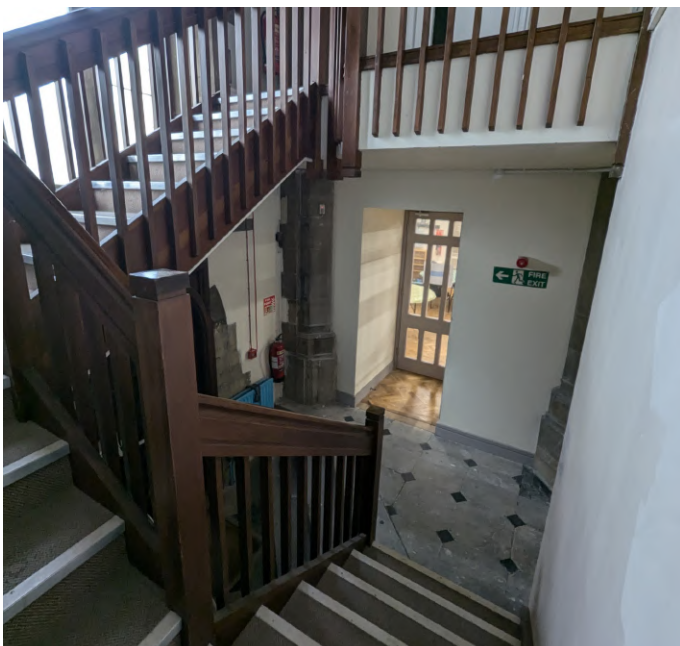
Entrance at west end of church (south-west corner) with access to community room and upper floors.
