**St JOHN the EVANGELIST
BIRTLEY
(2)**

QUINQUENNIAL REPORT
on the architect's inspection on

16 June 2023

IAN NESS
ARCHITECT
26 GROSVENOR PLACE NEWCASTLE upon TYNE NE2 2RE
tel & fax
0191 281 2559
i.ness@btinternet.com

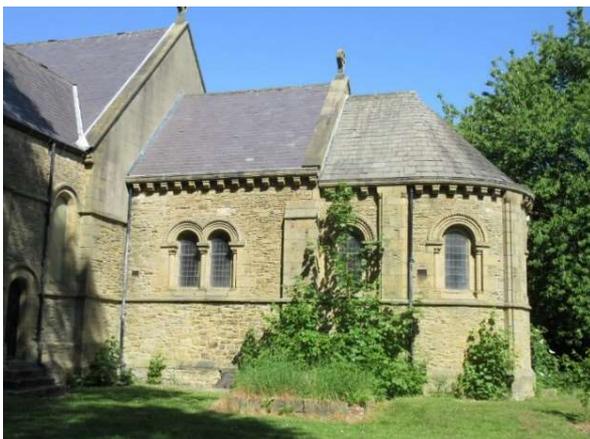
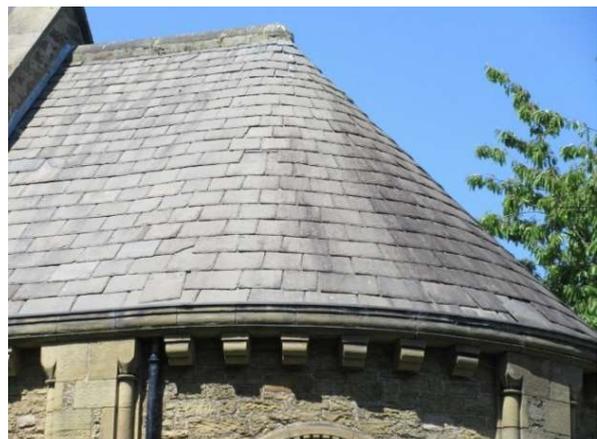
13. The apsidal **Sanctuary** has old diminishing westmorland slate, very large at the eave, narrow at the small radius at the top of the cone. A short stone ridge without the usual lead cap at a cone apex.
Most slates in bottom two courses are held on lead clips.
At S and SE two slates near eave slipped into gutter.
Several narrow slates at N side top are slipped sideways. A slater may be able to straighten and hold with a dab of silicon rubber. Otherwise sound and may serve a long time.
The former welded lead lining of the long level curved stone gutter has been changed to a substitute with metal drip edge.

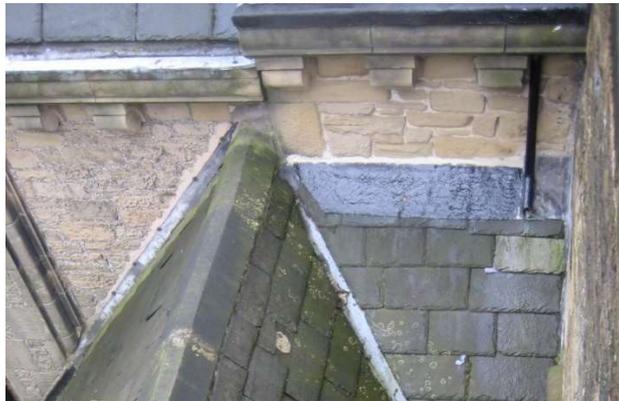
2023 – slate above Choir gutter, down pipe and Sacristy slate head flashing all missing

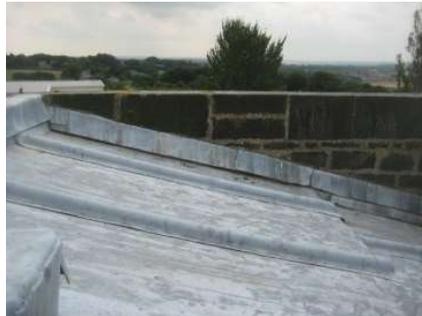
29. *No access to **Tower** roof at this inspection so following adapted from 2013.
A steep single pitched heavy gauge lead roof with drips and timber rolls. A lead burned hood on a ventilation shaft brought up from high level in the Nave.
A collar around the stainless flue had leaked slightly.*

*The narrow top S bay had slipped about 1" down slope and was pushed part way back in 2013.
No apparent fixings in lead tray or the upstand under the cover flashing. Needed suitable copper nail head fixings and a wider top flashing to cover them.*

The top cover flashings are wedged into grooves in the top of the E coping but not pointed so may leak slightly, perhaps contributing to the stone erosion seen inside the top of the tower.

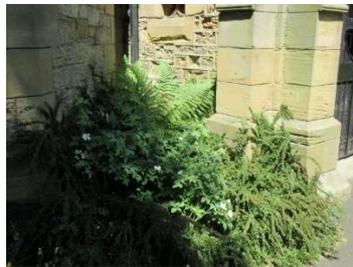
38. **N Vestry** plastic hopper and square pipe has been blocked (and damp damage on the stone and inside para 97). Check flow in rain and clear if needed. Gully blocked.
39. **Organ chamber** lead outlet to cast iron hopper and pipe to a blocked gully shared with a cast iron pipe from the Sacristy in the cleft between them. At **Sacristy** curved and straight cast iron gutter with E pipe to a gully shared with the Sanctuary N pipe. The pipes fair but some rust and fixed too close for full repainting. Concrete ground channel.
40. Gullies large earthenware dishes, mostly with iron grills, most choked or broken.

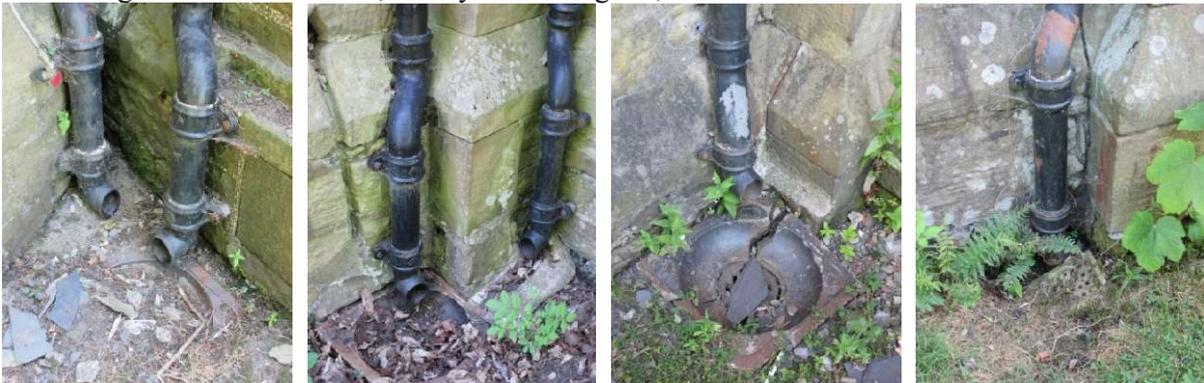
Most gullies are choked or broken, so rainwater more likely to soak into the ground and subwalls, adding to rising damp instead of running away safely to soakaways.

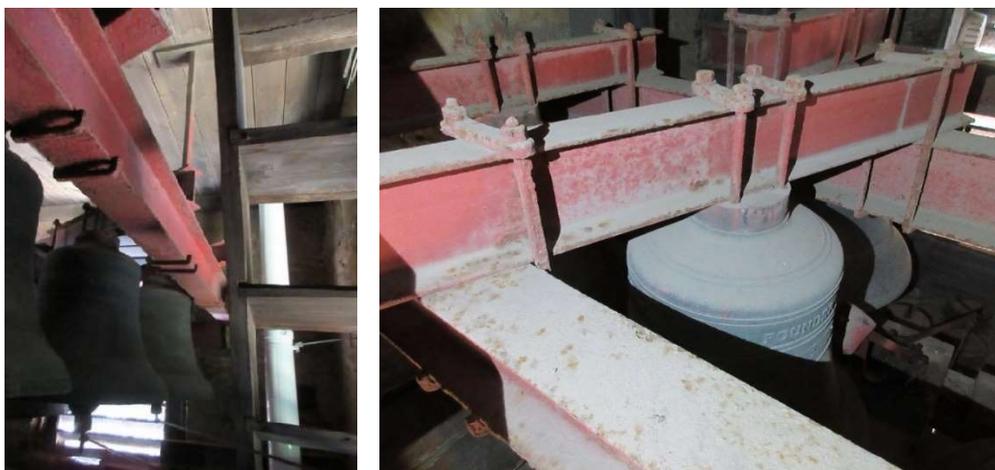
Top stage – under the slipped roof lead and under the roof hatch

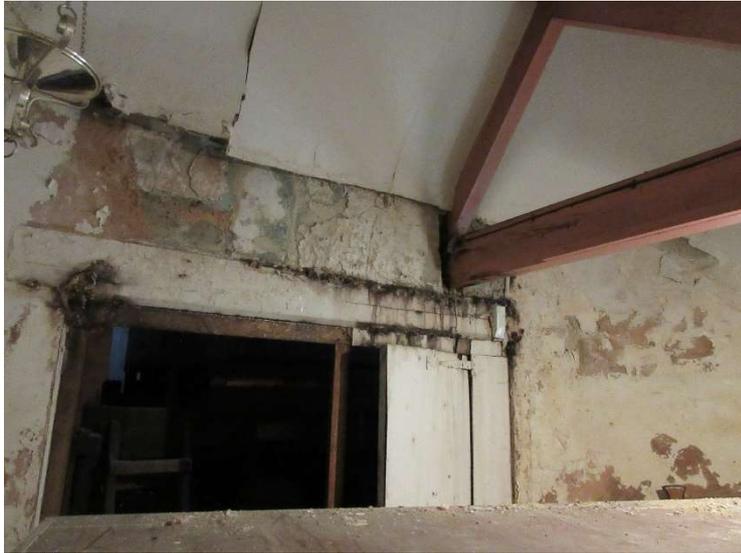
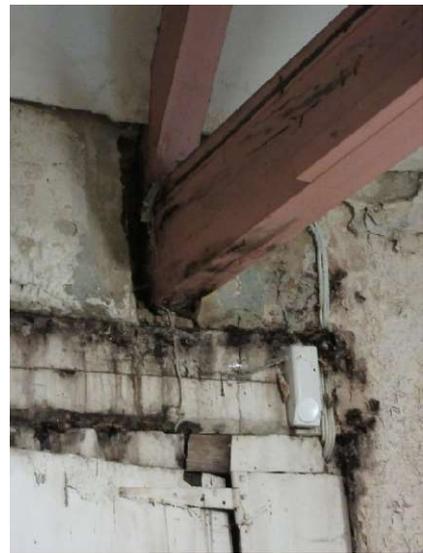
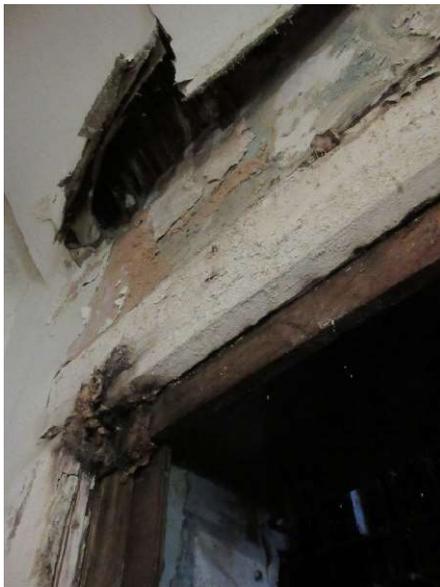
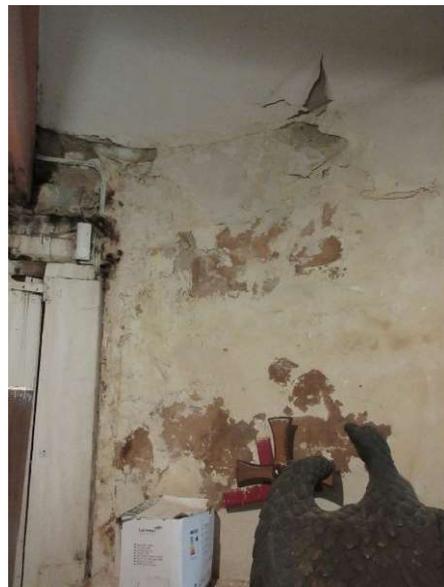
78. The **Choir** roof is one king post truss with curved braces on wall corbels. No visible defect.
79. The **Sacristy** small ridged and apsidal roof is open with plastered rafters. Straight and curved exposed purlins on a single king post truss at the apse centre.
 After the gutter leak (para 18) the truss W end under the box gutter is much softer than previously due to further rot. No visible movement at present but **structural failure** is now a possibility at any time.
 The truss rests on wooden lintels over former double doors between the Sacristy and Organ chamber. New fungal bodies on the lintels appear dried out but the lintels must also be weakened.
 If the Sacristy is not demolished the lintels should be replaced with concrete or steel and the truss end repaired, either with a timber splice or a steel shoe by specialist contractor.

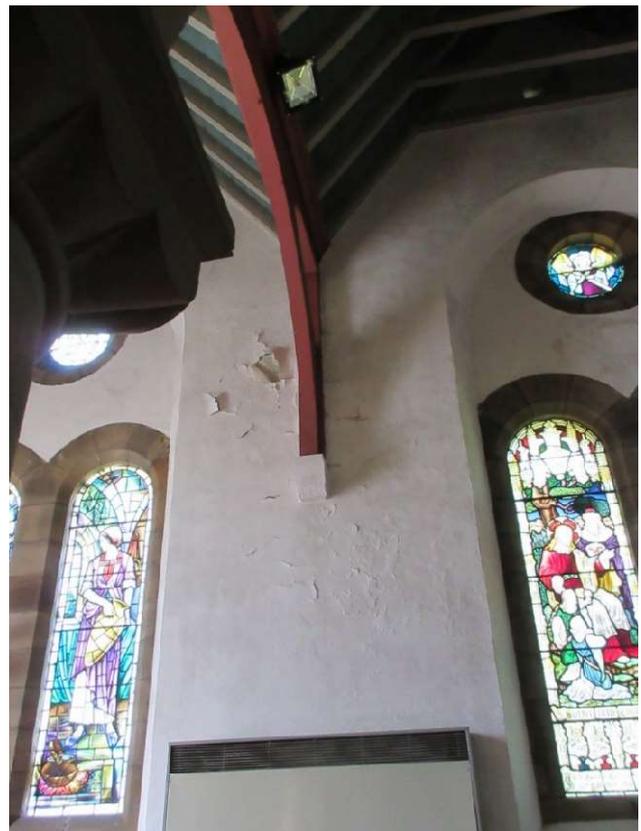
N Transept W corner

- at top of **S Transept SE corner**
- at **N Transept NW corner** and over and under the **W window** efflorescence of salts and paint poor (salts outside)
- at **N Transept NE corner** some mould on the paint (winter condensation on the coldest masonry)
