QUINQUENNIAL INSPECTION REPORT

BISHOP MIDDLEHAM, ST MICHAEL

**DIOCESE OF DURHAM
ARCHDEACONRY OF DURHAM
DEANERY OF SEDGFIELD
PARISH OF UPPER SKERNE**

**QUINQUENNIAL INSPECTION AND REPORT
January 2025**

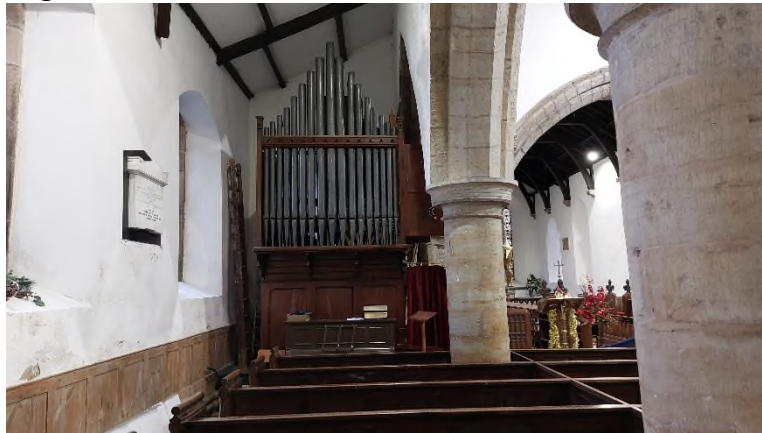
B Organ:

Harrison organ in the north aisle with blower at the east side of it within a simple pine casing. Cost £141-10/- in 1891. Originally sited in chancel and moved in reordering of 1906-1910.

Tuned annually. Plays well. Some lumber building up around it.

Recommendation: clear away the lumber to enable adequate inspection and get air to it.

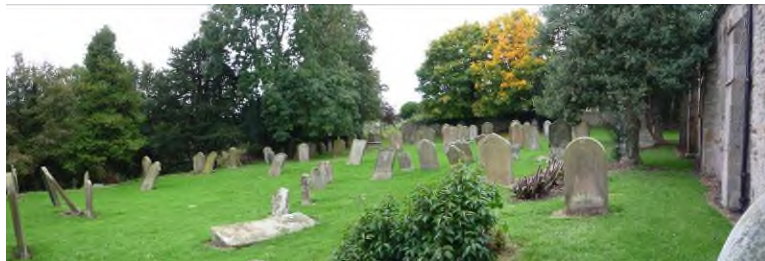
M **Churchyard:** is open and responsibility for maintenance lies with the PCC who operate an informal wildlife management scheme. There are some monuments that look to be close to toppling, these are tested by the PCC and this comes with various H&S dangers.

The war memorial (listed) was moved 1m further into the churchyard and away from the north boundary wall to reduce the chance of north boundary wall collapse. And the wall is ok.

There are listed monuments in the churchyard- see appendix and their condition needs assessing and recording. The Surtees family have a great presence.

Recommendation: review method of testing ability of the headstones to comply with H&S requirements. Assess condition of listed monuments.

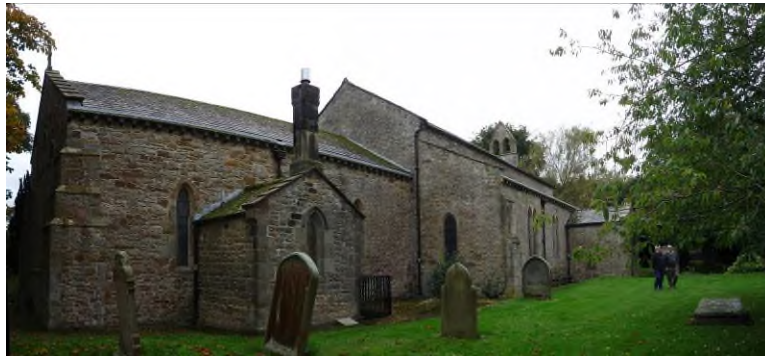
Roof general: all in good condition and all the flashings look tight. The bellcote flashings need tucking in and can be a part of the bellcote repair works. Did the bell hanger check them?
The comprehensive list is below.

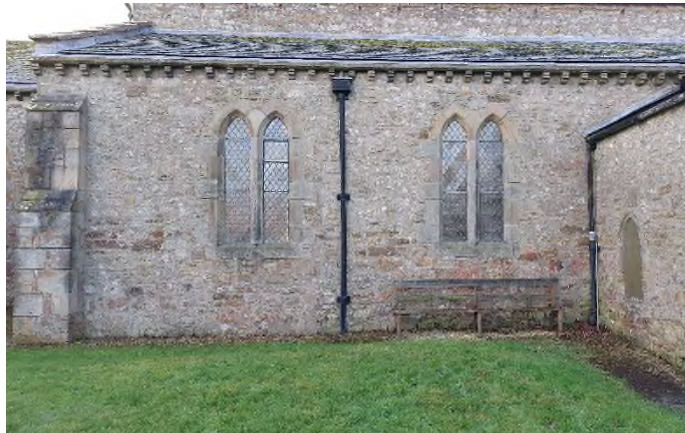
- North – reading from east to west: Open joints to the gutter corbel. Walling is generally sound, though there are some open joints to the base of the wall. The eastern most buttress is okay, apart from some slight open joints at the top stage.

- Window 1 – pair of lancets with slight open joints. Obscure diamond pattern with rusting ventilator, unprotected. Window 2 – pair of lancets with slight open joints. Obscure diamond pattern, unprotected.

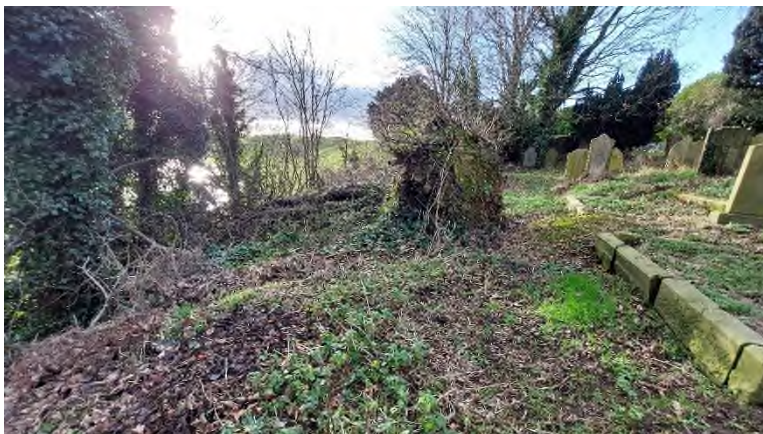
- **South Boundary:** runs down into a woodland that has an unmarked boundary. Is there a retaining wall here? Becoming overgrown. Yew tree blown over and intended to remain.

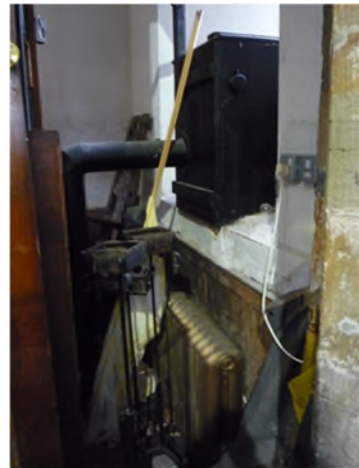
- Ceiling – sloping with exposed truss rafters and purlins. Plastered and painted panels in fair condition.
- Walls – painted plaster with exposed timber dado below (reused panelling from removed box pews in 1906). Some evidence of discolouration at window sills and plaster blowing a bit above the dado. Damp in the organ corner.
- Floor- see following section

Recommendation: remove lumber from organ area to encourage air movement

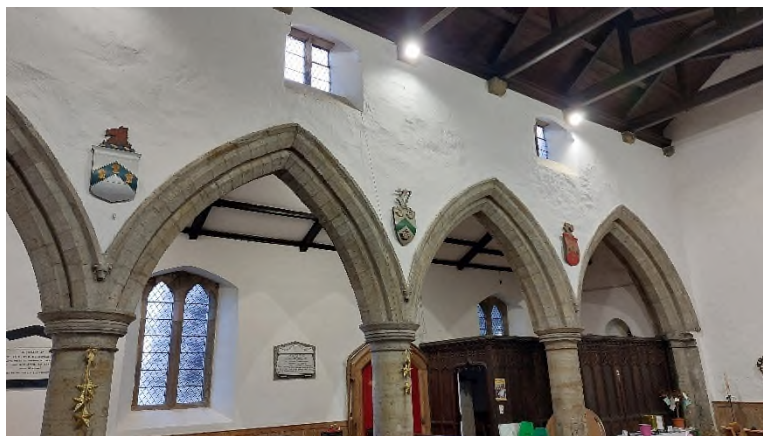
South aisle:

Same construction as north aisle.

- Walls – are in better condition than north.

Recommendation: none

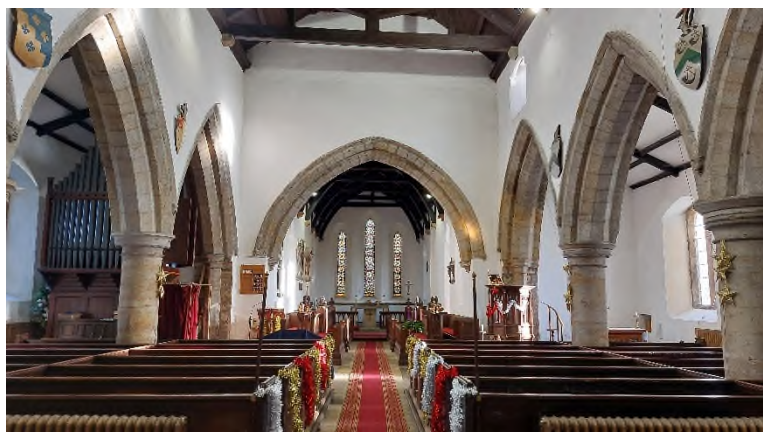
C Nave:

- Ceiling – exposed seven truss roof on stone corbels (S easternmost two in timber) with exposed boarding. No evidence of water marking. Timber corbel breaking up (because they couldn't fit a stone lintel at the clerestory opening?). If this is a weakened corner considering the stone erosion outside it could need prompt attention.
- Walls –
 - West – painted plaster with dado below. Some marking from water penetration from the bell rope pipe.
 - Window masonry okay, the glass is dirty and features St Michael in pictorial glass. New cabinet below supporting relocated reredos in good condition.

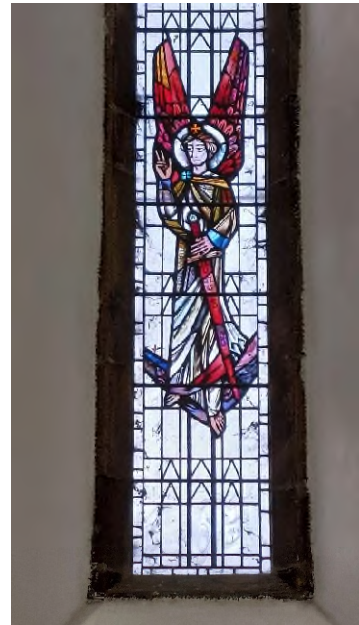
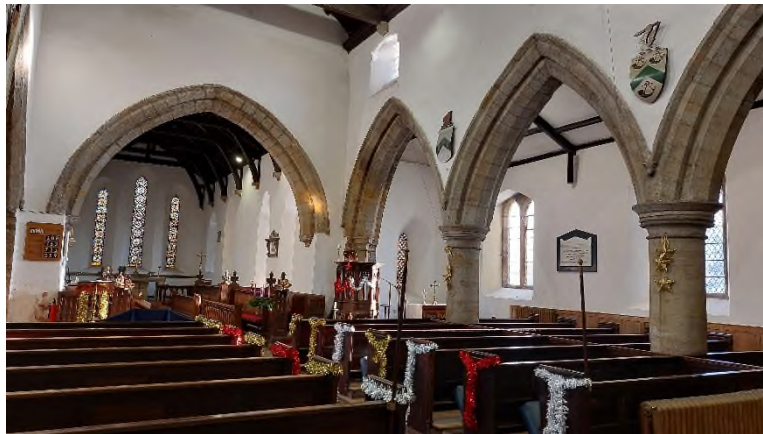
- Arcade - Lancet pointed aisles with circular drums and keel responds. Structurally in very good condition – there is no cracking evident to them, on either sides including that within the aisles. There have been some cement repairs to the bases as they have suffered from damp. Joints to the drums are circa 8mm and they look to have been lime washed in the past.

- Floor - Solid floor to all circulation spaces comprising concrete at the west end and stone slabs elsewhere. Some patching has occurred in the past and there is one raised slab close to the end of the pews on the northern side. A couple of open joints towards the front of the nave and areas of concrete by the lectern. Circulation areas are covered by carpet, in fair condition, though the entrance carpet is not fixed down. The west end has had its pew platform lowered to form a level surface with the reused pew platform boarding.

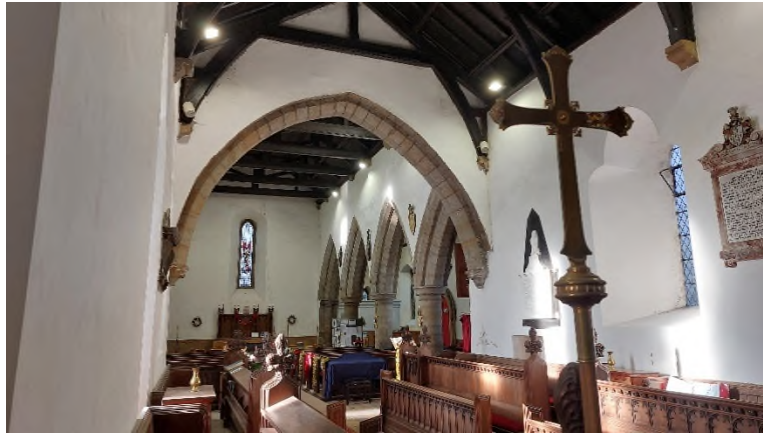
B **Chancel:**

- Ceiling – exposed roof and better quality than the nave. Six exposed trusses with no water marking.

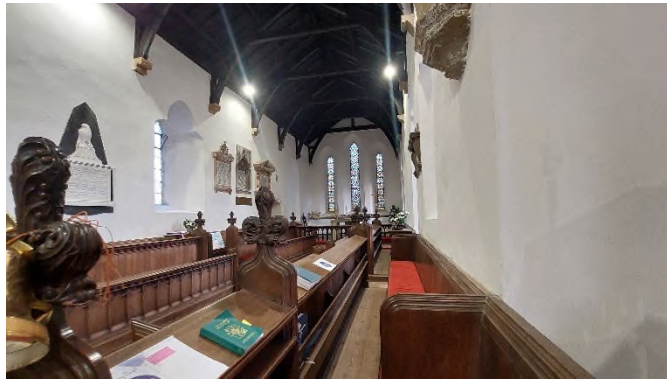
- Walls – painted plaster walls on all elevations.
 - East - has three light window with a shelf with some open joints to it – probably old screw fixings for cloth and some damp at low level.

- South - wall okay. The eastern most window has been re-glazed in the recent past and its pointing is undecorated and there are cobwebs.
 - West- formed by the chancel arch, whilst this has depressed slightly there is no cracking evident to it now, neither on the nave side.
