# Quinquennial Inspection Report

**Parish Church of St Nicholas  
Bishopwearmouth, Sunderland  
Diocese - Durham  
Archdeaconry – Sunderland**

**Date of report:** 13 August 2021

**Ref:** 21026

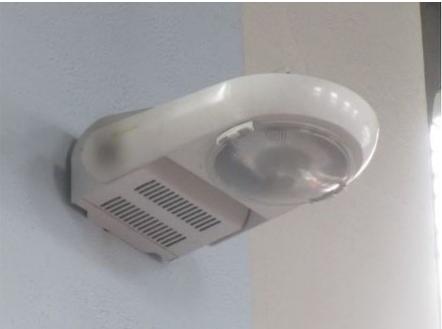
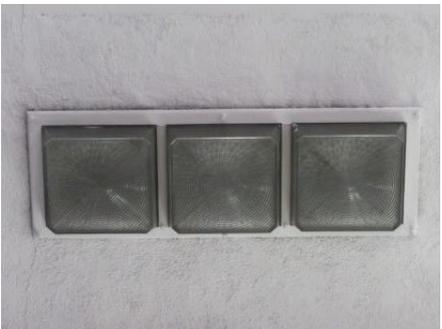
<p>A new distribution board was fitted in 2012 and there was some partial rewiring (mainly in the plant room area).</p> <p>New light fittings were installed circa 1996 and comprise wall mounted light fittings in the Nave and Chancel (upper photo); wall mounted spotlights in the Apse; ceiling mounted light fittings and wall mounted spotlights in the Lady Chapel. The original mercury tungsten filament light fittings in the high ceiling of the Nave and Chancel are used occasionally for special services (lower photo).</p> <p>Consideration should be replacing the luminaires in the wall lights and central lights with an LED type which be more energy efficient.</p> <p>2No plasma screens have been fitted at the front of the Nave.</p> <p>It is recommended that a full electrical test is carried out every five years and portable electrical appliances are tested every year.</p>	E
<b>4.4 Water supply</b>
