CHURCH OF SAINT BRANDON

BRANCEPETH

REPORT ON QUINQUENNIAL INSPECTION

Inspection Date: 17th August 2023

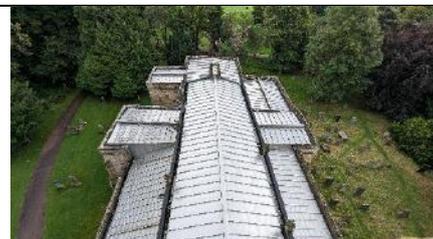
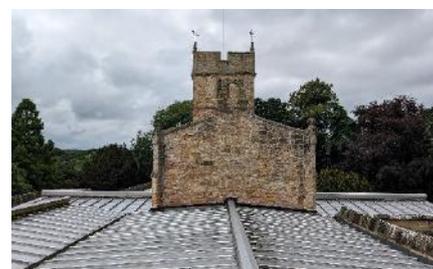
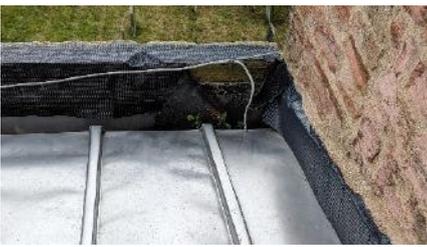
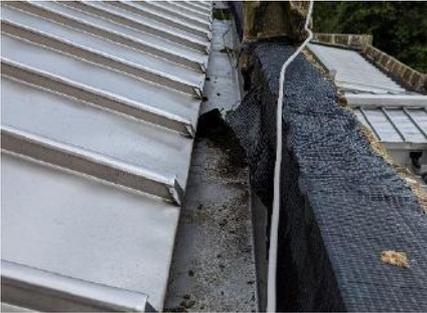
2.1.2.	<p>Nave Roof This is in stainless steel on a steel frame, all rebuilt post fire. The nave originally had lead flashings into stainless steel parapet gutters.</p> <p>The lead flashings have been replaced with black Ubiflex (or similar) which caps the copings. The quality of the installation is generally poor as elsewhere. The full length of the gutters could not be checked due to low parapets/access restrictions, however, there is a split section of flashing to the south west corner that needs urgent repair / replacement. There also appeared to be split sections over the westernmost outlets to both the north and south gutters. Replacement of the whole length of flashings in a different material should be undertaken.</p> <p>There is a build-up of moss in the gutters, particularly to the north side that needs clearing.</p>

2.1.13.		Recommendations:
	B	<ul style="list-style-type: none"> To the roofs generally: Replace the poor flashings comprehensively and with appropriate materials.
	M	<ul style="list-style-type: none"> To the roofs generally: Clear gutters of moss and debris, particularly to the north side of the Church.
	A	<ul style="list-style-type: none"> Until flashings are replaced, repair split sections of flashing to the Nave, Lady Chapel, South Transept and Chancel. Replace flashing to west end of South Aisle due to internal damp. Point flashings to vestry roof.
	A	<ul style="list-style-type: none"> Vestry: Inspect vestry roof to determine original location of loose piece of steel roofing and monitor interior for leaks.
	B	<ul style="list-style-type: none"> North and South Aisles: Remove vegetation to the west end parapets of the north and south aisles and make good / point on completion.
	B	<ul style="list-style-type: none"> North and South Aisles: Open joints to the copings of the north and south aisles should be pointed.

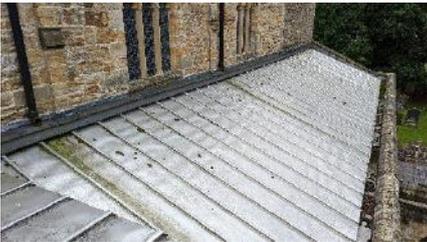
<p>2.1.3.</p>	<p>North Aisle Roof</p> <p>This appears generally to be in good order, however, there is vegetation growth to the west parapet that should be removed and pointed.</p> <p>Open joints to the coping stones to this parapet and the north parapet should be pointed.</p> <p>Moss to the gutter should also be removed. The flashings are generally in lead with only a small localised section of black ubiflex (or similar) to the north elevation. It is advised that high level access is arranged over the North Porch due to evidence of damp internally and externally. No obvious signs of failed roofing was visible but access was limited.</p>

A	<ul style="list-style-type: none"> North Aisle: Arrange access to inspect area over the North Porch
	A	<ul style="list-style-type: none"> Tower: Add a clip to the dislodged stainless steel to the tower roof.
	C	<ul style="list-style-type: none"> Tower: Improve access to the tower (eg hinging access hatch).
	C	<ul style="list-style-type: none"> Tower: Point open joints to tower parapet copings.
	M	<ul style="list-style-type: none"> North and South Porch: Remove vegetation to South and North Porch gutters
	B	<ul style="list-style-type: none"> North Porch: Re-fix slipped slate to North Porch
	C	<ul style="list-style-type: none"> North Porch: Check timber to North Porch roof and remove if redundant.

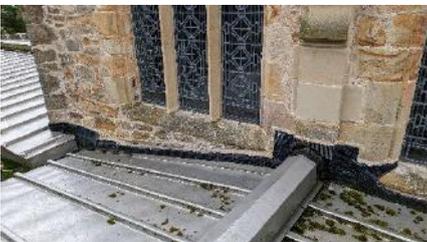
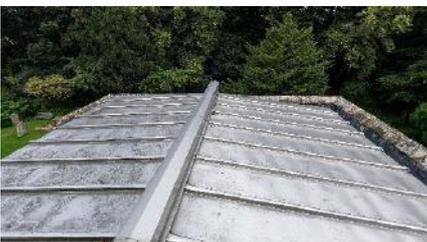
<p>2.1.4.</p>	<p>North Transept Roof</p> <p>The parapet has been reset and is generally in good order. The roof as elsewhere is stainless steel and the flashings have recently been stolen and very poorly replaced in black ubiflex (or similar). Replacement of the flashings in a different material should be undertaken.</p> <p>Moss should be cleared to the roof and gutters to avoid blockages. The gutter in this location is a bit shallower than other locations, and as it is to the north elevation, receives less sunlight and will be more prone to moss growth.</p>

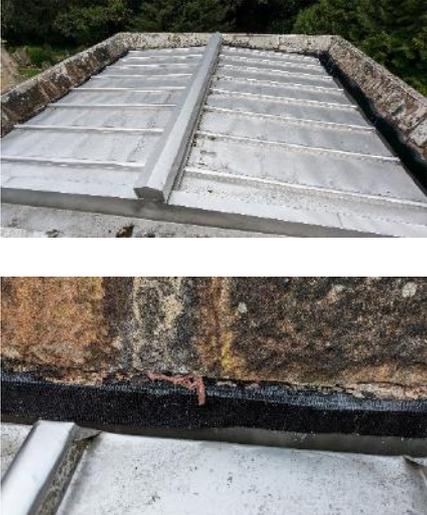
<p>2.1.5.</p>	<p>Vestry Roof</p> <p>The parapet is in good order. The roof as elsewhere is stainless steel and the flashings have recently been stolen and very poorly replaced – these should be renewed. The mastic pointing to the flashings has also failed and should be addressed.</p> <p>There is a piece of loose stainless steel (possibly from the end of a batten roll). It was not obvious where this has come from. The Church should be vigilant for leaks and the stainless steel should be retained for reinstatement in the future. Investigations should be made to see where this may have originated from.</p> <p>Moss should be cleared from the gutters to avoid blockages.</p>

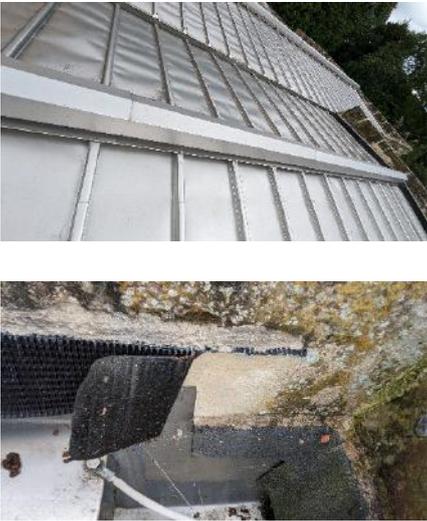
<p>2.1.7.</p>	<p>The Lady Chapel Roof</p> <p>Stainless steel as before and parapet in good order. Lead flashings have been stolen and poorly replaced in black ubiflex (or similar). The flashings should be replaced, particularly a split section to the south east corner.</p> <p>The copings were repointed in 2022 and the parapets are in good order.</p>

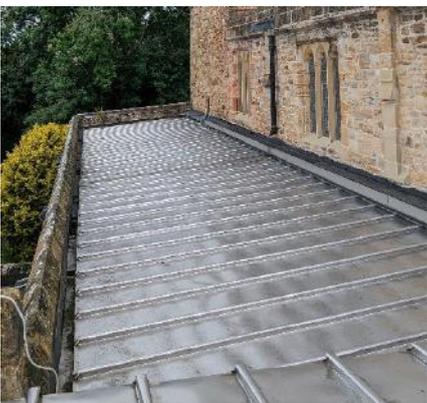
<p>2.1.9.</p>	<p>South Aisle Roof As previously this is stainless steel. The parapets are generally in good order, however, at the west end of the south elevation and to the west end parapet the copings require re-pointing. Vegetation removal is also required to the west end with repointing on completion. There is damp internally and therefore it is suggested these elements are addressed as soon as possible. It is also advised that the flashings are replaced and pointed to try and address the water ingress.</p>

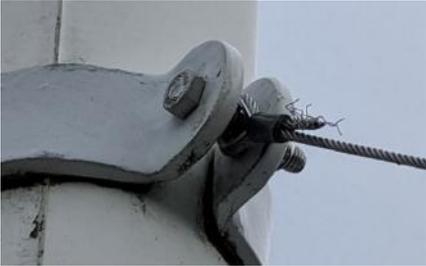
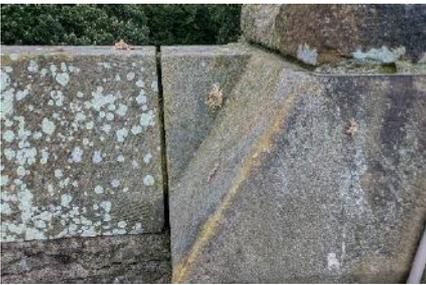
<p>Access to the tower is difficult and could be improved. The access hatch could be hinged (the damage to the clip could be due to the current hatch) and bars added to crenels (where this will not hinder access for the flagpole).</p>

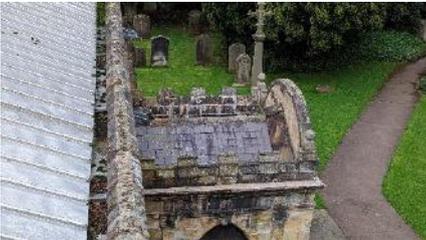
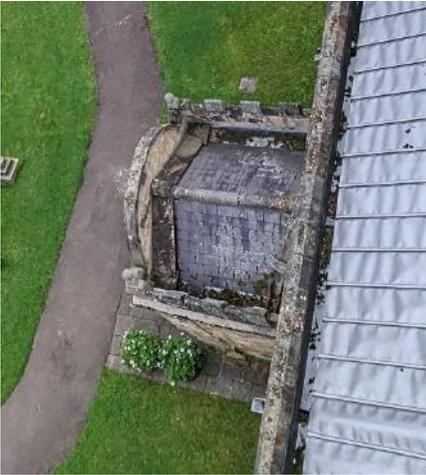
<p>2.1.12.</p>	<p>North Porch Roof There is a slipped slate to the west side that needs re-fixing. Gutters and outlet chutes need clearing and there is some vegetation to remove. There is a piece of timber to the west slope that was only just visible from the tower – this should be checked and removed if redundant. (The assessment was made at a distance from the North Aisle / Tower and closer inspection is advised)</p>

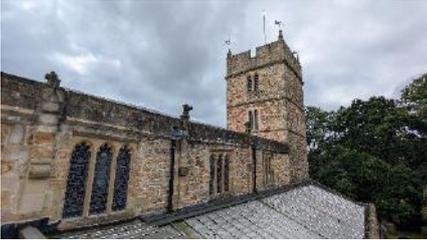
2.2.	<p>ROOF LEVEL STONEMWORK AND ROOFS: North Nave Clerestory Level Stonework and Windows from West to East</p>	
2.2.1.	<p>Windows Generally</p> <p>All of the windows at Clerestory level are in good order having been replaced within the last ten years with lead comes and clear glass.</p> <p>(Note: No close access on north side of roof)</p>

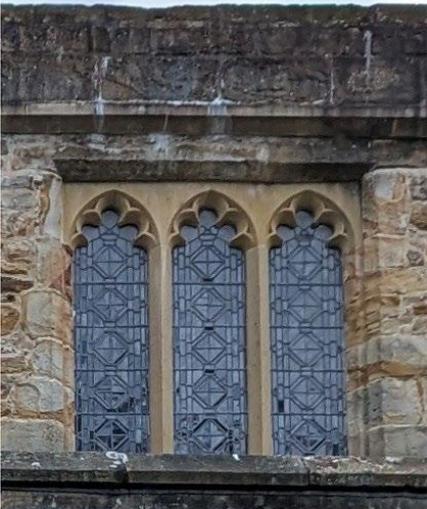
2.2.2.	<p>North Nave Clerestory Bay One (from west) Bay one is the tower. See tower stonework section.</p>	
2.2.3.	<p>North Nave Clerestory Bay Two</p> <p>The heads and two mullions of the window in bay two were replaced following the fire and are in good order. The cill is eroded but in adequate shape at the moment. The western reveal had stones which suffered some fire damage (are quite red) and have some fractures in them. The Eastern reveal is quite friable although in reasonable condition for now.</p>

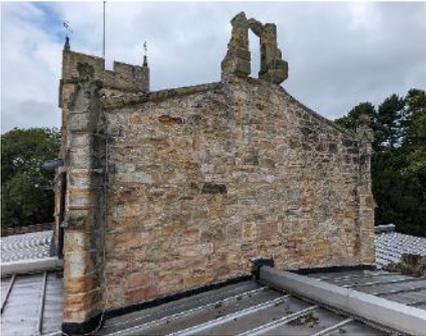
<p>2.2.8.</p>	<p>East Elevation of the Nave The east elevation of the Nave has been re-pointed. Some of the stones however are very friable and debris has been falling off onto the roof with the potential of causing blockages in the rainwater disposal. A number of the more friable stones should be brushed back and the debris removed on a regular basis.</p> <p>The parapet to the Nave gable had a lead capping to it. Now replaced with mesh reinforcement flashing. There is an open joint to one of the copings on the south side which should be pointed. The pinnacles and bellcote above appear to be well pointed and secure.</p>

<table><tr> <td style="width: 5%; text-align: center;">B</td> <td>• North Nave Clerestory Bay Three – Second window from the West: Replace the failed pointing below the cill</td> </tr><tr> <td style="text-align: center;">B</td> <td>• To the east elevation of the nave at roof level: Repair friable stones and regularly check for blockages and damage caused by falling stone debris. Point open joint to coping.</td> </tr></table>

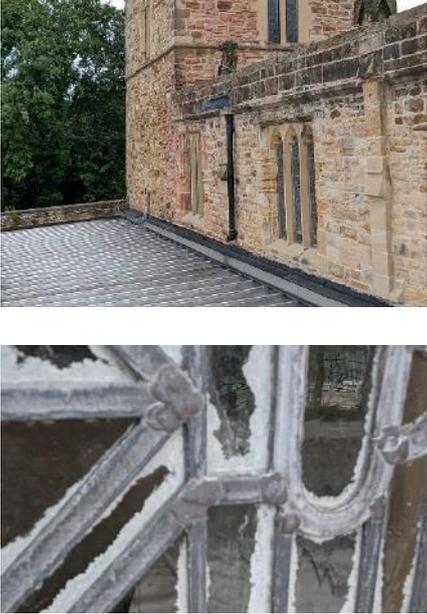
2.3.	<p>ROOF LEVEL STONework AND ROOFS: South Nave Clerestory Level Stonework and Windows From west to east</p>	
2.3.1.	<p>Windows Generally</p> <p>All of the windows at Clerestory level are in good order having been replaced within the last ten years with lead cames and clear glass. There is some bloom around the cames to this elevation which may be due to the environmental conditions as it is south facing. This may need cleaning in the future.</p>

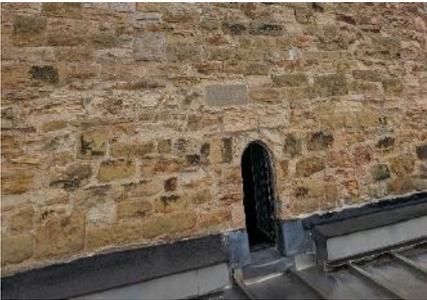
2.3.2.	<p>South Nave Clerestory Bay One (from west) Bay one is the tower. Access is gained via a casement window. See tower stonework section.</p>

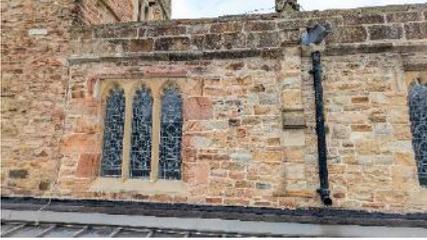
<p>2.3.4.</p>	<p>Between Bay Two and Bay Three is a small buttress. There is a crack to the buttress capping and the moulded section at the base is severely eroded and a new carved section should be inserted. There are a couple of open joints that require repointing.</p>

<table><tr> <td data-bbox="272 949 323 1070">B</td> <td data-bbox="323 949 1525 1070"> <ul style="list-style-type: none"> • South Nave Clerestory Bay Two – First window from the West: Repoint open joints and conduct conservation mortar repair to western reveal, considering application of burnt sand mastic along the window line. </td> </tr><tr> <td data-bbox="272 1070 323 1115">C</td> <td data-bbox="323 1070 1525 1115"> <ul style="list-style-type: none"> • South Nave Clerestory – Replace moulded stone to buttress and repoint open joints. </td> </tr></table>

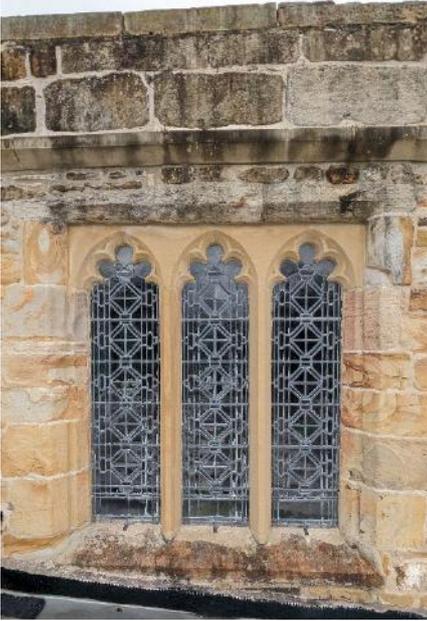
2.3.7.	<p>South Nave Clerestory Bay Five 4th window from the West</p> <p>Some conservation repairs are failing where they have been used to fill cavities in the stone.</p> <p>As before, post fire heads and mullions however the cill is older. The mortar fillet at the base of the window has failed in a couple of places.</p>

<table><tr> <td data-bbox="272 949 323 1070">B</td> <td data-bbox="323 949 1525 1070"> <ul style="list-style-type: none"> • South Nave Clerestory Bay Two – First window from the West: Repoint open joints and conduct conservation mortar repair to western reveal, considering application of burnt sand mastic along the window line. </td> </tr><tr> <td data-bbox="272 1317 323 1397">B</td> <td data-bbox="323 1317 1525 1397"> <ul style="list-style-type: none"> • South Nave Clerestory Bay Five – Fourth window from the West: Replace failed conservation mortar repairs </td> </tr></table>

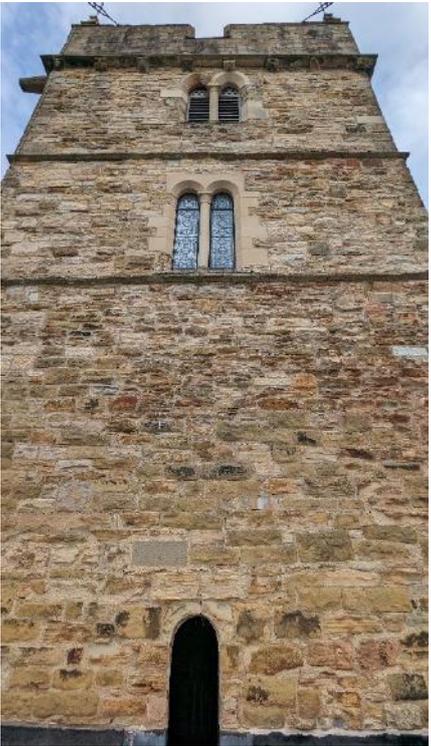
2.4.2.	<p>Middle Section of Tower South Side The glazing to the window has been replaced (post-fire), along with stone to the window heads, central column and reveals.</p> <p>The string course below the window is original if a little eroded. Some pointing to the string course is required.</p>

2.4.12.	<p>Recommendations:</p> <p>Base and Middle Section of Tower, South Side:</p> <p>B</p> <ul style="list-style-type: none"> Replace severely eroded stones in a programme of replacement. Conduct localised repointing in lime mortar. <p>C</p> <ul style="list-style-type: none"> Point string course and allow for additional pointing of areas below the string course. <p>Middle Section of Tower, east side:</p> <p>D</p> <ul style="list-style-type: none"> Conduct stone replacement either side of window (string course and course above) <p>Upper Section of Tower East Side:</p> <p>C</p> <ul style="list-style-type: none"> Seal junction between timber louvred opening and masonry with oakum and burnt sand mastic. <p>C</p> <ul style="list-style-type: none"> Point upper string course. <p>Base of the tower above the North Aisle roof:</p> <p>B</p> <ul style="list-style-type: none"> The small round headed window: stone at the bottom of the east and west reveal requires renewal. <p>Base Section of Tower West Side:</p> <p>C</p> <ul style="list-style-type: none"> Stone replacements required and repointing to window. <p>Middle Section of Tower West Side:</p> <p>B</p> <ul style="list-style-type: none"> Remove rusty box <p>B</p> <ul style="list-style-type: none"> Tower west side: remove vegetation from joints to tower base.

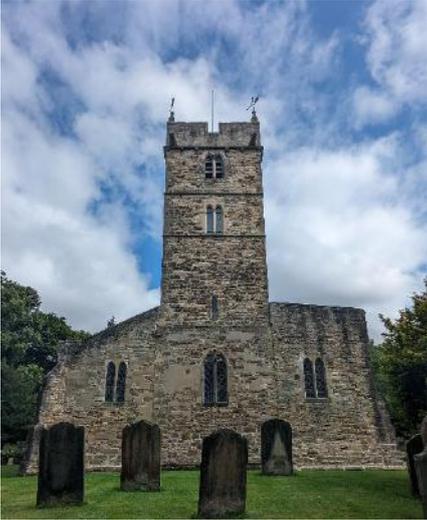
2.5.	WEST ELEVATION	
2.5.1.	<p>West End - Gable to North Aisle</p> <p>This gable has a lean-to roof with a parapet and a buttress set at 45°. There is a two lancet window opening and this has been re-glazed and re-leaded as have all of the windows following the fire.</p> <p>The pointing to the head and reveals of the window needs redoing.</p> <p>There are a number of replaced stones which were carried out over twenty years ago and the faces of these stones have been tooled. They do however have an ashlar appearance and unlike the rest of the stonework which is coursed and random coursed rubble. The face of some of these replacement stones is also spalling. Some of the historic stonework is severely eroded. And there will need to be a steady programme of stone replacement over the next few years.</p> <p>Pointing has been undertaken at plinth level (up to 1m), however, removal of hard mortar and pointing is still required to the window reveal and to the bottom left and top right of the window.</p> <p>At the base just above plinth level there is the incoming gas pipe.</p> <p>It is noted that the ground level slopes down towards the plinth and this may cause the base of the walls to get damper than they should, however, there is no obvious indication of that. The interior should be monitored for signs of damp to see if the lime pointing conducted in 2022 assists with allowing the wall to breathe and keep the fabric in good condition.</p> <p>Vegetation needs to be removed to the bottom of the gable / top of the buttress.</p>

2.5.3.	<p>Recommendations:</p>	
	B	<ul style="list-style-type: none"> West end generally: Stone work replacement needed (except upper tower)
	B	<ul style="list-style-type: none"> West elevation, north aisle: repoint stonework to window and localised areas to the bottom left and top right.
	B	<ul style="list-style-type: none"> West elevation, north aisle: remove vegetation and repoint open joints on completion.
	B	<ul style="list-style-type: none"> West elevation, south aisle: conduct localised repointing.
	E	<ul style="list-style-type: none"> Ground levels around the west end should be improved if damp becomes a problem internally.

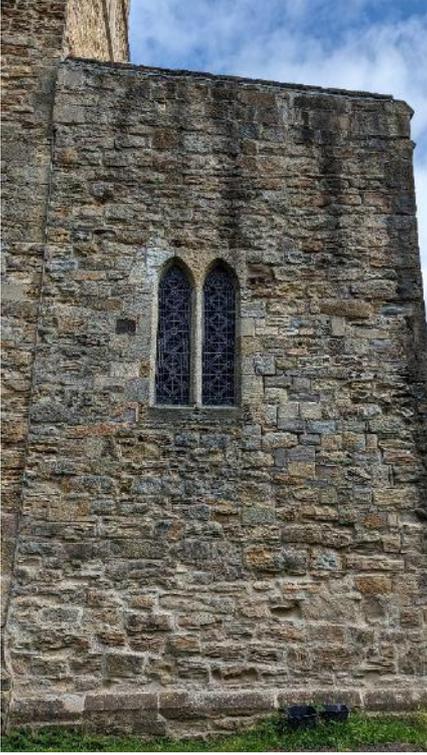
2.5.2.	<p>West End - Gable of South Aisle</p> <p>This has a two lancet window which has been replaced as elsewhere. The stonework around the window appears to be in reasonable order although some localised repointing is required to the bottom right of the window. Otherwise pointing is in reasonable condition – the lowest 1m was repointed in 2022. There is streaking below the parapet and the copings should be pointed and vegetation removed (refer to South Aisle roof). There is damp internally so this should be addressed as soon as is practicable.</p> <p>There are various very eroded stones in this elevation some of which will need replacement in the not too distant future. At the base of the plinth there are two cast iron access points to services beneath.</p>

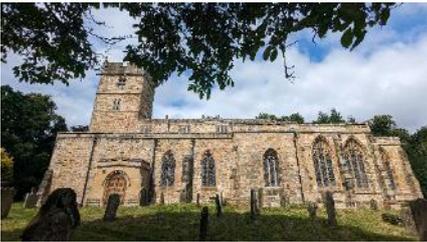
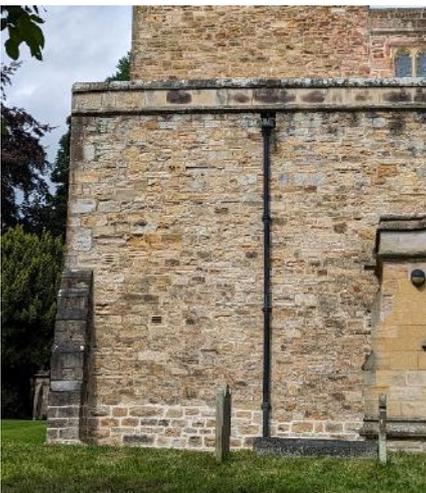
2.6.	<p>SOUTH ELEVATION From the West</p>	
2.6.1.	<p>South Elevation: Bay One To the West of the South Porch</p> <p>A couple of the coping stones in this section require re-pointing – this may assist with alleviating damp internally.</p> <p>Some stones are shaling fairly badly though the erosion isn't quite as bad as the west elevation. There is some hard pointing which should be removed and</p>

<p>replaced with lime mortar as it starts to fail or if damp starts to occur internally, but otherwise left as it could cause more damage to remove it. The bottom of the masonry was repointed to 1m in height and this should assist breathability at low level. There are two ventilation holes which have been constructed in stone and are very neat.</p> <p>At the base of the wall there is no plinth but there is a stone path. The grassed area slopes down towards it. The gully was relatively clear but will need routinely clearing. The overflow chute to the top of the downpipe has vegetation present needs clearing. Note that there is an overflow outlet at low level from the WCs beyond.</p>

2.6.11.		Recommendations:
	M	<ul style="list-style-type: none"> • Clear blocked gullies and downpipes throughout.
	B	<ul style="list-style-type: none"> • South elevations, Bays One to Three: replace eroded stone and repoint open joints and areas of hard mortar.
	B	<ul style="list-style-type: none"> • South elevation, Bay One: Repoint open joints to copings at west end.
	M	<ul style="list-style-type: none"> • South elevation, Bay One: Clear vegetation to overflow chute
	C	<ul style="list-style-type: none"> • South Porch: Repoint fine open joints to plinth, string course, hood mould and parapet.
	C	<ul style="list-style-type: none"> • South Porch: secure cables at high level.
	B	<ul style="list-style-type: none"> • South Porch: replace rusted gulley grate.
	D	<ul style="list-style-type: none"> • South Porch: refinish door.
	C	<ul style="list-style-type: none"> • South elevation, Bay Two: To the east of the South Porch; eroded stones require replacement below the window. Remove fixings.

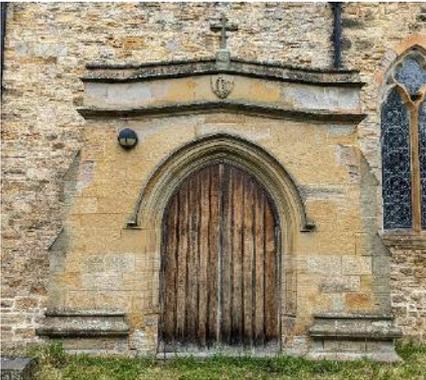
<p>2.6.2.</p>	<p>South Elevation: South Porch This is a Victorian addition and is of ashlar. Some of the narrow joints require re-pointing on the South elevation at plinth level, around the hood mould of the doorway, to the string course and to the copings.</p> <p>The new timber door had been varnished and it is now flaking off. It may be worth considering removing the coating and assessing the state of the door and refinishing. Note that there is an orange wire hanging loosely from the roof of the porch.</p> <p>Adjacent is a downpipe from the aisle roof and the grating in the gully is rusted and requires replacing.</p>

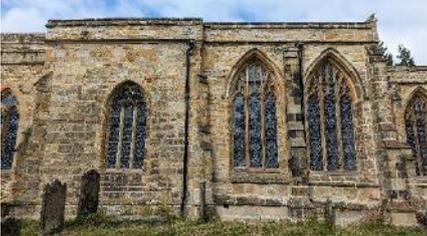
2.6.7.	<p>South Transept: South Elevation</p> <p>There is a three lancet window with lozenge shaped tracery above. The window glazing is post fire as elsewhere. The mullions and some of the reveal appear to be post fire. The head of the window appears to be well weathered although sound. Generally, the stonework and the pointing on this elevation is slightly better than some other areas.</p> <p>The bottom metre of stonework was repointed in 2022.</p>

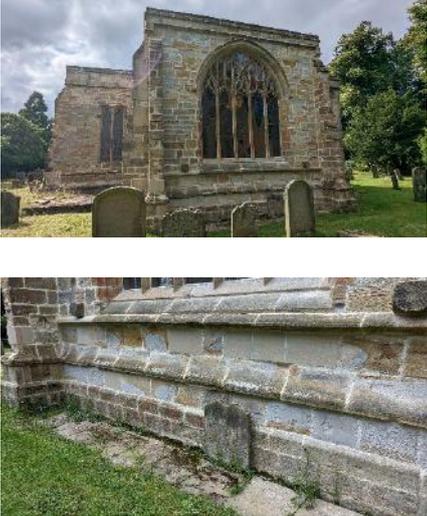
<p>2.7.4.</p>	<p>Chancel: East Elevation This has a five bayed window with decorated tracery above.</p> <p>Pointing to the entire elevation was undertaken in 2022 with stone replacements and repairs and as such the elevation is in good condition. Where conservation repairs were undertaken there may be a need in the future for further stone replacement (eg hood moulds) but this is not anticipated in this quinquennium.</p> <p>Note that there are a couple of interesting corbel type stones projecting from this elevation and also a well weathered carved stone in the south buttress. The origins of these are unknown to me. At the base of here there is a flagged path.</p> <p>The buttresses to the north are well pointed.</p>

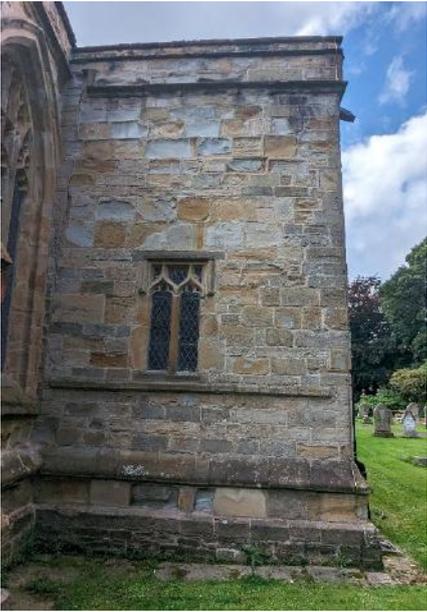
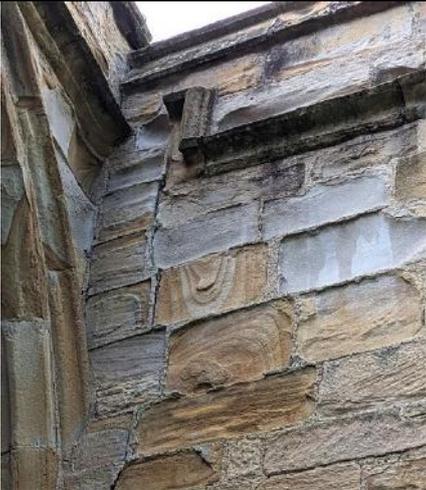
<p>2.7.6.</p>	<p>Vestry: East Elevation</p> <p>This contains a small two light window with diamond leading and a square head. The pointing on this elevation is generally good.</p> <p>There is erosion to this face, however, this is fairly consistent at high level and not of immediate concern. There are three stones at low level which should be considered for replacement.</p> <p>There appears to be a movement crack along the junction between the east wall of the Vestry and the North wall of the Chancel and this should be re-pointed and monitored.</p>

2.7.11.		Recommendations:	
	M	• Vestry and Chancel – remove moss to flagged areas	
	B	• Chancel: South Elevation, Bay One from the West: Remove ferrous fixing at low level, repoint.	
	B	• Chancel: North Elevation, replace eroded stones.	
	B	• Vestry: East, replace eroded stones.	
	B	• Vestry: East, repoint movement cracks and monitor.	
	B	• Vestry: North, repair cill	
	M	• Vestry: North, clear gully	
	C	• Vestry: West Elevation, fix handrail to steps.	
	D	• Vestry: West Elevation, repoint top right area of stonework, undertaking stone replacement (to string course) as required	
	C	• Chancel: North Elevation, first bay from east: remove fixings from reveals. Repair stonework above overflow. Open joints at the window head require pointing

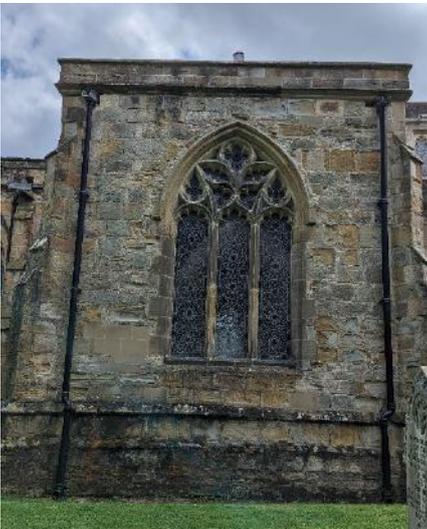
2.8.2.	<p>North Transept: North Elevation</p> <p>This has a three light window with tracery above. There are small fixings around the window stonework which require removal. However, the stonework around the window appears to be in reasonable order.</p> <p>The wall stones are suffering from erosion as elsewhere. Some areas of pointing are required:</p> <ul style="list-style-type: none"> • at the joint with the flagged walkway • below the lower string course • at higher level to the bottom left of the window hood mould <p>The downpipes and overflows appear to be working well and are free flowing.</p>

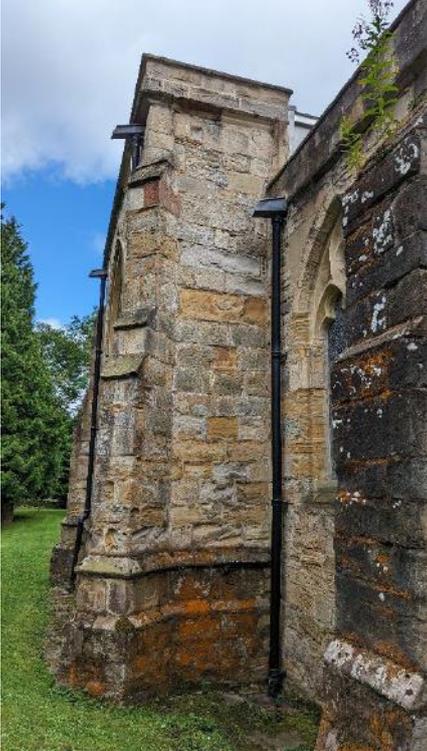
2.8.3.	<p>North Transept: West Elevation</p> <p>This is a very small section of wall suffering from some erosion but generally in reasonable order as is the buttress adjacent.</p> <p>Replacement of one piece of stone to the string course should be considered in the future, along with a few weathered stones to the buttress.</p>

<table><tr> <td data-bbox="264 1115 323 1160">M</td> <td data-bbox="323 1115 1525 1160"> <ul style="list-style-type: none"> North transept: remove moss to flagged area </td> </tr><tr> <td data-bbox="264 1361 323 1480">D</td> <td data-bbox="323 1361 1525 1480"> <ul style="list-style-type: none"> North transept: West Elevation, replace one stone to string course and eroded stones to buttress. </td> </tr></table>

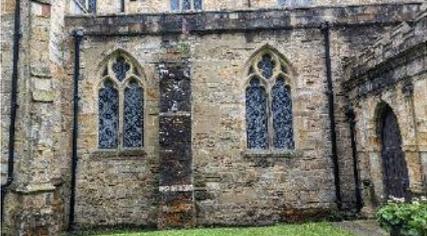
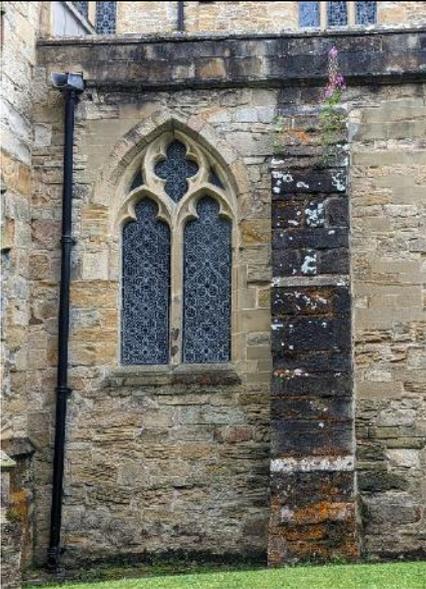
M	<ul style="list-style-type: none"> North transept: remove moss to flagged area 	B	<ul style="list-style-type: none"> North transept: East elevation, repair stone at the base of the southern reveal. Replace weathered stone to buttress. 	B	<ul style="list-style-type: none"> North transept: North elevation, point joint at ground level, lower string course and areas to the bottom left of the window. Small fixings around the window stonework require removal. 	D	<ul style="list-style-type: none"> North transept: West Elevation, replace one stone to string course and eroded stones to buttress.
M	<ul style="list-style-type: none"> North transept: remove moss to flagged area 									
B	<ul style="list-style-type: none"> North transept: East elevation, repair stone at the base of the southern reveal. Replace weathered stone to buttress. 									
B	<ul style="list-style-type: none"> North transept: North elevation, point joint at ground level, lower string course and areas to the bottom left of the window. Small fixings around the window stonework require removal. 									
D	<ul style="list-style-type: none"> North transept: West Elevation, replace one stone to string course and eroded stones to buttress. 									
2.9.	<p>NORTH AISLE ELEVATION</p>									
2.9.1.	<p>This elevation is split into four bays from the East.</p> <p>North Aisle: North Elevation, Bay One from the East</p> <p>This bay has a two light window with tracery above. The tracery and mullions appear to be in reasonable condition. Some of the voussoirs require re-pointing. There is a crack in the cill which requires repair.</p>

<p>There are some areas of the cornice and copings that also need repointing, other than these the pointing is in reasonable order. The stone is suffering from erosion as elsewhere.</p> <p>The buttress between bay one and two appears to be in reasonable order. Vegetation requires removal.</p> <p>Moss to the flagged area requires removal.</p>

2.9.5.	Recommendations:	
	B	<ul style="list-style-type: none"> North Aisle: North Elevation, Bay One, remove vegetation. Repoint voussoirs and repair cill. Repoint cornice and copings.
	B	<ul style="list-style-type: none"> North Aisle: North Elevation, Bay Two. Repoint cornice, voussoirs and around base of downpipe. Consider extending the downpipe or introducing a flashing to the plinth.
	M	<ul style="list-style-type: none"> North Aisle: North Elevation, Bay Two. Clear gully.
	A	<ul style="list-style-type: none"> North Aisle: North Elevation, Bay Three. Arrange high level access for inspection and remove vegetation above North porch.
	B	<ul style="list-style-type: none"> North Aisle: North Elevation, Bay Three. Point cornice and copings

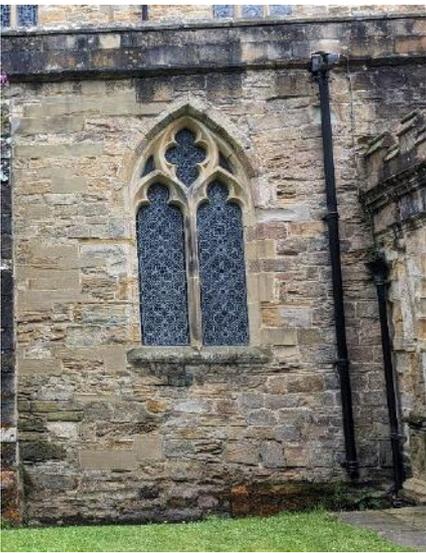
<p>2.9.2.</p>	<p>North Aisle: North Elevation, Bay Two from the East</p> <p>This bay has a two light window with tracery above. The mullion and tracery appear to be in reasonable order. The voussoirs require some re-pointing.</p> <p>The pointing appears to be sound except for at the cornice and base of the plinth where the downpipe discharges into a stone gully and the plinth is damp. Consider extending the downpipe or introducing a flashing to protect the plinth. Clear the gully which is blocked.</p>

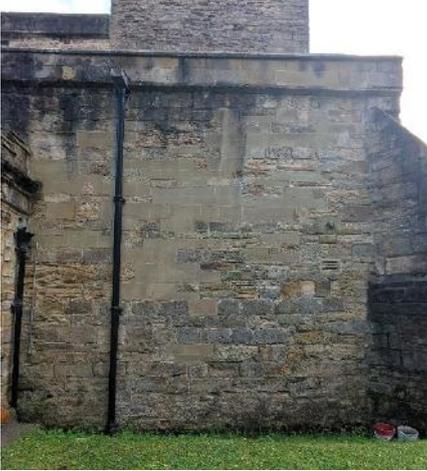
2.9.4.	<p>North Aisle: North Elevation, Bay Four</p> <p>This is a blind bay with a considerable amount of replaced stone which is in dressed and tooled ashlar which appears rather unsympathetic. The pointing appears to be in reasonable condition. This elevation also has a vent constructed in stone as on the South side.</p>

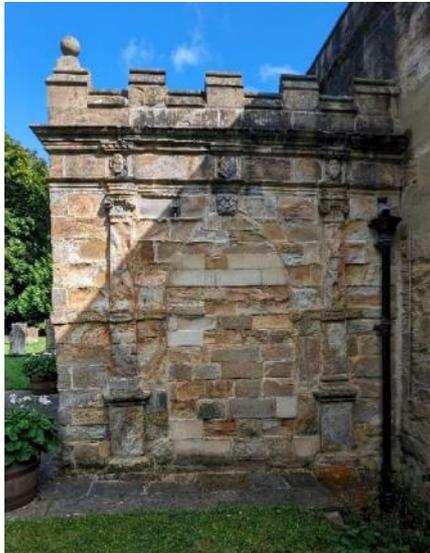
2.10.3.		<p>North Porch: West Elevation</p> <p>This elevation has an opening which has been blocked up with stone. One is severely eroded. There is a carved keystone as before and two flanking pilasters. At higher level there is a daylight sensor for the lights.</p>

2.10.4.	<p>M</p> <p>C</p>	<p>Recommendations:</p> <ul style="list-style-type: none"> • Vigilant maintenance is required to ensure the good order of the porch. The outlets are blocked and require clearing. • Carry out 3D recording of the carved details for archive purposes.

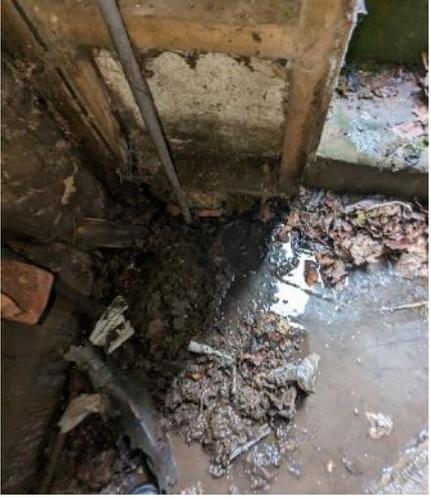
2.11.	BOILER HOUSE	
2.11.1.	<p>The boiler house is accessed via stone steps which are protected by a padlocked grille. It is constructed of stone with a concrete raft and felt roof. The adjacent oil house is a brick vaulted structure.</p> <p>The steps are mossy which is a slip hazard. The moss and vegetation should be removed.</p> <p>The boiler house floor has an accumulation of debris and standing water was present to the floor. Once some of the debris was dislodged, the water discharged through a hole to the east of the doorway. It is recommended that the floor is cleared of debris regularly to allow water to drain.</p> <p>There is redundant boiler equipment that should be removed.</p>

2.11.2.	<p>Recommendations</p> <p>M • Remove debris to steps, vegetation to roof and debris to boiler house floor.</p> <p>B • Remove boiler house and oil tank store.</p>

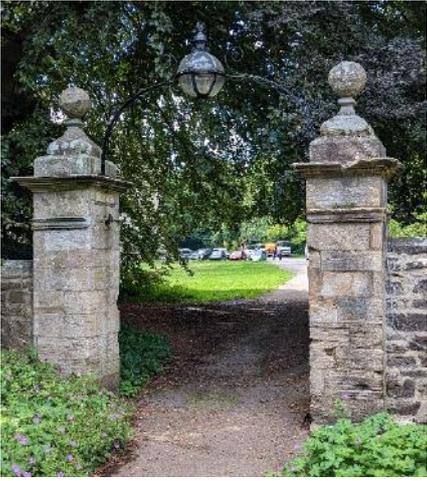
2.12.	<p>CHURCHYARD</p>	
2.12.1.	<p>The Churchyard is still open and is maintained by the Parochial Church Council. Some of the great number of headstones are listed Grade II in their own right. These are slabs to Jane Foster 1721 and Henry Mills 1807 (four metres South of the Church); monument to Robert Thompson 1729 (three metres South); headstones to John Wilson 1782, Hannah Stockburn 1777 and Thomas Johnson 1799 (ten metres South). In addition the main entrance gate piers gates overthrow an adjacent style and are all listed Grade II. These features were not examined in detail.</p> <p>Since the last QI a scan of the churchyard was completed and linked to the burial register. The church are reminded that this platform can also be used as an active tool to manage the churchyard.</p>

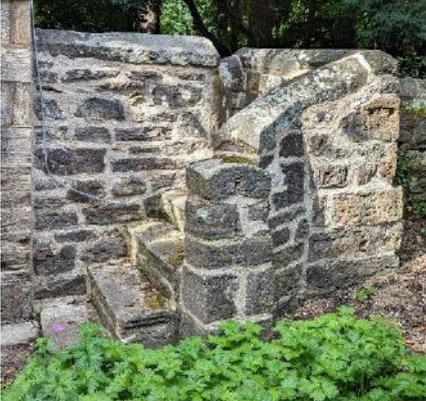
<p>2.12.2.</p>	<p>The entrance gate, constructed of oak and of a delicate barley twist design, is off site for repair and redecoration.</p> <p>The gate piers are in reasonable condition although the cabling to the lamp at the apex of the iron overthrow has not yet been properly concealed and should be fixed to the wall. The iron overthrow and lamp have recently been refurbished and are in working order.</p> <p>To the east of the gate is a stone stile and the metal grate from the pit set under the stile bar at the top of the steps is missing. This is a hazard for those wanting to use the stile. The stile was repointed and vegetation removed in 2023.</p>

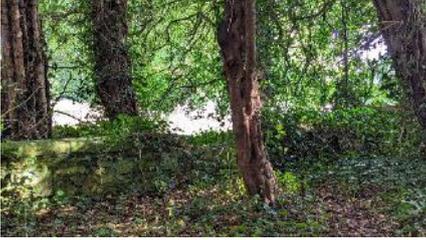
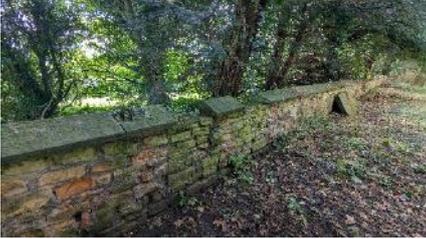
<p>2.12.3.</p>	<p>Most of the boundary walls are obscured by foliage however where they are visible, joints are open in places and re-pointing and consolidation should be considered. There are a few locations where coping stones have been lost – these should be replaced to avoid further damage to the wall.</p>

2.12.6.		<p>Recommendations:</p>	
	B	<ul style="list-style-type: none"> Churchyard: Obtain an arboriculturalist's report, consult as required and act on recommendations. 	
	C	<ul style="list-style-type: none"> Churchyard: Carry out pointing to boundary walls and replace missing copings. 	
	D	<ul style="list-style-type: none"> Churchyard: Fix cable to wall at gate / stile. 	
	D	<ul style="list-style-type: none"> Churchyard: Redecorate railings and reset gate to Boyne memorial

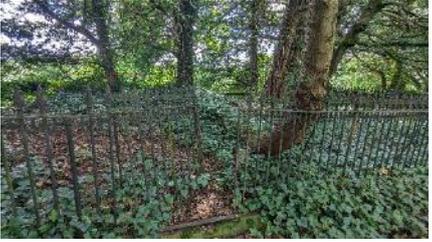
2.12.4.		<p>There are a number of mature trees which appear to be healthy on superficial inspection. A specialist should be asked to examine them and report within the next five years. As the trees are within a conservation area, all are protected – refer to the churchcare website for further guidance.</p> <p>One of the trees is at risk of damaging the railings to the Boyne memorial – this should be assessed by a specialist. The railings themselves need redecoration and the gate resetting.</p>

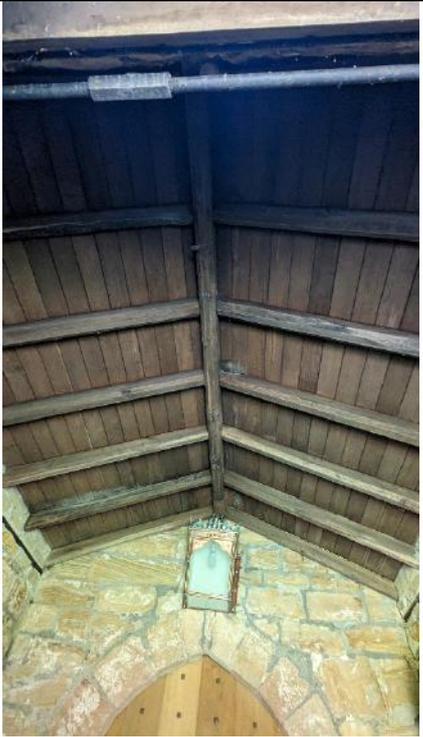
3.1.5.	<p>North Porch: Ceiling</p> <p>At the top of both of the walls to the west and the east there is some steelwork which may be in connection with some structural work that was carried out about 30 years ago to the roof. This should be brushed back and repainted. The stone floor is flagged and is in good condition as it is protected by a mat.</p> <p>The ceiling is timber boarded and with exposed rafters and ridge. Whilst most is in good condition, there is evidence of water ingress to the south east corner which corresponds with the blocked outlet externally. The roofing should be checked when the outlet is unblocked. The timber boarding should be left to dry after the outlet is cleared and if there are issues, boards replaced in oak and stained to match the adjacent.</p>

C	<ul style="list-style-type: none"> North Porch: Rub down and repaint metal bars at high level. Redecorate ferramenta to doors.
	B	<ul style="list-style-type: none"> North Porch: Allow boarding to dry. Water damaged boarding may need to be replaced in oak, stained to match adjacent.

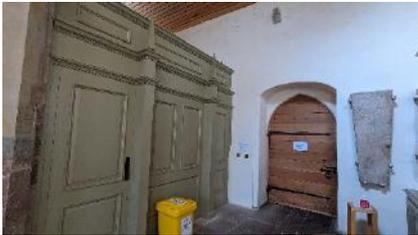
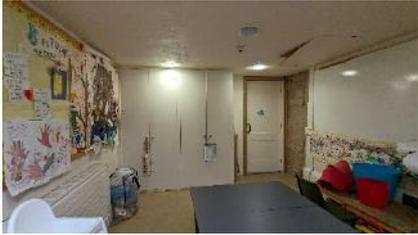
3.2.		NORTH AISLE
3.2.1.		<p>North Aisle: West End School Room:</p> <p>To the west is a small room sectioned off with a painted timber screen. The floor in the room is vinyl. There are two radiators and a small sink. There is a lay light in the ceiling which allows light in from the window at the west elevation. There are fitted cupboards for storage and also for the electrical installation and lighting, all completed post-fire. The lights are inset into the ceiling and there is a smoke/heat alarm. This room is used for Sunday School. All in reasonable condition.</p> <p>The hatch to the ceiling was not operational and the catch / hinges should be checked and repaired. This would allow access to clean the lay light. There also appeared to be evidence of damp to the west end wall (visible from the Nave), but close access was not possible. External defects should be addressed and the interior left to dry before redecoration.</p> <p>One light has lost it's cover which was in the cupboard – this should be reinstated.</p>

3.2.4	Classroom: Ease loft hatch.	1
		3.2.4	<ul style="list-style-type: none"> North Aisle: Bay Two, fill and monitor hairline crack. North Aisle: Bay Three, fill and monitor hairline crack from the east side of the cill of the window running vertically as it is on the West side of the cill. 	1

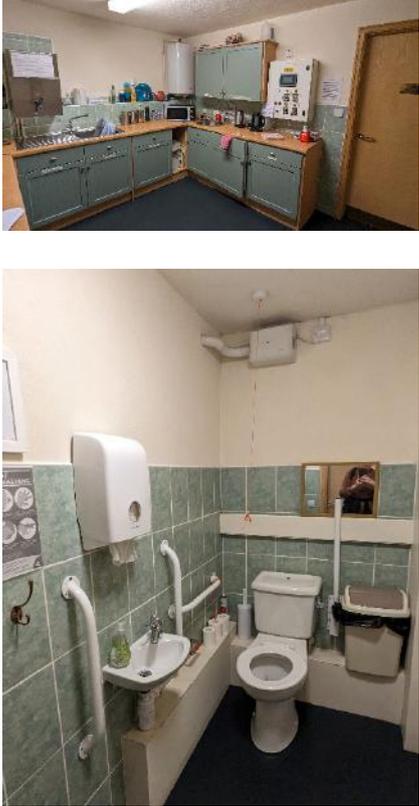
<p>3.4.</p>	<p>SOUTH AISLE</p>	
<p>3.4.1.</p>	<p>South Aisle: West End This is partitioned off with a softwood painted screen behind which is a kitchen and two WCs. The kitchen is fairly new and in good order with a radiator, a hot</p>

<p>water boiler and controls for the heating. Only the ceiling hatch is showing wear.</p> <p>Following that there is a lobby with two WCs. One wheelchair accessible - this one also has the baby changing unit. The disabled WC has a large radiator and the entire compliant grab rails etc. It is noted that the emergency cord was tied (presumably for cleaning purposes) – this should be untied so that it is accessible to pull if someone fell. The boxes in front of the accessible WC door should also be removed so that the door can be fully opened to allow manoeuvrability in a wheelchair.</p> <p>It was noted around this kitchen and WC area that in the junctions of the ceiling and the wall small cracks have appeared and these should be filled and redecorated in due course.</p>

2.12.6	Churchyard: Redecorate railings and reset gate to Boyne memorial	1
		3.1.6	North Porch: West wall, improve unsightly wiring.	1
		3.4.5	South Aisle: kitchen, fill cracks in plasterwork.	1

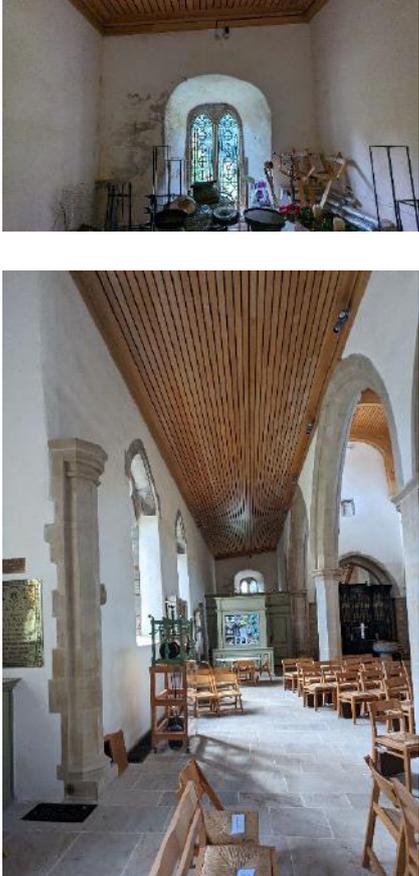
<p>3.4.2.</p>	<p>South Aisle Split into three bays. Bay one: has the doorway into the South Porch. Above the kitchen and WCs, there is visible evidence of damp to the west wall. Pointing and flashing to be improved externally.</p> <p>At this end of the aisle there is a foam extinguisher. The render and paintwork has a slightly mottled effect but it is not too visually intrusive.</p> <p>Bay two: has a two light window. The cill of the window is very powdery and the whole of the window reveal and cill should be brushed down and the dust vacuumed up. Here there are 10no cross slabs displayed vertically. It was noted that there are some cracks in the render to be monitored.</p> <p>Bay three: also has a window with powdery stonework.</p>

2.1.13	Tower: Add a clip to the dislodged stainless steel to the tower roof.	1
	3.4.5	South Aisle: Bay Two and Bay Three, brush down and vacuum powdery stonework. Monitor cracks in render.	1

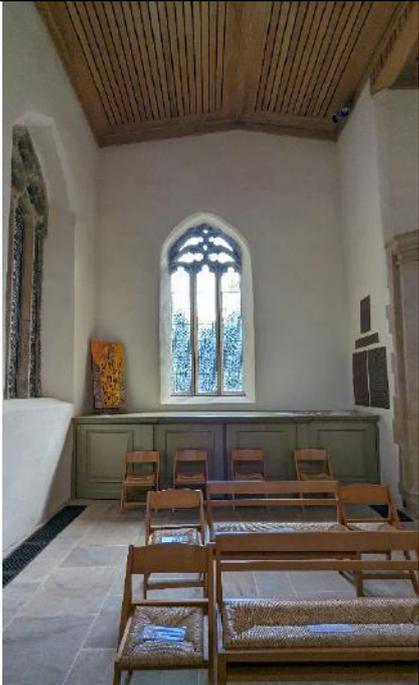
<p>3.4.3.</p>	<p>South Transept At the end of the Aisle stands the South Transept which extends only a couple of metres to the South.</p>

<p>This has a three light window and storage cupboards as in the North Transept and appears to be in good order.</p> <p>Within this space there is an internal window into the Lady Chapel. At the cill of the window is a small crack which should be repainted and filled and also to the apex. Also to the left of the window cill to the South window, there is a small crack.</p> <p>To the east of the South Transept is a small passageway which has a stone lintel above. There is a crack through that stone lintel but it is understood that structural work was undertaken to ensure the structural stability of this during the rebuilding.</p>

3.2.4	North Transept: Repair joinery to cupboard.	1
		3.4.5	South transept: repair cracks around openings.	1
		3.8.5	Tower: maintain and review the boilers regularly and clean droppings.	1

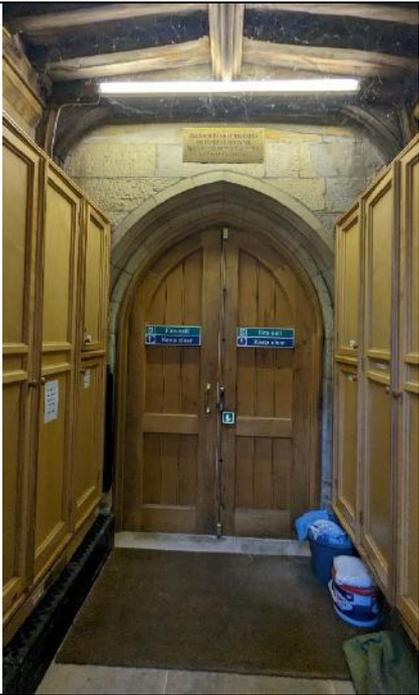
<p>3.4.4.</p>	<p>South Porch</p> <p>The structure within the Porch appears to be sound although a slight damp smell was noted. There is a push bar release mechanism to the South Porch for easy escape. The door to the Porch has been renewed and matches the door to the North Porch.</p> <p>There is some shaling of the stonework at high level – the gutters should be checked for defects.</p>

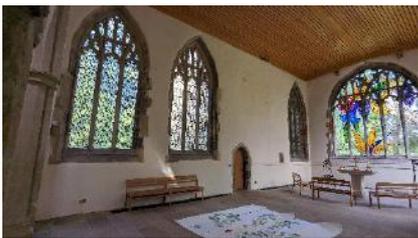
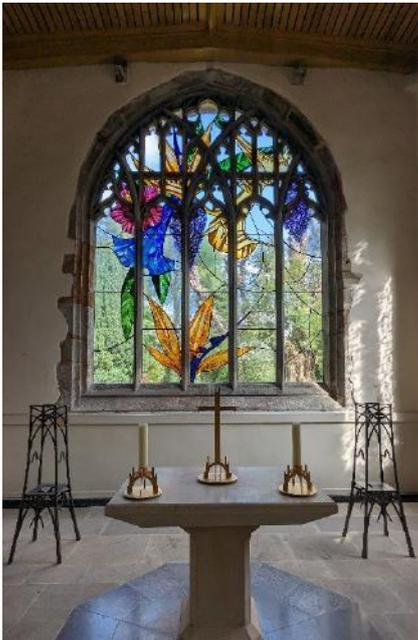
<p>3.5.1.</p>	<p>Chancel: North Wall Split into four bays Bay one: has a window with three lights. No defects.</p> <p>Bay two: has a window of three lights. This has a small crack running through the render from the cill which should be filled and repainted. Also at the apex.</p> <p>Bay three: has a doorway into the vestry and above that is a patch where it is understood some wall painting was discovered, subsequently covered with lime wash. Within this bay is a small squint view hole through from the vestry towards the East altar.</p> <p>Bay four: has a three lancet window. There are some ferrous fixings in the reveal which should be removed if possible. Other than that no other defects were noted. Also a dado arrangement for venting the lower wall.</p>

<p>3.5.4.</p>	<p>Recommendations:</p> <p>D</p> <ul style="list-style-type: none"> • Chancel: North Wall, bay two, fill cracks and repaint. <p>D</p> <ul style="list-style-type: none"> • Chancel: North Wall, bay four, remove ferrous fixings. 	
<p>3.6.</p>	<p>THE LADY CHAPEL</p>

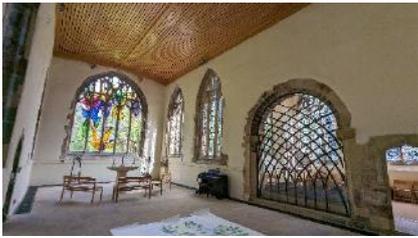
<p>3.5.3.</p>	<p>Chancel: South Wall This is split into three bays.</p> <p>Bay one: The first bay from the East contains a small aumbry which is rusty and is not used and a three light window. Crack at the apex. No further defects noted.</p> <p>Bay two: is a three light window with no obvious defects.</p> <p>Bay three: is an archway through to the Lady Chapel. This is glazed with a wrought steel frame and lattice work by Brian Russell. Also there is a squint hole through from the Lady Chapel towards the East end.</p>

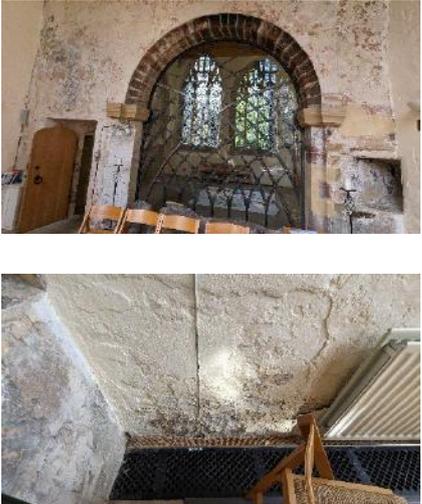
<p>3.6.1.</p>	<p>To the Lady Chapel there is a doorway with an ogee lintel with new oak door. The Chapel has three large external windows and one internal window all in good order. South west window requires pointing at cill.</p> <p>The lower areas of external walls are showing signs of damp. The east wall especially. The new lime pointing externally and rainwater disposal should help. The external boiler house removal would also address splashback.</p> <p>There are five wall lights with exposed MICC cabling which could be improved upon. There is also in the wall below one of the windows a piscina in reasonable condition.</p> <p>To the North there is the effigy of Neville which was conserved following the fire. It is noted that there is a yellow residue on the arm and shield.</p> <p>Note that there is some wall painting adjacent to the doorway.</p>

<p>3.6.2.</p>	<p>D</p> <p>M</p> <p>Recommendations:</p> <ul style="list-style-type: none"> • Lady Chapel: South west window requires pointing at cill. • Lady Chapel: Rub down plaster and monitor. (Removal of boiler house recommended to further reduce damp - refer to Boiler House)

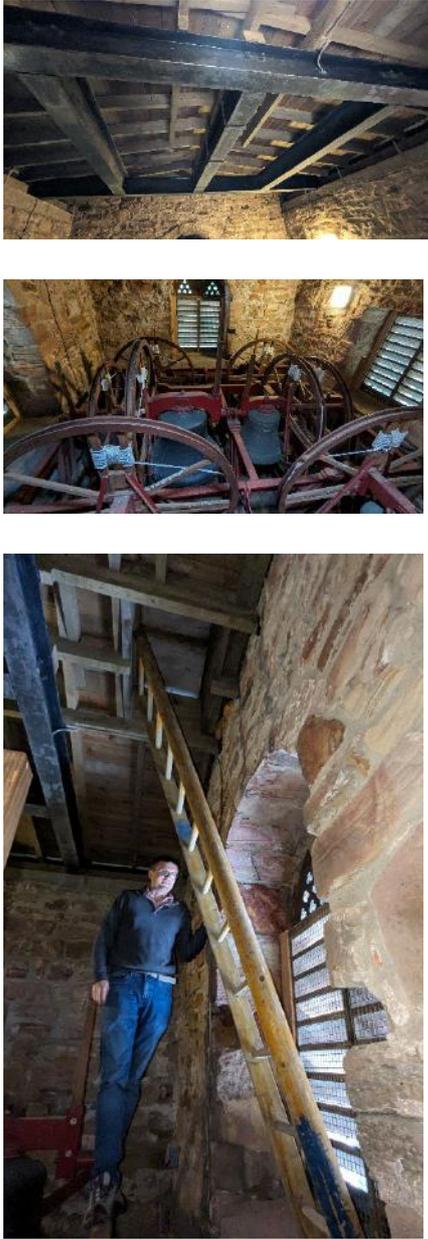
3.8.	TOWER	
3.8.1.	<p>Bell Chamber</p> <p>The bell frame is new since 2004. There are eight bells and they are rung regularly. The roof to the Tower is also relatively new which has a steel framework on a concrete wall plate and timber rafters and boarding above. The hatch onto the roof was difficult to manoeuvre and could be improved. The timber ladder is wedged between the window reveal and roof beam leaving very little space. The bell frame is also in the way to access the ladder. Access may be able to be improved by adding a small landing area from the window reveal across to the bell frame and reviewing positioning of a new fixed ladder. The hatch above could also be hinged.</p> <p>Grab rails could be added internally above the hatch to the bell chamber. The hatch is very narrow meaning that the ladder cannot be lengthened through the hatch, however, the steel bell frame means this cannot be widened.</p> <p>There is evidence that a bird has accessed the bell chamber and the Church noted that there had been an occasion when the hatch had been left open. The Church should ensure that all openings are closed after inspections. The louvred openings all have mesh that is intact so it is thought that access by a bird must have been via a hatch or window. The bellframe and bells should be cleaned of droppings.</p> <p>There is working lighting to this space.</p>

<p>3.8.5.</p>	<p>Recommendations:</p> <ul style="list-style-type: none"> C • Tower: maintain and review the boilers regularly and clean droppings. B • Tower - Chamber below Bell Chamber: point up gaps around windows. B • Bell Chamber: Improve access to the roof.
