CHURCH OF SAINT BRANDON

BRANCEPETH

REPORT ON QUINQUENNIAL INSPECTION

Inspection Date: 17th August 2023

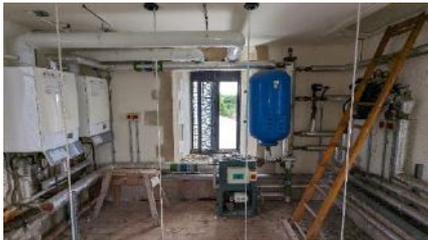
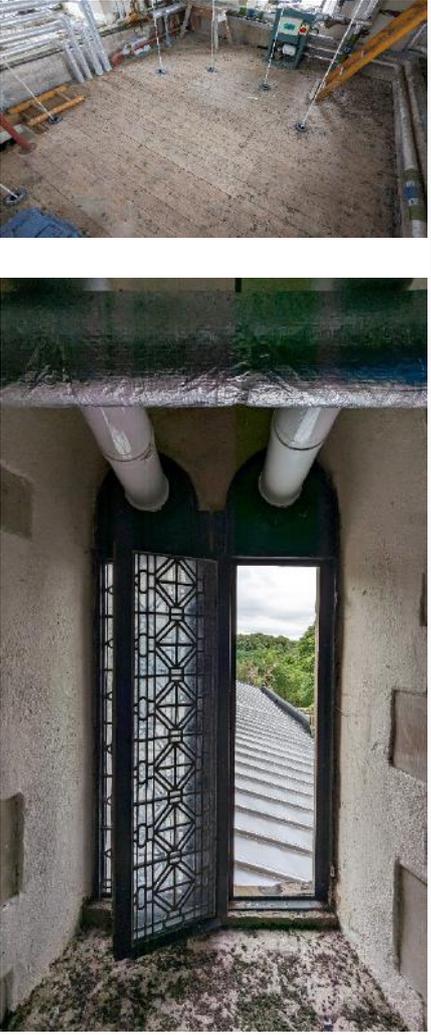
3.8.2.	<p>Chamber below the Bell Chamber</p> <p>This houses the plant room. Which includes two new gas fired boilers, a hot water system and manifolds for the under floor heating system etc. These were all new in 2014. Some evidence of leakage is old from previous boilers.</p> <p>There have been bats accessing this space. All of the windows have been renewed and are in good order. It was noted around the west window and the south window that there are gaps which are allowing the ingress of rain water and possibly insects and bats</p>

<p>and should be filled/ pointed. This is likely to require ecologist input.</p> <p>The interior is in good order and access into this space from the Ringing Chamber has been improved. There is also access from this level onto the Nave roof. Visual inspection only.</p> <p>The floor should be cleaned of droppings and flies. There is evidence of water damage, and it is assumed that this was due to the hatch that was left open as the roof appeared in good order.</p> <p>The lights need replacement bulbs.</p>

<p>3.8.5.</p>	<p>Recommendations:</p> <ul style="list-style-type: none"> C • Tower: maintain and review the boilers regularly and clean droppings. B • Tower - Chamber below Bell Chamber: point up gaps around windows. B • Bell Chamber: Improve access to the roof.

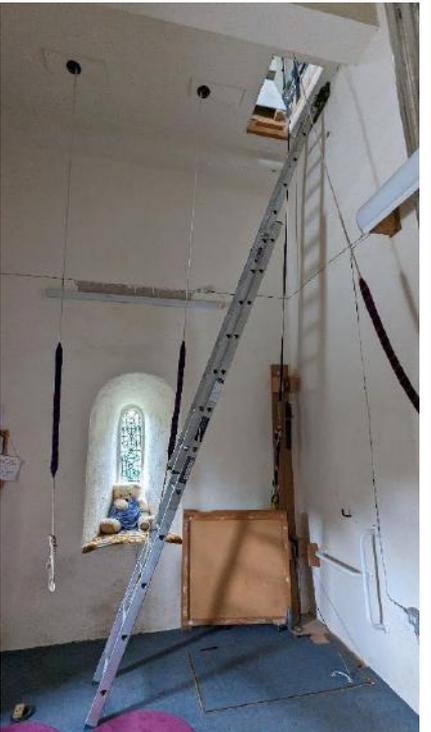
<p>3.8.3.</p>	<p>Ringing Chamber</p> <p>The bell ropes are terminated in this space. This has had a new floor and a new ceiling. The heating pipes which are lagged pass through this space. There are four fluorescent type lights on the walls. The windows are new and in good order one of which is openable to gain access onto the Aisle roof. The hatch from below has a counter balance which works well. There is also a moveable barrier so that it can be arranged around the hatchway in the floor whilst people are entering and leaving the Bell Ringing Chamber. There is a simple softwood timber bench arrangement to the East. There is a small shutter into the main body of the Church. The lighting cabling goes over the niche to the East side of the Bell Ringing Chamber within a galvanised metal conduit. This is rather intrusive.</p>
