**St MARY and St CUTHBERT**  
**CHESTER LE STREET**  
(4)

**QUINQUENNIAL REPORT**  
on the architect's inspection on

**26 April 2023**

a grade I listed building

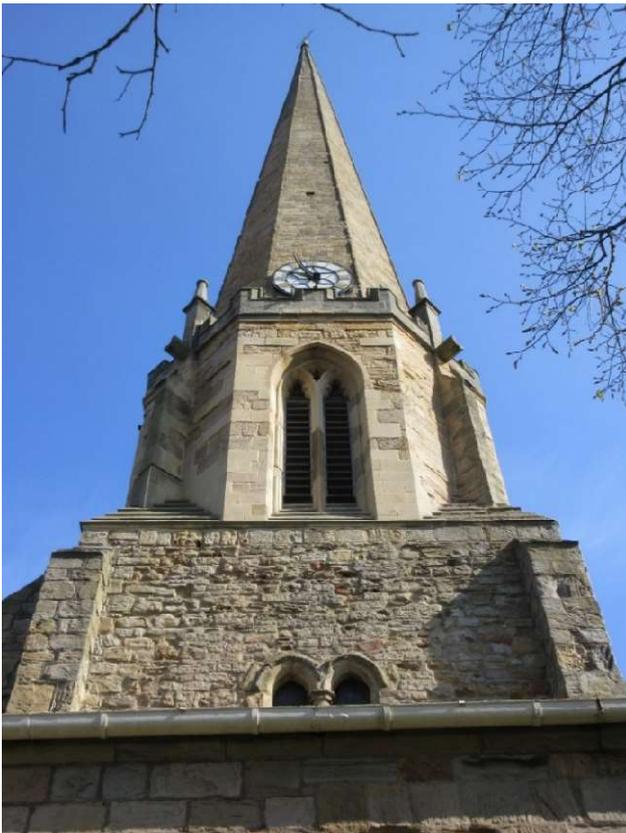
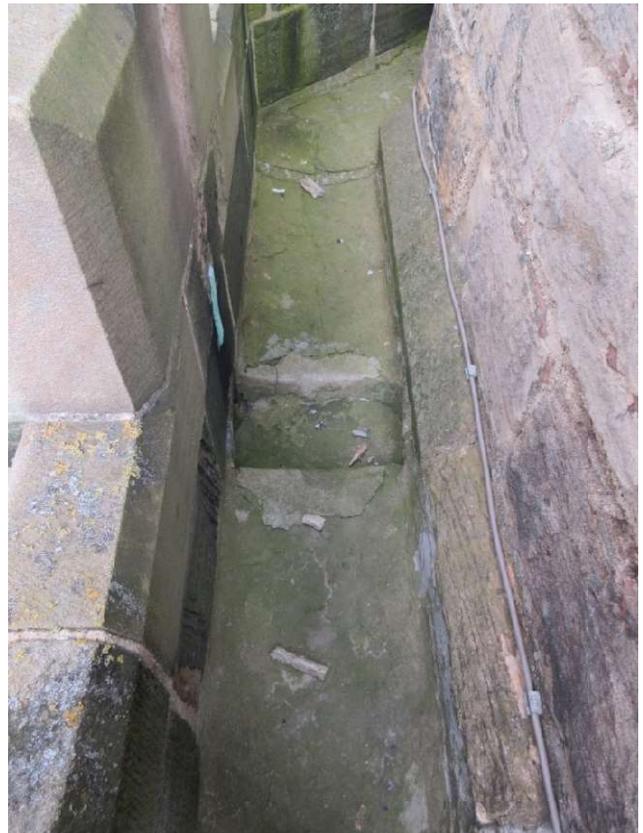
25. The Tower's sound low parapet and its pinnacles have bronze staples and bracings. Water from the Spire runs in a stone channel with steps and mortar patches in places to four corner spouts which appear to function. The amount of water running off the Spire into the channel may be limited except in storms but minor cracks in the channel must let some water into the Belfry wall thickness. Sealant has been used on the channel in the past but is not in good condition. The timber hatch out to the Tower parapet needs paint.

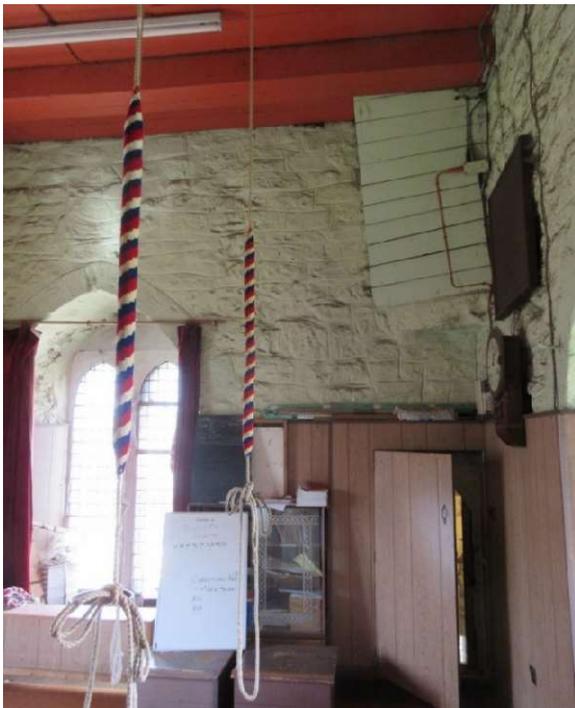
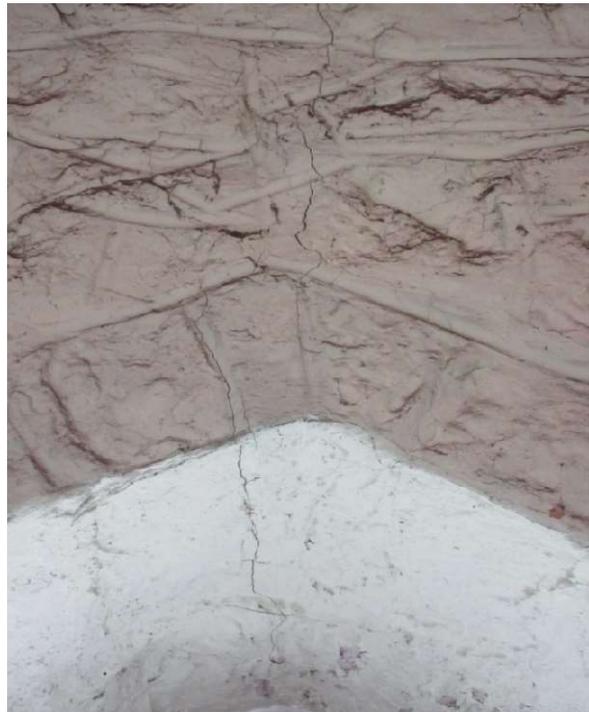
34. The tops of the arches at three external windows have hairline cracks, widest at N where at most it is 2mm and extends into the wall above.
35. Spiral stair – walls emulsioned or oil painted, with patchy decay similar to the Spire. Rope handrail and worn treads.

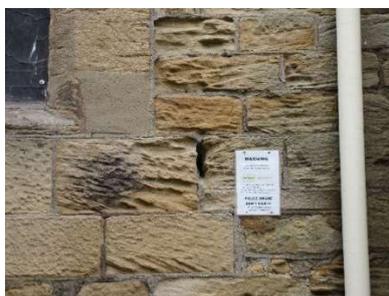
36. E gable – fair rubble stone with old and new lime pointing. Watertables and some joints above cill level pointed since last. Some stone faces decayed or pocketed. Buttresses fair.
37. Chancel S – squared coursed stone, mainly good but some minor decay above the windows and next to the door. Next to the E window sill a wide open vertical joint with a deep void behind.

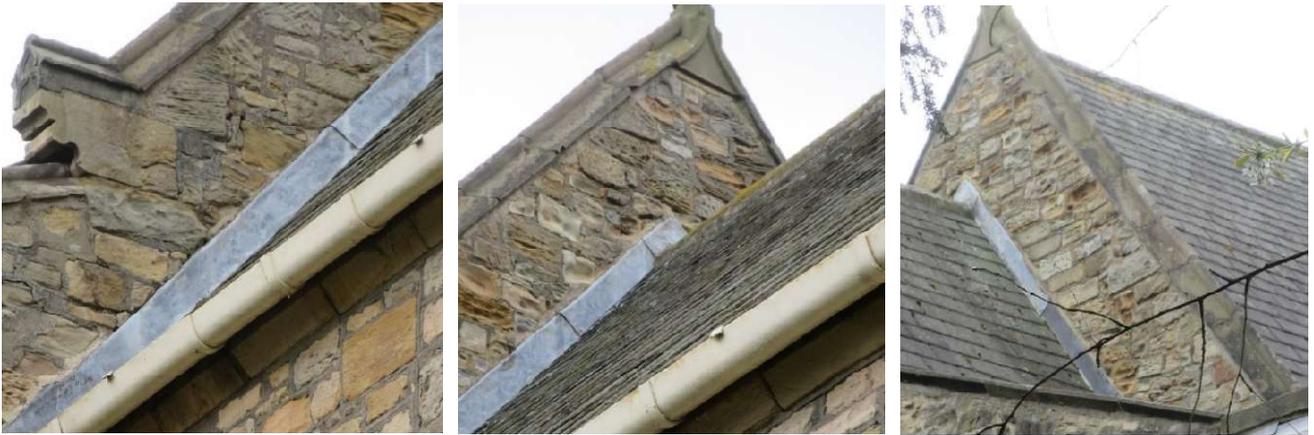
38. Nave E gable – fair but deep decay at isolated stones near the peak and holes in the pointing especially low on the S side.

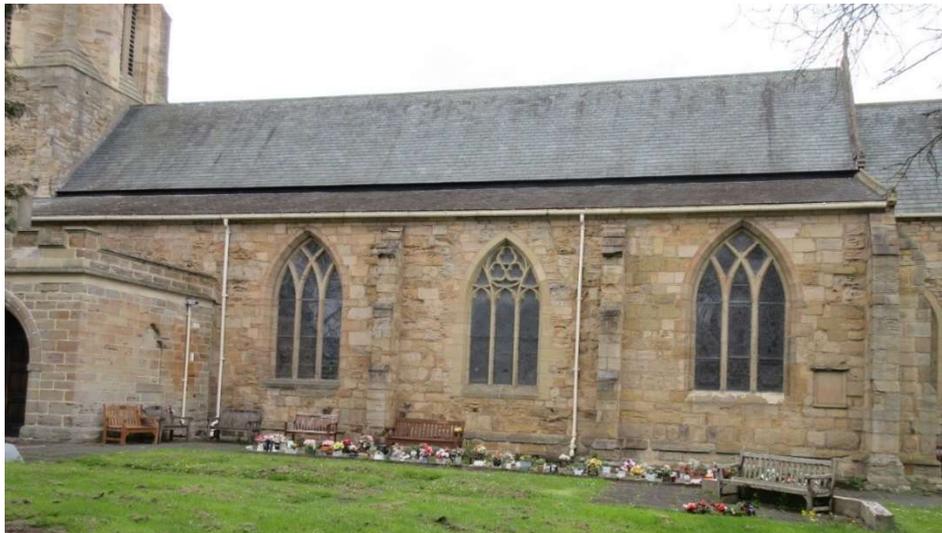
The two W bay walls and buttresses are all decayed (either face, pocket or soft bed) with light coloured hard pointing. Decay appears very slow so may be left to continue.

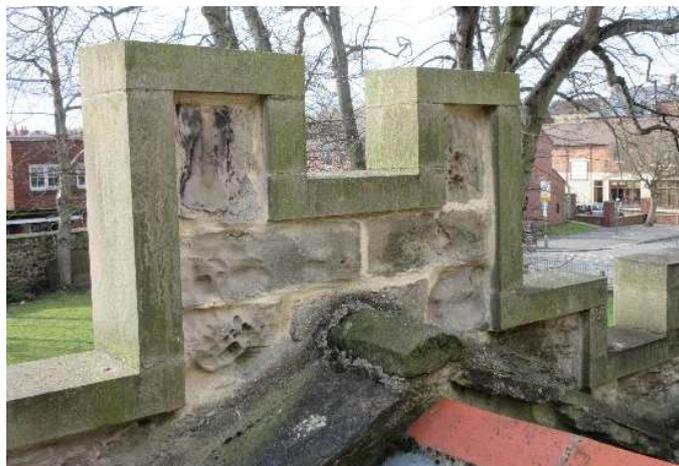
41. Porch ashlar good after lime pointing and renewal of a dressed band under a drip course. Honeycombed stone remains in the parapets.  
 Surface shaling of the whole W side suggests it is face bedded.  
 Gable and E good externally apart from loss from soft beds. Modern stepped plain flat copings. The inner gable parapet stones are ancient and eroded, thinning some stones substantially.

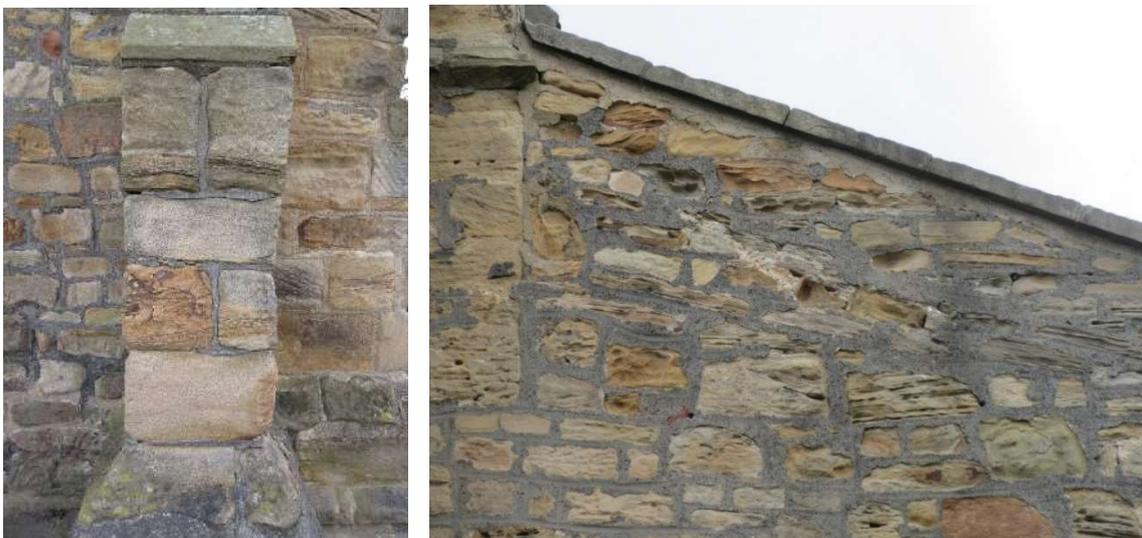
42. S Aisle W gable including its N buttress – many stones including the buttress have slight surface decay behind hard dark pointing. Scattered pocket decay especially close to the top of the gable.

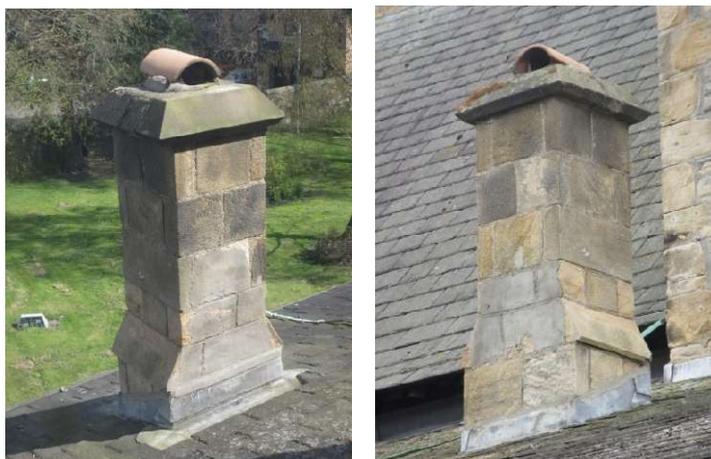
44. Chimney above Ankerage – Surface decay in lower stone courses – 3 courses at S side, 2 at N - is now covered with thin cement mortar, unlikely to last.

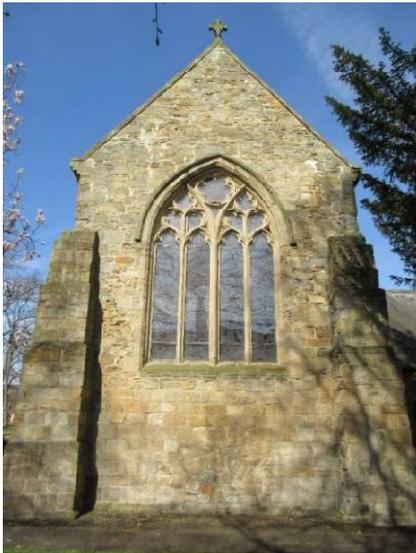
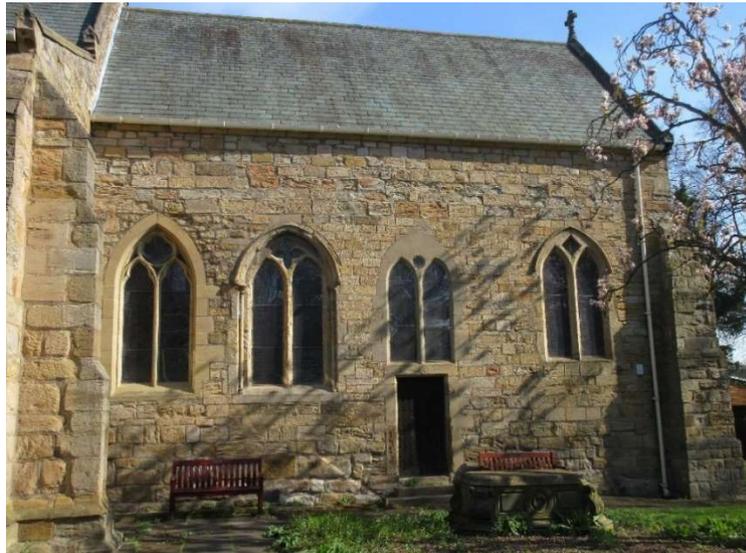
S Chancel

50. E – four light Victorian in an older arch and hoodmould. Window good except open reveal joints.

The older hoodmould and arch are decayed, with some loss of mortar patching from the peak arch stones.

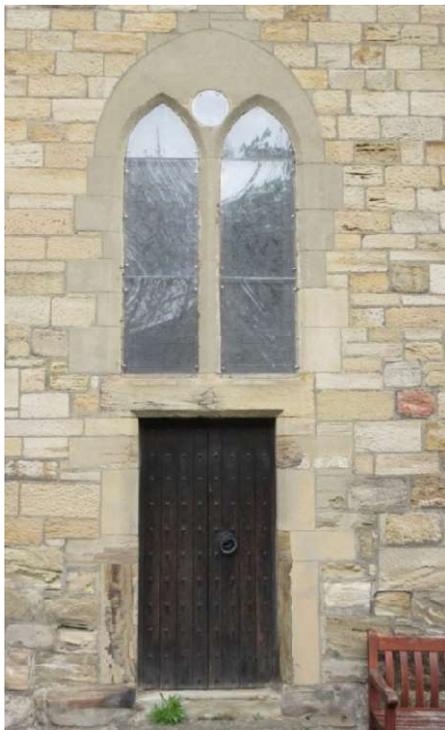
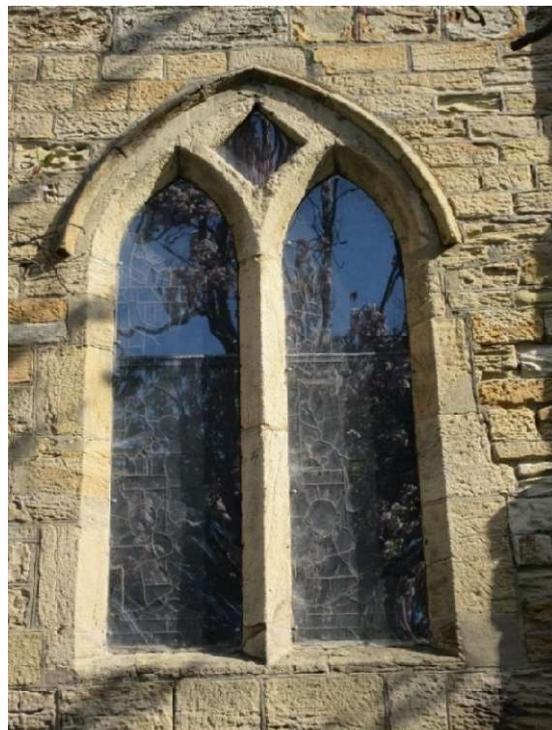
51. S Chancel E – two light with a square light in Y plate tracery. Plainest hoodmould. Weathered and mortar patched, minor splitting but fair.
52. S Chancel window over priest's door – two light with small roundel. No hoodmould – cut off?. All mortar faced except sill/lintel. Minor mortar losses but fair.

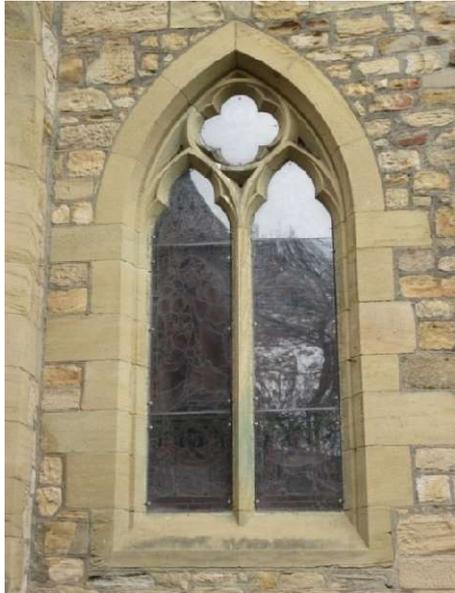
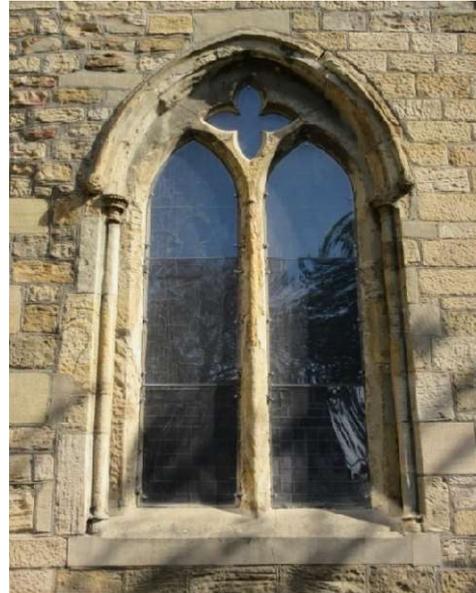
55. S Chancel W – two light with cusped tracery and quatrefoil, no hoodmould, appears Victorian. Minor losses at sill and many joints. A little weathered but good overall.

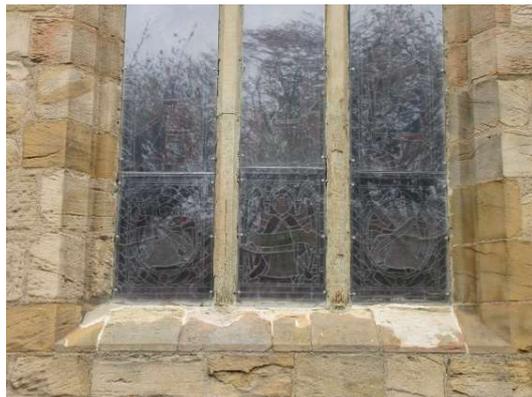
E end of S side S Aisle

57. S Aisle S side E end – three light plain interlaced Y tracery, no hoodmould. Parts of tracery may be renewals. Loss from some soft beds, some delamination at bottoms of mullions and loss from sill. Well pointed, fair overall but renewals may be needed in say 10 years.

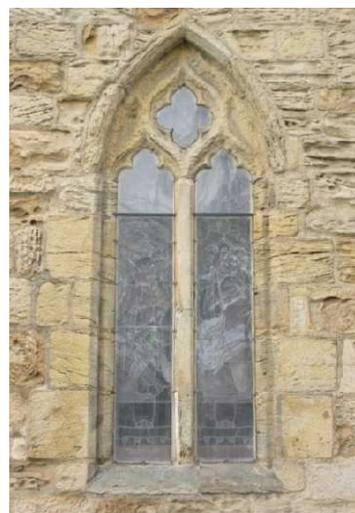
- 60. Porch door opening – stone arch fair, well pointed.
- 61. S Aisle S side 2<sup>nd</sup> from W – two light, quatrefoil in decorated tracery, no hoodmould. Appears a Victorian restoration in an ancient arch.  
Some delamination started in the Victorian mullion.
- 62. S Aisle S side W - Ancient, two light, quatrefoil in decorated tracery, no hoodmould. Very weathered.  
Replacement mullion with slight delamination at the bottom. No visible change.
- 63. Belfry – four twin louvred openings good after widespread renewals.
- 64. Ringing Chamber – three ancient, two light windows with hoodmoulds and centre shafts. Hood moulds mostly lost, weathered, mortar patched at W but fair overall.
- 65. Tower W window – large three light in hollow moulded surround, tracery part renewed or mortar patched, rest surface decayed.

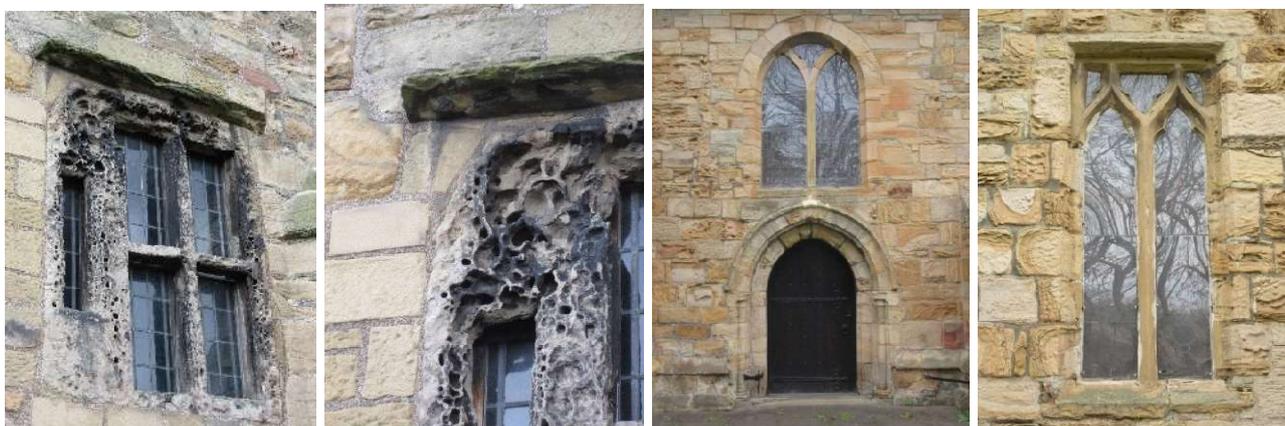
- 68. Boiler door, Ankerage door and small W window – weathered but sound.  
Ankerage – modern two light N window good. N door and stair good.
- 69. N Aisle NW – two light, much mortar repair in two colours at mullion, tracery and two reveal stones. The rest very weathered but stable. Sill decaying and joint open.
- 70. N Door – hoodmould, engaged shafts, weathered. Hoodmould peak renewed since last report.
- 71. Window over N Door – round headed with slightly concave moulded surround, plain square mullion and Y tracery. All arch stones decaying especially two at top deeply. Some mortar patching under arch. One reveal and both cills decaying.
- 72. Mid N window -three light Victorian all good except narrow joints at reveals open.
- 73. N Aisle NE window – square head, three light weathered but fair. Some decay in cill.

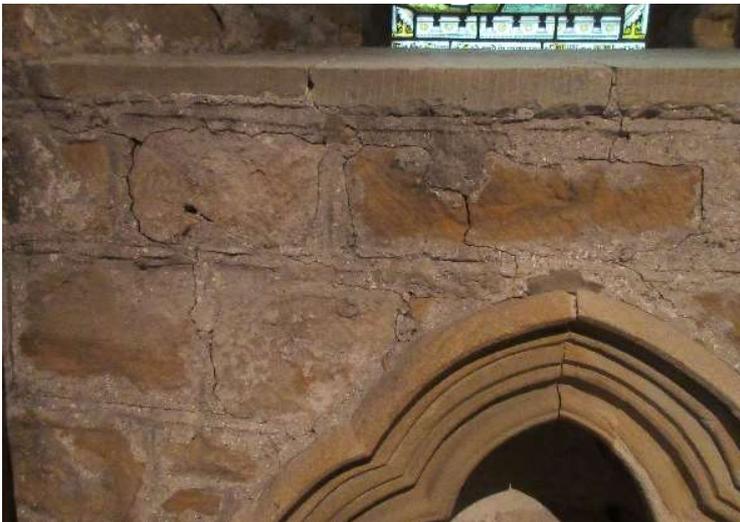
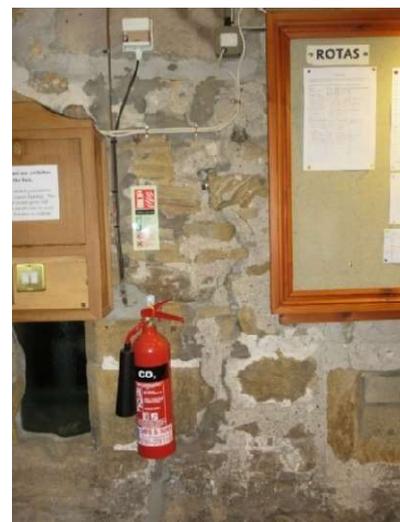
87. The Chancel S wall has minor opening of wide lime mortar joints close to the SE corner, in the crown of the E arch over the piscina, in the E window L reveal and cill, no visible change.

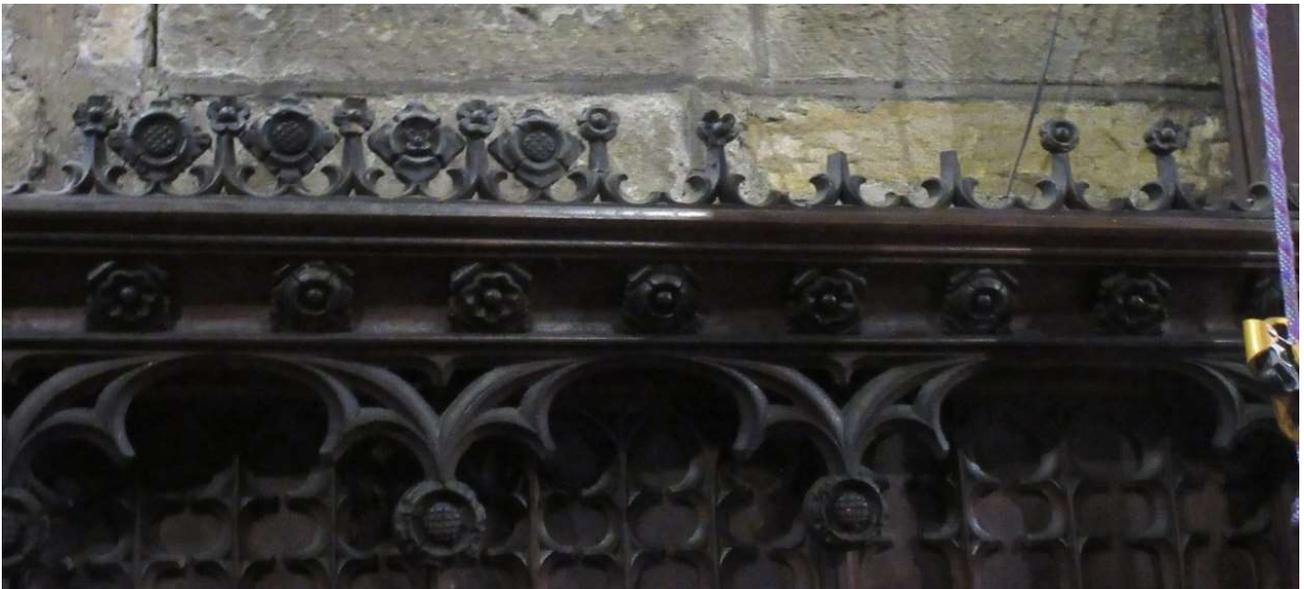
91. Parts of the cresting at the Chancel panelling is broken and missing. Detached cresting in the Crypt may match for salvage. If not your architect could suggest an expert wood carver to replace the missing parts.

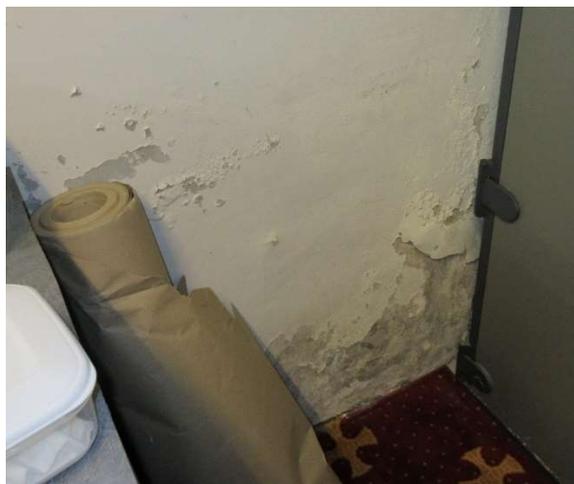
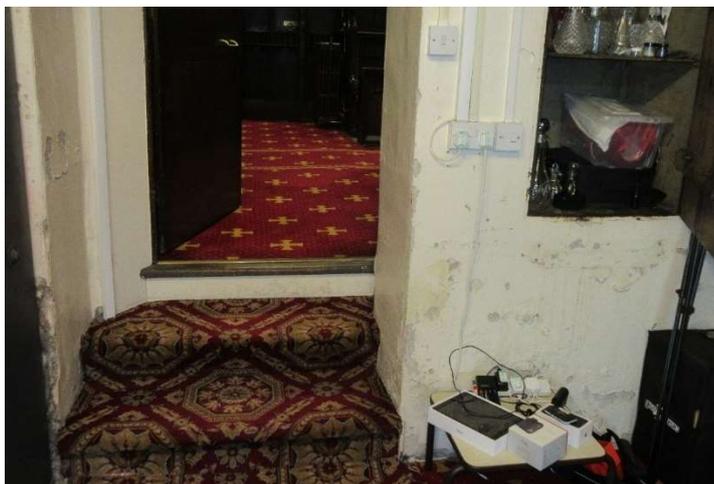
96. In Clergy Vestry some rising damp in plaster against Chancel and its E wall. Less damp since better maintenance of the rainwater goods and gully outside which must be cleaned at least once a year.

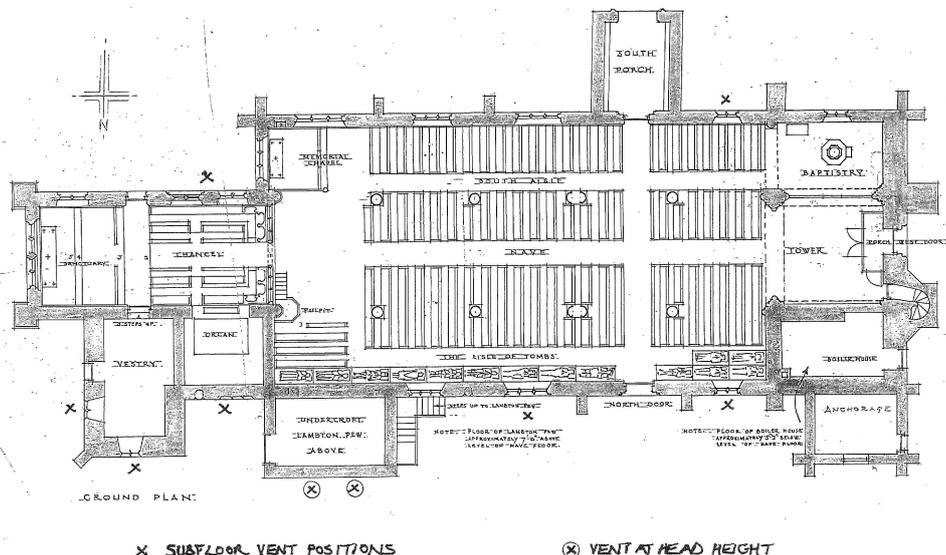
109. Subfloor vents are below paving level and kerbed. Ventilation depends on the small spaces outside the grills being kept clear of debris at all times.

Mud clogging the vent well SW of the S Aisle (from which I lifted a hedgehog) needs to be cleaned out.

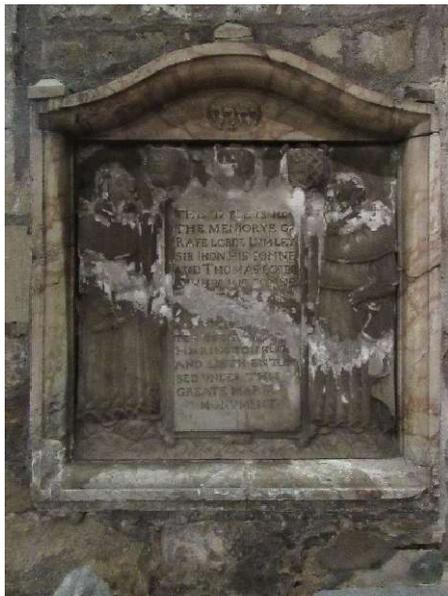
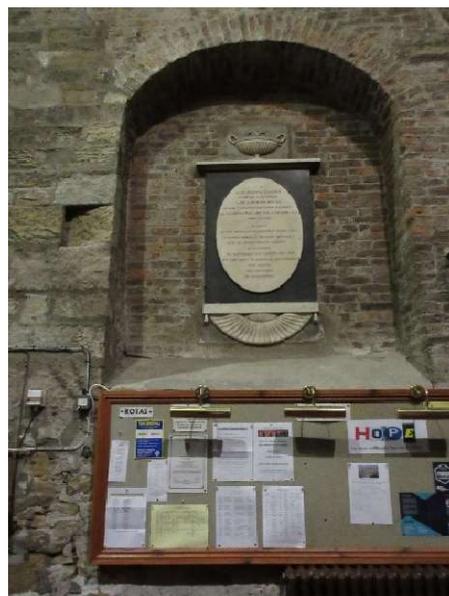
121. Three large marbles on the front of the Lambton Pew and two smaller recessed into the wall to its L.

The latter are part illegible after losing some surface but seem stable now. If the wall behind and window above are kept in good repair the monuments may not suffer further damp penetration.

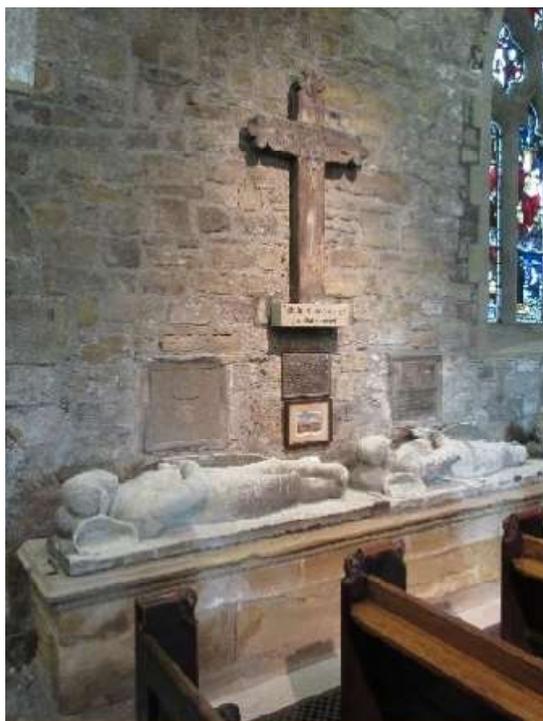
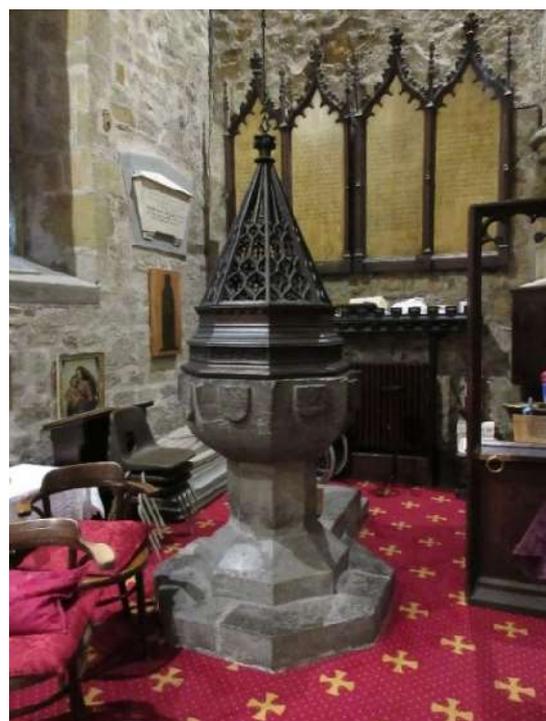
122. Numerous stone effigies on a continuous plinth along the N Aisle wall are in mixed condition but appear stable. An effigy and upright ledger stone in the Baptistry.
