St Mary the Virgin, Cockfield

Quinquennial Inspection

CONDITION SURVEY 2021

THE DIOCESE OF DURHAM
The Care of Churches Measure 2018: Quinquennial Inspection Report Form

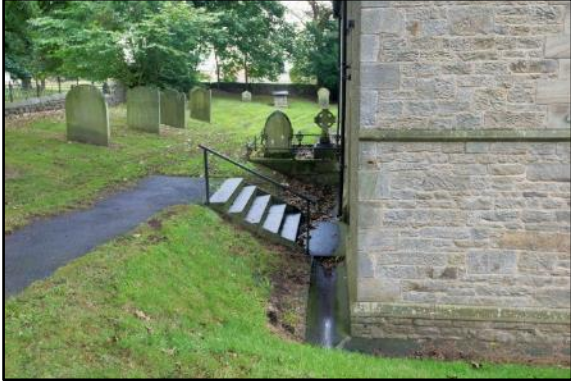
<p>6.01</p>	<p>Churchyard Comment on the general condition of the grassed and planted areas.</p>	<p>A very tidy, walled churchyard with many graves. Mainly grassed with well controlled trees. There is a significant change in level on the north side of the church.</p> <div style="text-align: center;">

<p><i>North side of the churchyard</i></p> </div>
<p>6.02</p>	<p>Listed Grave Stones</p>	<p>These are all in acceptable condition.</p>
<div style="display: flex; flex-direction: column;">

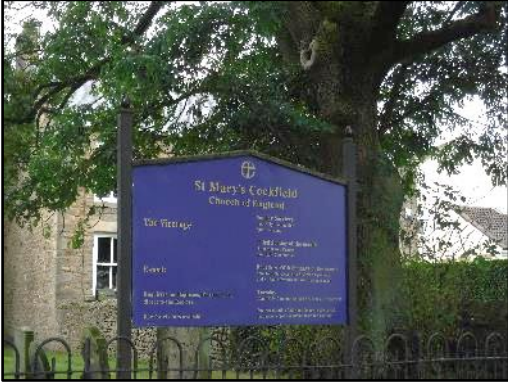
6.07	Buildings within the curtilage	None.
6.08	Notice Boards	<p>Main board This is located next to the north gateway and is in acceptable condition.</p>
