QUINQUENNIAL INSPECTION REPORT

CONSETT, CHRIST CHURCH

QUINQUENNIAL INSPECTION AND REPORT
April 2022

David Beaumont BA (Hons) Grad Dip, RIBA, AABC

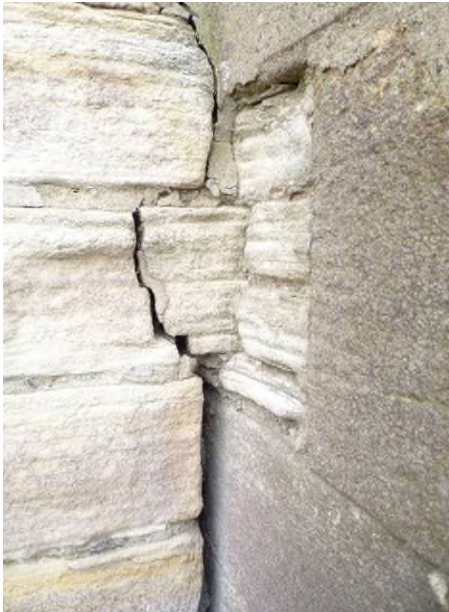
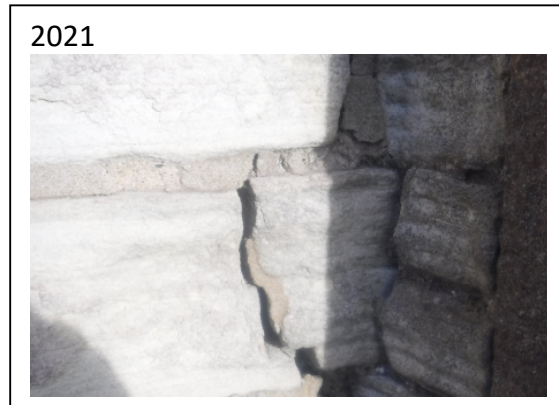
2016

The tower is the significant item, in that there is significant vertical cracking to the tower on the south west corner, probably due to poor ground conditions at the SW corner. The tower has been the subject of an engineer's report in 2004 and a quick comparison between the pictures of the cracking then and now shows little change, however the underlying problems remains and joints remain open. Because of dropping of mortar and one stone (causing the west doorway to be closed temporarily) in 2014, a high level inspection was carried out by Taylor Hastwell. They reported multiple pointing failure, cracked stones, rusting metal ties, crushing to the west wheel window, etc. Their estimate was £27,000 ex vat however this does not include the engineer recommendations of 2004, when an estimate was produced for £60,700 ex vat. The engineer report recommends full scaffold and Cintec anchors installed along with a complete repoint and stone repairs. It is probable that this engineering figure can be revised up to c. £100,000 ex vat. The whole repair of the tower, inc scaffold, is probably in the region of £150- 175,000 ex vat and professional fees.

The recommendations of the report in 2004 are still valid and with recent mortar failings and recent close inspection, the combined results mean that the church should address the tower defects in the next five years.

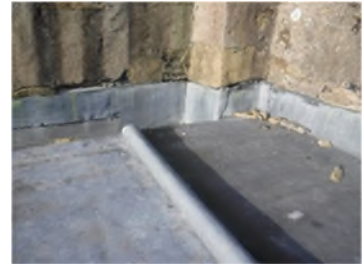
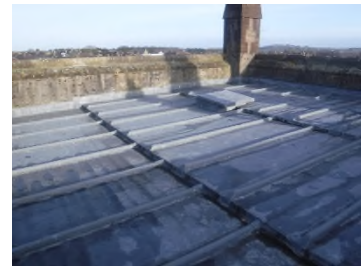
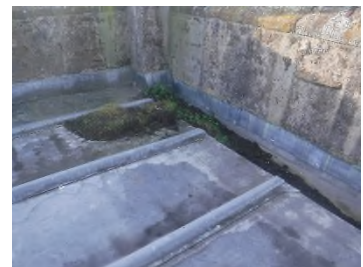
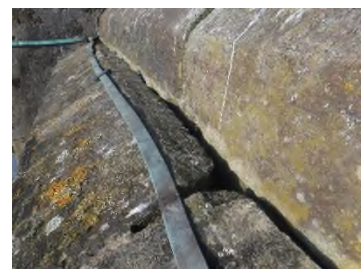
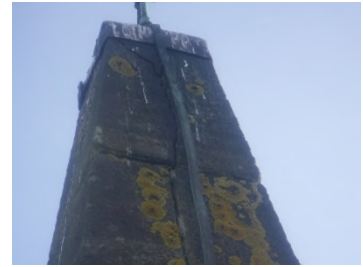
- Parapet coping on the east side has lost its mortar fillet and is open to the sky. It is expanding the outer face walling, and water will be getting in the core, though it is held by cramps. On the south side, one cramp is wearing out and there is an open joint in the coping stone. there are a few open joints on the S side and on the W. A timely point up is advised here. You can see that there are open joints by looking overhead. Inside the parapet wall is rendered off and generally it is sound, there is a bit of a crack showing on the N side and I could argue that there is also one showing on the E side but that actually looks like an old patch possibly, structurally there doesn't seem to be anything physical here.

- The four pinnacles are all reasonably fair, they have their joints weathered out a bit and of course I am only looking at the inside of them not their outsides. The S W pinnacle apex is cracked. Caused by the rusting steel dowel pin inside it, so they have all got this potential to crack but there is only one visible from the inside. They should all be replaced in stainless come the time of the tower repair works. They should all be inspected by a

Recommendation: Replace hatch covering with lighter material, reinstate flashings, sweep up, carry out repointing, remove grass, repair loose pinnacle apex and point up parapet.

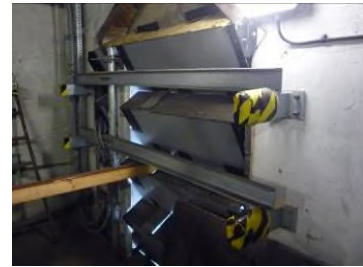
- **Ceilings** – Timbers look ok, bit of damp at the underside of the parapet but nothing problematic.
- **Walls** – There is some stone shaling from the crowns of the belfry window openings. This is the inner arch which looks to have loose keyed stonework. This occurs mostly on the west side, though there is also a couple of dropped stones around about the north. Previously they have been rendered around the inside, it just seems that the exposed ones are losing their face.

- Cracking to the northern and southern sides where the roof beams are loading and they are probably just exploiting the weakness of the arch.
- The west has hairline cracking – 0.5mm cracks at their heads and they don't seem to have anything particularly evident about them.

- Bell frame as before, looks ok. Room has telecom equipment within it, infills the louvres which conceals the back of the transom columns so you can't see them for inspection. There is one that looks to have a shear crack outside. and there may be more.

- **Floor** is good and dry and it supports the timber bell frame containing eight bells.
- The stairs up to the roof hatch are ok but the hatch itself is just too heavy to lift and needs a better arrangement.

Recommendation: Lighten the hatch and put it on hinges with a keep.

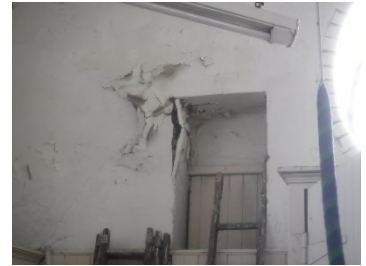
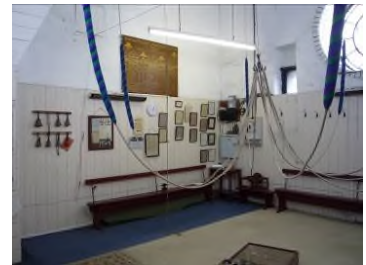
- **Ceiling** – Warped fibre board panelling looks damp (but I don't think it's 'wet' and the ceiling is beginning to break up on the N side just above the foot of the stairs. Two steel beams have rust coming through the paint work- they just need redecoration.

- **Walls** – Lime washed plaster breaking up on the W side where there is a little recess by the side of the window and also on the N side at the bottom of the white ceramic faced brick lining to the circular window for the clock dial

- **Floor** – Is solid and contains the bell ringers' fly collection.
- **Miscellaneous** - Small cupboard to one side full of maintenance equipment. Within the clock cupboard the small window on the W Rooks are nesting, glass is broken and there is also an exposed lintel that looks a bit run down and the plaster is coming away a bit and there is quite a bit on the floor which won't be helping the clock mechanism.

Recommendation: Remove rust to beams, clean up the dial vent holes and shutters. repair rook glass, eradicate flies, redecorate

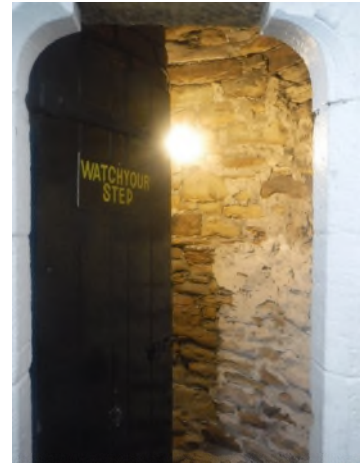
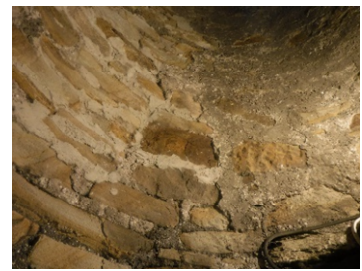
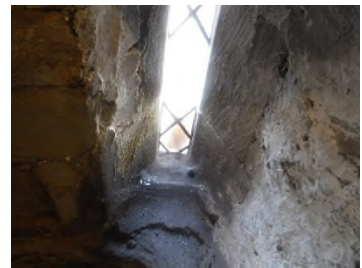
- The steps have some lamination to the tops but are generally sound.
- Walls are reasonably ok, the render has come off most of it and it has been patched up a bit with cement, there doesn't seem to be any obvious cracking to it, the glass reveals are all rather dusty and the bottom window has a bit of cracked glass to it.

Recommendation: repair glass

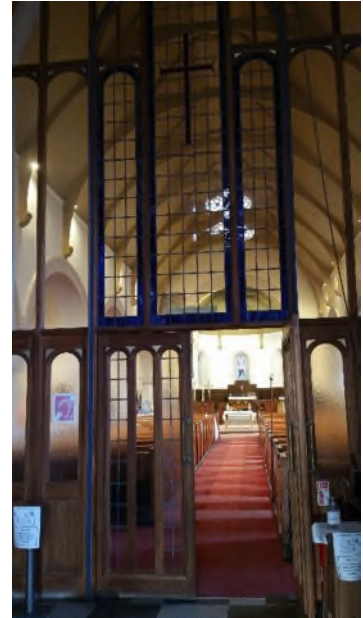
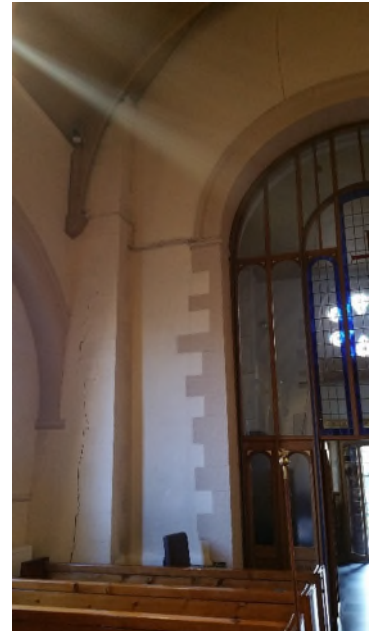
- **Ceiling** – Flat ceiling of boarding like elsewhere.
- **Walls** – Are much the same as last time, horizontal crack to the N side just below the corbels. W wall has crack coming down from the rose window, I think the decoration to the arch is just a little worse than it was before. Slight crack at the angle of the two walls to the left of the Parish clock plaque and a crack to the arch head of the doorway at the bottom of that doorway the wall has been patched up with some gypsum plaster. Slight crack to the arch into the nave on the N side.

- **Floor** – Is nice granolithic tiles they are ok.
- **Miscellaneous** – There is a timber lobby, door is catching slightly and the carpet is kept down by tape and could do with updating to avoid becoming a trip hazard. The entrance doors are ok, they just fit but there is a draught coming through them of course, hence the lobby, the former curtain has gone now.

Recommendation: update carpet, consider draught stripping entrance doors

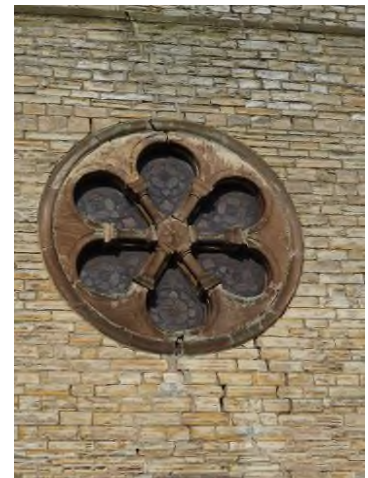
West face- Bird nesting in the small window under the dial, crack running through the rose window and head of the doorway, multiple erosion and open joints. Separation to the south buttress.

West Elevation – Chip out to the pinnacle top of the NW corner. Quite a bit of erosion to the parapet. Belfry openings look ok. There are cracks/open joints to the cills (same as the other sides)

Recommendation: The recommendations of the engineer report in 2004 are still valid and with recent mortar failings and close inspection when carrying out roof repairs, the combined results mean that the church should address the tower defects in the next five years.

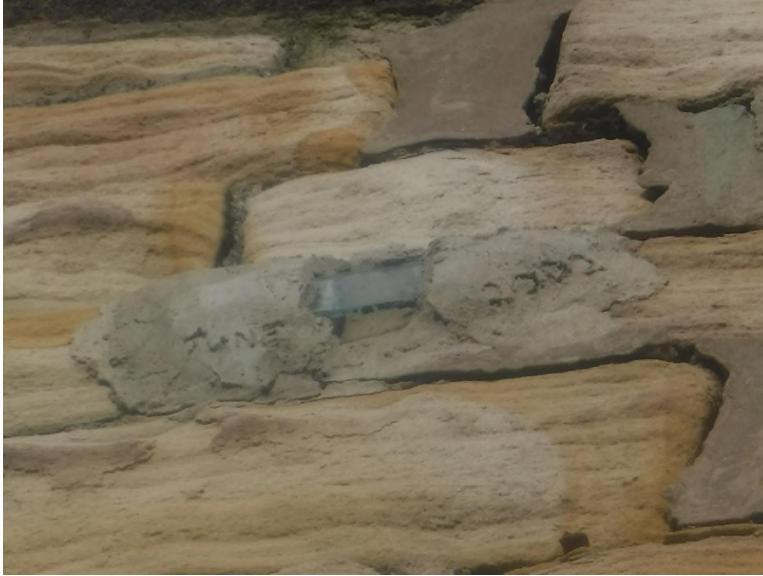
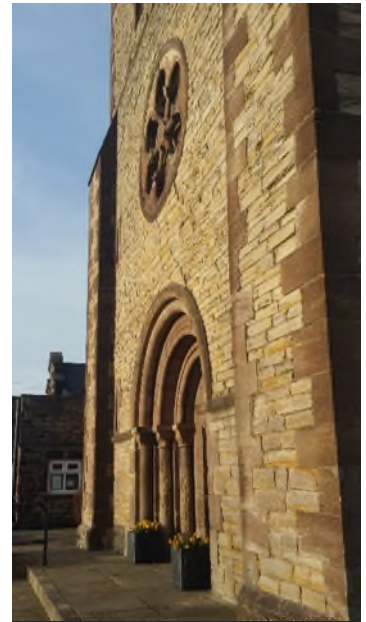
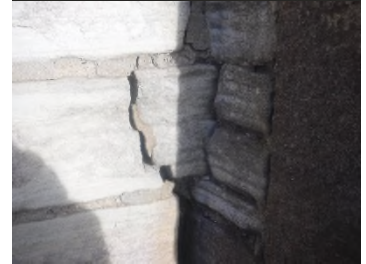
Above the clock dial are open joints and slight suggestion of movement and you can start to see it wriggling down from roundabout six o'clock past the Rooks nest right through to twelve o'clock on the rose window, coming out at six o'clock and also at five o'clock wriggling down to the arch, I don't think it has progressed since the last inspection from a casual look at the old images. The rose window spokes look to be coming apart as they lose their compression as the tower widens and that is a worry. There's a lot of wide joints with cement pointing falling out. A lump came out of the rose window c. 2018 causing the entrance to be barriered off. The steeplejack returned and removed some of the loose cement.)

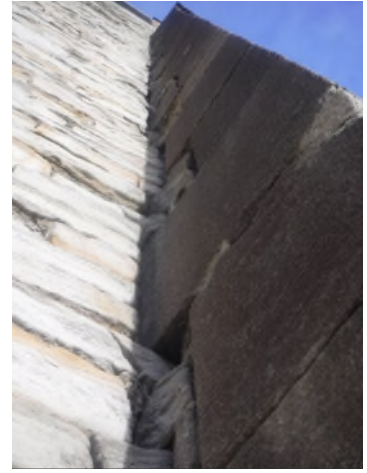
South Elevation –

Better condition than the E, you can see the cracked pinnacle top here, open joints mostly at the parapet, there is a crack to the W quoin of the window and I think that is from last time. The buttress shear cracking looks the same.

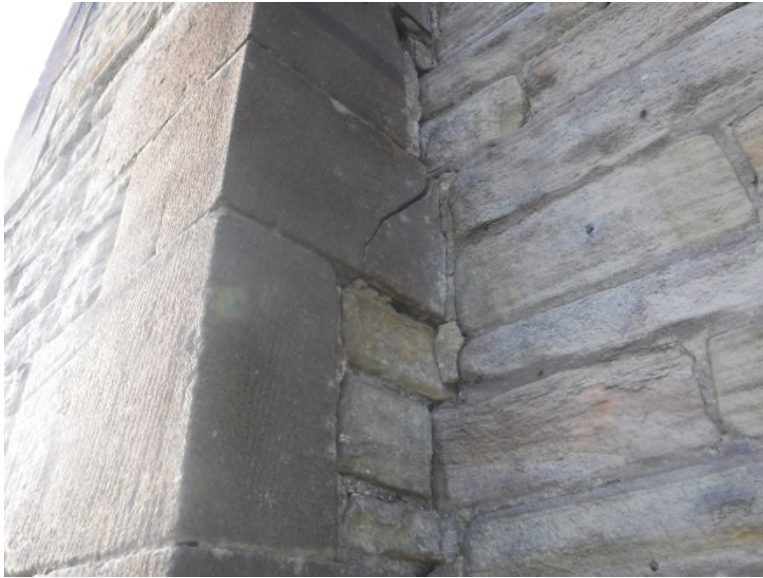
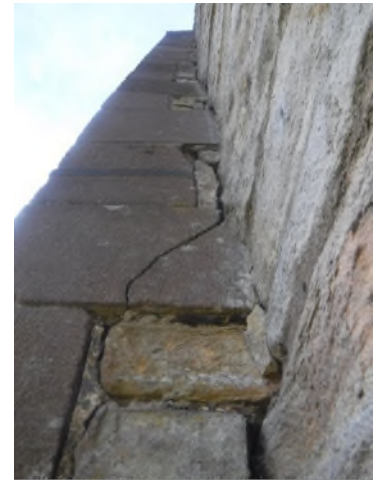
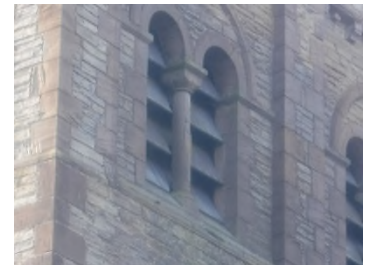
East Elevation –

Loss of pointing to the parapet, below that the general walling has quite a lot of loss on the stonework. The belfry openings look ok but the S one has a bit of a chip out of the face of the transom column and it may have a shear crack below the capital.

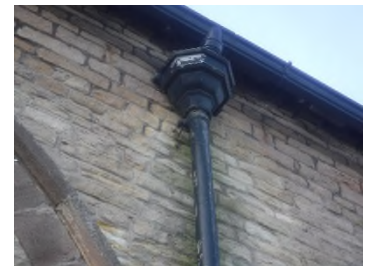
South side – Gutter ok but grass up at the tower end, downpipe in dire need of decoration but is ok, leaves in the salt glazed gully. Is the central downpipe hopper blocked?

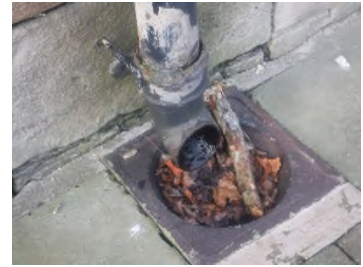
West end – Octagonal hopper and downpipe needs decoration, bandaging and the collar is rusting.

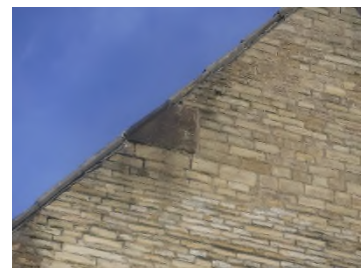
The watertable is laminating badly, the cross also laminating, walling is eroded badly below the apex above the window, also to the left of the window and to the right of it too,.

The kneeler is losing its bond and this needs some diligent repairs. It hasn't changed much in the last 5 years but it shouldn't be ignored.

Recommendation: Repair cross, remake the watertables, rebuild kneeler and repoint open joints.

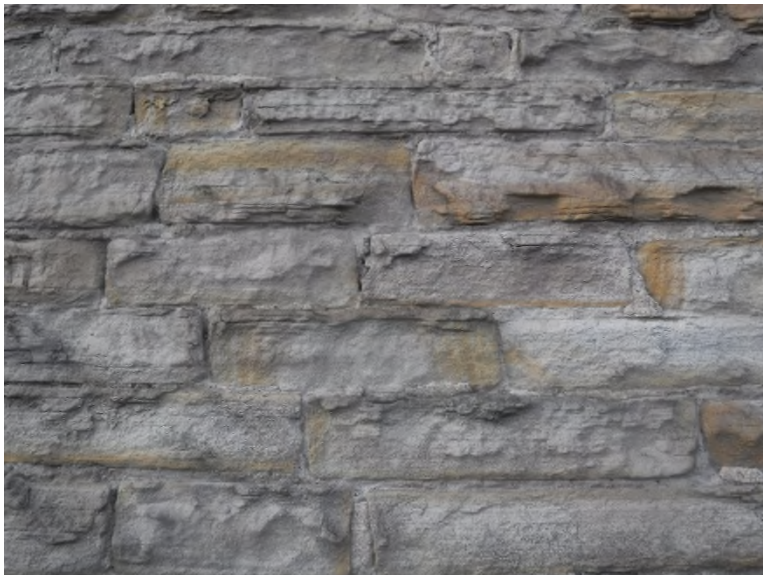
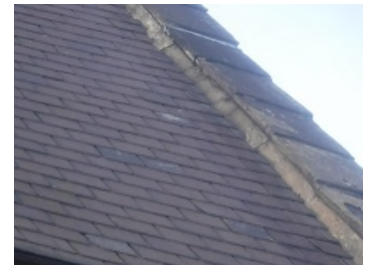
Masonry is quite poor quality (cheap because it's arcade infill?), designed for an aisle which was never added so the walls are likely to be thin in between the arches. Arcade arches are all ok. There is some green wash onto the central downpipe, is that hopper blocked? Quite a bit of erosion at the E end at high level has been repointed I think, but don't know who by, and the buttress is a bit gnarled as well.

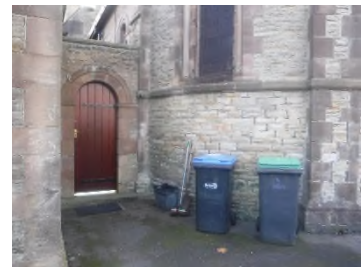
East end – This is semi-circular masonry rather damp looking at the bottom of the wall, is that because of the tarmac up against it? Buttresses are ok, some of the cement pointing is rock hard and it should all be replaced in lime. The bottoms of the window shafts continue to splinter on the rusting dowels.

Recommendation: repair shafts.

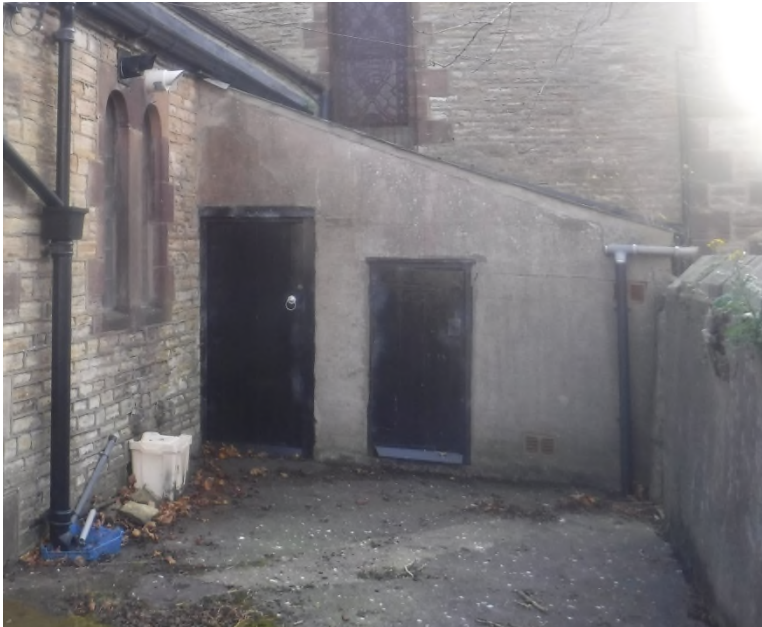
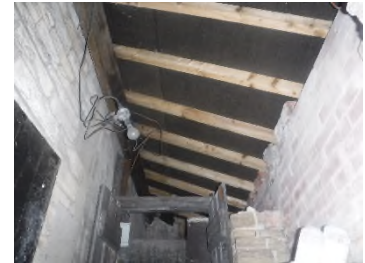
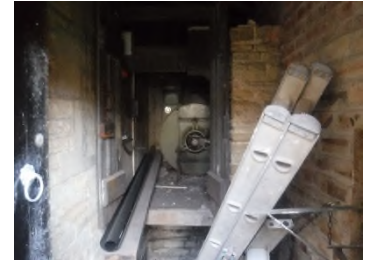
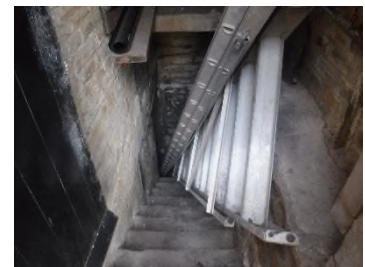
Oil Tank Store:

Two rooms to the outbuilding under a common sloping roof:

south- steps down to basement room. not possible to inspect as stairs blocked by ladders

North- Brickwork with brittle cement rendering over it, cracked at the lintel, all the way round. adjoining retaining

wall is in poor condition.

Filled with chairs and objects

Recommendation: clear our lumber

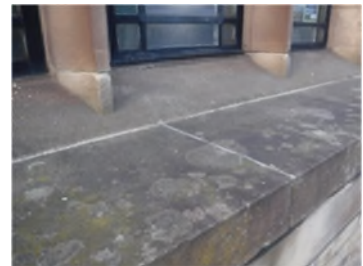
North Aisle:

Some cracking towards the east end close to the westernmost window. These all have metal guards that are beginning to rust a bit and stain the wall below. Cement repairs and some slight open joints towards the western end. Buttresses are all okay.

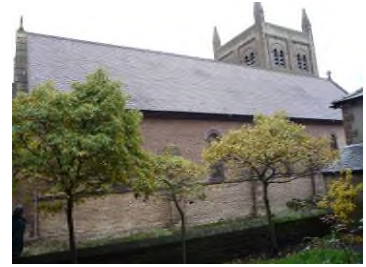
Masonry here is not too bad compared to the S side but unfortunately it has been splattered with cement pointing at the bottom. Buttresses are generally fair, windows are ok- they have got mesh guards and they are rusting slightly at the cills. The yard comes right up to the walls and has got a loose slate margin.

Recommendation: None.

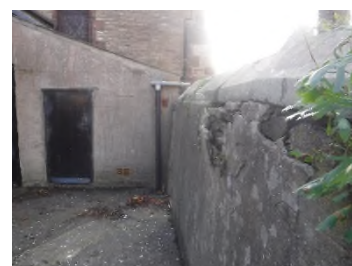
The wall is rendered on the inside and this is breaking down in many places. The coping is also uneven.

Tarmac floor which is covered in algae and leaves. The wall returns around to the northern side of the boundary enclosing the boiler room and the coping here is particularly poor and the plaster below it. The whole of the yard area here needs a sweep out, it is very damp.

Recommendation: repoint and partial rebuild boundary wall, sweep up

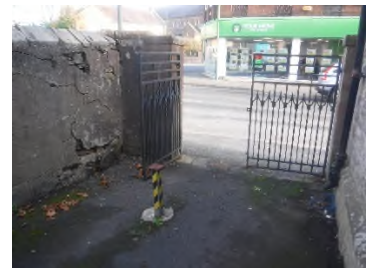
Faces Church Street. Stone walls are generally okay. The entrance to the rear of the church is here with steel gates which are rusting.

Recommendation: Redecorate gates

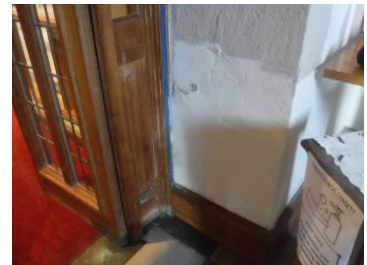
D Entrance lobby: Timber draught enclosure formed of glazed screens. The entrance door is slightly warped and the catch just about holds the lever in place. The hinges have had various types of washers added to them over the years however it is generally serviceable. A former curtain rail remains to keep the draught out in the past. The curtain is now gone. The side door doesn't latch properly.

Recommendation: Ease doors

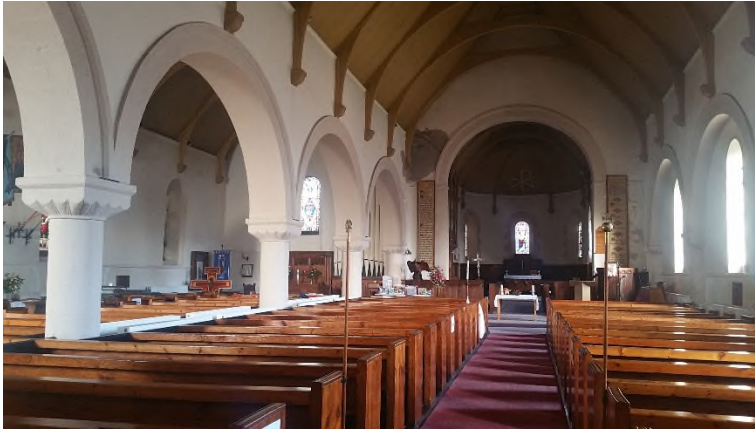
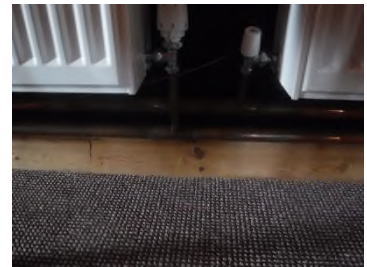
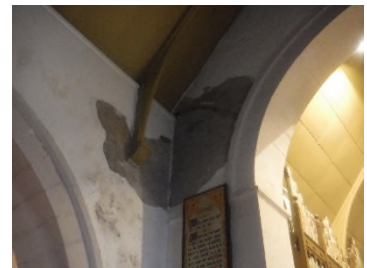
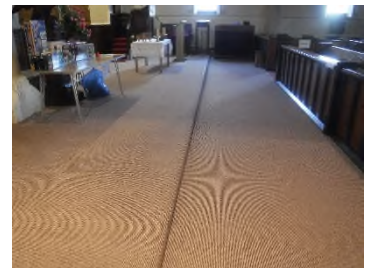
D**Nave:**

- **Ceiling** - Open ceiling with exposed trusses. The ceiling has (probably fibre) board added to provide some insulation, the boards are curling slightly in the metal grid frame.

- **Walls** –
 - **East chancel arch** – 3mm crack almost at the apex of the arch in the walling as last inspection. The arch itself has approximately 1mm crack and this looks like it is depressed slightly. Area of walling to the left at the springing point has water penetration marking and the plaster is spoiled. The right hand side behind the pulpit also has damp markings from a former, now repaired, valley leak. The arch has been painted in Artex, probably to disguise flaking plaster.

- **South wall** – The wall is formed from four arcade columns containing single Romanesque type windows within it. Walls at high level look okay, as does the infill to the arcade. The arcade columns sit on plinths and these have lost some of the sharpness to their mouldings and there is evidence of damp. Timber dado panelling between the columns seems sound. Gaps due to heating installation have been filled.

- **West wall** – 5mm crack reported in last QI on the southern side of the semi-circular arch boarding and the wall might now be 6mm. Also historic hairline crack to the arch which is also decorated in

Artex. The southern side of the wall has a long vertical crack of approximately 6mm at the base tapering to 2mm at the top as the last inspection. This looks like a shear crack resulting from ground movement or tower loading. The base of the wall is showing some damp and some poor cement infill.

- **North wall** – This is formed from four arcade columns. Walling above is okay, though at the eastern end there is some former damp penetration. The arches are all sound apart from the eastern side of the E arch where there is damp showing through the joints, spoiling the plaster. The shafts sit on square plinths, enclosed now by pews and they appear in reasonable condition.

Recommendation: Point gaps after tower works and redecorate.

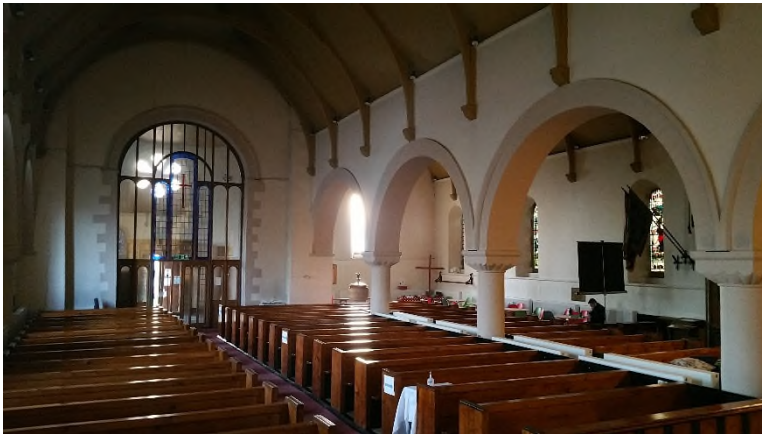
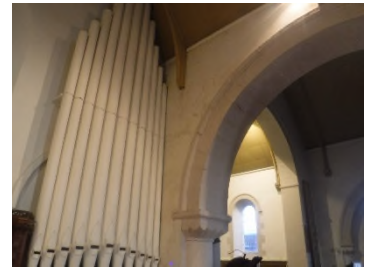
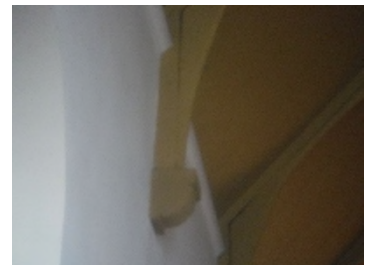
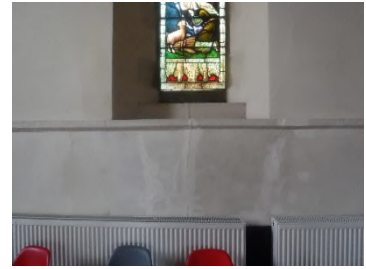
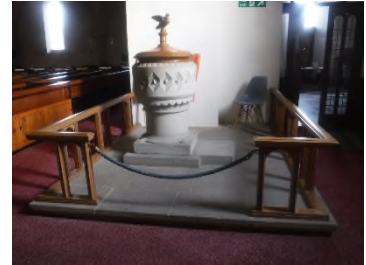
D North aisle:

- **Ceiling** – To the same design as the nave and showing some shrinkage at the collars, but this isn't structurally problematic.
- **Walls**
 - **East** – Gable wall featuring Romanesque window above the Lady Chapel. Damp at arch. To the right of the window are the speaking pipes of the organ.
 - **South** – This is the opposite side of the nave arcade and the comments are as before. The damp at the

east end might be affecting the foot of the truss post? Some minor shrinkage.

- **West** – some damp spoiling the plaster on the North Slope due to repaired water table failure. Hairline crack of approximately 2mm rising to the ridge from the crown of the Romanesque arch. Slight cracking through the lintel down to the ground of approximately 0.5mm and similarly on the left hand side of the window of approximately 1mm. The string course on the left hand side of the sill is lower at this point, again showing shear cracking. There is also some water marking that suggests the window might be leaking, and damp showing in the bottom left hand reveal. The outside watertable and pointing is poor here so that is the likely culprit.

- **North** – Wall contains five Romanesque single light windows with stained glass. Some slight cracking below the corbels of the trusses, mostly at the western end of approximately 1mm that loads on to the arch. Some damp showing at the reveals of the windows close to the glass which is where the wall is at its thinnest and just requires decoration upkeep. Some cracks in the wall below the string course of the window sills, mostly at the western end, due to ground heave? though there are further easing's towards the middle and the east of approximately 1mm.

- **Floor** – This item is the floor of both the nave and the aisle. Timber platforms for timber pews which are okay. Circulation areas are solid with new carpet. North western area formed for coffee has had the pew platform lowered. A new area created around the war memorial. A new platform has been introduced forward of the chancel in timber and there are some slight creaks to it but it is well carpeted and looks good, however there is the potential for tripping at the step, though the church does install temporary guarding.

Recommendation: Repair plaster at dado panelling, fill

cracks and redecorate when tower works are done and east end has dried out. Mark the chancel step.

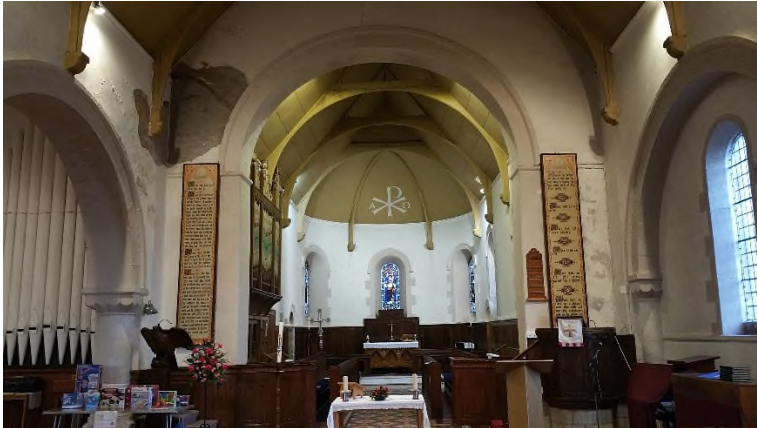
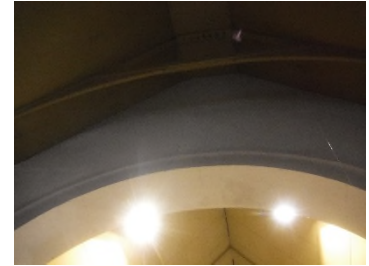
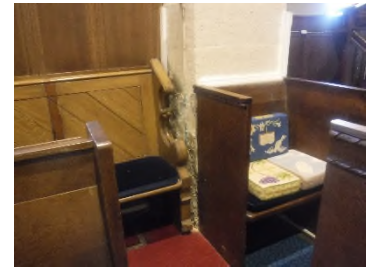
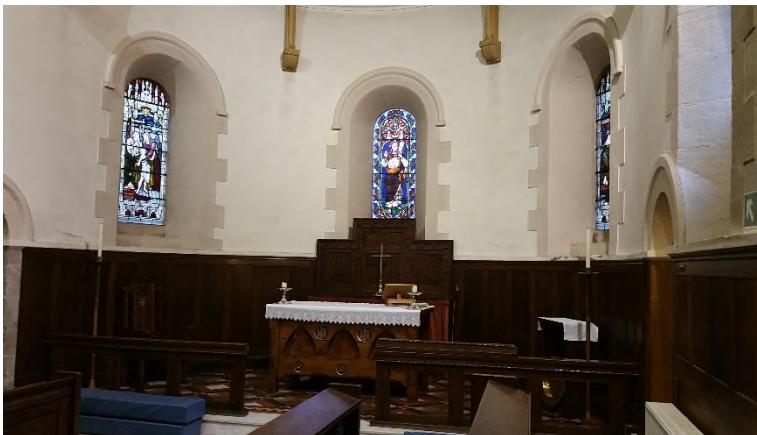
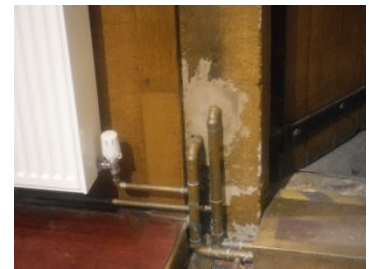
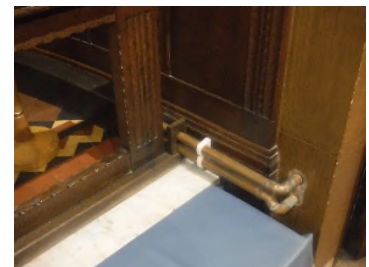
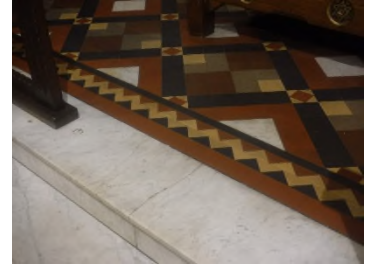
- **Chancel:**

- **Ceiling** – Same design as nave but with apsidal end. Here the ceiling has large format polystyrene tiles that are all in place.
- **Walls** –

- **East** – Curved apsidal end showing some slight dirt markings through lack of insulation. 1mm crack to the right hand side of the keystone of the central eastern window. The keystones look to have dropped slightly on the north and south side, though those are historic and have been decorated over and there is no cracking showing.
- **South** – Crack to window by the vestry door of approximately 1mm going up to the eaves. Damp showing just at the springing point of the adjoining

chancel arch and some erosion to the string course stone at the western window. Good oak, dado panelling below on all walls.

- **West** – Chancel arch damp showing to the north side in the jointing spoiling the decoration. 1mm crack at the keystone. Base of the columns are reasonably okay, the northernmost has the most efflorescence on it.
- **North** – This contains the organ, Damp at the western top of the wall, the remainder is okay.
Floor – Solid floor in the circulation areas with decorative tiling. The pew platforms are covered in linoleum and all in fair condition.
- **Sanctuary** – Has white marble steps with a crack in the top step of approximately 1mm and cracking to the decorative tiling on the left hand side of the step.

Recommendation: none

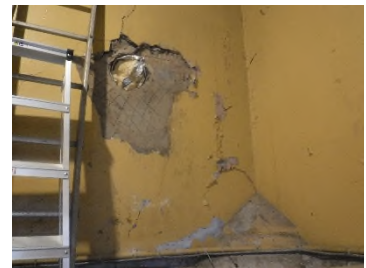
Door is okay, though it has lost its draught proofing stripping. This room contains the Ideal Evo Max twin boilers, expansion vessels and controls. Also the gas meter. The room contains various lumber. It also contains the distribution board. Timber sarking boarded roof.

- **Walls** – Are plastered and flaking through damp.
- **Floors** – Solid with old linoleum, all requires updating.
- **Exit door** – Is in reasonable condition though unable to be tested on the day.

Recommendation: remove lumber

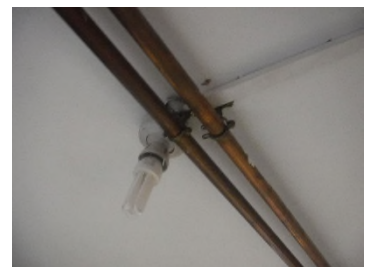
Vestry lobby:

- **Ceiling** – Plaster redecorated. surface mounted heating pipes. clips undone. Ill thought-out route against light fitting.
- **Walls** – Plaster
- **Floor** – Vinyl covered
- **Door** – To chancel slight catch on the floor
- Areas that have had new pipework require

updating.

Recommendation: clip pipe, ease door

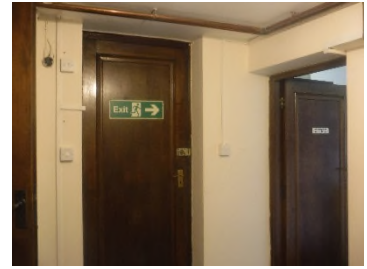
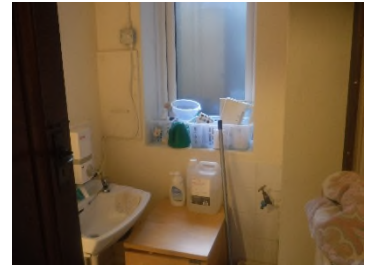
E WC:

- **Lobby** – Plaster ceiling
- **Window** – Plastic to the small courtyard.
- **Floor** – new vinyl.
- **WC** – The WC pan and cistern renewed. Walls and ceiling same as lobby.
- Rear door from lobby catches.

Recommendation: ease door

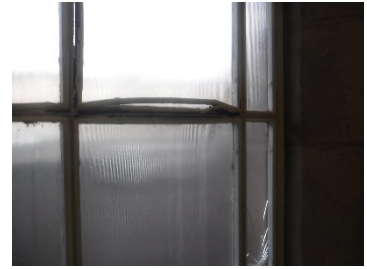
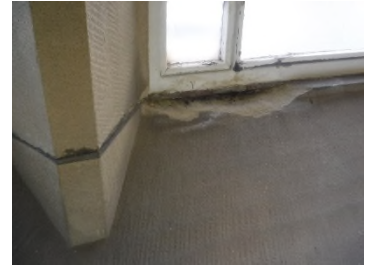
- **Door** – catching.
- **Ceiling** – Flat ceiling with sloping margins showing slight historical cracking and in need of decoration.
- **Walls** – Plaster with flaking decoration. South wall has large three light windows, displayed reveals that are in good condition containing metal framed

windows with timber glazing beads. Some of the glass has been broken in the past and the glazing beads are loose. Some have been replaced with putty rather than glazing beads. Looking shabby now. Perhaps security ought to be considered in this room.

- **Floor** – Herringbone parquet flooring in good condition.
- **Wall cupboards** – Oak and need some slight adjustments and latching to fix back better.
- The room contains quite a bit of lumber which could be removed.

Recommendation: Decorate ceiling and walls, refix glazing beads and remake poor putty pointing with new glazing beads. Ease cpd doors and remove lumber. Consider security.

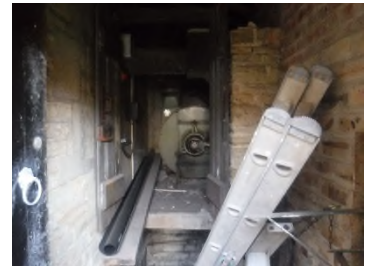
Walls - Stone to church, brick to remaining.

Floor – Solid.

Recommendation: Remove lumber.

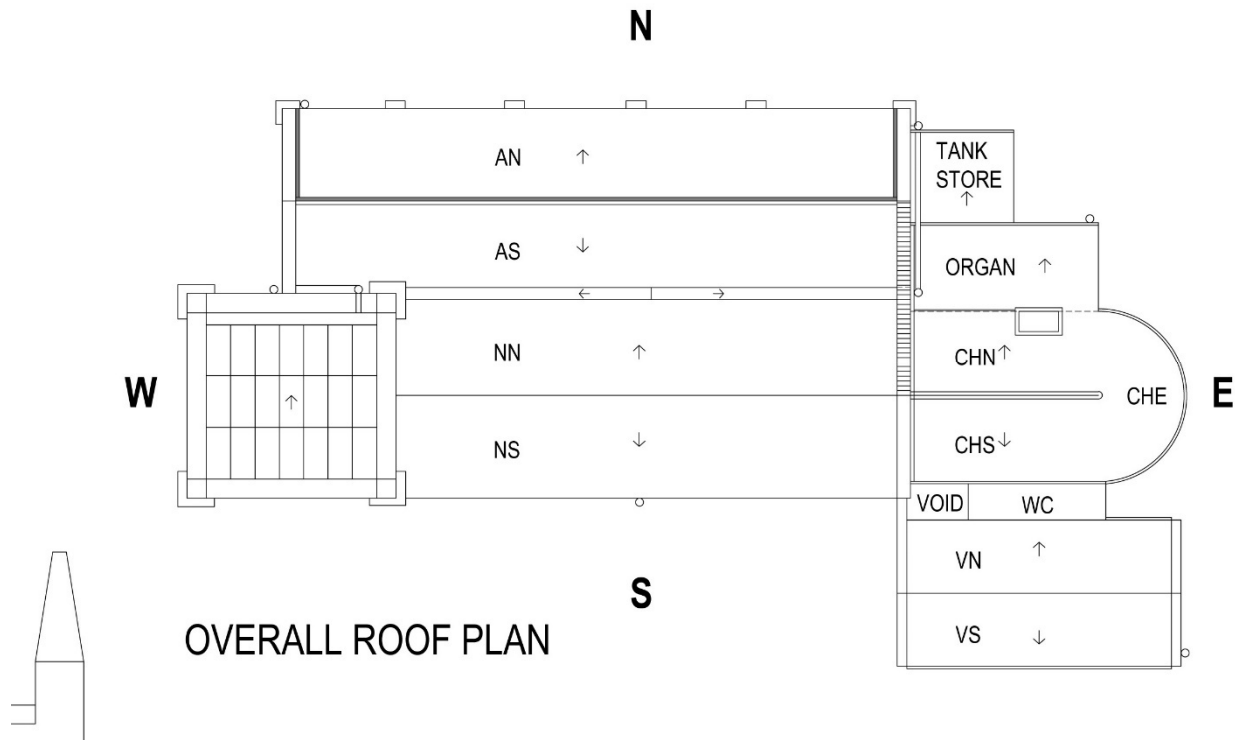
The state of each roof slope, to the best of my knowledge, is as follows -

AN - Reslated by us in Nov 2015, using 14" x 12" second-hand Welsh slates to your specification. The roof that we took off had been reslated post-war but was failing because of the lath nails that had been used, which had deteriorated badly.

AS - 14" x 12" Welsh slates on lath on bitumen felt. We assume that this slope was last reslated post-war at the same time as AN. It loses slates in strong winds, The lath nail haven't been investigated, and although it looks to be more stable than AN did in 2015, I would recommend it for renewal within 5-10 years. The slate quality is OK, suitable for re-use as happened on AN.

NN - 18" x 9" (and some 10") Welsh slates on battens and bitumen underfelt. Again, I would suspect that this roof was reslated post-war, along with the North Aisle roofs. Slate quality generally is poor, and slates regularly fall off in windy weather (the central valley acts as a wind tunnel, so the inner slopes are more susceptible to damage than are the outer slopes). I would recommend this slope for renewal within 5 years.

NS - Generally as NN, but does not lose as many slates, as mentioned above. The ridge tiles between these two slopes could do with rebedding, especially as any damage on this slope tends to be at that level, but the reslating of the inner slopes would include rebedding. I would recommend renewal in say 5 to 10 years.

Tank store - Slated in the not-too-distant past (but more than 9 years ago) with 600 x 300mm fibre-cement slates, which suit its shallow pitch. No action needed apart from maintenance when the slates get broken by trespassers.

VN and VS - the Vestry - Welsh slates on battens and bitumen underfelt. I don't know when this was last reslated, but it seems to be in fair condition and not in need of imminent reslating. Odd slates sometimes need to be replaced, but it does not seem to be vulnerable to strong winds.

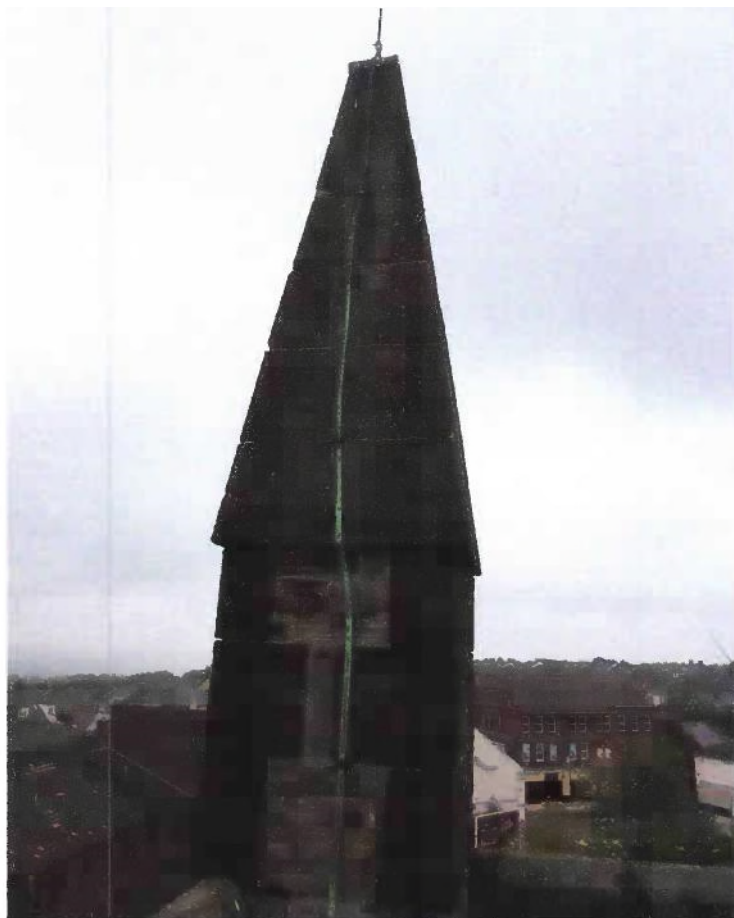
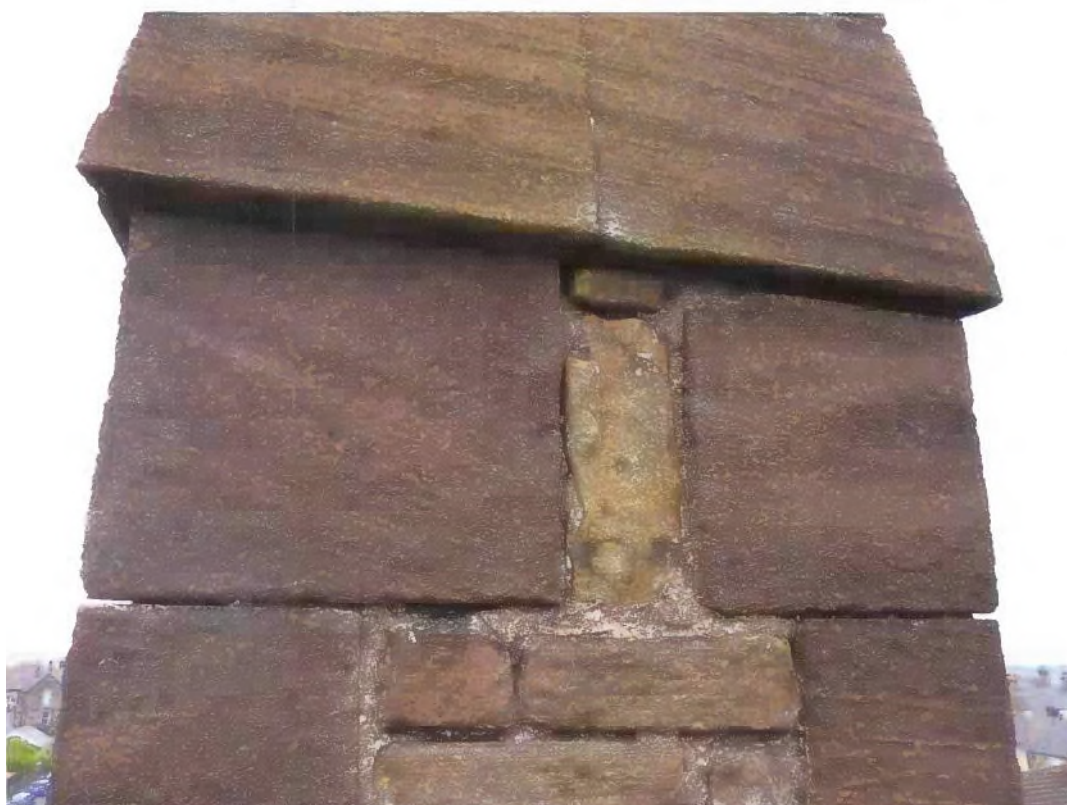
Examples of the pinnacles.

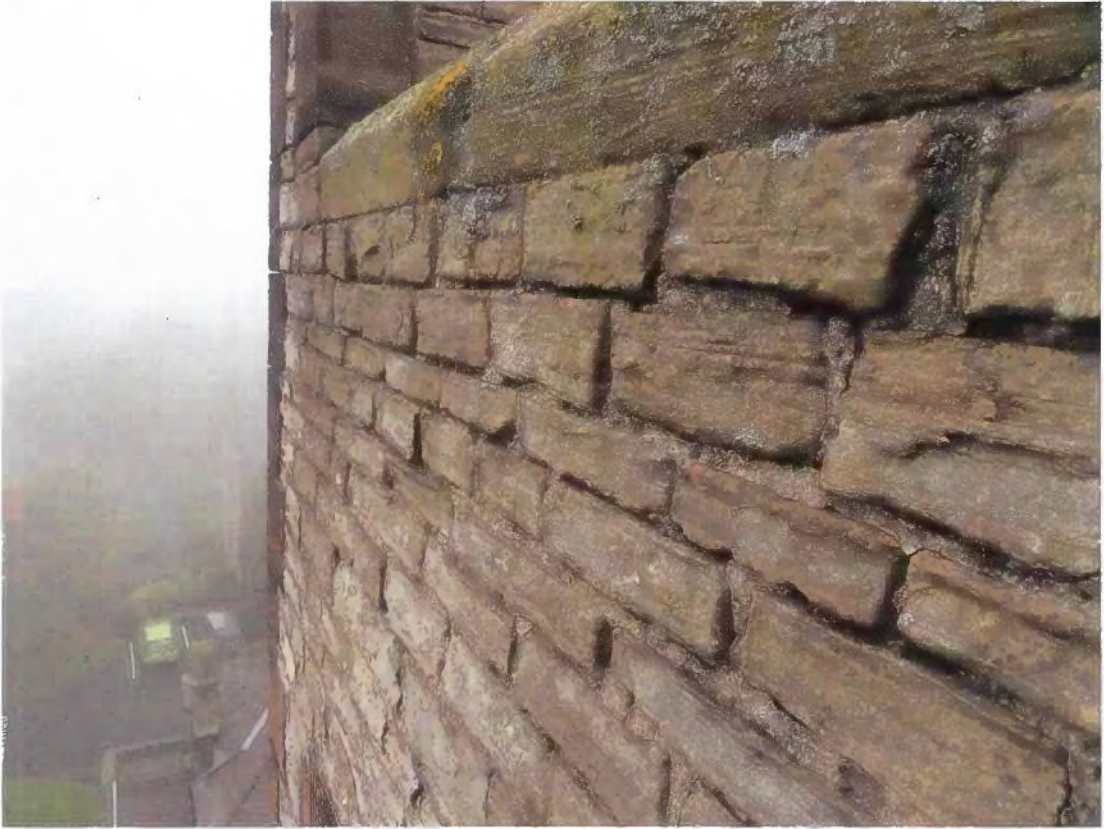
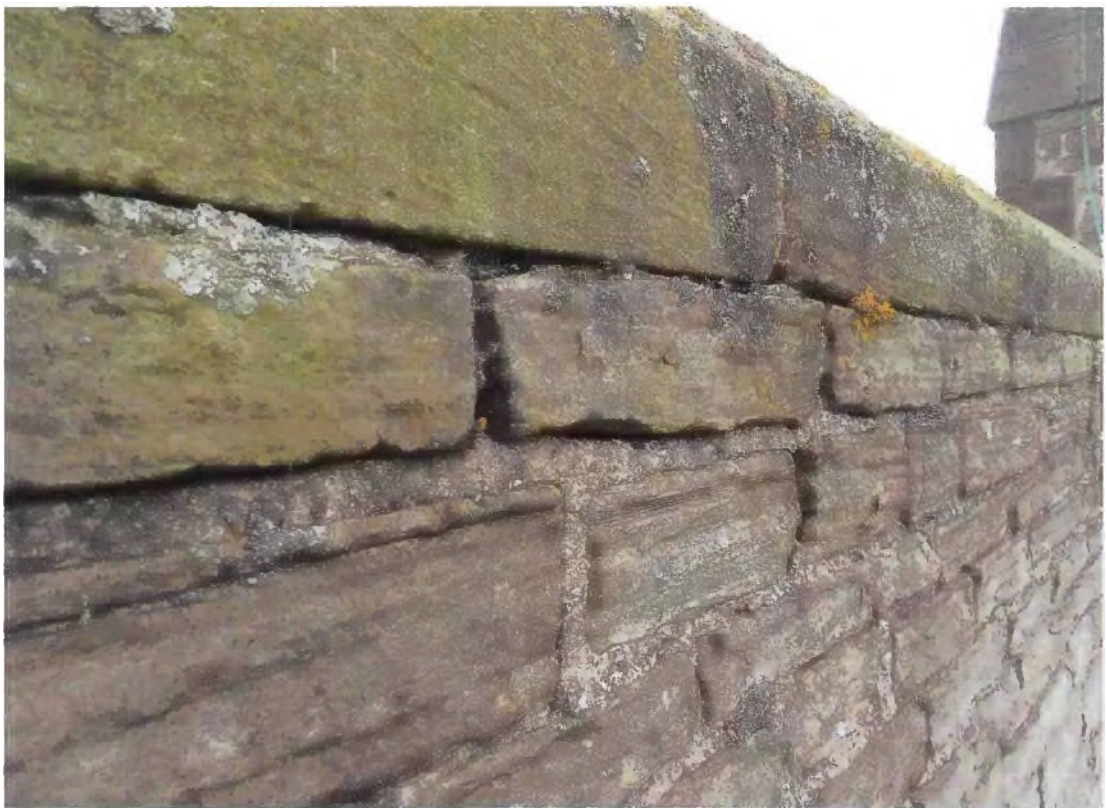
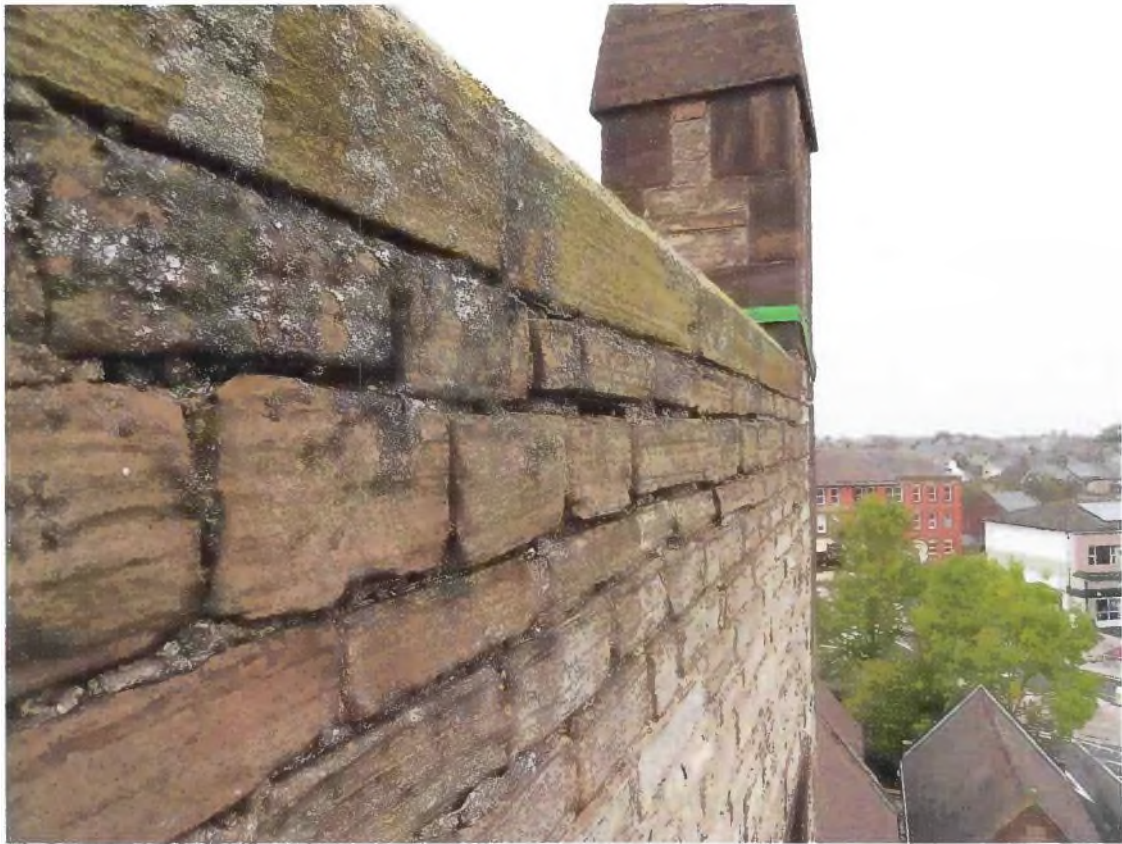
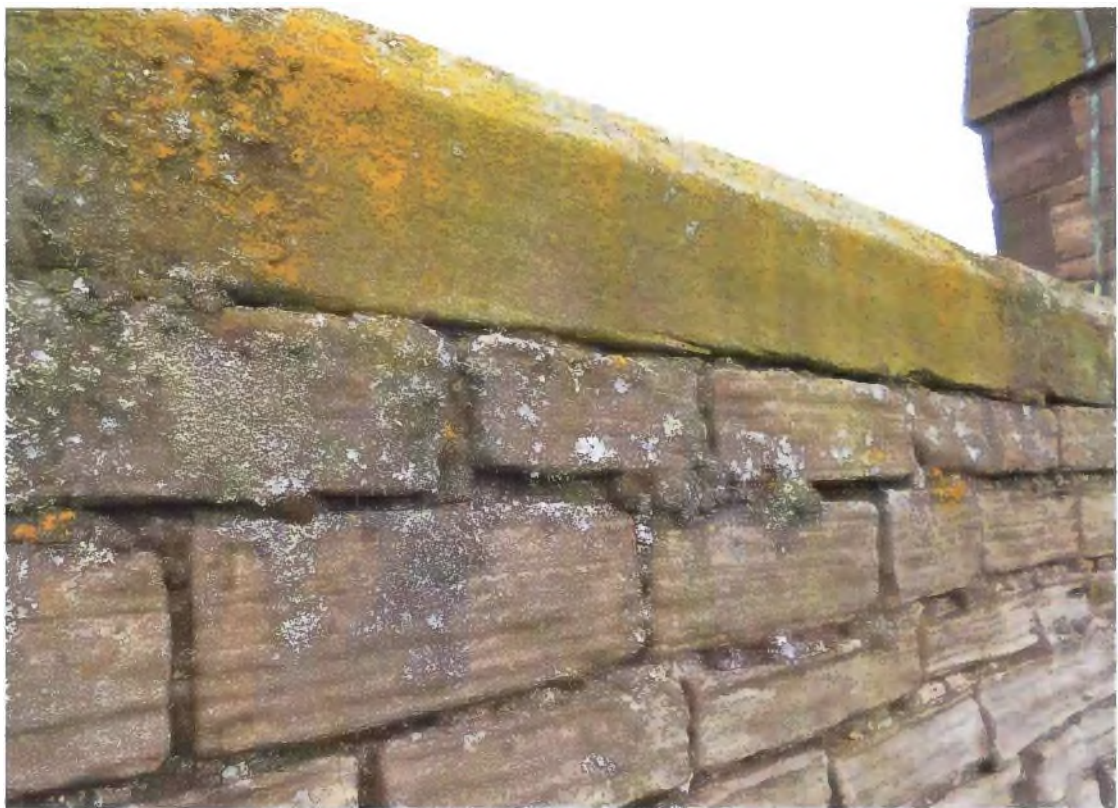
Examples of pointing to section B..
