QUINQUENNIAL INSPECTION REPORT

CONSETT, CHRIST CHURCH

QUINQUENNIAL INSPECTION AND REPORT
April 2022

David Beaumont BA (Hons) Grad Dip, RIBA, AABC

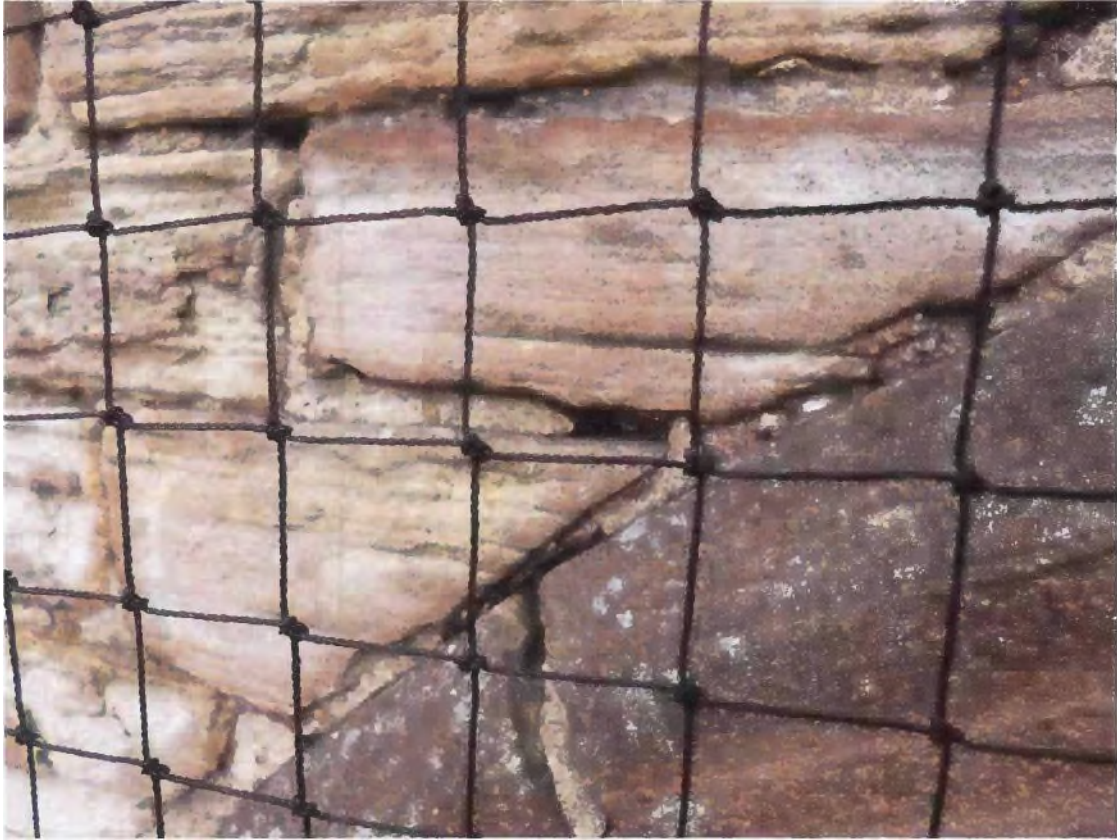
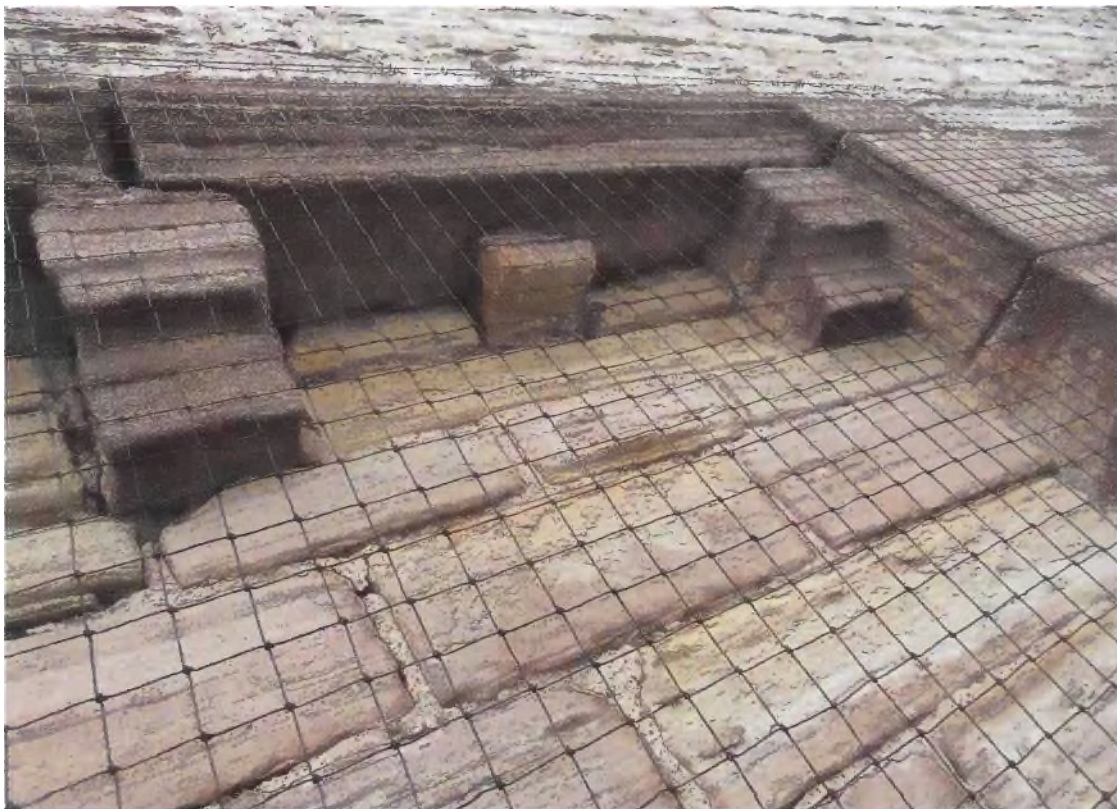
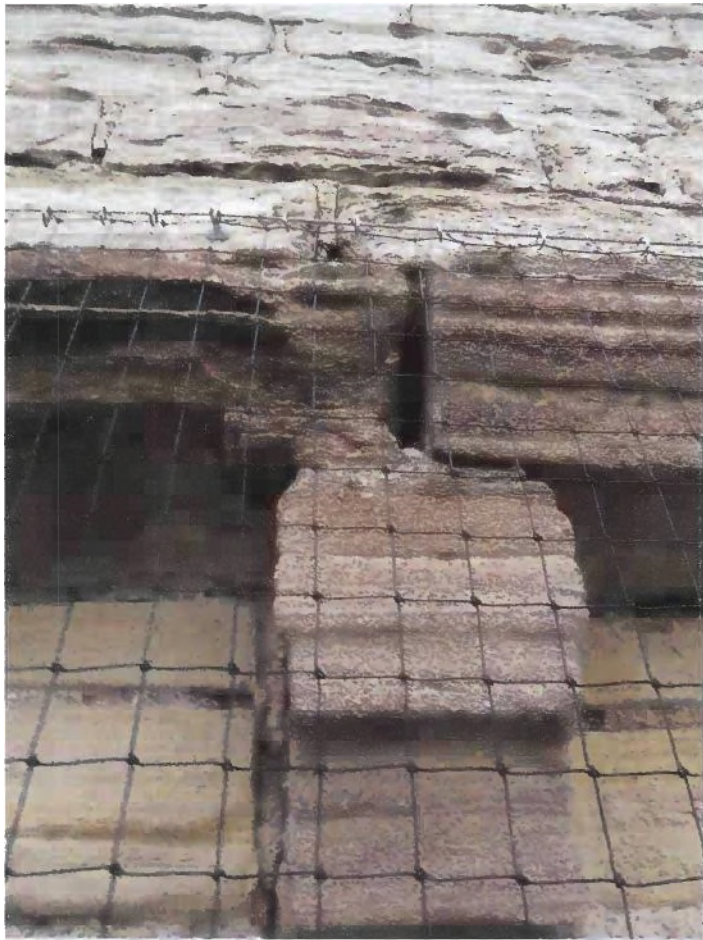
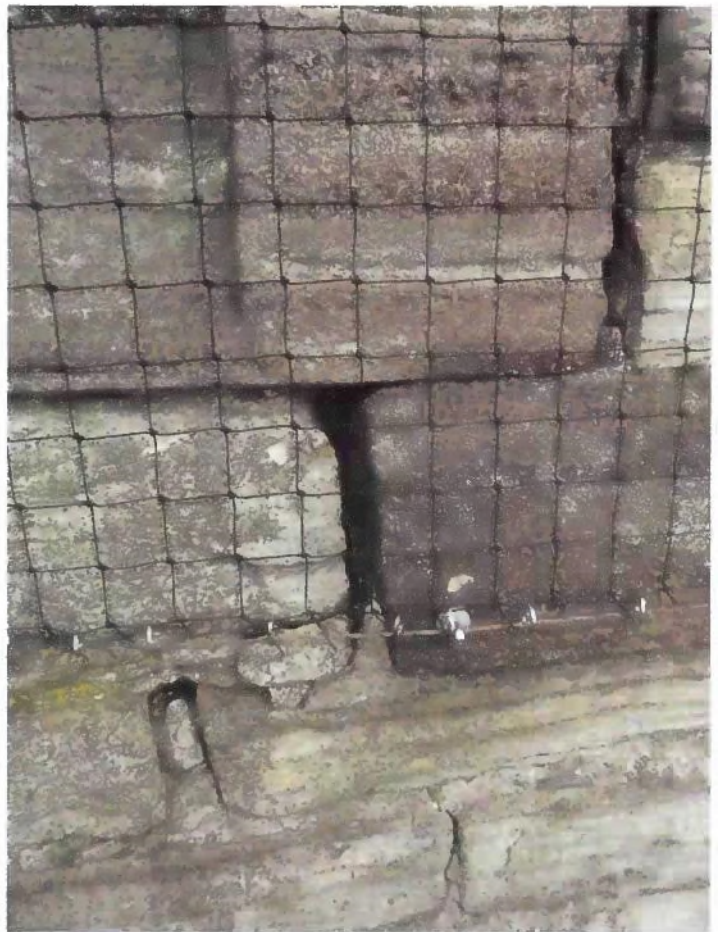
Examples of section C.

- 7.9 Repoint 100% of stonework to rose window.
- 7.10 Stitch with stainless steel and epoxy resin the failed sill stones in section C.
- 7.11 Remove all framework and mesh from section D and replace with stainless steel.

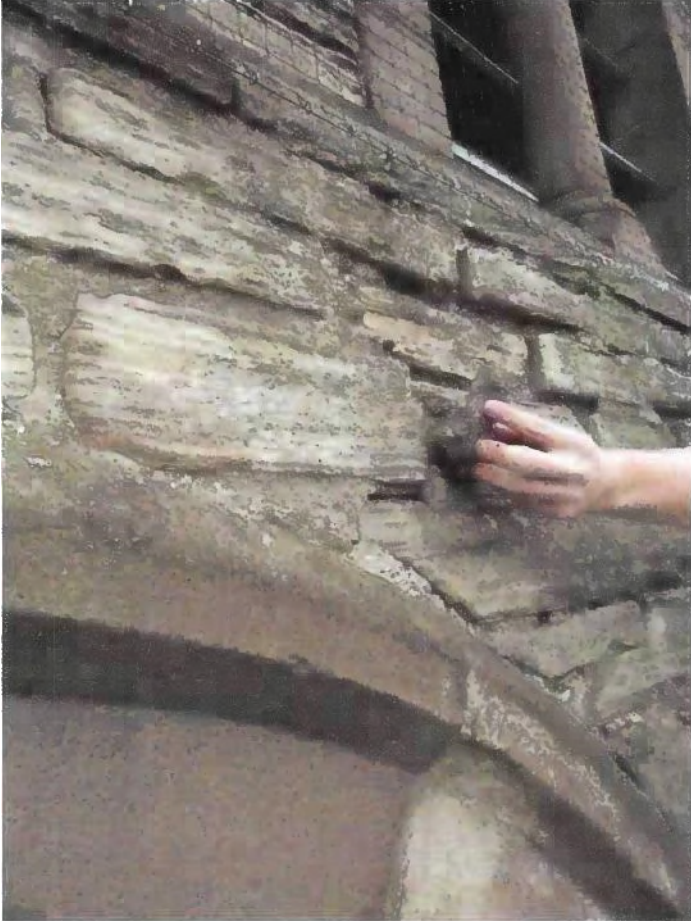
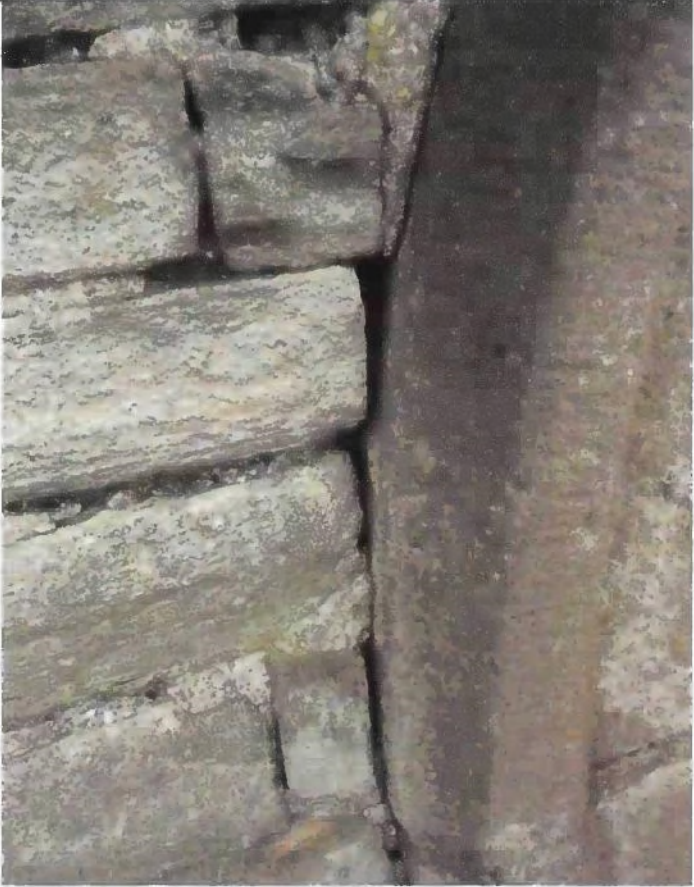
Examples of section D.

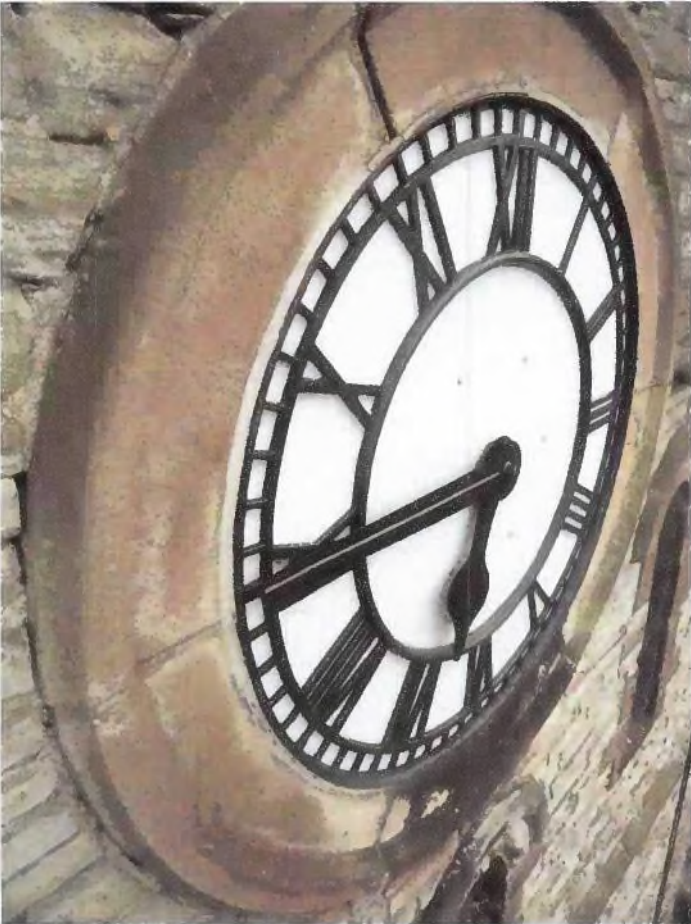
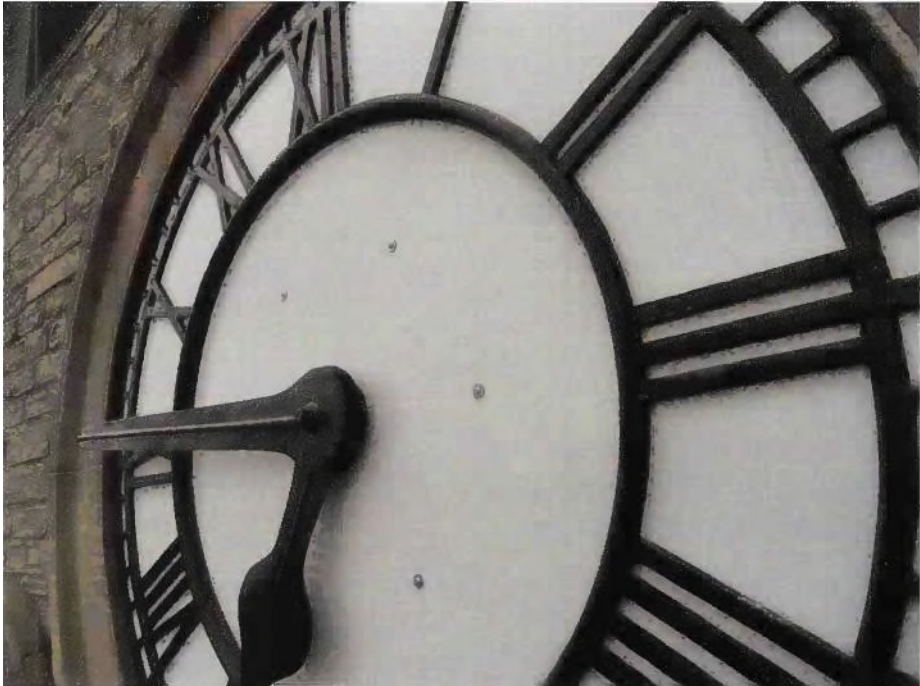
Examples of clock faces.

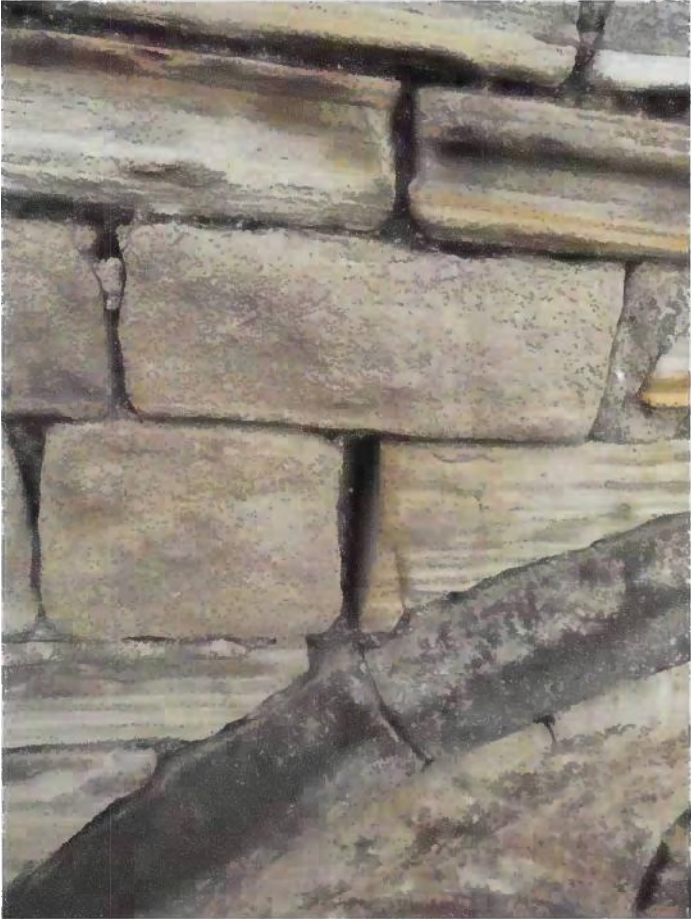
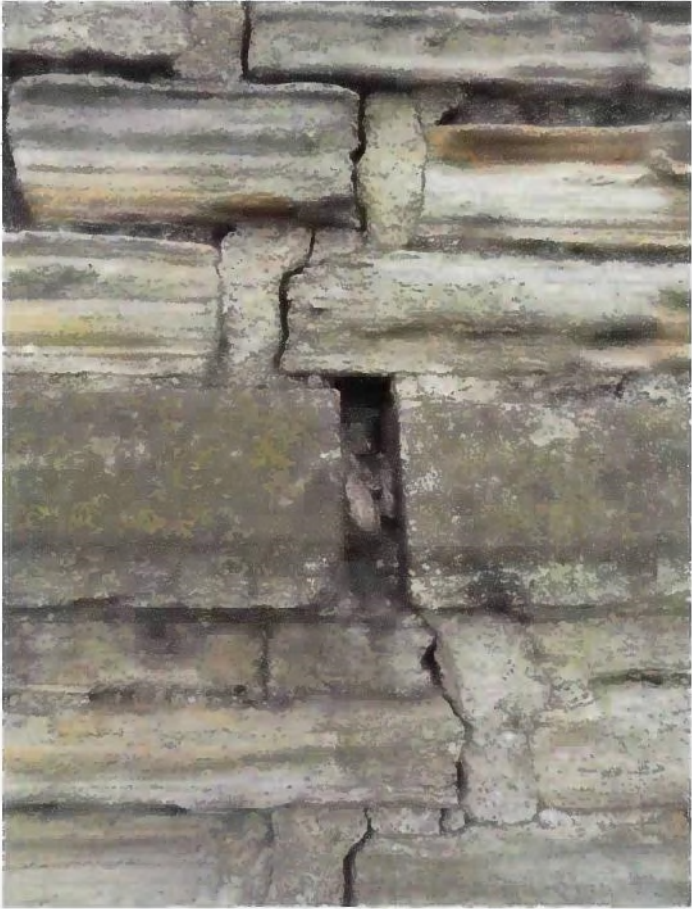
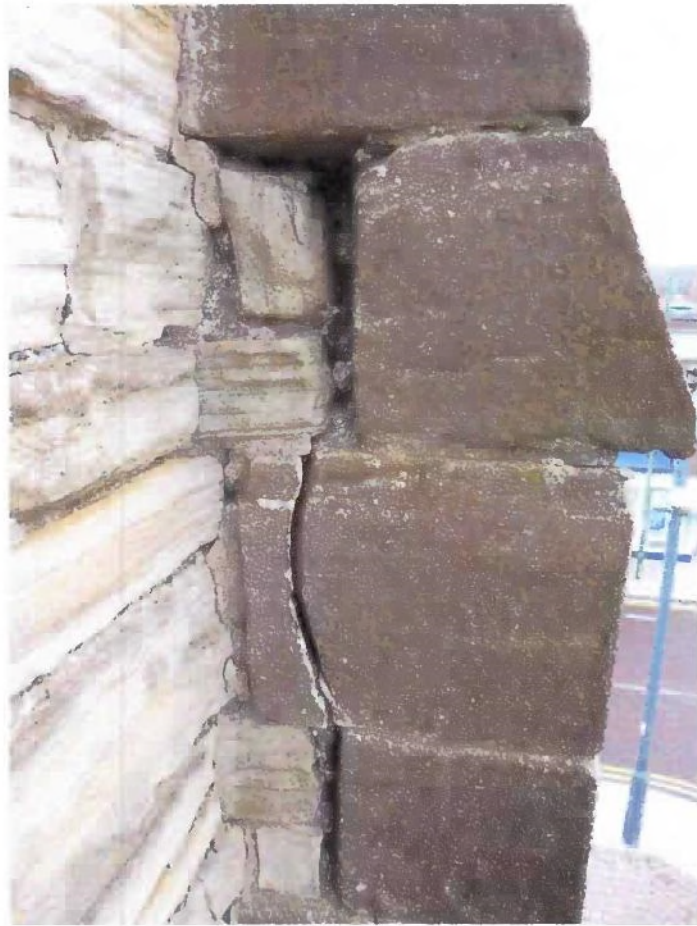
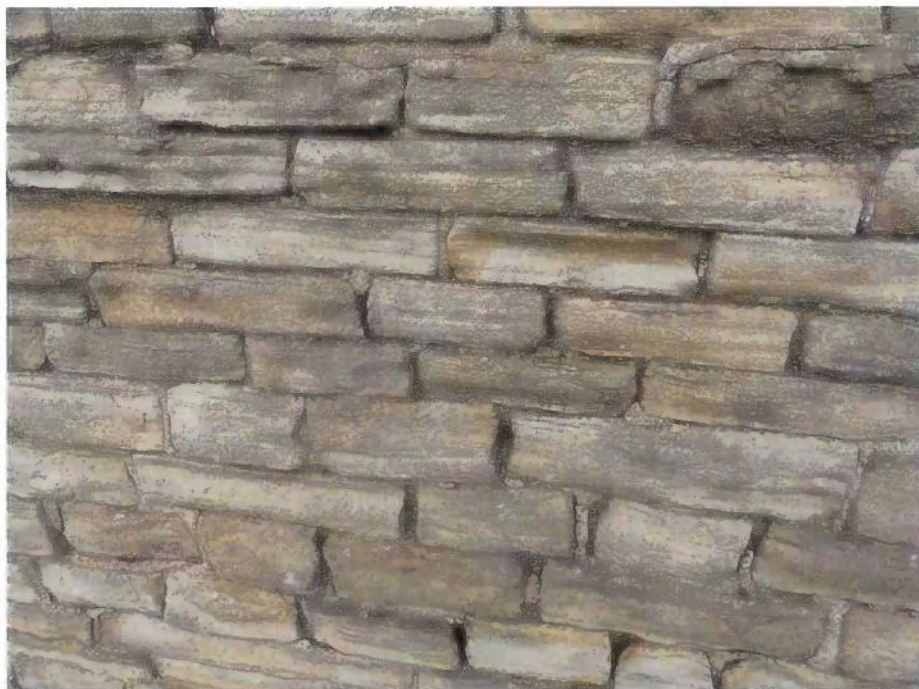
Examples of section E.

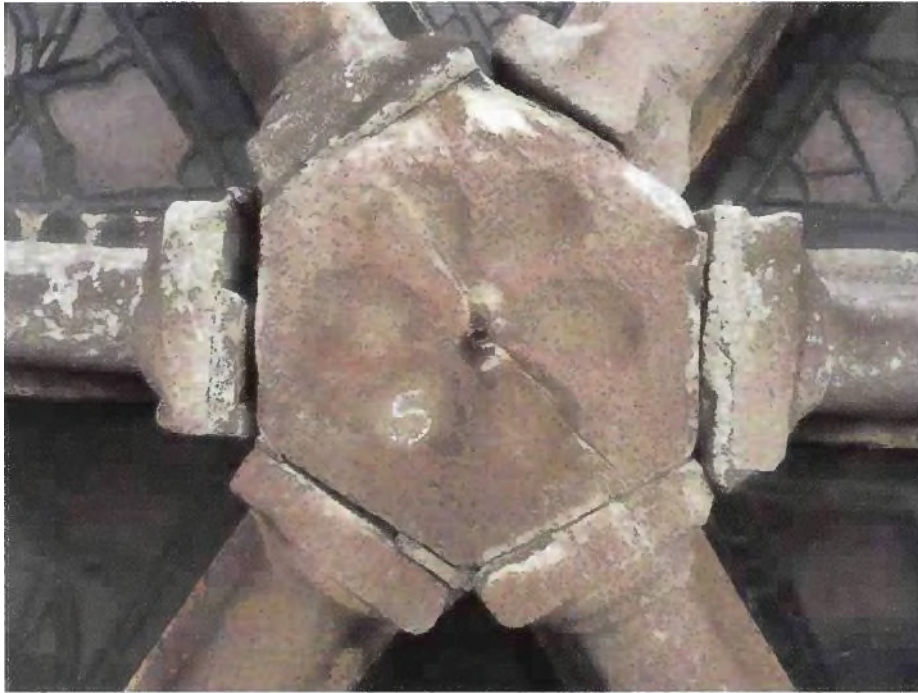
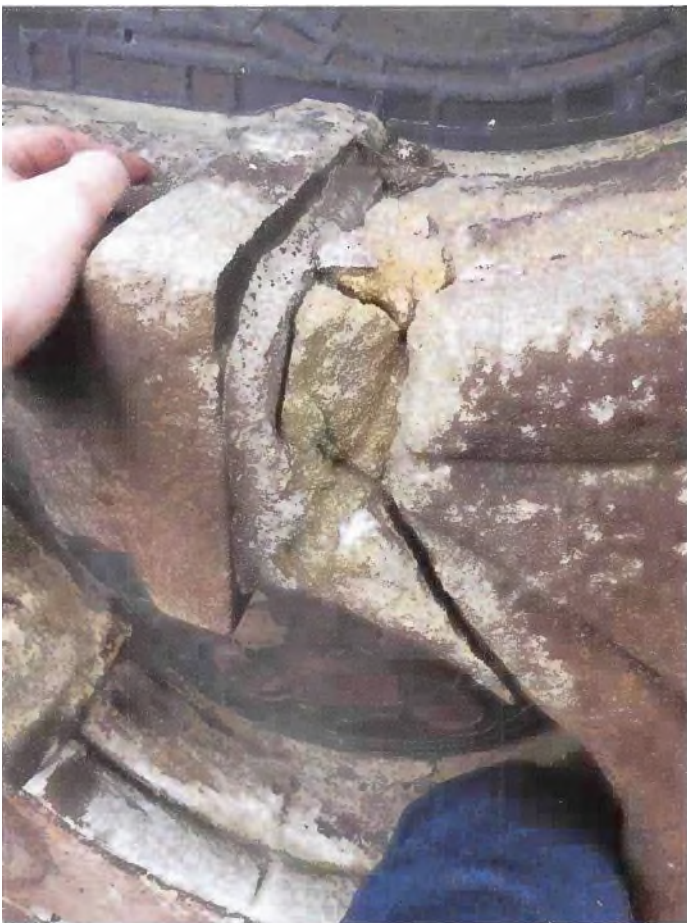
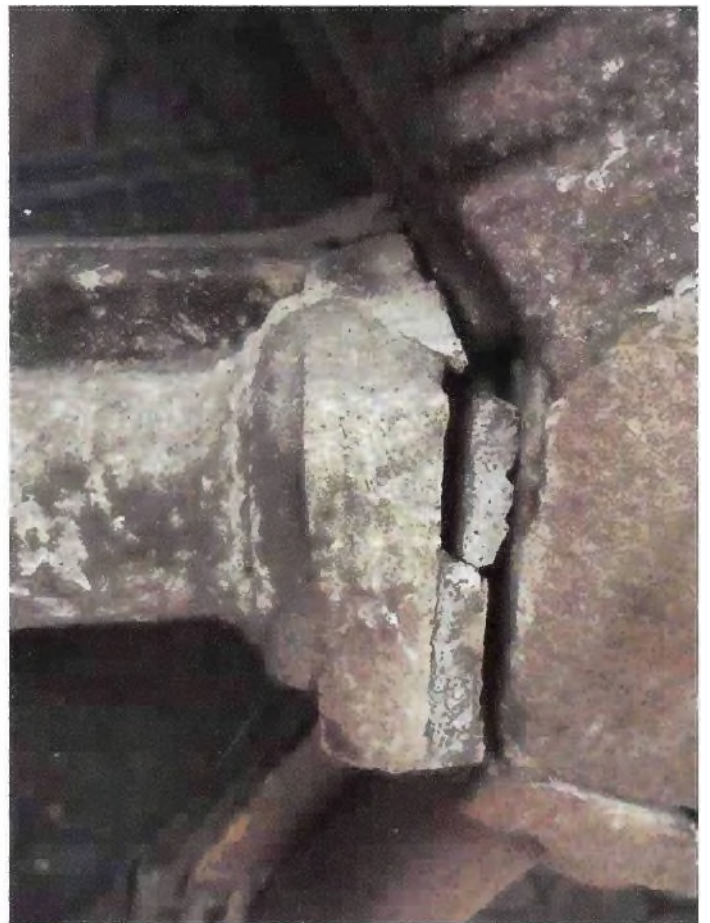
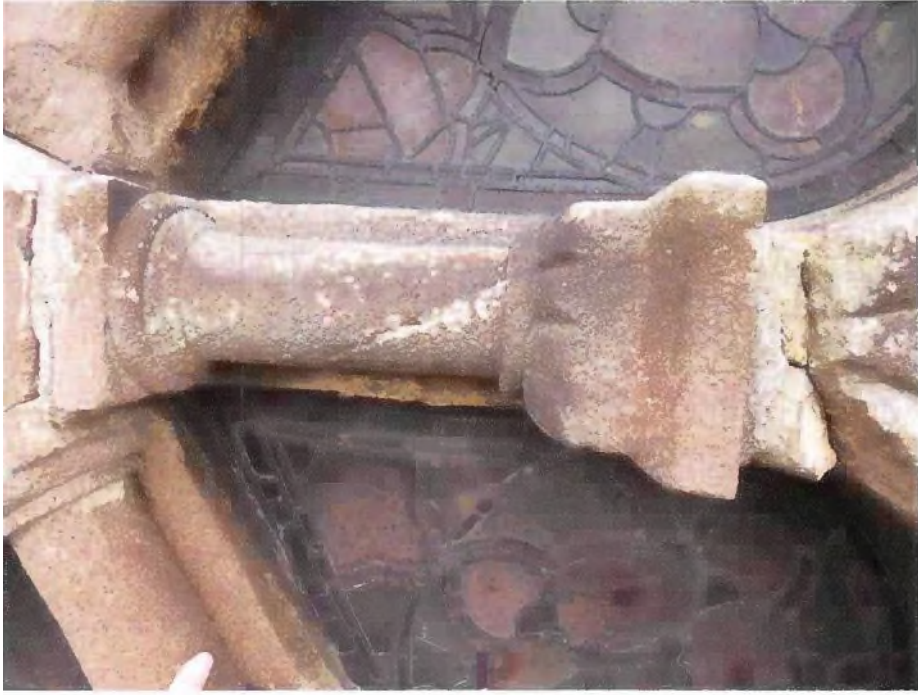
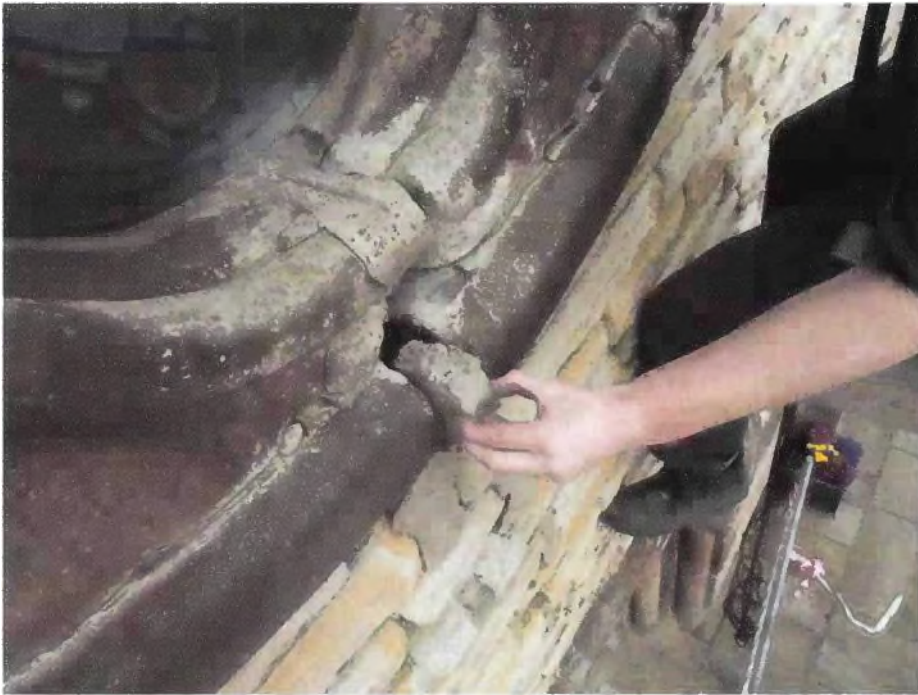
Examples of rose window.

- 7.6 Lift and reset the failed stone to rose window.
- 7.7 Fit new section of stone to rose window (point 2 of attached picture).
- 7.8 Refit section of stone removed during inspection to rose window.
