**QUINQUENNIAL INSPECTION REPORT
OF
DALTON-LE-DALE, ST. ANDREW**

**DIOCESE OF DURHAM
ARCHDEACONRY OF DURHAM
DEANERY OF EASINGTON**

QUINQUENNIAL INSPECTION AND REPORT

DATE August 2021

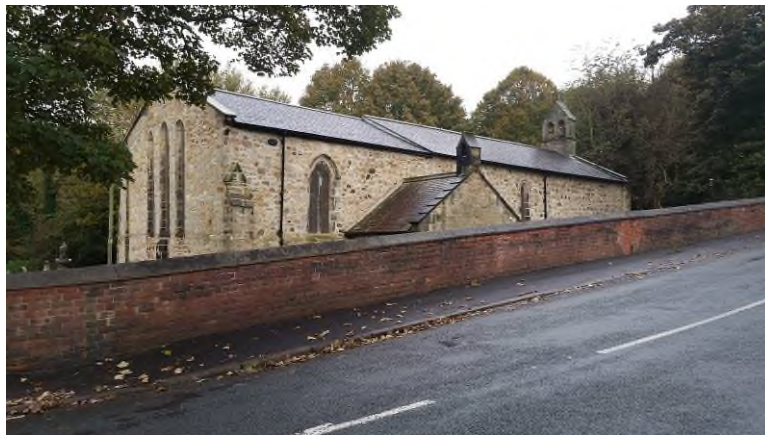
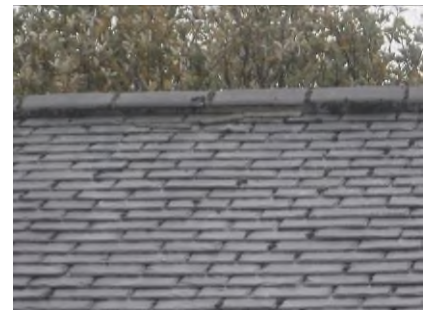
Nave:

- N slope** – Angled clay ridge tiles all almost all ok, one or two laminating. The bedding is coming away in one or two places.
- W abutment** – In lead to bellcote and water table, ok.
- E abutment** – Is a lead flashed verge to the chancel and that all appears to be ok.

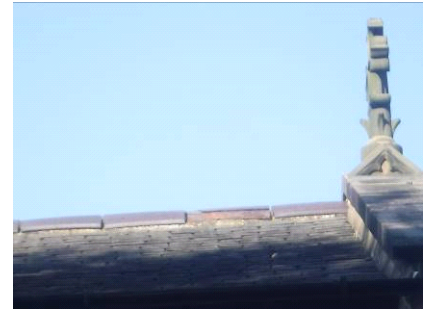
E abutment – Pointed up to the stone water table. Is there a crack in the mortar 1/3rd the way up? It is damp inside at this point.

Recommendation: check condition of chancel N slope flashing

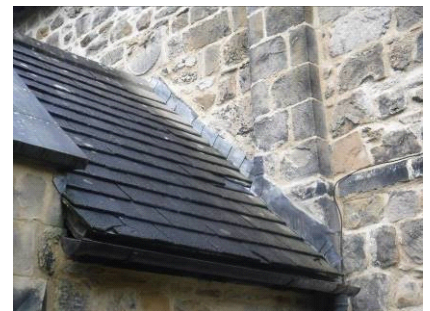
N abutment – Lead flashing looks to be missing here, looks like there has been something stuck on and somebody has tried to take the flashings out.

General – Slating is the same, there is one cracked slate.

Recommendation: install cover flashings to nave and gable abutments

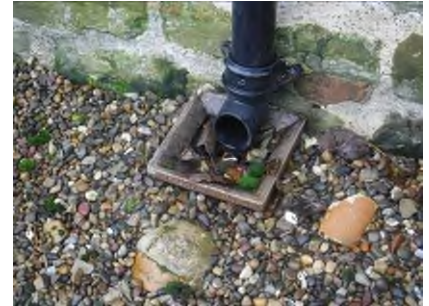
M **Nave and Chancel:**

Cast iron half round and circular downpipes, all of these were renewed as part of the GPOW works in 2019 and they all appear satisfactory. The gullies need to be kept clear.

Recommendation: keep gullies and channels clear

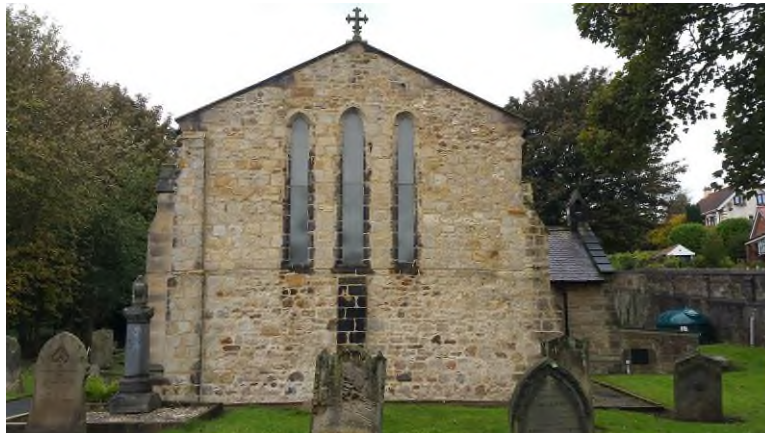
E **Nave and Chancel:**

E elevation – Water table is good, the walling is generally is random rubble much patched over the years, it has a central buttress discoloured through pollution, there is a step in the wall with original buttress on the N side and corner rectangular buttress on the S side, which is then further backed up by a more modern Victorian buttress. The end of this wall appears to feel very ancient.

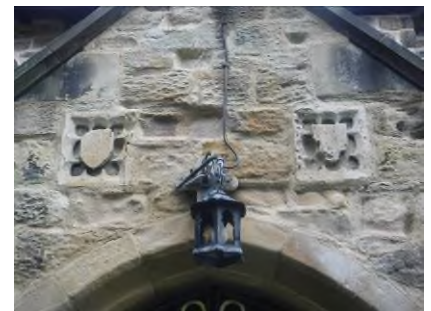
Porch:

Walling is all generally sound, it has at the S, two shields built-in above the doorway these are eroding now but generally ok. At

the W is part of a magnesium limestone looking stone, is there a moulding to it, it is actually possibly just erosion.

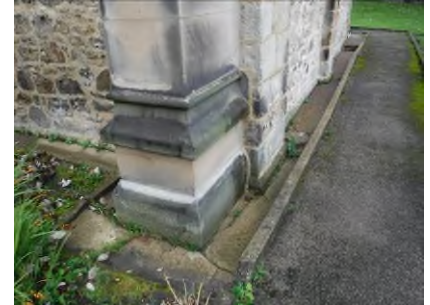
E side – Single storey buttress supporting the E gable which is showing signs of pollution but its ok. There is a clasping buttress at the S E corner it looks like an addition perhaps, there is also a further addition of more Victorian ashlar style here at this position but it is slightly laminating but it is ok.

N side – The buttresses here are pilasters and they are all in good condition.

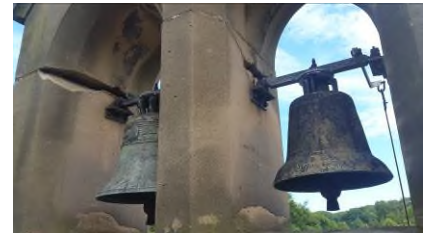
Bellcote:

Two bell bellcote in ashlar stonework formed at the W end, a small chip out of one of the stones (see image from 2017) reported in the last QI was repaired in plastic mortar in the 2017 GPOW works and appears ok.

Recommendation: none

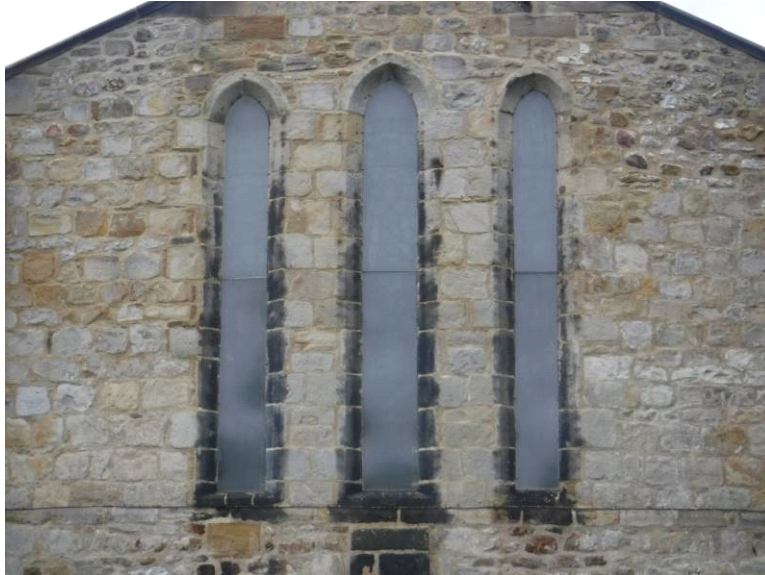
D **Chancel and Nave:**

E side – Lancet three light, polycarbonate now, chamfered jambs ok.

S side – This features a row of six lights at high level and a single at low level with adjoining door.

Below them a trefoil headed single window quite eroded head but it is ok. It has had a repair to the jamb in new stonework and the cill is somewhat eroded but doesn't need replacement yet, covered in polycarbonate.

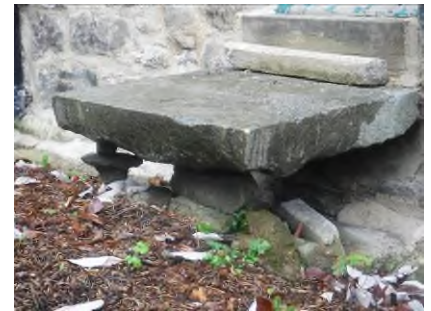
Chancel doorway:

Formed by chamfered lancet arch with green painted vertical boarded door (same style as the porch door), pointed into the opening and this door is not in use, it has a very basic step to it which is barely propped up on some cobbles.

Recommendation: none

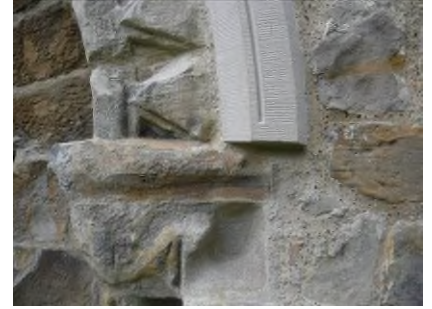
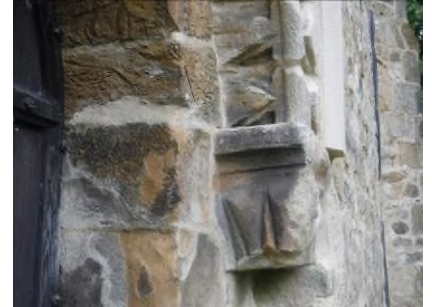
- **Chancel N door**

This has been extensively restored by Skillington Workshops who have consolidated the arch mouldings. The hood mould has been replaced. Oak boarded door within in natural finish, nail head, this door does operate but is not regularly used.

Recommendation: none

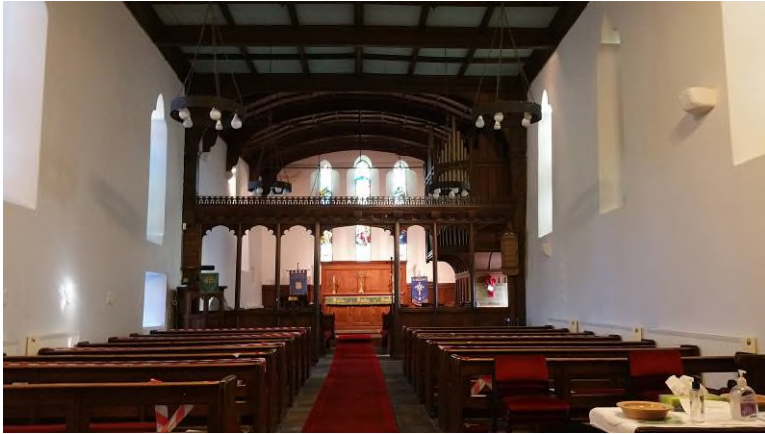
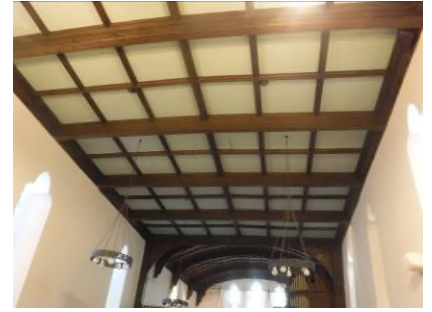
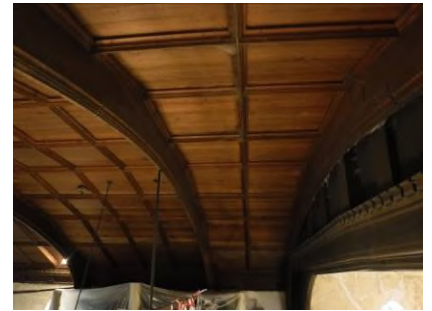
D **Nave:**

Cranked principal beams create seven bays with ribbing in between that has painted boarding, some open joints in the boarding. The attic has a lot of accumulated dust and dirt that falls through the gaps. There is no insulation.

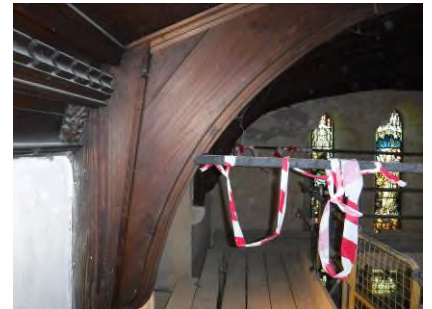
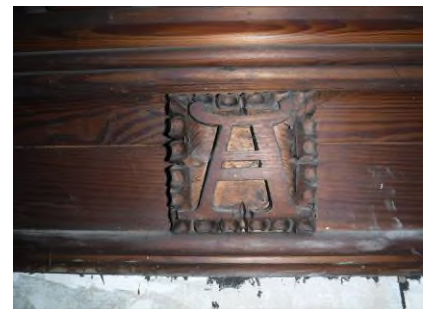
Chancel:

Has more elaborate arrangement than the nave with five trusses, three have metal tie rods, the trusses have curved beams and they form four bays which have ribbed and narrow boarded panels between them, all in natural finish, the general condition of these are good. There are gaps to the perimeter of the roof and roof dust and dirt is falling through gaps. Unknown if insulated (probably not much space to fit it in).

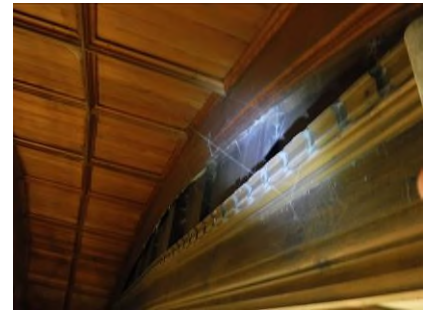
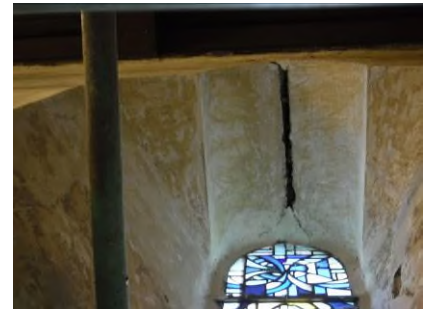
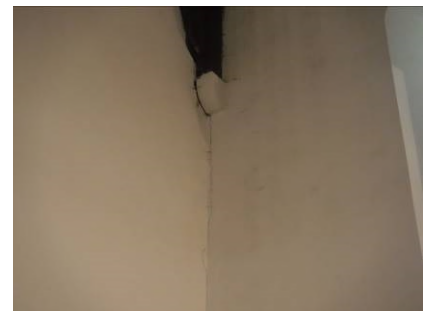
D Chancel Arch:

The space between the nave and the chancel is effectively continuous, though there is a form of arch created by the chancel truss shape and posts coming down the side which in turn support the screen and this arch appears ok. But there are gaps evident at high level at the junction- which must have occurred since it was installed in 1907. There are voids in the masonry and so it would be wise to consolidate this when there are other repairs to do in the area.

Recommendation: consolidate gaps

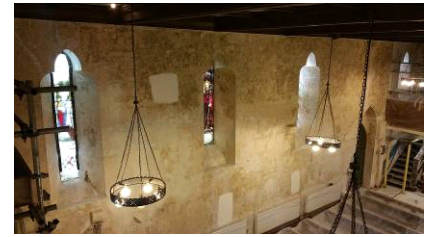
The walls were stripped back to plaster in the 2019 works and this revealed gypsum plastered cracks of 1958 repairs.

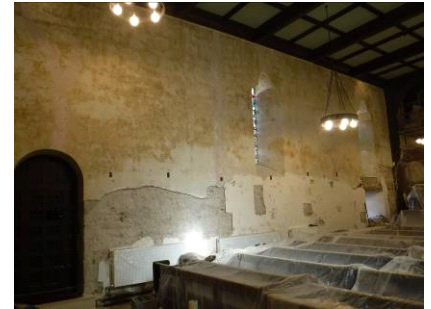
They feature at all the windows at the nave and predominantly at the S and E. The gypsum covers concrete/cement underlayment. There was no movement evident to the wall cracks but there is at the chancel.

Recommendation: none

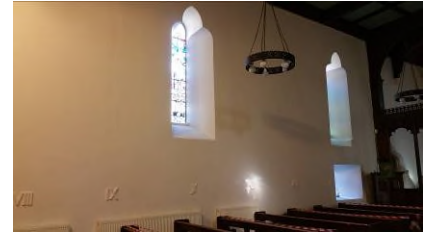
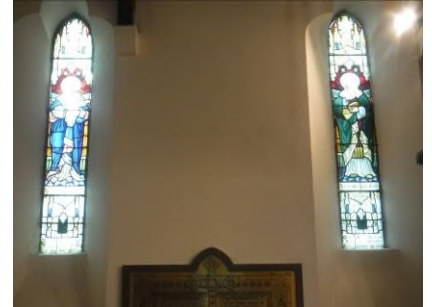
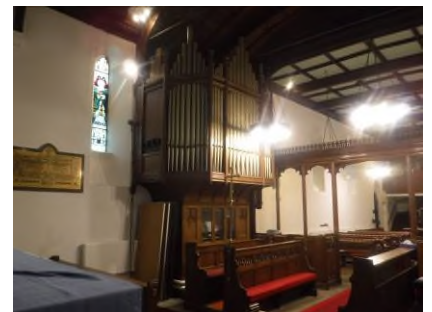
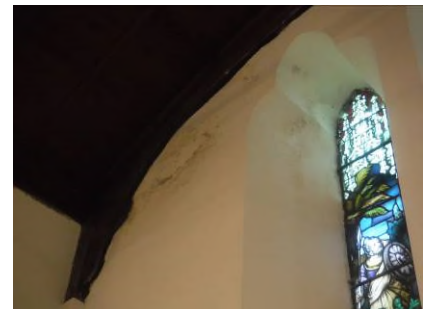
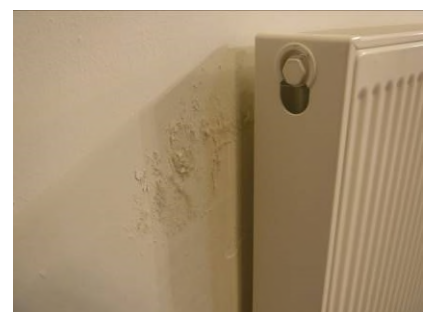
Particularly the N side at low level, though it is a small amount, the chancel gable high level on N side (May be caused by a roof leak) and also within the w.c. in where this is showing above the lower remedial plaster put in when the WC was constructed.

Recommendation: brush down salts, redecorate after a long period of drying out has occurred.

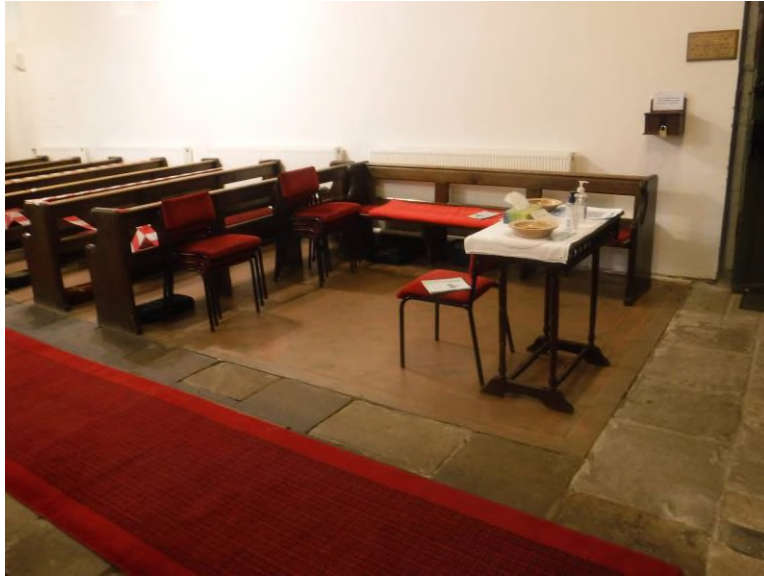
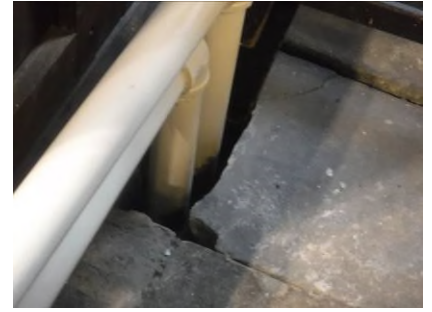
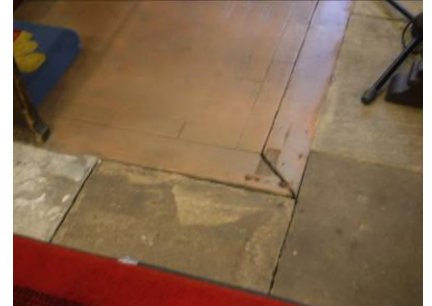
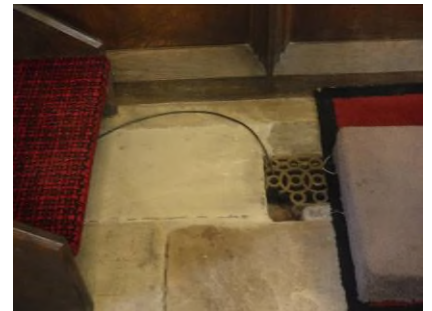
There is a Gregson Family burial vault at the west end under the font. Not inspected. Access is blocked.

The circulation areas are paved. Flush pew platforms in recently painted, herringbone parquet. One assumes these to be suspended but they do feel very solid. There are some open joints and undulation to the stone paving particularly close to the porch and within the aisle. The w.c. has vinyl.

Recommendation: point open joints, close off heating pipe voids.

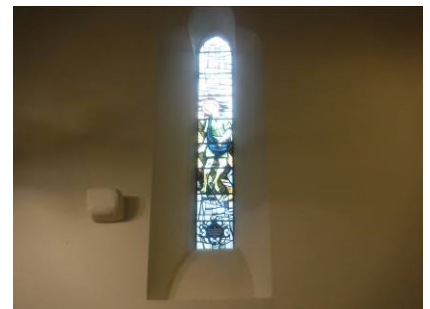
N – Pictorial in memory of John Stoker, some dirt just within the polycarbonate.

Recommendation: a further clean down of the glazing is suggested.

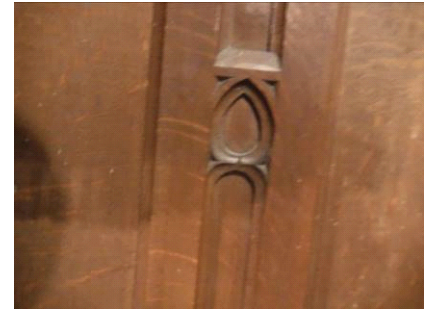
Simple oak panel (1907) behind the altar is ok, alongside that is oak panelling in good condition though there are some paint marks on it.

Recommendation: remove paint marks

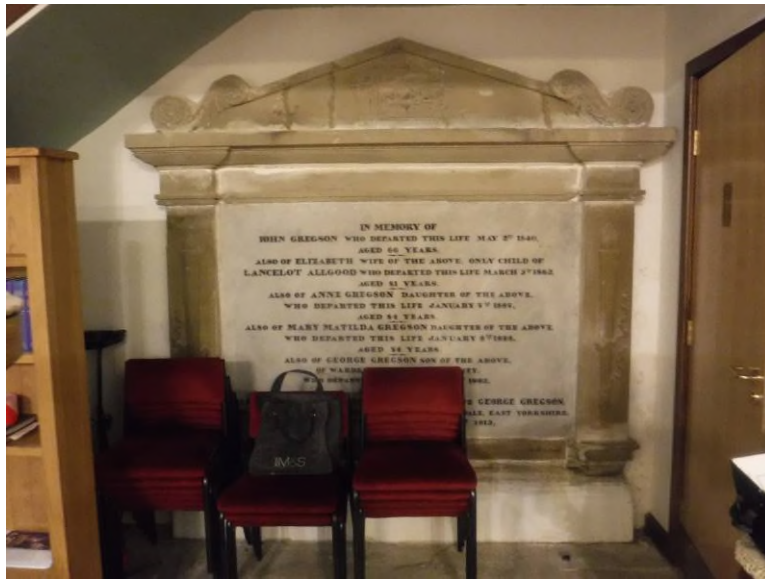
Below gallery, relocated Gregson memorial tablet which is a pedimented rectangular frame, this was in a previous position, there is some damp showing to it around its perimeter.

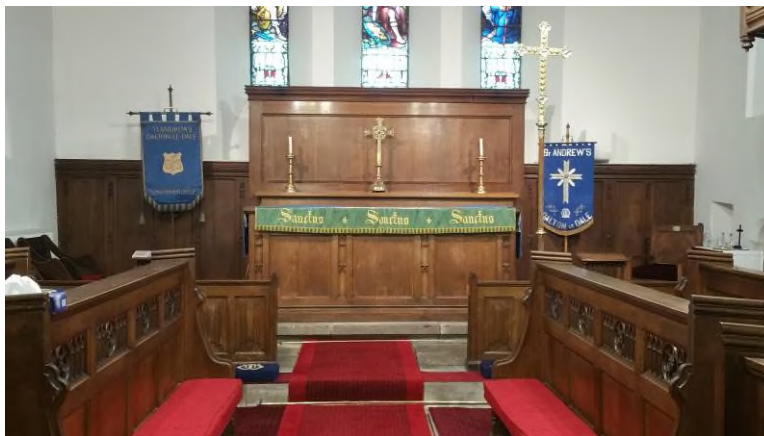
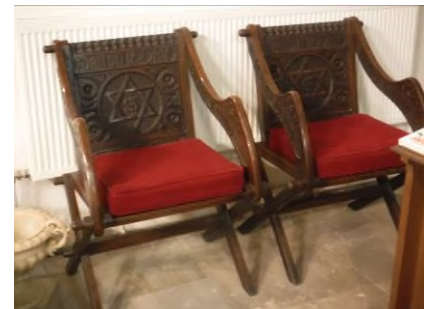
The chancel choir stalls are all in oak, 1907, including the two Priests reading desks. Within the chancel are a Bishop's chair, and two Glastonbury chairs inscribed 'Dalton-Le-Dale'. Water? marking to the altar and communion rail.

Recommendation: remove marking to altar and rail.

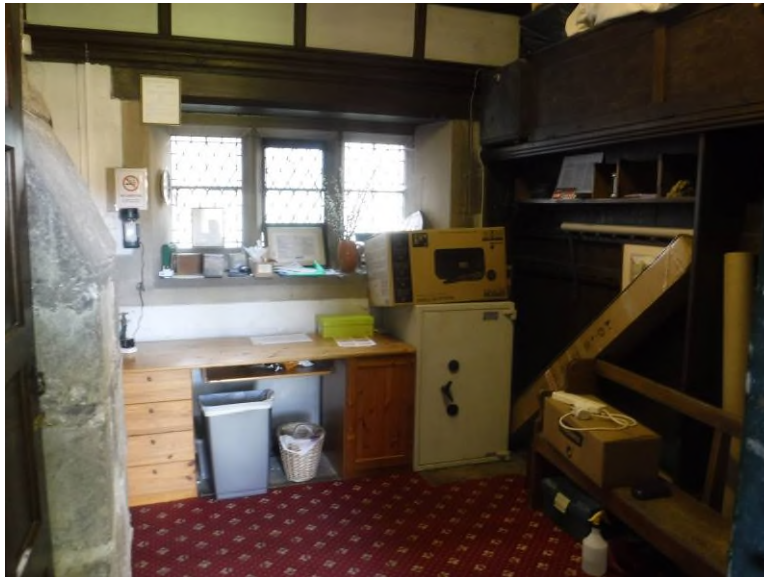
Ceiling – Boarded ceiling some open joints, same style as the chancel without trusses.

Walls – The walls are a mixture of exposed masonry, but some of it is decorated in lime wash looks ok, the N wall is all full of pegs and timber fittings and somewhat full of bits and pieces as well.

Recommendation: tidy up

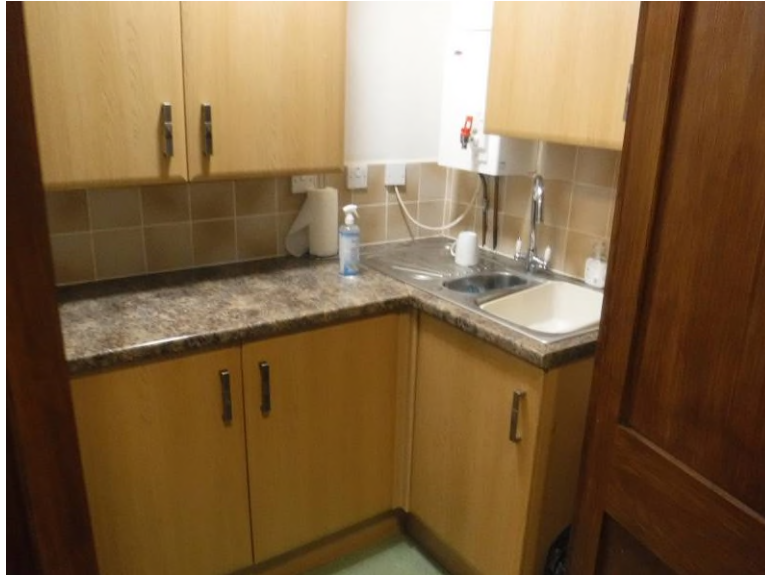
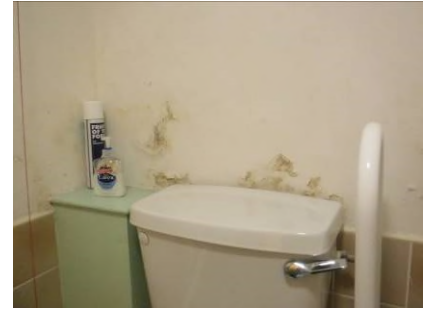
Ceiling – decorated plasterboard. Ok...

Walls – decorated plaster and tiles. Ok.

Recommendation: brush off salts.

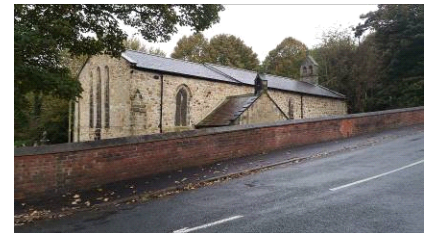
N side –Buttressed brick wall on top of a probably, concrete retaining wall, both are cement rendered. Holds back the high level road. The masonry on the road side in brickwork is ok, on the inside the render is coming away a bit, there is also signs of cracking to both the wall and the retain, though they seem old There are drainage pipes. Are these active and adding to the water level at the N?

Recommendation: repair fencing, establish if N retain drainage is discharging.

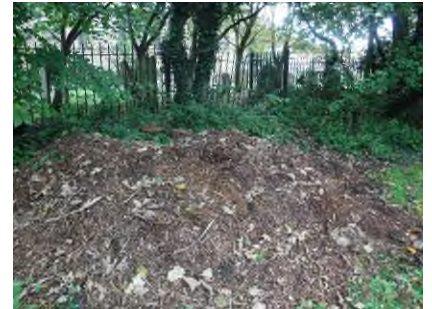
S side – Modern metal railings on top of a stone retaining wall holding back the graveyard with a drop of approximately six feet to the other side, seems ok. Large Ash tree close to the W end. There is a few changes of direction of the fencing probably around old tree stumps and there are holly's now growing in amongst these. This looks out onto the play area and some parts of the fencing are breaking down now.

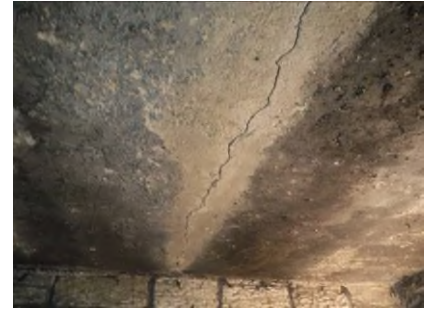
Ceiling – Shuttered concrete ceiling cracked in two or three places possibly where there are internal steel beams, it all appears serviceable.

Walls – Predominantly stonework walls which have been heavily cement pointed but these appear generally ok.

Outside – There is a sump pump in the bottom landing. The area around the walling within the stairs is broken down a little bit and could do with a repoint.

Recommendation: repoint stair wall, decorate door,
