**QUINQUENNIAL INSPECTION REPORT
OF
HOLY TRINITY, DARLINGTON**

**DIOCESE OF DURHAM
ARCHDEACONRY OF AUCKLAND
DEANERY OF DARLINGTON**

QUINQUENNIAL INSPECTION AND REPORT

September 2020

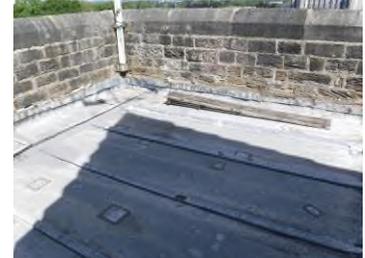
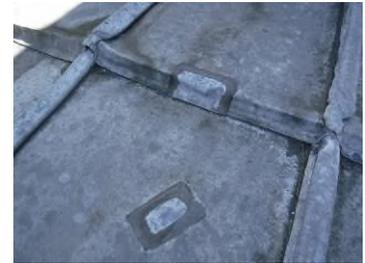
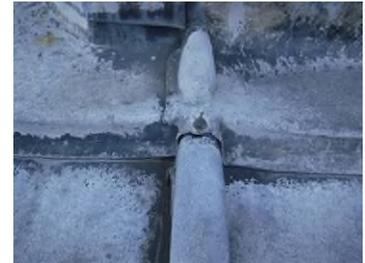
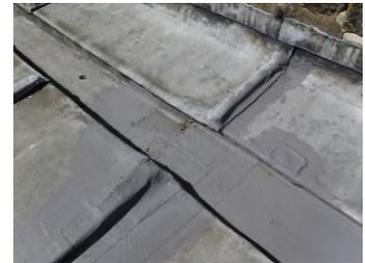
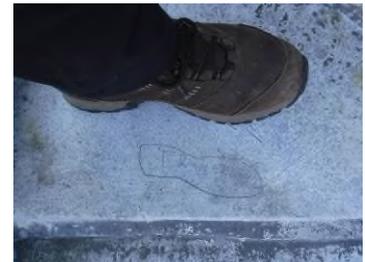
Hollow roll leadwork looking quite old now, the rolls are a bit deformed but serviceable, it has multiple patches in leadwork in the past and they seem to be holding up. Some graffiti on it. The flashings are all ok to the masonry. There is a fairly shallow parapet gutter in lead and there has been a patch-up repair at the step- might this be glass fibre, I can't really tell, it looks a bit botchy. It has been painted up as if to give this a little bit more life. But I can't tell how long it's got. Keep under review.

The stonework parapet surrounds the roof and this is generally sound. There is one buttress on the south side whose masonry is breaking apart a little and could do with re-pointing.

Recommendation: repoint buttress

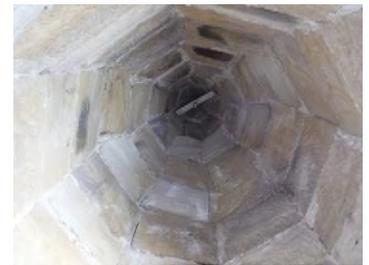
Tower Spirelet:

Octagonal stone roof that has some wear and tear on it but generally seems ok. It is crowned by a weather vane (restored in 1973) and this is the support for the lighting conductor terminal. Below the spire is an octagonal turret, this is where the entrance door to the roof is, there has been some repairs to the bottom moulding under the spire that I can see on two sides. Below that the general masonry is ok, a couple of open joints, one caused by a rusting door hinge. A plain boarded door which has lost its decoration.

The inside of the spire roof is open and the stainless steel fixing down for the weather vane looks good. The spire itself is made from honey and a lighter coloured sandstone, some open jointing looks all sound from the outside so a repoint on the inside is questionable, there is some salt showing to it.

Recommendation: update door, improve draught proofing.

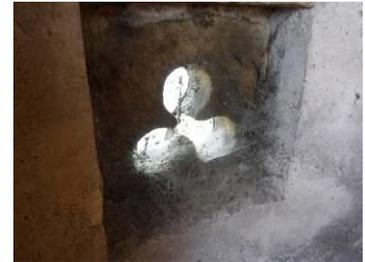
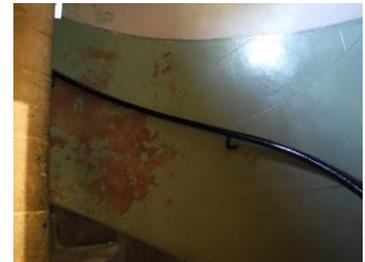
Tower Stairs: At the upper stages of the stairs there is quite a lot of dust that has blown in off the roof that could do with being removed. There is some erosion to the treads but nothing that needs repairing. The walls are lime pointed, quite coarse, and there is quite a lot of shrinkage, but it is doing its job and its holding its surface. There are some areas that are becoming loose but there is nothing really poor about it. Can be left. The top landing has a staging that must be for access up to the underside of the spire to put a ladder on.

cracked glass. They need a good clean down of flies and cobwebs to see them better.

The walls up to the ringing room are smooth plaster, painted with a green dado. The decoration is suffering a little from damp.

At the bottom of the stair tower there is a collection of lumber underneath the stair which could do with clearing out and there is also some old cable.

Recommendation: sweep down and inspect windows, clear out lumber.

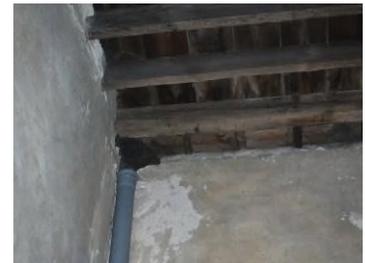
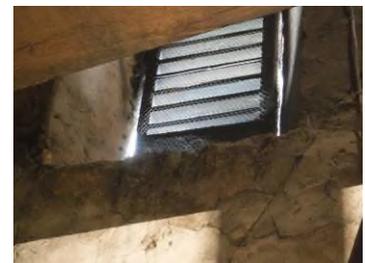
- **Ceiling** – This is the underside of the lead roof. Boarded with open joists, looks ok with a bit of damp probably where the parapet gutter is but I can't see any water leakage, there has been some in the past but I don't think there is anything presently- due to the glass fibre repair? Plastic downpipe with question mark over the connection to the parapet gutter.
- **Walls** – Lime pointed masonry walls are generally sound.
- **Mezzanine Floor** – Boarded. OK.
- **General** – The louvres are timber and they are covered with sound deadening boards but a couple of them are openable, though the hinges look a bit rusty. There is one open louvre on the east side with a bit of chicken mesh, maybe the mesh is breaking up a little bit and there might be some fabric there, there is also two roof alarm speakers here

Water was reported to be on the belfry floor whether that is the floor of these bells or the floor below isn't evident. There was no water at the inspection.

Recommendation: check rainwater pipe connection. Clean up louvre mesh and deadening, oil hinges.

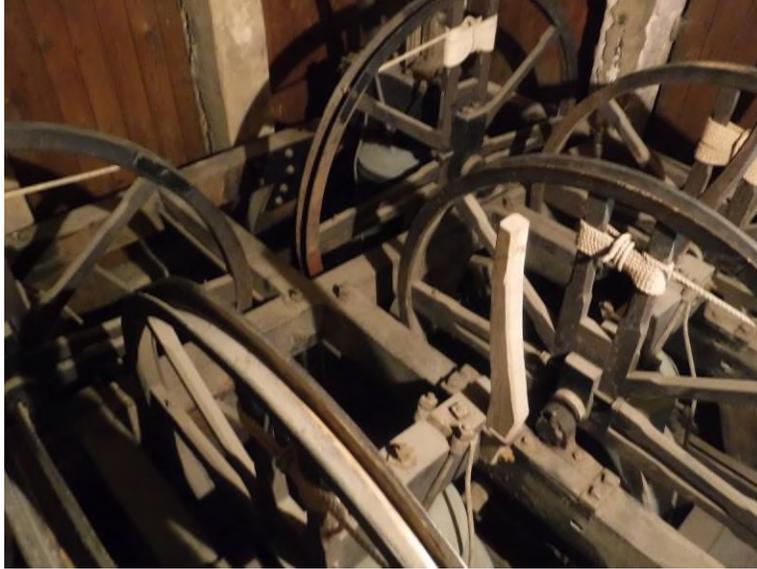
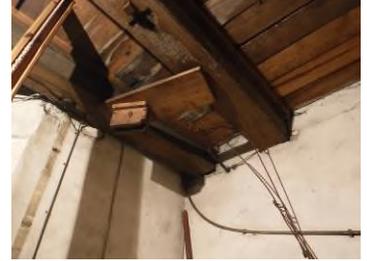
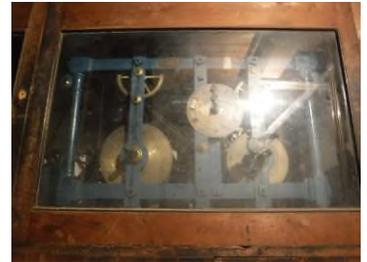
Bell frame:

The bell frame is sat on four stout timber beams, running in the north-south direction. In-between them there is boarding to provide sound deadening.

Floor - The floor of the belfry room is a timber boarded floor- just a bit dusty and looks generally sound and there are ropes passing through here to the ringing room below.

There needs to be a grab rail at the top of the stairs at the top of the bell frame.

Recommendation: grab rail to stair, door redecoration and easing, remove lumber.

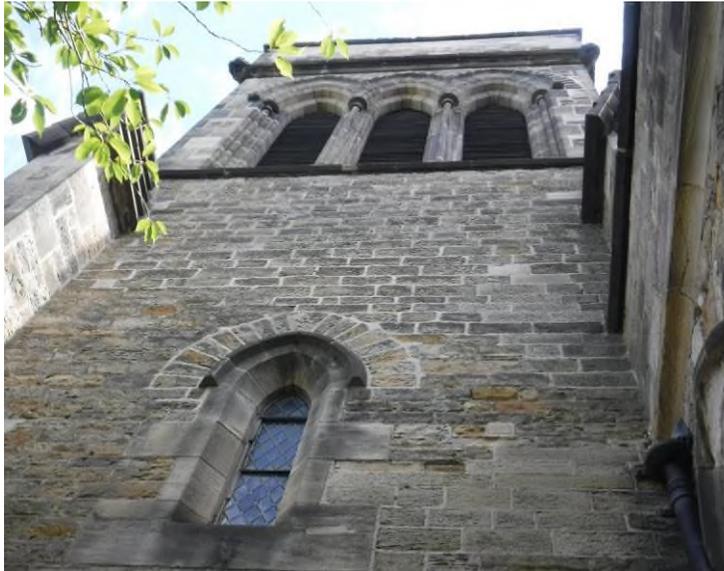
- West side –

Some open joints to the parapet upper stage.

Belfry has heavy cement pointing to the arch work but it will do, the timber louvres look ok, perhaps some open joints at the bottom of the mullions but generally alright.

Walling below that has been cemented regrettably but it is all generally sound.

There are a couple of areas just above the downpipe which are looking a bit poor but they will survive.

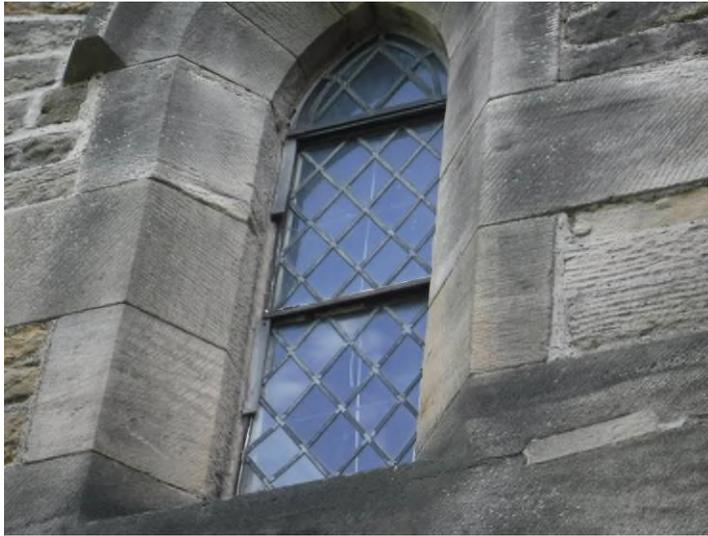
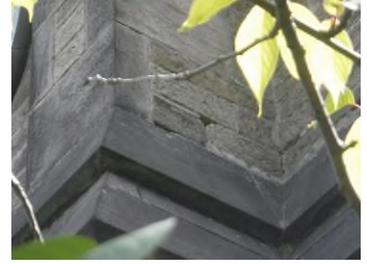
The ringing room window is losing its pointing into the opening and it looks like the ventilator is losing its putty. Slight open joints to the buttress on the ground.

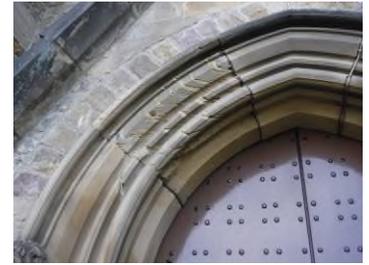
One of the arch stones has eroded more than the others, possibly because there was just a fault on this one on the bedding line but there does look to be damp to it. The nook shaft looks to have been replaced as has some of the door surround stonework. Slight shaling of some of the stonework and a bit of a loss of moulding on the western most kneeler. The buttresses either side look ok.

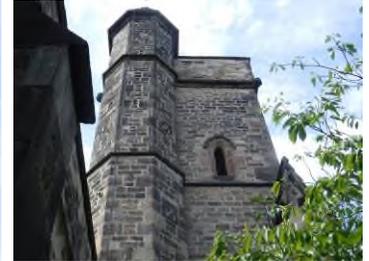
East side –

The parapet stage has a couple of eroded stones and a bit of a weakness at the quoins perhaps. Might be some open joints at the large string moulding, the stages below that have been cement pointed and there has been some stonework repairs I think, but it is all generally sound.

To one side is the stair tower that has been repointed in one go at high level which seems ok. There is just one area by the downpipe at ground floor level where there is some stone erosion but it will survive.

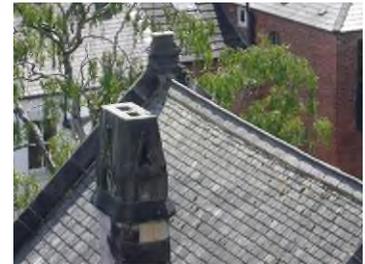
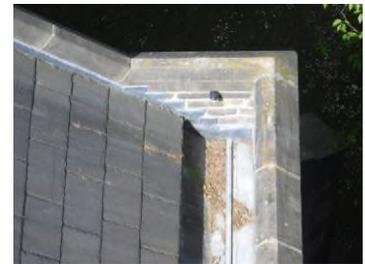
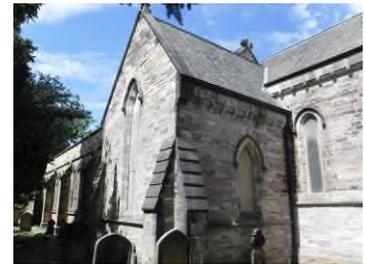
The principal roofs of the building were re-slatted in Westmoreland slate in 2015 and all is well with them. There has been some slight repairs to the (older) chancel roof slating but it all looks sound. Leaf build up in the nave west end high level of gutter.

Recommendation: ensure annual clean-up of parapet gutters.

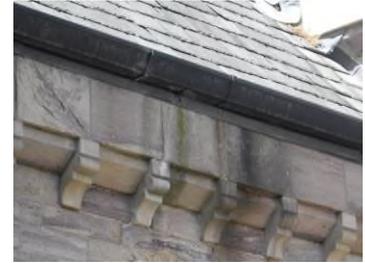
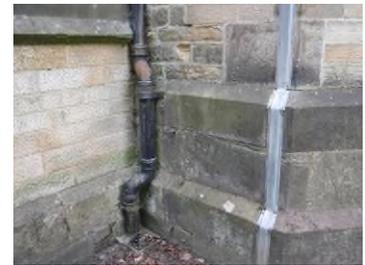
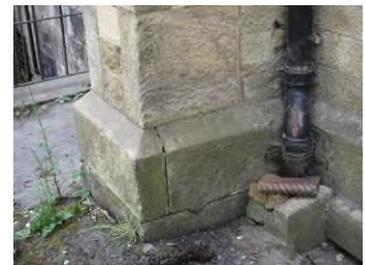
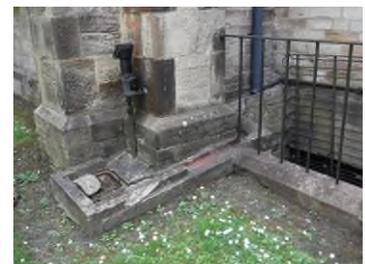
There are some gullies that are broken and are not directly underneath the downpipes, one noticeably on the north side.

The chancel discharges at high level on to the north vestry roof and I can't see where it goes to on the north.

South Transept has a gutter leak on the east side.

Recommendation: revisit north drainage report and decide best course of action for repairs. Overhaul the gullies so that they receive their rainwater fully and remake surrounds and fit grids as required. Redecorate metalwork. Repair gutter leak to s transept e side. Check the system in a downpour.

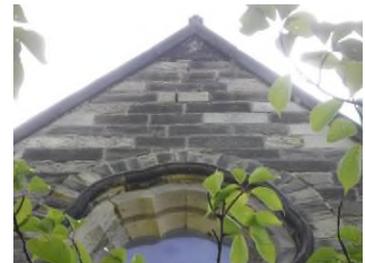
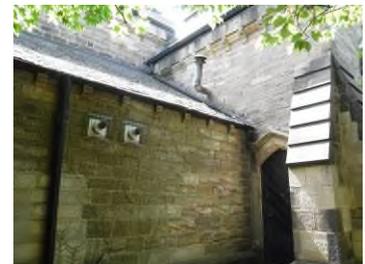
Water table looks ok though it has lost its cross, the corbelling on the west and east looks a little eroded but is ok. The west walling is alright. The gable has some open joints particularly at the apex and just below it and also the relieving arch over the multifoil window. The two lancets below that look ok though there is a bit of wear to the hoodmould but it doesn't need any work. The walling below that all ok, bit of a rusty air grate but it is solidly in.

The east facing wall corbel is good and the walling is ok. There is a slight movement crack to the left of the flue (which would look nicer vertical). The elevation contains a door to the organ chamber which looks unused, the threshold needs replacing by the looks of it and the door requires decoration.

Recommendation: update door

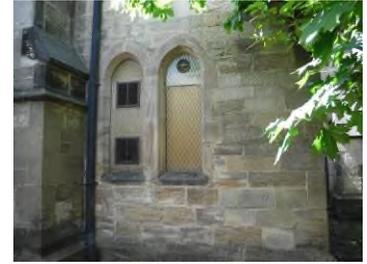
- **Vestry:**

Slight open joints at the high level to the guttering on the corbels on the north side.

On the east, cracking to one of the lancets above the arch but it looks old, there has also been stone repairs above it suggesting that there is an historical problem there.

Recommendation: none

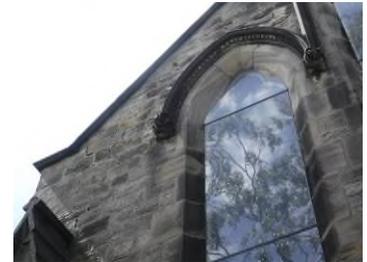
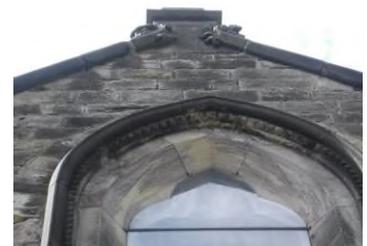
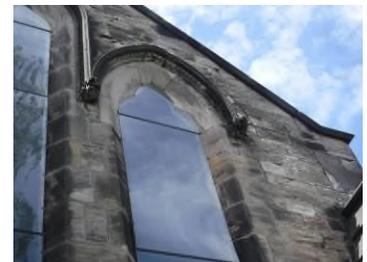
- **Chancel:**

The north side corbelling looks good. There is a bit of a rusty air grate in it and some erosion to the stonework but sound enough.

The west gable water table looks good, the relieving arches underneath it have open joints and some stone erosion, in fact there are a couple of stones that aren't laid on bed and work is wanted here. There is also some slight movement at the kneelers particularly on the south side. Hood moulds to the triple light window are ok, some slight erosion to the foot of the middle window cill. There are bees creating a home in the air grate on the south side.

The south side corbel is ok. There is an old crack between the two windows at high level running right down to the ground and looks to have cracked the stones in the past but it has been

repointed up and there doesn't seem to be movement with it now. The windows look ok apart from the pointing in of the polycarbonate glazing which has lost its opacity. Buttresses ok.

Recommendation: none

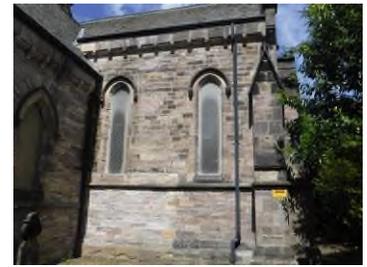
- **South Transept:**

Gutter leak staining the corbel course on east side, walling generally ok as is the window, it has Lexan sheeting here that looks a bit awful but there to deter the intruders.

The south gable is quite worn and the water table itself is ok but the masonry walling has got quite a clear amount of damp in it which suggests there might be a flashing issue on the western side and the masonry itself needs a repoint here at high level. Window looks ok, Lexan sheeting again and is coming apart I think in the bottom bit of it.

The western face is ok as are the buttresses.

Recommendation: check slate flashing, repoint

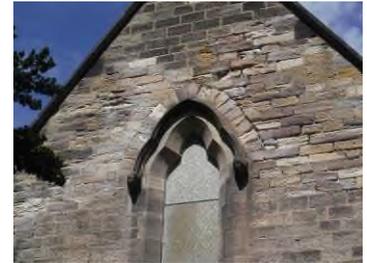
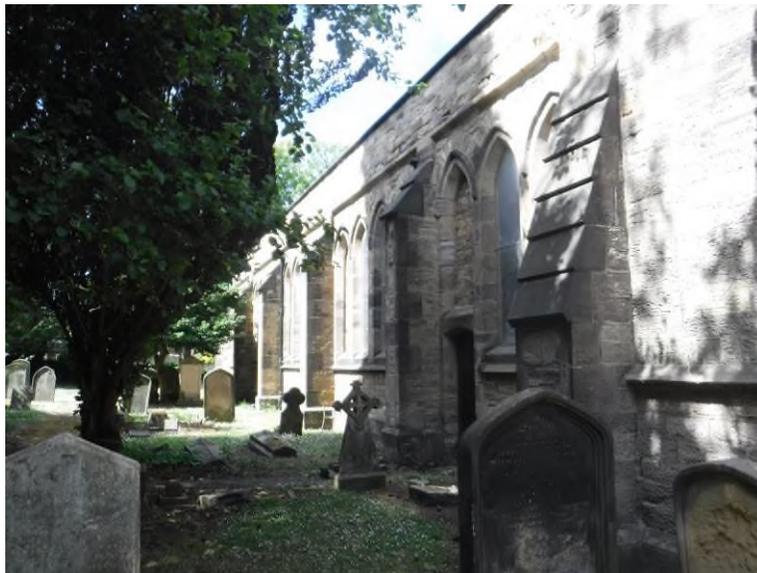
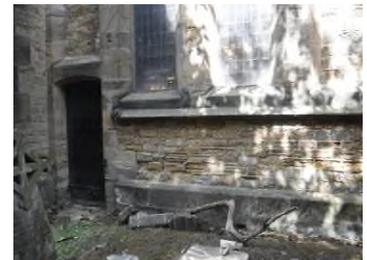
- **Nave:**

The parapet capping was repointed as a result of the GPOW works.

Which didn't extend to replacing some of the walling and there is a requirement for 10 possibly 12 stones at the eastern end to have work done to them.

Bay one: Four window openings, two of them blocked in, rather crudely repointed in masonry, some open joints. Lower part of the wall below the window is ok but pointing coming away and evidence as to why cement pointing is bad. Unused door, black painted looks like there is rot in one corner of it.

Bay five: Has a crack in one of the central windows, has been boded up in cement, it doesn't come to the ground.

Recommendation: replace/plastic mortar repair eroded stonework and repoint

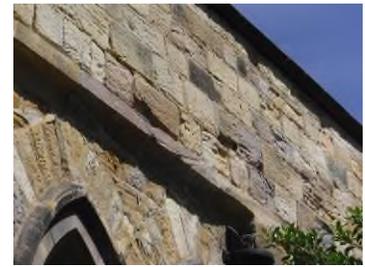
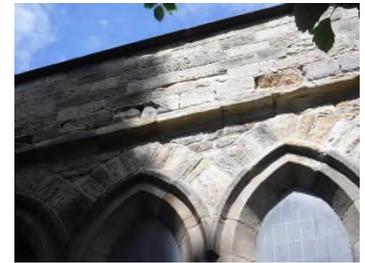
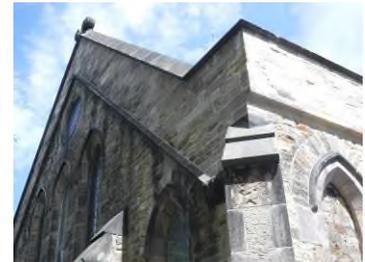
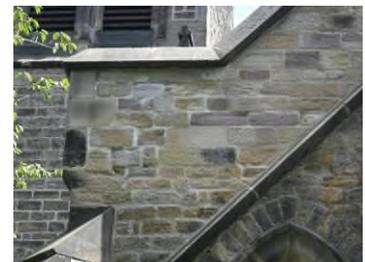
- **West Gable:**

Water table repointed as part of 2015 roof works, the apex has lost its cross. Some of the walling at high level was also repointed above the window raking stringcourse. Interestingly there is damp showing at the northern cheek and that there is also slight damp on the inside. Central window Lexan is coming apart and the other windows are unprotected. The remainder of the walling looks ok, there are a couple of open joint areas at two of the lancets. Angular buttresses and a bit of open jointing at the raking stonework tops.

Recommendation: repoint

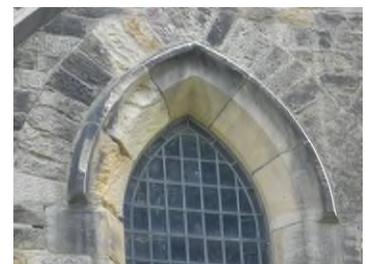
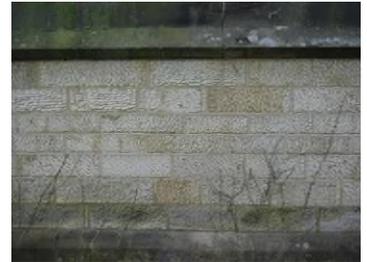
North side:

Bay one: Parapet ok though there are open joints to the underside of the corbel, a bit worn and at around about the centre of the windows it is beginning to be eroded at the lancet arches. One stone at low level eroding.

Bay three: Here you can see the parapet over all of the bays and it is generally sound with a couple of open joints but no major issue. Open joints to the corbelling and again some erosion to the stonework above the lancets- all down to cement. Large areas of stonework replacement under the windows, some ill matched.

Bay five: Erosion to one of the blind windows above the doorway and some repair work over the basement steps. There is a door here same story as the other side.

Recommendation: repoint

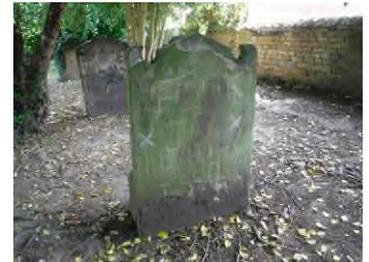
Churchyard:

Within the churchyard are undulating tarmac paths, some tarmac missing on the north side and the roll top kerbing is uneven and missing in places, it looks a little down at south side.

There has been some tree management but the south still feels rather full and the tree cover does provide some screening for anti-social behaviour. The south east gate was padlocked at the inspection. Is that permanent to deter intruders? The east boundary is getting full now and its clearing back would protect the wall- that is suffering root invasion to break the stones and would improve surveillance.

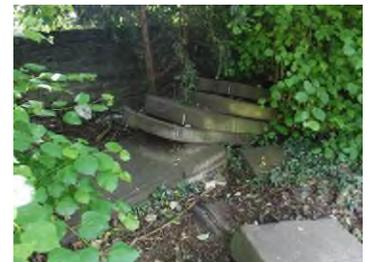
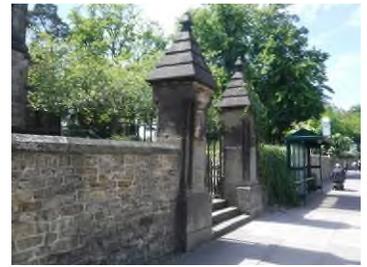
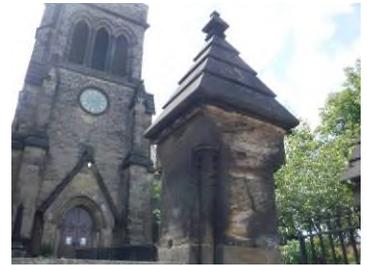
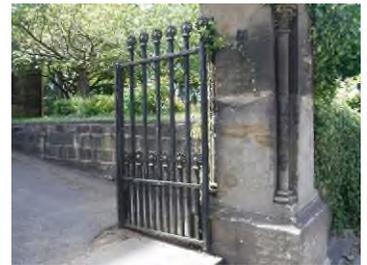
D **North side:**

Stone wall retaining the high level churchyard, some ivy covering and heavily cemented. There is a very nice pair of original gate posts that are leaning in slightly and are broken as a result of iron rust expansion, looks like the gates got reset, it's not quite clear but I think the gates have been repositioned, the gates

themselves are in need of redecoration and they are probably rusted into position in the open position. Just within the entrance steps which are uneven and coming apart, there is a further stepped landing the sides of this are poor and the handrail is leaning in. Opposite that is also another return with a fairly pedestrian metal guarding that is a bit broken and coming away a bit. There is also some open joints just where there is a tree.

Recommendation: redecorate gates, repair guarding, remake entrance steps, repoint open joints

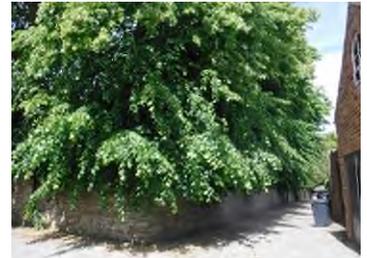
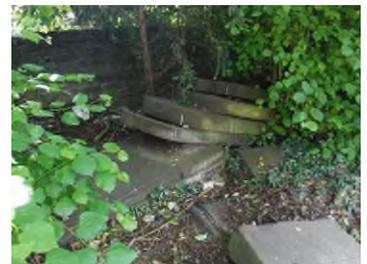
D East side:

Very tall stonewall in generally fair condition, it is retaining the churchyard, there is some damp showing at low level, some ivy growing over the wall tops and particularly the conifer trees are beginning to encroach into the yard. There are some openings in the wall into the churchyard wall that have been filled in with laminate sheeting.

Root encroaching into the wall head breaking the stones

Recommendation: remove tree cover, ivy and invasive plants, trim back. Repair coping and wall joints, tidy up redundant memorials and remove scrap timber and detritus.

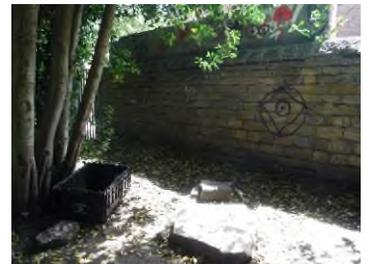
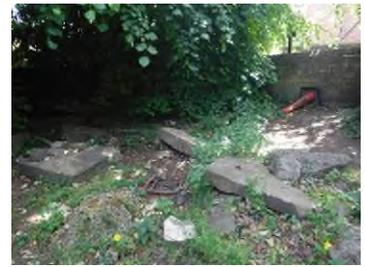
South side:

Viewed from the outside stonewall returning round from the east. The coping stones are coming apart by the gate posts, rather low quality gate that is padlocked presently and you can't get back into the churchyard on this side. A bit of a crack at the corner of the wall. Trees very dominant they are overhanging

into the alley rather significantly, the majority of the boundary is on to a private house.

Recommendation: reduce tree cover and repoint crack, remove graffiti

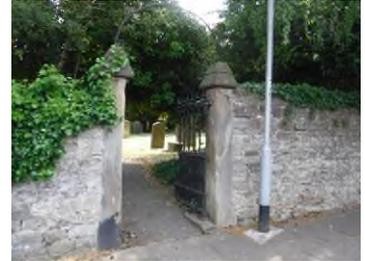
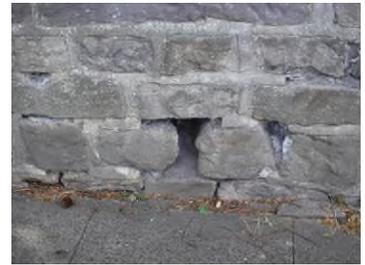
West side:

This is a higher quality coursed stonewall, some erosion midway up I guess and that this is probably the level of the raised ground behind it, it seems to be more of a problem at the southern end. There are many open joints and some stones missing. Entrance on the west side no doubt an original metal gate much dilapidated no longer working. The sandstone piers are fair but are eroded and they have lost the over mantel light.

Recommendation: repoint open joints, repair, redecorate and reset the gate

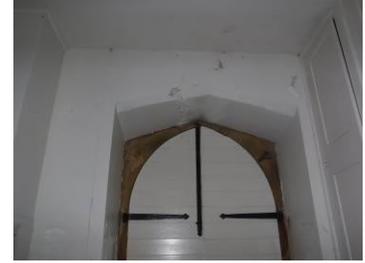
E **Porch Outer Lobby:**

There is a crack on the lintel inside which begins to relate to the dampness that we can see on the outside of the porch, also both door reveals are damp at high level as well as low. The cupboards could do with latching as they are swinging open, bit of a trip hazard in that there is a very large coir mat on the stone flagged floor and it is easy to trip over it even though it is well fixed down, there is also a little bit of damp showing in the floor but I don't think there is anything to be done about it. The double doors into the inner porch are ok but there is no draught proofing on either of the two pairs of doors nor the one that leads into the nave. The argument is that it is helping ventilate.

Recommendation: latch the cpds, change the coir mat to a lower profile entrance matting, consider draught proofing doors

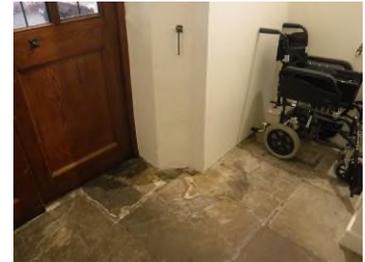
E **Inner Lobby:**

Decoration is ok, some slight erosion to the steps to the tower but they will be fine, the floor is the same as the outer lobby, slight humping of the floor towards the nave but again not really a problem, there is a loose mat on the floor. The floor spring of the nave door needs adjusting so that the doors stay in position and again there is no draught proofing on this.

Recommendation: see above

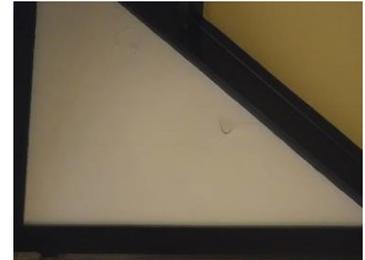
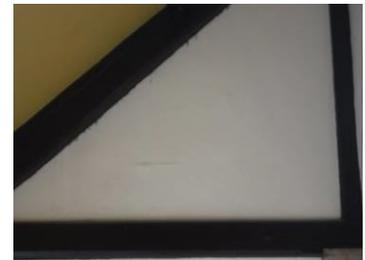
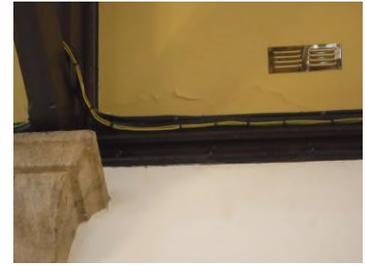
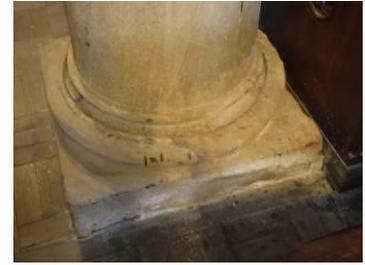
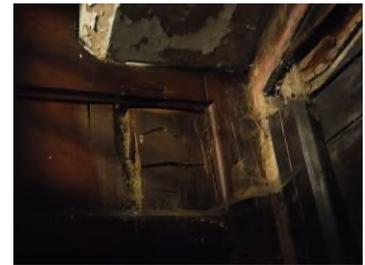
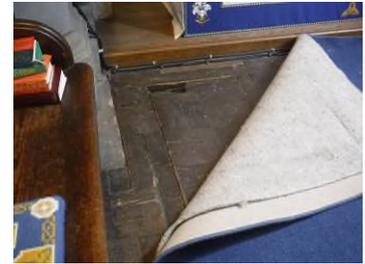
D **Nave and Aisles:**

This comprises a central nave and two aisles. The 2015 re-decoration to the nave and aisles is holding up. There are patches at the cheeks of the west end and the west side of north aisle and this looks due to damp coming through the wall due to missing external pointing. There is no evidence of the previous water damage by the organ in the eastern part of the north aisle.

The major problem in 2015 was rot in the aisle trusses at their feet as they went into the wall, there seems to be no evidence of that now due to the repair works.

There is some earth cable in yellow and green on the surface of the cornice spoiling the look. Below the painted walls is timber dado panelling that is all in good condition, hard up against it though is the central heating system radiators but the panelling doesn't seem to have suffered as a consequence.

The floor is basket weave parquet flooring all on the same level. It has had a clean-up on the south side in 2016. Loose block by the lectern.

Dip in floor by south aisle east end. The floor just in front of the Lady Chapel altar is sinking, it might be the duct cover collapsing, and it needs opening up and investigating.

Recommendation: update the aisle porches, consider the fire escape plan and if alternative ironmongery is required, investigate floor at Lady Chapel, repair dado

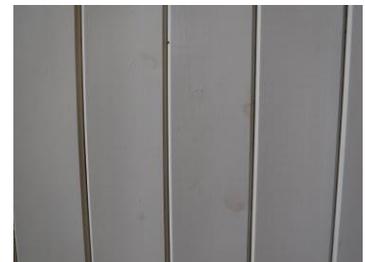
Servery and Store:

At the west end are new servery and store facilities installed in 2016 which comprise a servery with sink and two w.c's, one of which is for disabled use. The servery door rattles in the frame a little, the lobby door on the inside has lost its rose. Knots are beginning to show through the paintwork. It seems too soon to redecorate.

Some loose parquet tiles in front of the servery.

The eastern store is ok but there is a split in the door veneer caused by putting a hook in. The radiators have new mdf covers in the children's area and await their decoration.

Recommendation: door repairs, fix loose flooring, decorate rad covers,

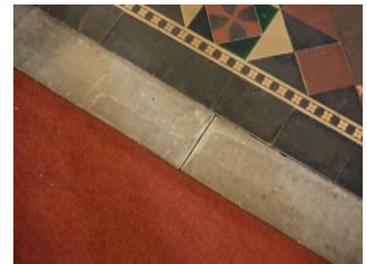
- **Chancel:**

- **Ceiling** - The decoration on the ceiling is blooming slightly. It didn't get re-decorated as part of the 2015 works.
- **Walls** – These are all good. Apart from one area where the decoration is coming away in the north east corner. There is no cracking to the chancel arch.
- **Floor** – The floor is a combination of Minton tiles in the choir and the sanctuary has green marble. The circulation in the sanctuary is covered in carpet in the style of the aisle.
- **General** - Tablet and chancel cross and additional tablet for the great war and world war II, altar rails brass in good condition, also a Bishop's chair in oak and pair of chairs.

Recommendation: none-

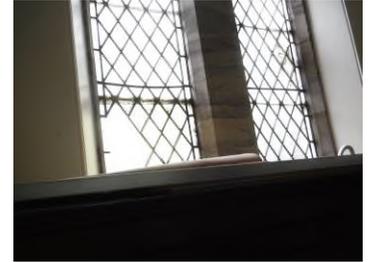
B Choir Vestry:

This room was painted out as part of the 2016 works and is quite a remarkable transformation considering its earlier condition. The floor is the basket weave parquet seen in the nave. The room has a redundant fire place. The room has various original pitch pine cupboards.

There has been glass broken in here and it has got a temporary Perspex repair and that really does need attending to.

Recommendation: repair glass

B **Choir Vestry:** repair glass 500

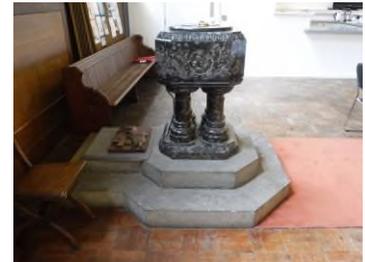
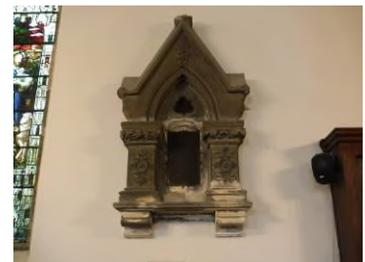
South Aisle – Hewburn tablet, bit of damp showing at the corbel. And this corresponds to open joints in the outside walling.

Large memorial tablet to John Wood with a bust above, one of the corbels has lost the side of its face otherwise looks ok but is dirty.

Recommendation: attend to the masonry repairs externally, let the memorials dry out, brush off salts and then assess for cleaning.

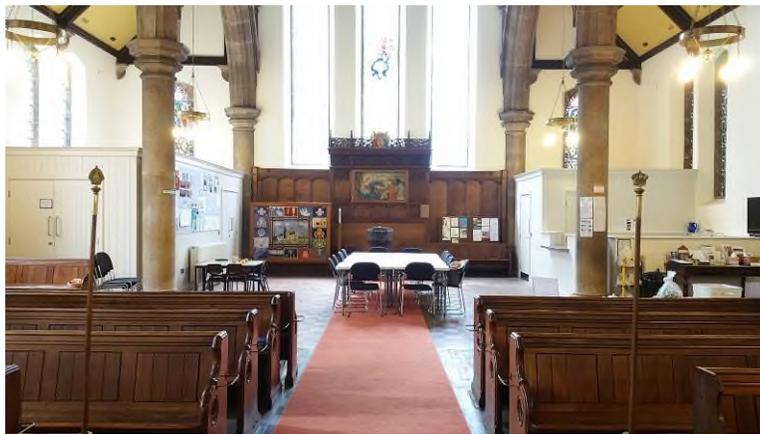
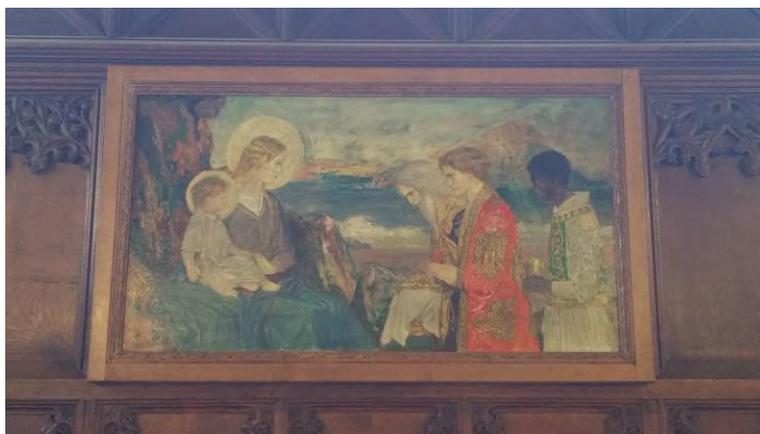
West end –

This is the former reredos and part of the Lorimer furnishings moved to the west end in c1950s. It features a painting of the Epiphany by John Duncan RA, recently cleaned. It is a magnificent piece.
