**INSPECTION OF CHURCHES MEASURE**

**CHURCH OF ST. JOHN THE BAPTIST  
LOW DINSDALE, DARLINGTON, COUNTY DURHAM**

**QUINQUENNIAL INSPECTION 2017**

**QUINQUENNIAL INSPECTION REPORT 2017**

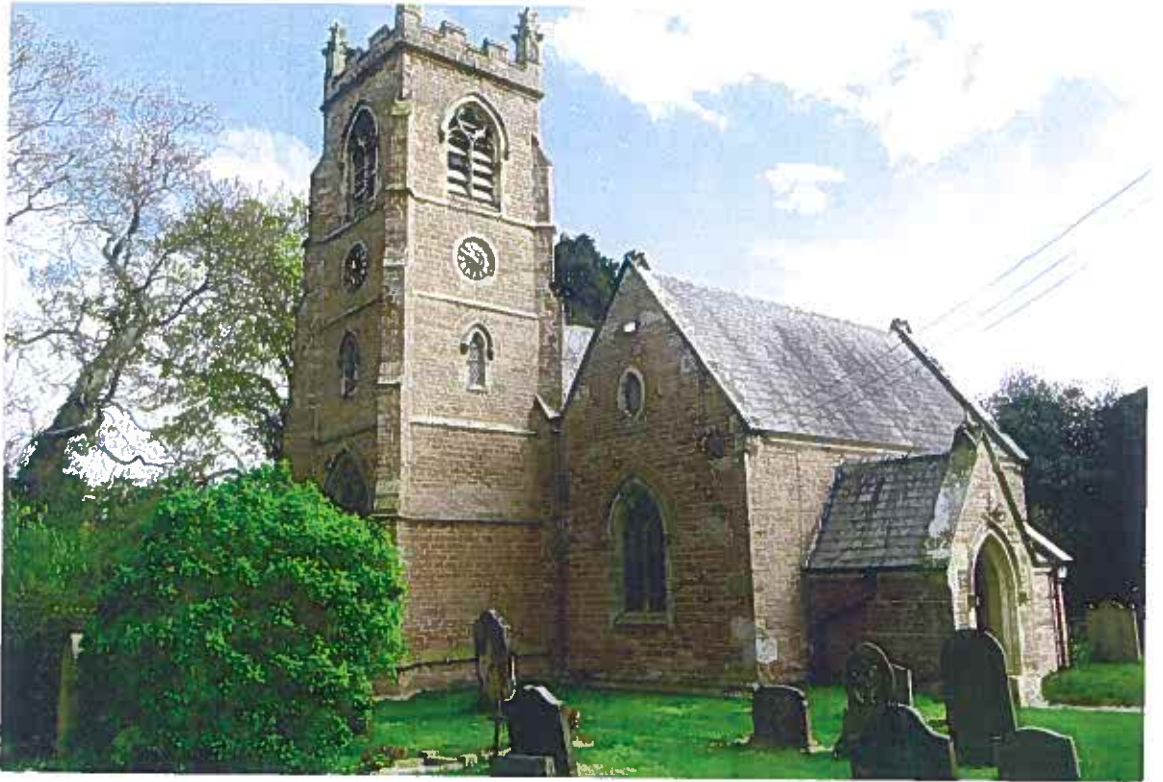
3

1. Lych Gate from Forecourt. Note damaged roof tiles
2. Lych Gate from Churchyard. Note damaged roof tiles.
3. View from South West
4. Tower from South West

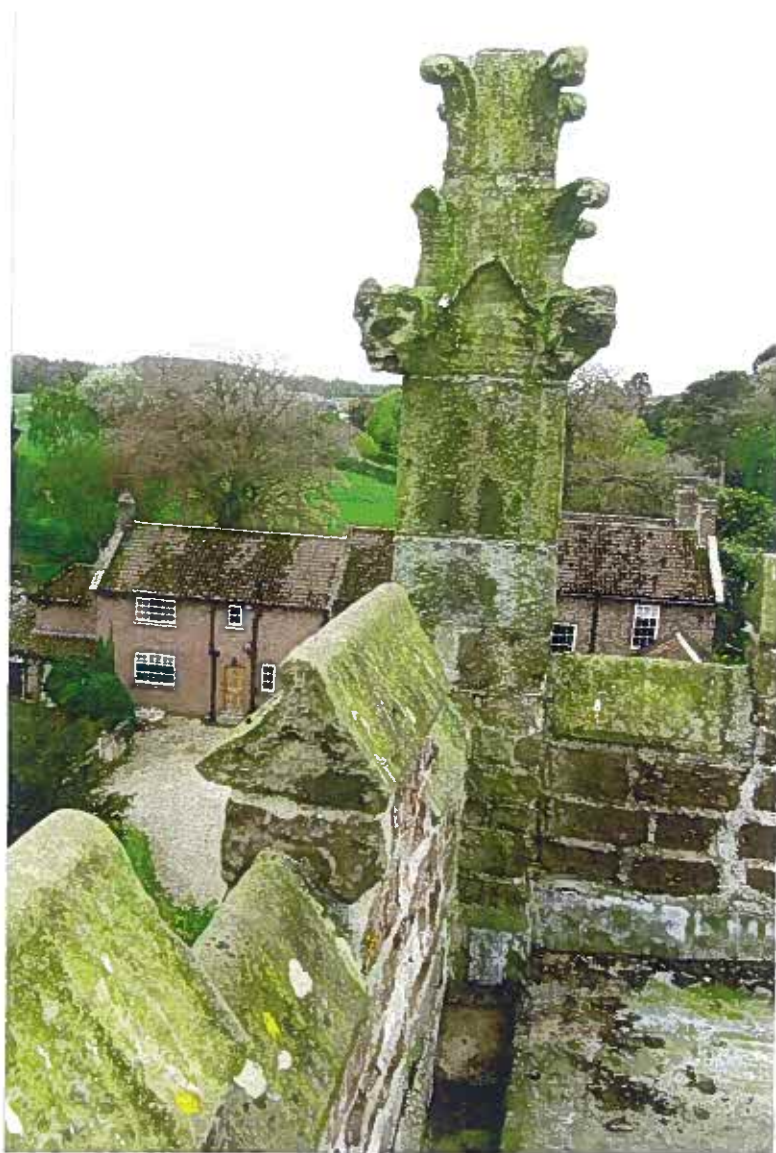
15

14. Parapet to South face of Tower plus pinnacle. Note vertical crack
15. South East corner pinnacle to Tower
- 16 North West pinnacle to Tower. Note leadwork

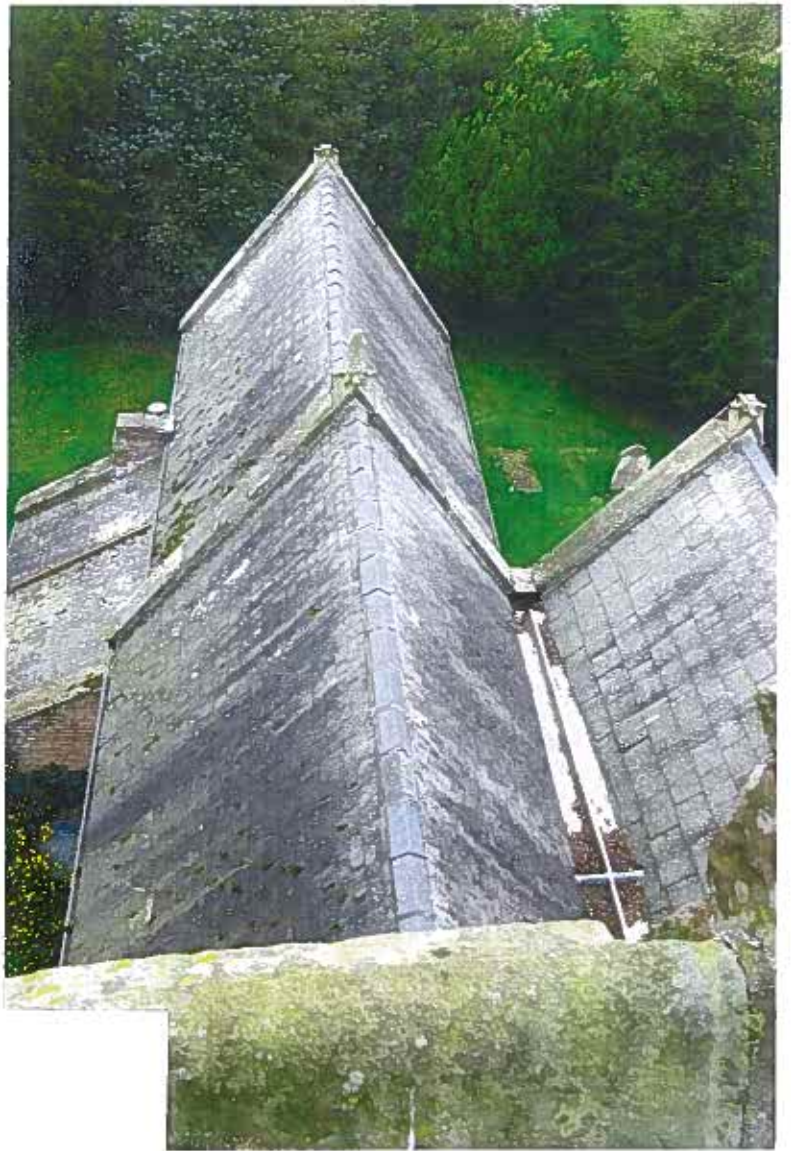
17

17. Roofs to Nave, Chancel, South Aisle and Vestry from Tower
18. North west pinnacle and access trap from belfry.
- 19 View from South Porch across South Aisle to Nave and Organ.

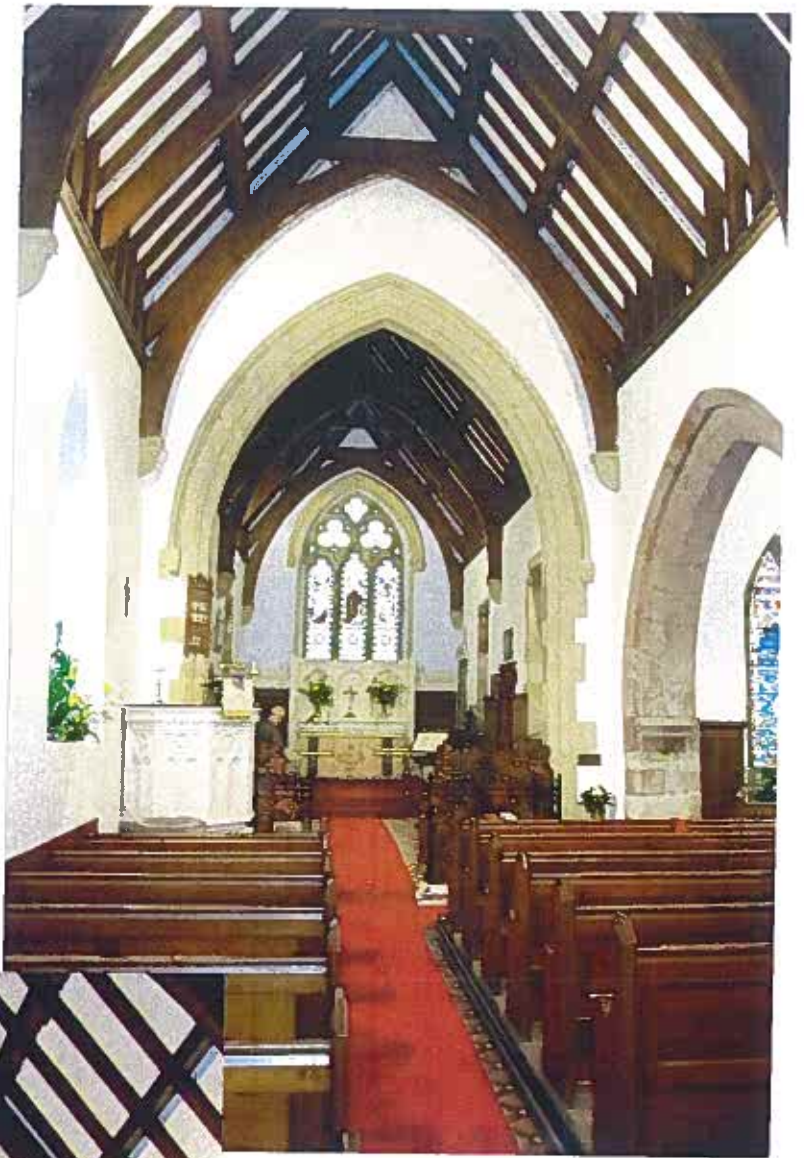
21

20. South Aisle looking East. Note new floor tiling and relocated font
21. Nave looking East to Chancel
22. Chancel
23. South East corner of South Aisle with relocated font.
24. Nave looking West toward Tower base. Note new Kitchennete
25. South East corner of Chancel. Note historic efflorescence
26. High level plaster efflorescence to South Aisle wall above South Porch
27. Plaster efflorescence to Nave/Chancel arch
