**St NICHOLAS
DUNSTON**
(281)

QUINQUENNIAL REPORT
on the architect's inspection on

11 May 2023

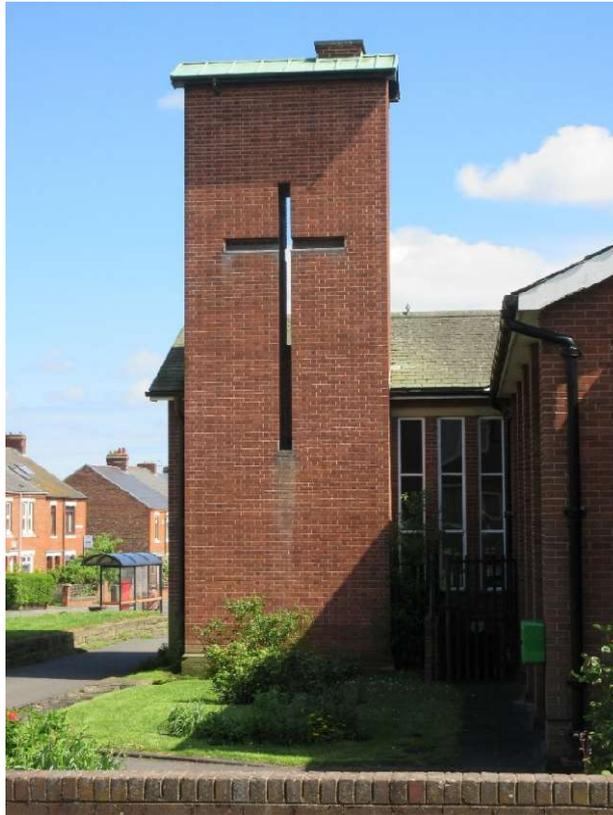
6. A large basement under the N Transept divided into Boiler room and oil tank room.
A disused chimney built into a fin-like brick bell turret pierced by a cross shape.

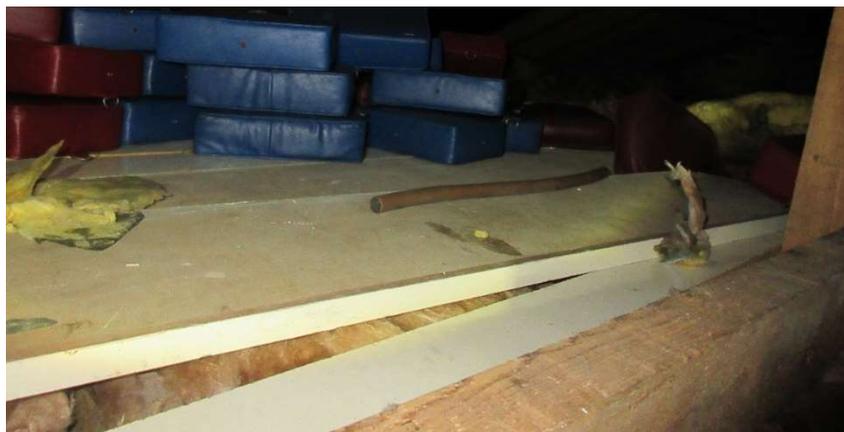
30. In Church small flush mineral tiles fixed as a shallow vault across the whole Nave, Chancel and N Transept. Painted white and sound though some lines of joints are open perhaps due to seasonal movement of the frame above. The Transept 'vaults' intersect the Nave at curved cover beads. A vertical tiled bulkhead links the Nave and lower Chancel vaults. No ready access and unlikely to be insulated.
31. The tiles are pierced for many recessed downlights and fissured to prevent unpleasant echo except plain over the organ to reflect sound.
32. The Narthex, wc, Choir and Clergy Vestry ceilings are sound painted flat plaster. Minor cracks at Clergy Vestry.
The accessible void over the Clergy Vestry has stored material and insulation quilt between ceiling joists and under a plywood deck.
