QUINQUENNIAL INSPECTION REPORT

DURHAM, ST GILES

**QUINQUENNIAL INSPECTION AND REPORT
March 2017**

David Beaumont BA (Hons) Grad Dip, RIBA, AABC

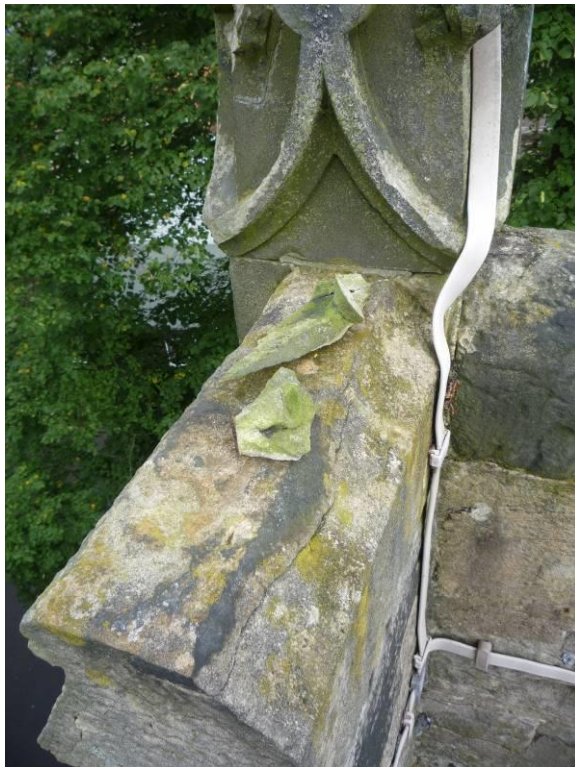
North west pinnacle stone fractured which was taken down during the inspection.

The lightning protection is to the south west corner with a down tape.

Recommendation: check all pinnacles for soundness, repair pinnacle

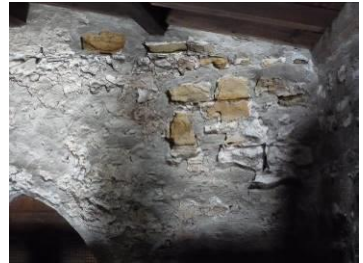
- Ceiling – Exposed, boarded with one central beam. Supported purlins and boarding in good condition.
- Walls – Lime washed and heavy cement pointing and there are some deep pockets of erosion, particularly to the west and south faces and these should be looked at. They have an impact on the structure of the tower.
- Floor – Lead lined with two outlets on the east. Quite a large build-up of leaf litter on the floor.
- Windows – four louvered windows with mesh that has broken down and will allow birds in.
- Large medieval bell frame with some woodworm, though this looks dormant.
- Door – onto nave roof formed through the louvers has rusting hinges and loose cabling for the roof detection system.
- Contains three bells hung from the rusting steel frame, operated by clappers connected to ropes down to the tower ground floor.

Recommendation: repair walling stonework, clear floor leaf litter, repair mesh, ease roof access door and clip loose cable, derust bell frame and paint

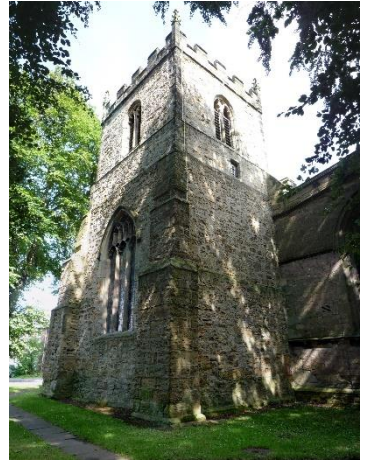
- East elevation –
 - Upper - parapet okay, string course okay, upper stage. Two outlets from the roof onto downpipes look okay. Walling generally is okay, as is the tracery to the belfry window, though the louver boards could do with some decoration.

Carry out selective stone walling repairs, assess tracery condition and repair as required, Redecorate louvre boarding.

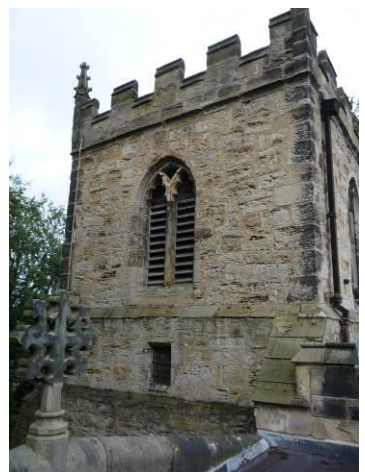
- Upper – erosion to the Y tracery, rust showing on the ferramenta to the deafening chamber window.
- Middle and lower – stonework okay.

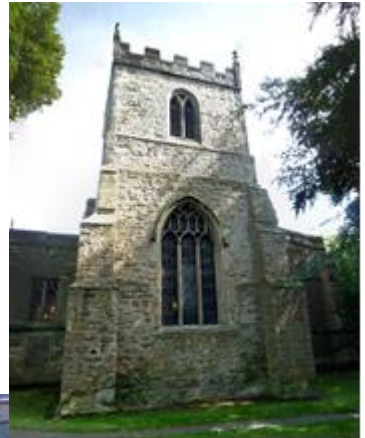
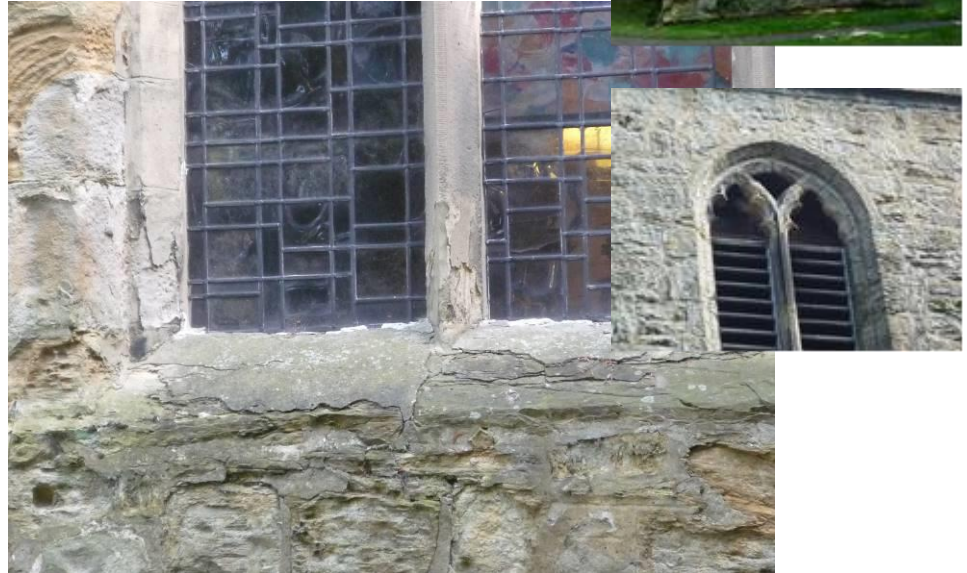
- Upper – erosion to the Y tracery on the belfry window and also the bottom of the mullion
- Middle and Lower – a combined stage containing the west window. The walling generally is poor, particularly at arch level where there is some quite deep erosion. Some erosion to the mullions as they join the sill.

- The left-hand buttress has deep erosion.

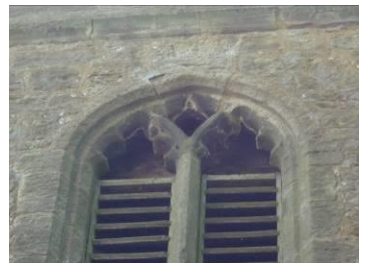
- Upper – Slight chip and movement to the keystone off the belfry lancet but okay for the present.
- Middle and Lower- this elevation stonework is better

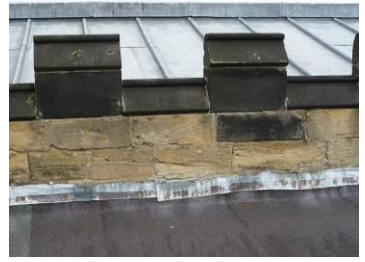
Formerly a lead roof, but now covered in mineral felt which has had some patching, it would be worthwhile understanding when this was installed to gauge better its life expectancy.

- West abutment – okay
- North abutment – one piece of lead flashing coming away
- East abutment – flashing in mineral felt with some cracking to the pointing.
- South abutment – okay. The parapet gutter in the south-east corner appears to be sunk and is back falling and this has potential for providing water ingress into the Lady Chapel below.

Recommendations: consider changing mineral felt coverings to more longer lasting finishes, repair loose flashings and repoint open joints to walling and chancel/nave watertabling, repair south aisle parapet gutter lining over Lady Chapel, remove leaf guards

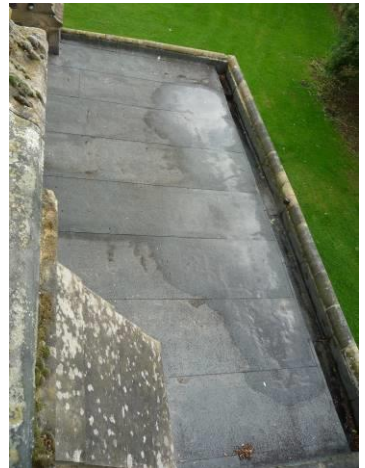
Mineral felt flat roof, not able to be well inspected but appears satisfactory.

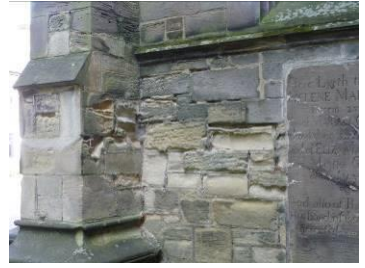
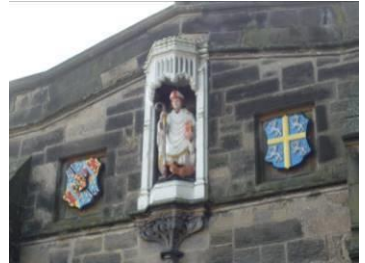
- West elevation – erosion to stonework adjoining the buttress and some also to the tablet.
- North elevation – open joint just above the statue of St. Giles on the raking parapet area to the west of the arch where the stone face is coming away and needs de-shaling.
- East elevation - okay

Recommendation: Update the walling assessment carried out by the Jeremy Kendall and plan for a significant round of repairs

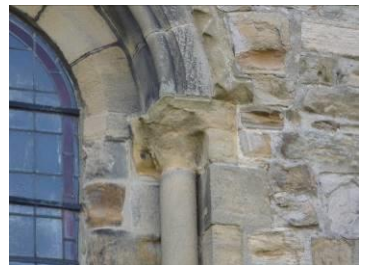
- North - Loss of detail to the water leaf capital of the Romanesque window and erosion to the jambs. Open joints to the buttress top.
- East – open joints to the feet of the raking parapet, particularly at the north side suggesting a slight wall spread.

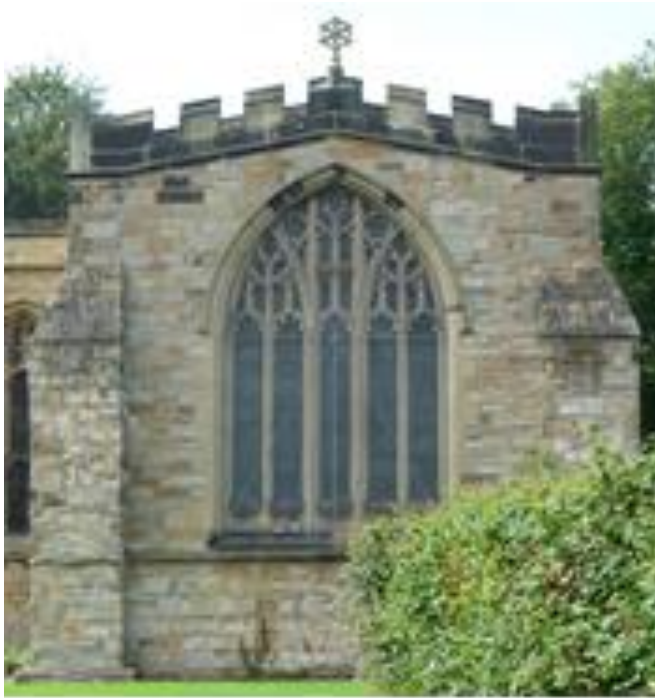
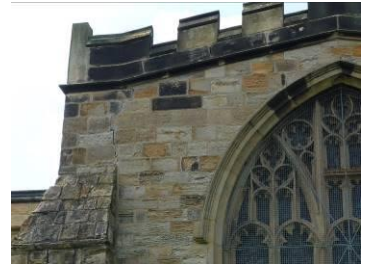
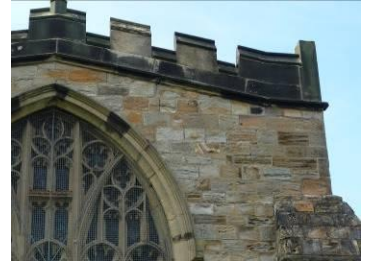
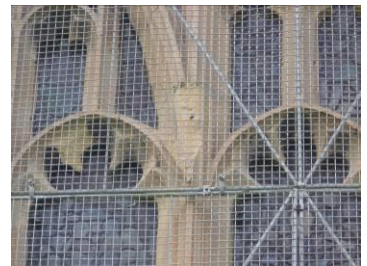
- The buttress on the north side is also leaning over, though this looks historic. Multiple erosion to the stonework at low level. Galvanized guarding to east window fixing has broken the tracery.
- South – erosion above the Romanesque window head and loss of detail to the capital.

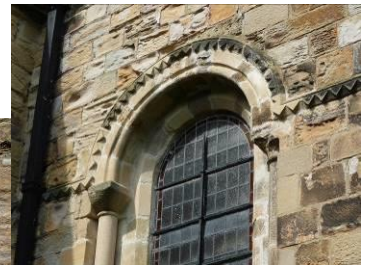
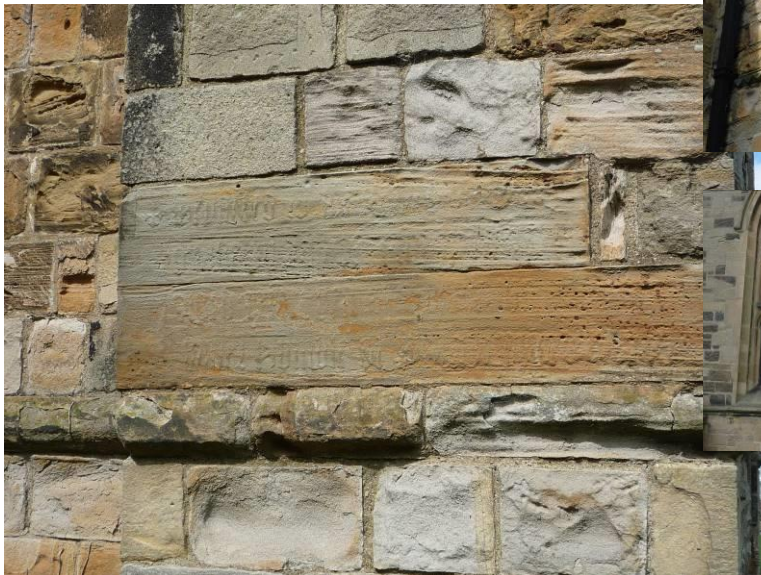
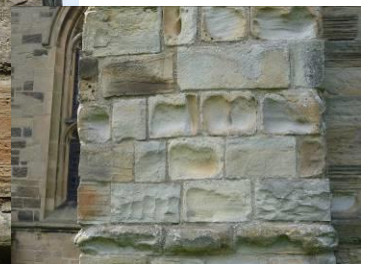
- Erosion to the stonework on the buttress corner, such that the lettering is unreadable now.

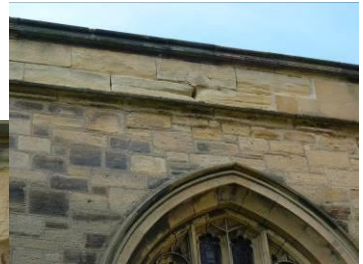
- East – open joint and fractured stone on parapet above string course. Splitting to mullions of window.

- Major loss of stonework below string course adjacent to boiler house.

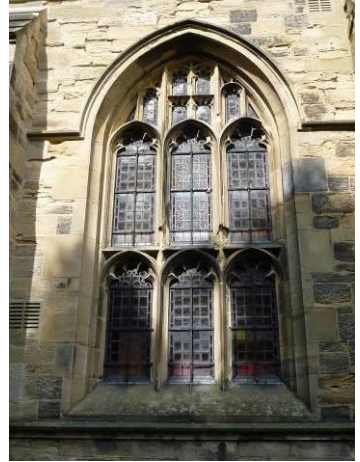
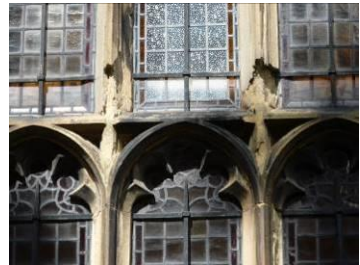
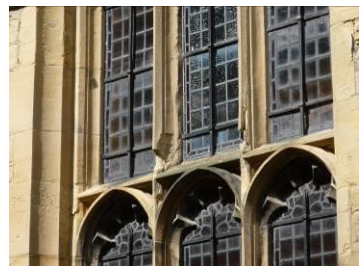
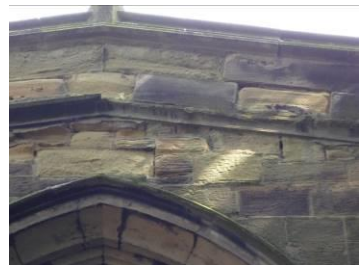
- South - This elevation is the most decorative of the elevations and suffering from major stone erosion to not just the walling but also the windows. It is undergoing a period of renovation and there is further work to do. Stone erosion, in particular over the whole of the elevation and a combination of de-shaling and new stonework is required. Of greater concern, perhaps, is the condition of some of the mullions and they are splitting at their junctions.
- A comprehensive survey of the stonework was carried out by Jeremy Kendall a couple of years ago and it is recommended that this be brought up to date and a comprehensive restoration programme be put in place.
- West – the raking parapet has open joints and some stone degradation on the south side. Also, the string course is broken at that point. The window similarly is suffering from a fracture to the mullions of the tracery.

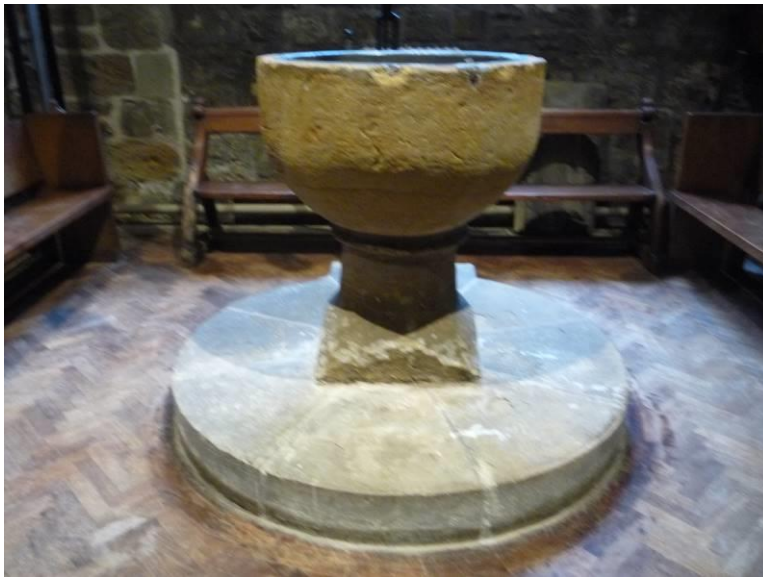
- Font – sandstone, slight delamination, lead lined and sat on a plinth – all reasonably fair.

Recommendation: none

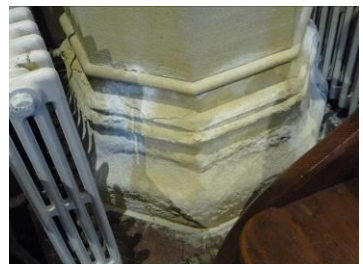
- Ceiling – exposed boarding with horizontal beams supporting ridge and purlins. Only a couple of areas of water marking, though these will probably be from the previous leaking roofs. Some woodworm established to beams at the west end when redecorated in 2016. Only seen at the outer edges of the beams and not affecting structure.
- Walls –
 - West – slight crack at high level by the pipe, heavily cement pointed. The arch has a slight crack and the final stone at the apex doesn't look quite right but will do.
 - North – this is the medieval wall leaning outwards. Very little defect to it, apart from at low level by the radiators where there is some slight lamination of the stone which is down to the cement pointing.

- East – this contain the chancel arch and all looks sound though there is damp at the bottom of the base of the shafts.
- South – this is formed of a five-arch arcade and is part of the Victorian restoration works. No cracking above the arcade and recently decorated. The arches are all sound, as are the columns, apart from their bases towards the western end where there is a loss of detail, though structurally they are all sound.

Recommendation: arrange inspection of woodworm in nave

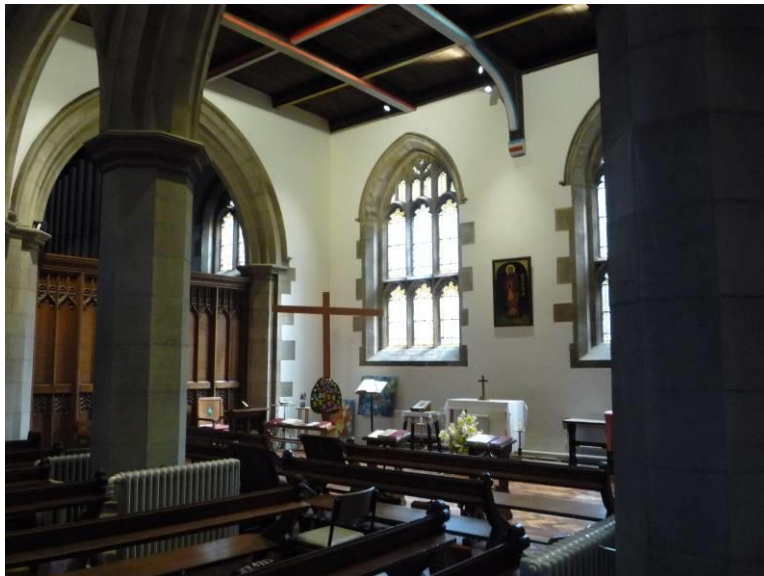
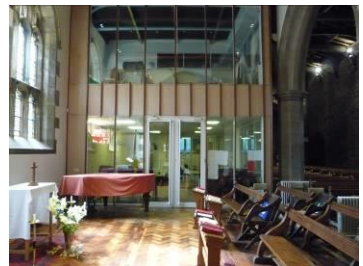
- **Lady Chapel:**

- Ceiling – an aisle ceiling that runs over the top of the rest of the aisle works. It's a fairly shallow ceiling, boarded and in good condition.
- Walls –
 - West – this is the new enclosure in a glazed screen- ok
 - North – arcade
 - East – leads to the organ, the arch here is

- okay. The walls are painted plaster.
- South – recently decorated and blemish free. The two windows stonework is ok, but we know that it is not outside.
- Floor – larger format herringbone flooring with some gaps but serviceable.

Recommendation: none

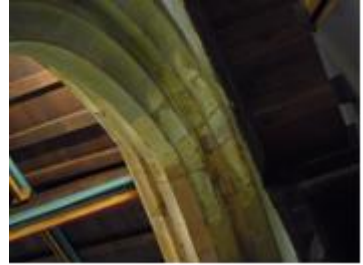
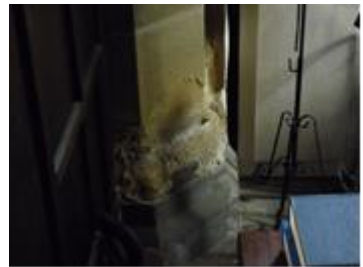
C Vestry:

- Ceiling – Exposed boarded ceiling, no evident defect.
- Walls –
 - West – plastered, some flaking. Slight crack at the lintel to the doorway but looks generally okay. The door is bolted up and the recess has some low-level damp by the bottom hinge.
 - North – panelling at high and low level with former fireplace. Two recesses for robes and for the safe. Crack to the fireplace surround.

- The room has a collection of different heaters and dehumidifiers.
- East – plastered, seems to be okay with a four-light window. Part of the mullion is breaking away because of the rusting ferramenta.
- South – two windows, some splitting to the mullions.
- Floor – possibly suspended with carpet.
- Baxi boiler in small cupboard.

Recommendation: include the windows into the stonework assessment

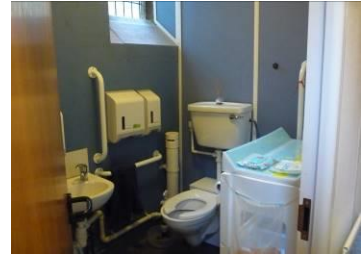
Disabled WC:

- Rather full with the baby change which does restrict wheelchair access, perhaps a drop down would be better. The fittings are all generally okay, though a cupboard also restricts wheelchair movement and the locking on the door needs slightly easing.
- Water stain to the ceiling panels.
- Rear doorway – emergency exit door to the outside looks okay. The window above has had a recent break in and a temporary repair.

Recommendation: consider drop down baby change, ease door lock, renew stained ceiling panels, repair window

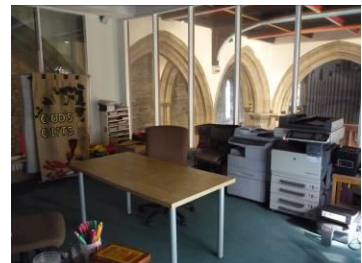
Upstairs Room 1 – photocopier room:

- Ceiling – water staining to the boarding.
- Walls – all okay.
- Window – rusting ferramenta and salting to the back face of the guarding rail.
- Floor – carpeted and creaks slightly.
- The room contains lots of papers. Also, two photocopiers and a piano.
- Door – closes a little hard into the opening.

Recommendation: ease door

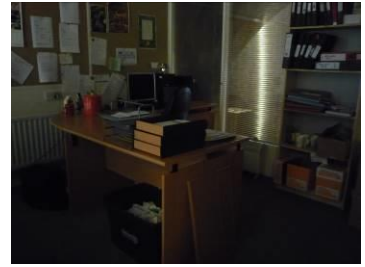
Upstairs Room 2 – administrator’s office:

- Ceiling – slight water staining.
- Walls – as the other rooms.
- Floor – suspended.
- The room contains a lot of cupboarding and a modern office desk and photocopier.
- Door – needs easing in the opening.

Recommendation: ease door
