**St Mary the Less, Durham**  
(St John's College Chapel)

**Quinquennial Report**

**3<sup>rd</sup> November 2022**

**Sarah Harrison** BA(Hons), gCAP, MArch, PGDip, RIBA

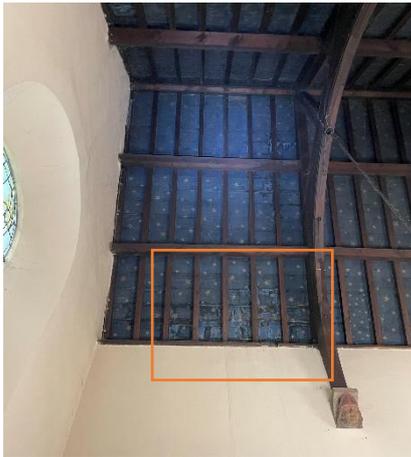
13 – Roof of Chancel

- 11.1 Very steep roof with arch braced trusses to **Nave and Chancel** on stone corbels with coats of arms/ faces to each, wide sarking boards exposed to the underside.
- 11.2 **Porch** – stone arch, crack running from east side of door to highest point, appears to be historic. Stone internally shows signs of erosion and efflorescence,
- 11.3 **Vestry** – Timber rafters with wall plate affixed to external wall, wall plate has been heightened at some point, given presence of a previous lead flashing. Timbers appear in ok condition, some damp staining.
