**QUINQUENNIAL INSPECTION REPORT
OF
EASINGTON LANE, ST. MICHAEL AND ALL ANGELS**

**DIOCESE OF DURHAM
ARCHDEACONRY OF SUNDERLAND
DEANERY OF CHESTER-LE-STREET**

QUINQUENNIAL INSPECTION AND REPORT

DATE November 2022

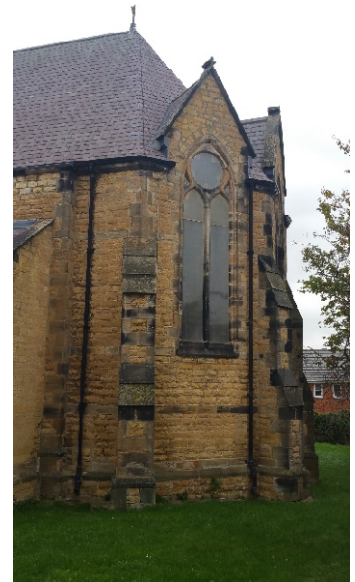
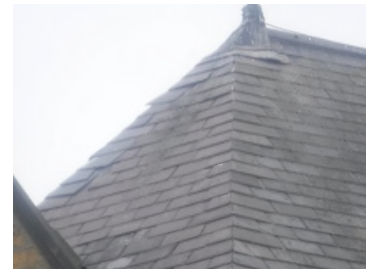
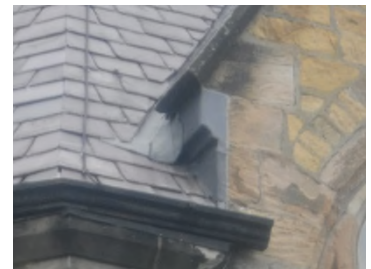
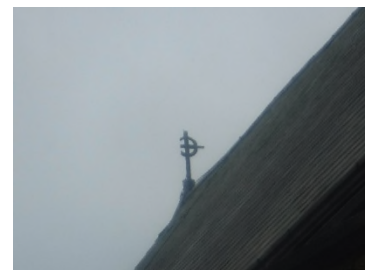
The slating is generally sound on the apse. Flashings have been stolen and been replaced in lead alternative. The cross at the apex is missing part of its arm. At the W end the stone cross has gone in the past, there is a terminal here as there is also on the W end.

The slating to the apse roofs looks ok. And their ridges are ok as well. There is a loose slate sat in the gutter in the NE corner and this area has seen many repairs in the past so there is a bit of a patchwork of different slates.

North side – Some loss of slating towards the E end just above the chimney stack, there is a bit of moss on this elevation, slight undulation to the slating at the eaves a couple lifting and one definitely missing and some loose at the eaves. E abutment is to the aps hip which is ok. W abutment same as the other slope looks ok.

Recommendation: replace slipped slates

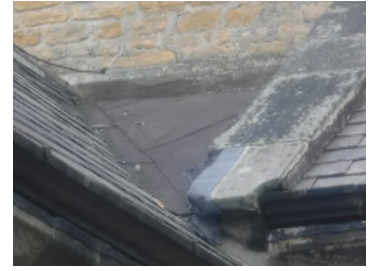
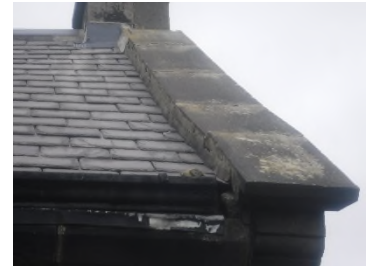
watertables aren't level here and I don't quite know why. There is a crack to one of the kneelers and it has just shifted a bit and humped, I think it has a chimney at the apex without a pot.

West side – Same story as the E not able to see into the valley easily other than to note it is all in mineral felt and I also can't see the gable of the N aisle.

Recommendation: fix loose slates and inspect surrounds when up there.

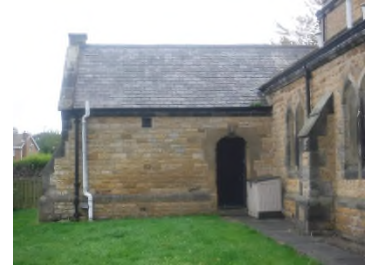
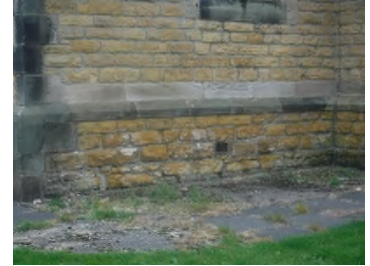
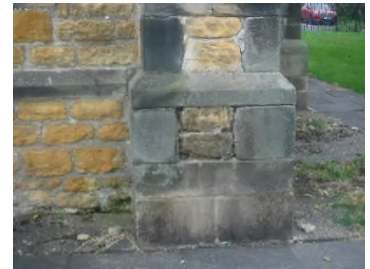
Vestry:

West side – Area of stone broken out under the buttress in the NW corner.

Recommendation: monitor open joint

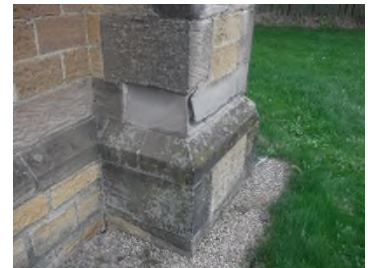
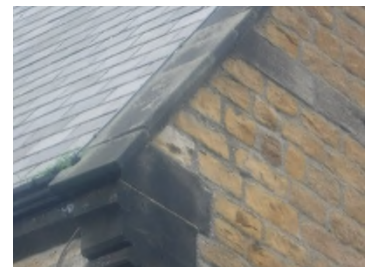
North Aisle:

West side – Watertable a bit rocky and wonky and the built-in mid stone looks as if there could be a joint problem there and that might be some water coming in there in fact there is a bit of a crack running down below it. Walling is generally sound but a bit of damp showing below the plinth here but that is ok I think.

Recommendation: repoint cracking

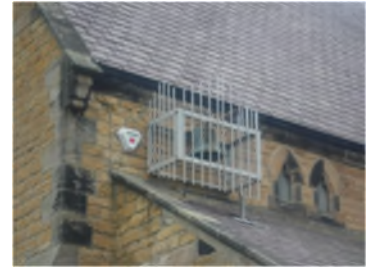
D Bell:

Single tolled bell on the S side protected by a galvanized metal frame, things are looking a little rusty now around it and the lead slate looks as if it could be fixed down a bit better.

Recommendation: redecorate cage.

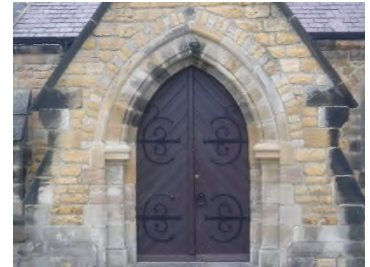
Door recently decorated ok and the arch surround has been restored satisfactorily by David France Ltd (who also replaced some of the west end mullions). The E and W elevations have a pair of quatrefoil lancet headed windows in heavy masonry surrounds these are ok.

Recommendation: none

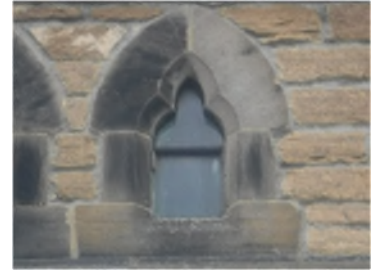
The clerestory lights are set as individual windows in a pair and the masonry is ok. The middle and either side seem to have ventilators perhaps there is a horizontal metal bar at the springing point that is also noticeable on the other side. The glazing pointing seems to be breaking down around the square part of the windows.

Recommendation: inspect when next doing roof work

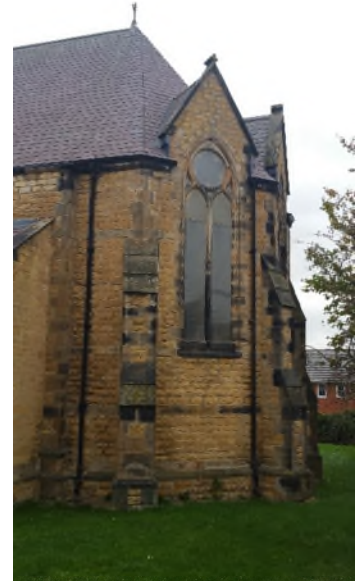
M East end Apse-

Facet 1 – Slight breaking up of the circular joint on the side.

Facet 3 – The apex and upper mullion have been replaced and that looks ok, the bottom part of the polycarbonate has also been replaced and the circle as well.

Recommendation: monitor window masonry (I don't think there are repairs coming soon but it would be wise to keep an eye on it)

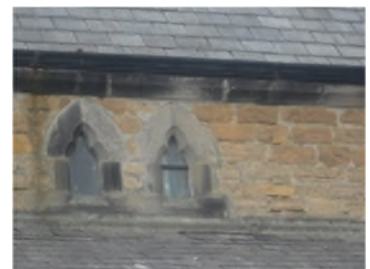
M North Nave Clerestory

Same design as the S with four pairs of individual lancets. These seem to have two ventilator bars here, the central one has got cracked glass in it, the glass actually looks obscure, however the masonry looks fine.

Recommendation: inspect when next doing roof work

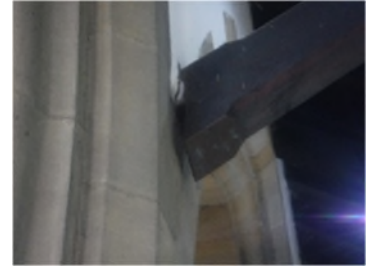
M North and South Aisles:

These are lean-to structures with simple trusses formed of a principal rafter and a strut, these struts go back to the arcades and are moving, the N isn't able to be inspected as it's now enclosed by the aisle partition, but there is evidence on the N at the W end of movement. The majority of the movement is on the S side where it looks like the S aisle wall head is bowing out because the three intermediate trusses supported by the arcade columns all are moving out of their sockets, the worst being in the middle and that is approximately 30mm, but it looks to be old movement which I think has two stages of movement looking at the paint marks on them, probably the initial first settlement and then gradual over time and the question is, has it stopped moving? Is it as a result of timber shrinkage that has pulled these members out? It could possibly be so, if they failed I doubt the roof would collapse but it is worthwhile checking what the N is looking like above the screen to get a better idea of that, but externally there are no obvious problems.

I also wonder if the shoes have been retro fitted? The backs of the shoes aren't all the same thickness, so are not a 'set' so might they have been fitted at different times? No that can't be the case because how could they fit them in, it doesn't make sense.

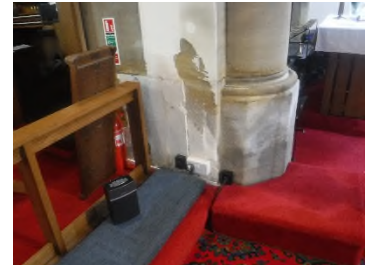
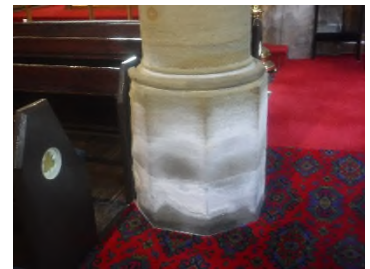
Formed of four arches supported on circular pillars and octagonal bases - there is no evident movement to the arcades. The bases on the S side have damp to their high level octagonal bases and they are beginning to come up onto the drum particularly effecting the W most on the S side.

The N side are partially enclosed partitions and they look to be telling the same story as the S perhaps not so badly, they are not so troubled on the N. The capitals are roughed out and are awaiting carving.

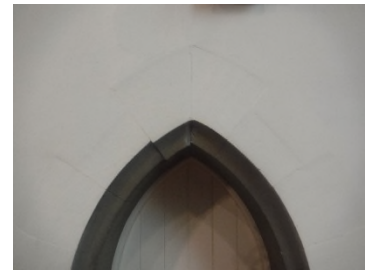
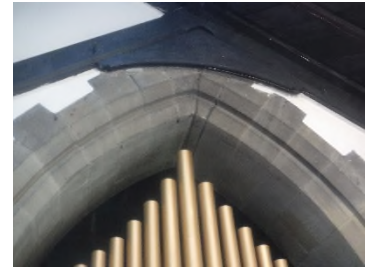
There are two arches here, one to the chancel mostly hidden by pipes so not all able to be seen but it looks as if there has been a minor drop of the keystone underneath the roof corbel support. And there has been a slight drop of the arch on the S aisle on the S side and again this looks historic.

Recommendation: none

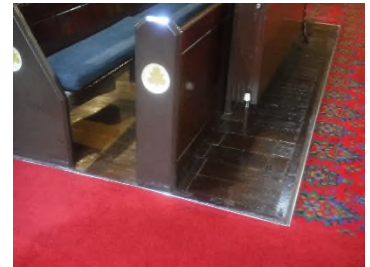
Floors: The whole of the building has a suspended timber floor. The nave has ventilators on the walls below the floor level, the circulation areas though are solid and so the underfloor ventilation is just ventilating the pew platforms. The N aisle is carpeted and so whilst difficult to determine, there may well be a mixture of a margin of solid by the columns and timber for the rest. The floors are not level and do undulate slightly. They are not trip hazards to speak of, but it is odd that they sort of roll as you walk along them, they are sinking at each of the column positions but not bouncing. I think historic. But worth keeping an eye on them as they may be suggesting the floor joists are failing at the column bases. All the chancel is suspended timber possibly until we get to the sanctuary. All the circulation areas are carpeted and are very good condition. The back offices are a combination of carpets and safety flooring all of which are in fair condition.

Recommendation: monitor floor level

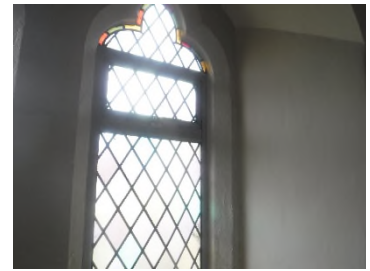
Window is a mixture of coloured and obscure diaper pattern glazing peculiarly but ok.

Recommendation: clean down cobwebs

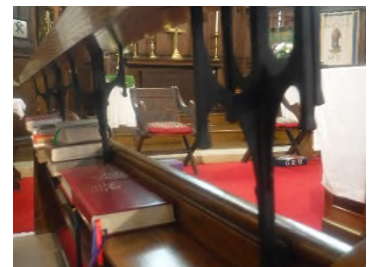
The pews are standard pew furnishings rather glossy painted with a chocolatey brown colour to them with very nice blue seat covers on them.

Octagonal font looks like a great big bolt and some more Glastonbury style chairs and assorted cabinets for books and pamphlets here.

Recommendation: none

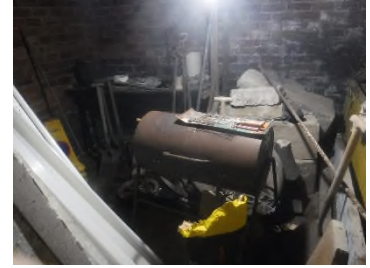
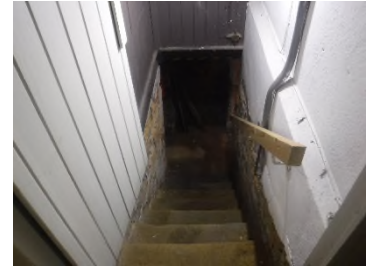
Access to these rooms is down a set of stone steps and these are ok but the side walls are rather damp, they have been cement pointed in the past and that is breaking away, it is best if these were brushed down and left to breathe a bit. It has a new handrail. No sump pump but there is a sump in the boiler room floor.

Recommendation: clear out store room, brush down walls and ventilate the space

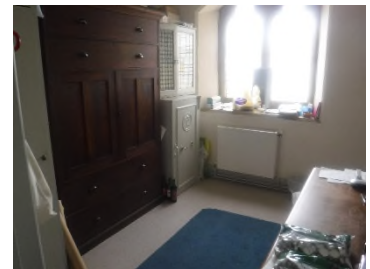
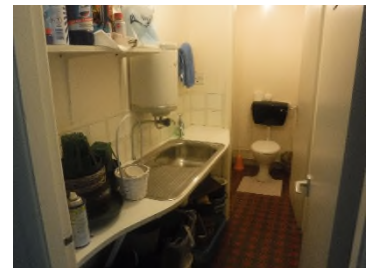
Fairly basic flower vestry in the W.C. lobby again it is rather over filling with items. The hot water over the sink doesn't work probably on purpose, the w.c. looks ok.

Recommendation: check hot water heater is required

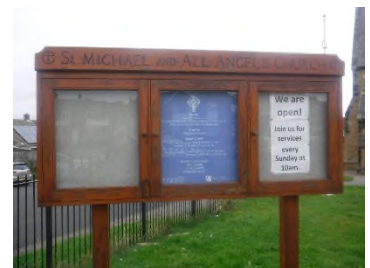
Timber sign with three windows. Varnish is breaking down.

Recommendation: revarnish sign
