**St Mary, Easington**  
(46)

**Quinquennial Report**  
On the architect's inspection of

**11<sup>th</sup> November 2025**

**Sarah Harrison RIBA**

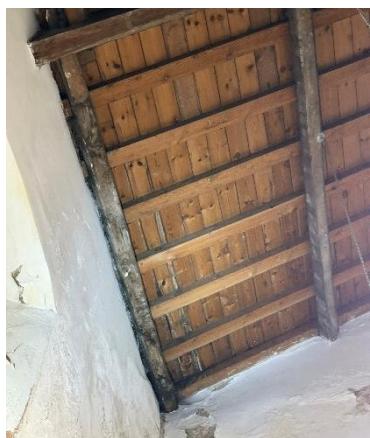
Figure 32- Vestry

**12.4 Organ Chamber and Vestry** - The roof structures to the organ chamber and vestry are similar in form to the north aisle, with simple timber construction. The east end of the purlins and ceiling boards are stained by what appears to be recent water ingress. Again this could be linked to the watertable condition.

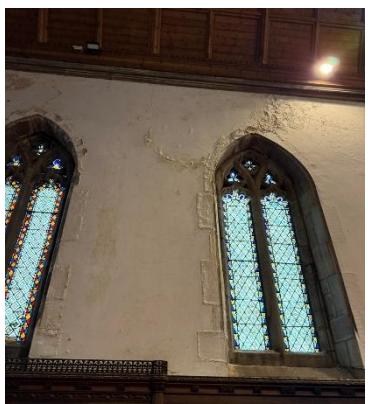
Figure 38- Chancel South

14.1 **Chancel** - The condition has deteriorated greatly since the last inspection report. The missing lead to the southern box gutter has caused water to penetrate into the top of the south wall and this is clearly evident above the easternmost lancets. There also appears to be flaking plaster above each of the trefoils on the east wall.

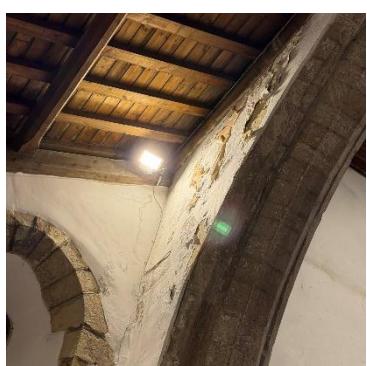
Figure 40- S aisle W end

**12.3 Aisles** - The aisle roofs are of simple lean-to construction, with principal rafters, purlins, rafters and boarding, and curved braces down to corbels on the north side only. Water staining is present, particularly bad at the west end of the south aisle, slightly lesser to the east end, and at both ends of the north aisle,

the purlin to the east is very stained. Additional marking is visible to the boarding along much of the north aisle roof length. These appear to be longstanding, though the areas noted as more severe may be worse than previously reported and could be linked to the condition of the watertables externally.

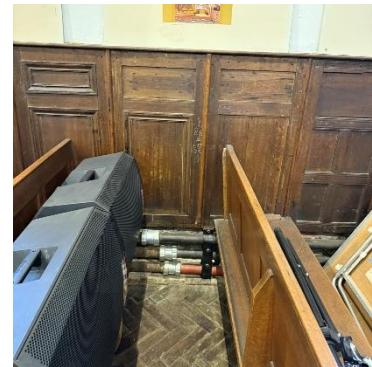
Figure 41- Dado panelling

15.1 **Chancel** –Dado panelling in oak to all sides, the reredos is largely mid-17th century, comprising carved and painted panels beneath a crocketed canopy, and is in good condition. The vestry door is oak paneled and in good condition, though not opened.

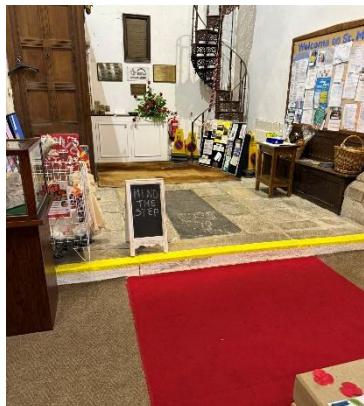
Figure 43- Tower base

- 18.1 **Entrance** - The stone floor is undulating with a number of open joints
- 18.2 **Tower** - The tower floor is one step higher than the nave and is formed of stone flags, which undulate slightly. A blue ledger stone is set centrally within the floor. A coir mat with an edging covers part of the floor; while this may present a minor trip risk, options for improvement appear limited, other than replacing it with a slimmer mat with a rubber edge.
- 18.3 **Choir, Nave and Aisles** - These areas have solid floors, likely pitch pine laid in a herringbone pattern. Circulation routes are carpeted. The floors are generally sound. Heating grilles are likely present beneath the carpeted areas.

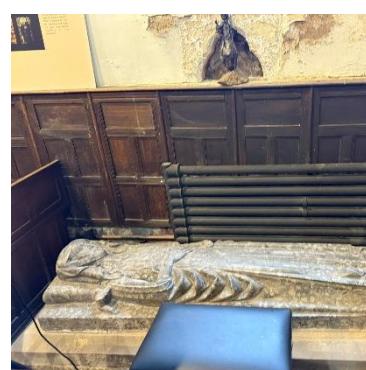
Figure 45- Effigies

19.7 **North and South Aisle East Ends** - At the east end of the north aisle is a well-preserved 14th-century female effigy in Frosterley marble. At the corresponding position in the south aisle is a 13th-century sandstone effigy of a knight, together with a medieval stone coffin. Both effigies are located close to large radiators, and consideration may need to be given to the potential long-term effects of heat on the historic stonework, as well as the damp surrounding conditions.

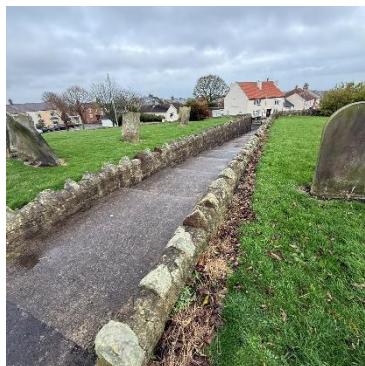
The northern boundary comprises a substantial battered stone retaining wall, approximately 1.5 metres high, retaining the churchyard. Much of the wall is battered to resist ground pressure. The wall has been subject to cement repairs, with poor pointing noted near the north-west gate and scattered open joints along its length. A shrub is growing from the top of the wall at mid-length, and some coping stones have fallen. To the north of the vestry, missing stones have left voids in the wall face.
