St John's Church
Eggescliffe

Inspecting Architect Ulrike KNOX RIBA AABC

Report on Quinquennial Inspection
13th April 2021

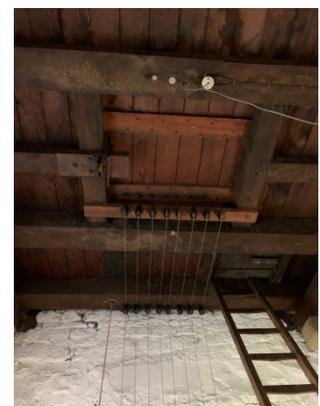
3.3. WEST END

3.3.1. At the end of the Nave there is an arch leading to the base of the Tower. This is used for ringing two bells and also for a children's area. The lower section is panelled with timber and there are two

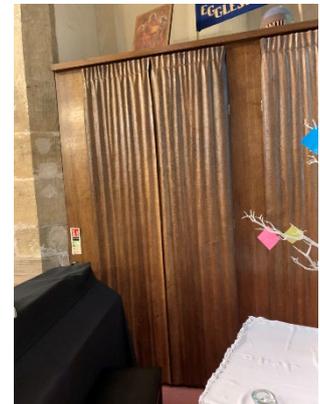
3.6.5. Here there are two radiators and underfloor grilles.

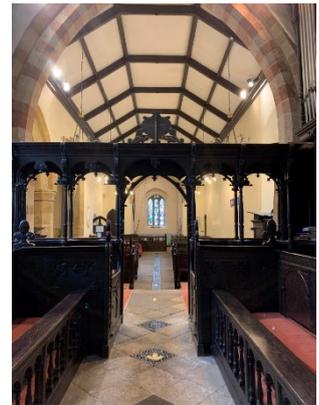
Floor is stone in smaller square tiles set at the diagonal. There are three steps up to the Altar sanctuary area with a timber Altar rail.

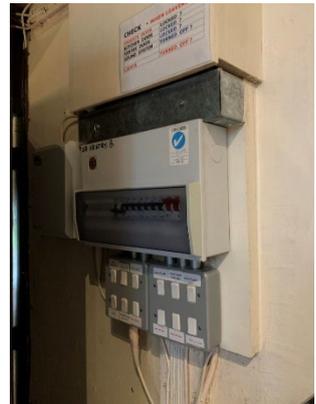
3.8.4. Within this space there is a Victorian style radiator and also the incoming mains. The distribution board and switches all appear to be in good condition and new.

- C • Redecorate ceiling and improve ventilation.
