Diocese of Durham

ESCOMB
Saxon Church
(176)

QUINQUENNIAL REPORT
on the architect's inspection on

14 August 2017

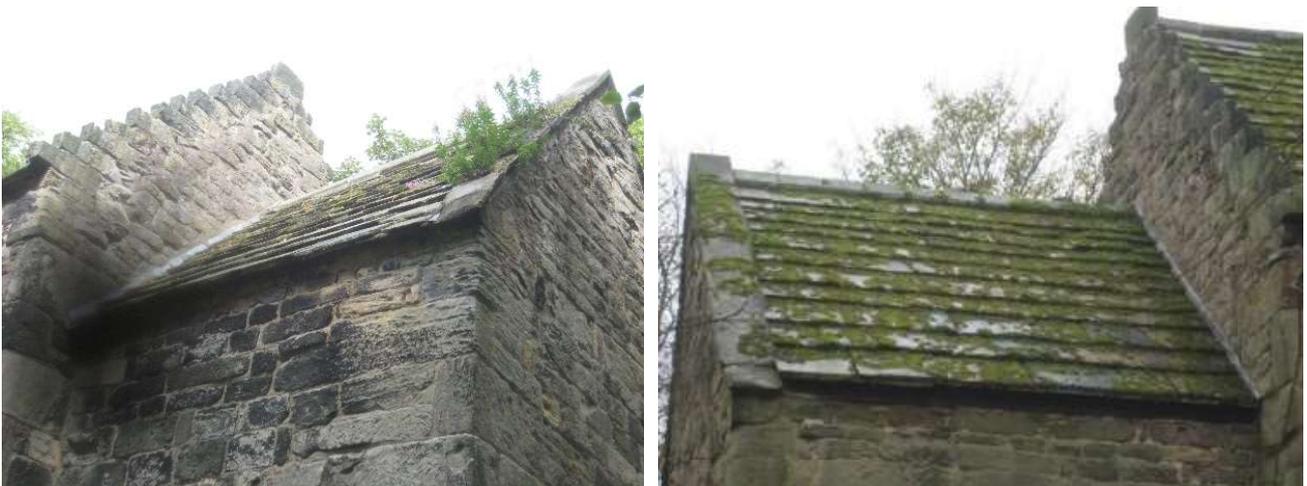
21. At **Chancel** lead soakers and cover flashings against the Nave gable seem sound. At E gable soakers covered by mortar fillets against stone watertable slabs.
At SE plants grow in cracks in the fillets and in open joints between watertables. The plants, reported since at least 2007, will widen the cracks and open joints which must let water in risking rot in the ends of the purlins and sarking boards.
Thorough overhaul of least the watertables (rebedding, repointing, new fillets over the soakers or, better, lead cover flashings) is due.

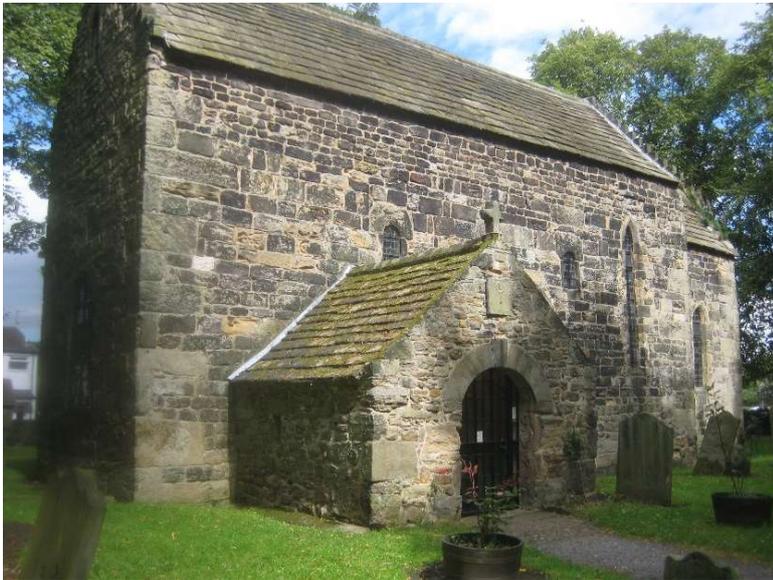
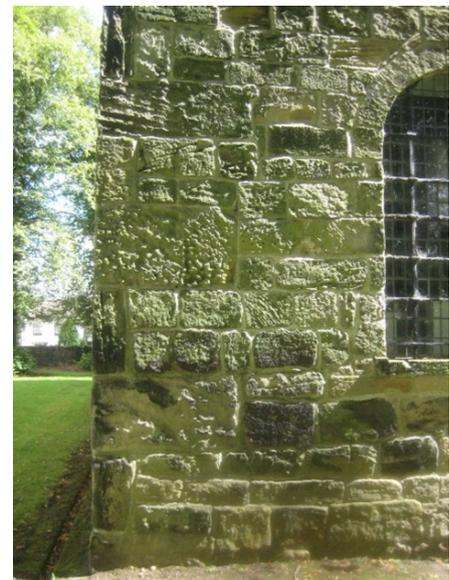
29. The masonry generally in good condition with sound flush lime pointing. At N Chancel and N Nave traces of former render.
30. A British Museum report Oct 1988 describes
- the N walls as widely covered in algae (still the case) and severely eroded implying that exposure and the slightly acid algae have weathered the ancient masonry.
 - the S walls as covered in a black sulphated dirt layer

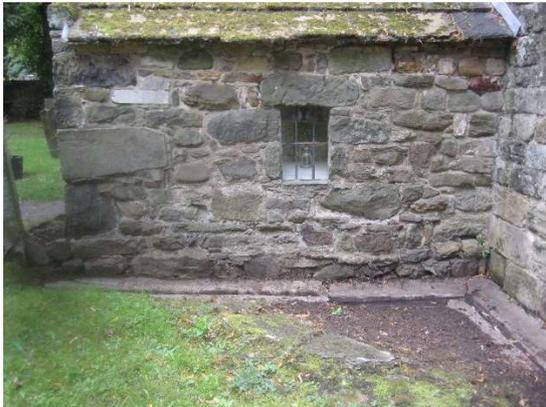
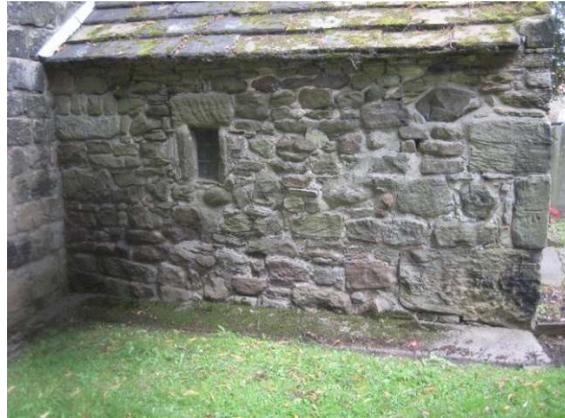
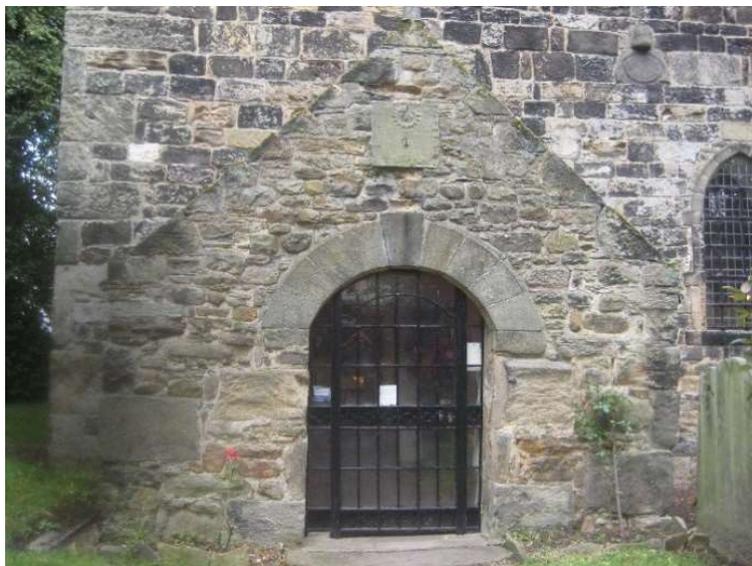
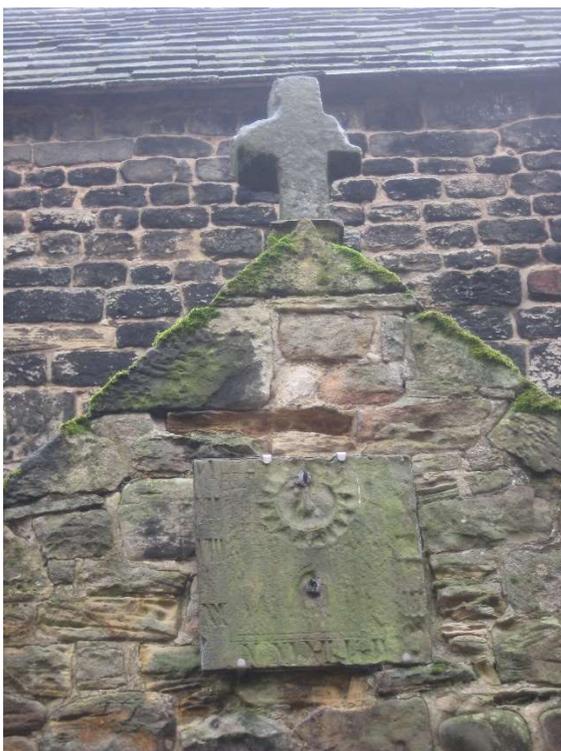
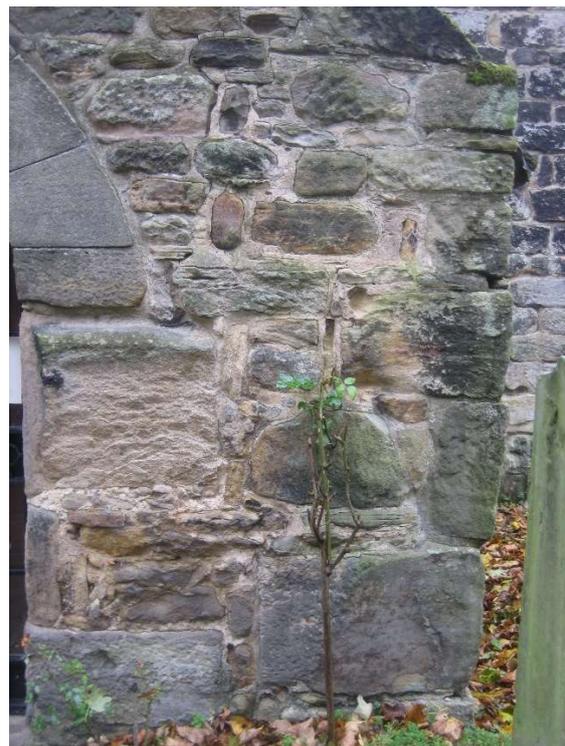
36. **Porch** small rubble with large quoins with wide and narrow pointing, mostly in good condition but deep decay in one stone over sundial and minor decay pockets E of door. One large hole in pointing at W. The gable may have spread very slightly (many mortar joints slightly cracked). Said in display to have no foundations, as often the case at added porches.

37. One arm of gable cross broken.

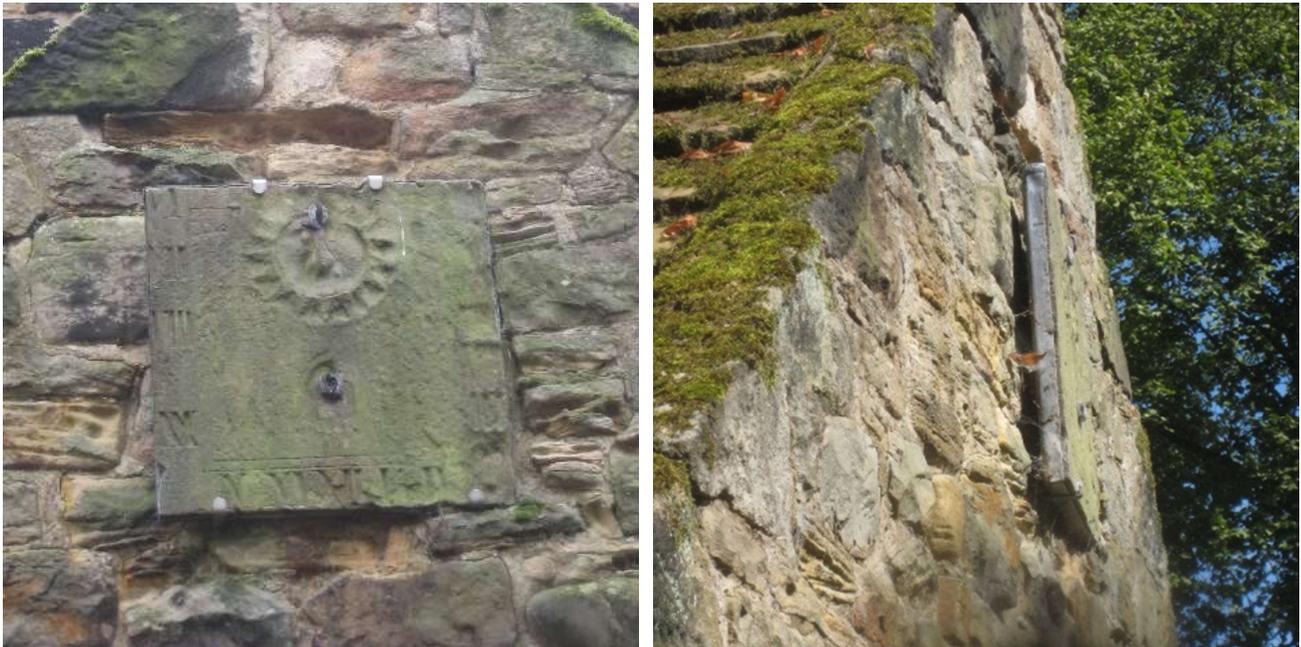
43. Following a report by the British Museum Oct 1988 cleaning and consolidation of the inscribed roman LEG VI stone and block with raised rosette (both N Nave) Saxon Sundial (S Nave) and early 17C Sundial (Porch gable) was apparently done 1989 by Seamus Hanna (his quotation Nov 1988). He described the Saxon Sundial as believed to be the oldest in its original position. Gnomons missing from both sundials.
44. A further Hanna report April 2001, not seen, was mentioned in the 2007 quinquennial report.
45. The Porch sundial is not built in but lead backed and slightly offset from the wall, perhaps for correct orientation. Held on four stainless steel clips. One side weathered but otherwise fair.

46. The LEG VI stone is protected by a slightly projecting stone.

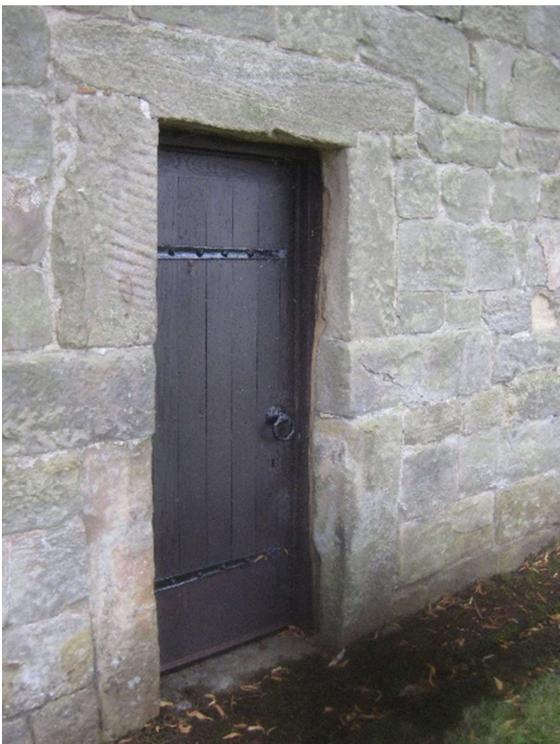
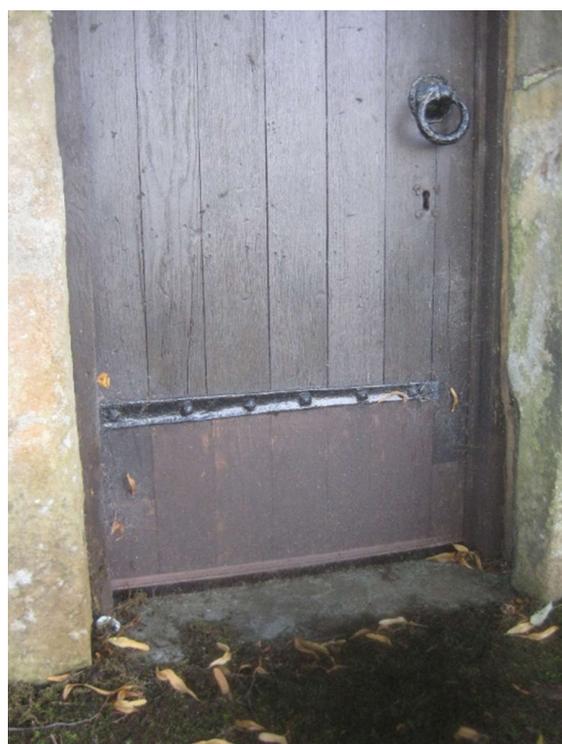
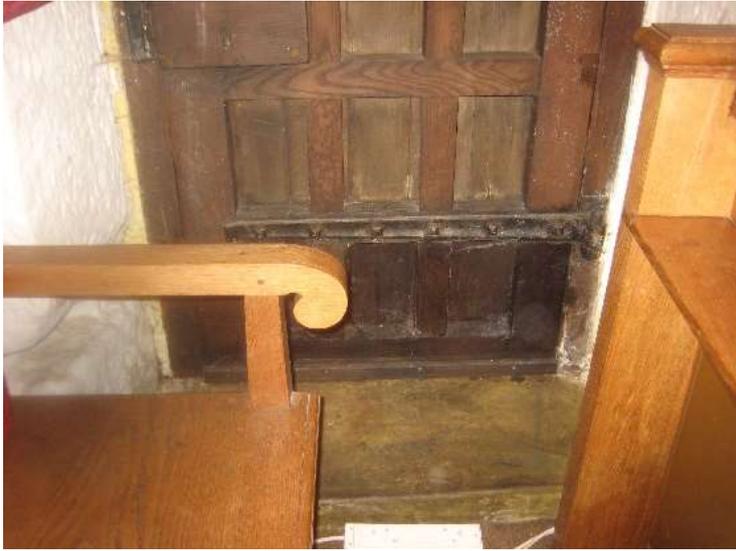
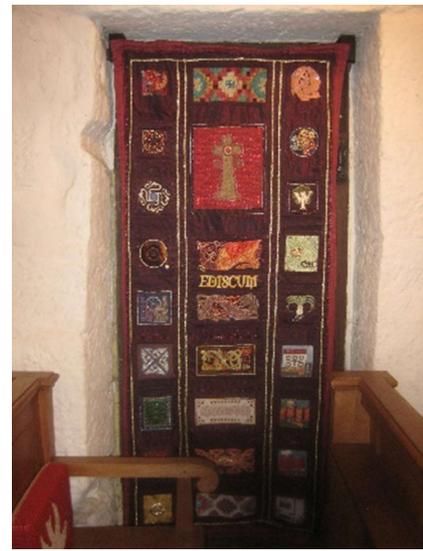
53. Porch square headed gates painted steel and frame, well pointed to the stone and fixed to a timber inner lintel. Made into doors with polycarbonate sheet applied inside, making painting and cleaning difficult. Deadlock and latch with knobs.

54. N door and frame stout oak. Its W frame was exposed to the weather by stone decay, now more protected by repairs. Good stained repairs of the bottom of the door. Rot was due to wet leaves lying against both frame and door which need to be kept dryer by frequent clearance.

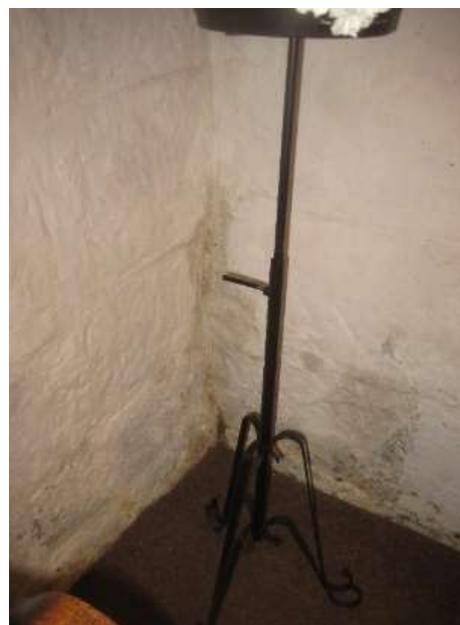
63. Some damp at bottom of Nave SE corner (rising damp or stone decay outside para 35) and very slight damp under the W window behind the frontal box/pew.

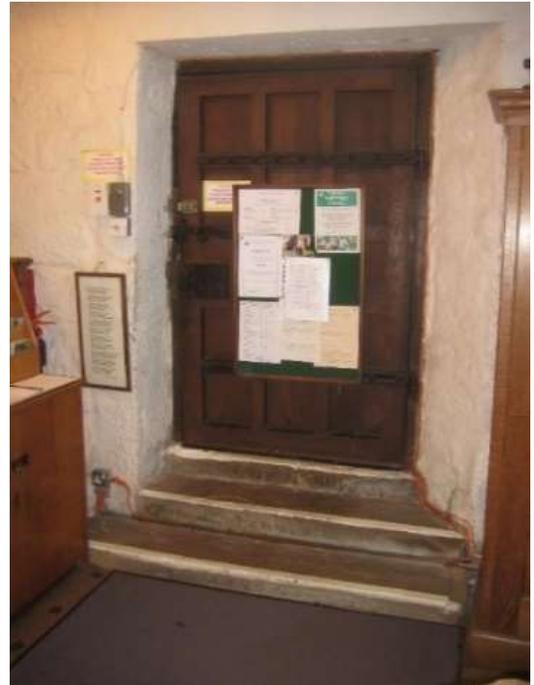
64. Porch inner door wide framed oak in oak frame, good condition. Only draught stripping is a bottom brush.

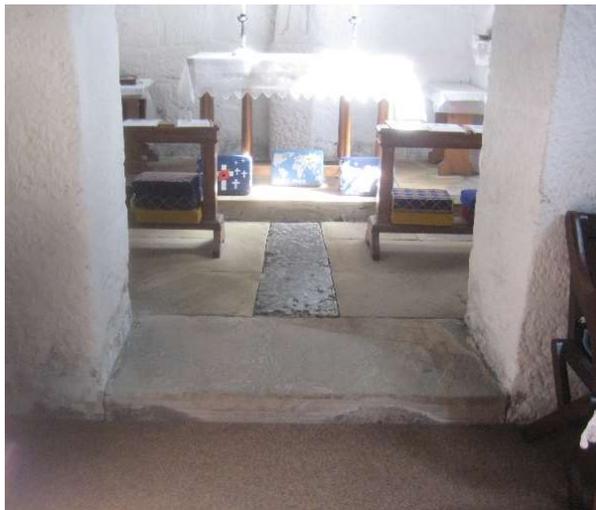
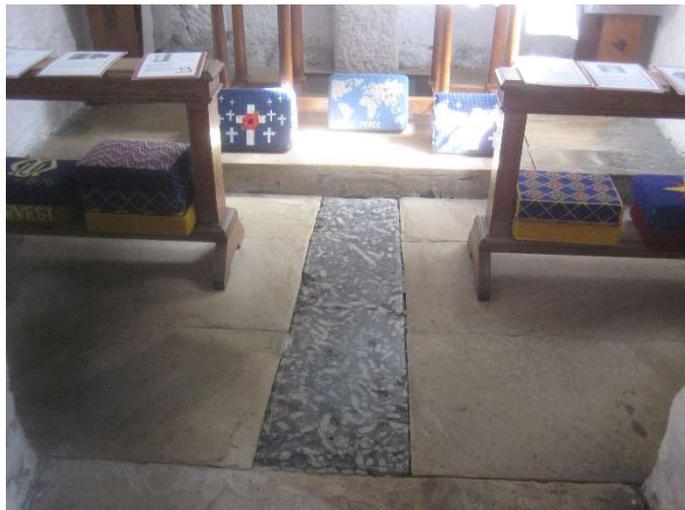
72. At Chancel plain sandstone step at arch (minor loss of surface at back edge) and at altar platform. Sandstone flags except a strip of Frosterley Marble 'grave cover' on the centre line with chipped edges. Good except minor loss of surface along sandstone N edges.

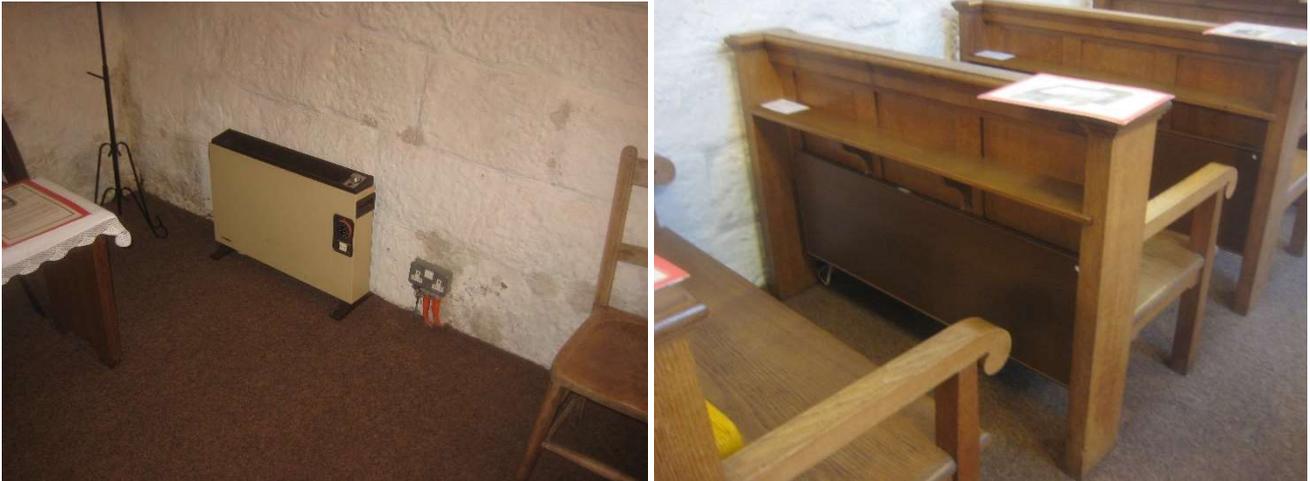
79. A small electric floor standing radiant panel at front of Nave. Loose fan heater by back pew.
Electric heater panels fixed to back of each pew with trailing flexes and loose multi sockets from limited wall sockets. One side only controlled by a timer switch.

80. The church is especially difficult to heat, having a small occupancy and floor area but large air volume due to the height and large uninsulatable roof and wall surface areas. On some days the poorly heated interior is colder than outside. In parts of the winter services move to the village hall.
81. The present arrangement of electric panels immediately facing the congregation makes sense as a strategy to get radiant heat directly to the people but does not warm the fabric which becomes a cold radiator in winter.
82. If the electrical supply is sufficient, further opportunities are either an electric heating mat under the carpet or under a new higher stone floor on insulation on the present floor
OR further radiant heaters in the pendant light fittings pointing downward in Chancel and Nave.
83. Electric blowers over the Porch outer door may direct hot air outward not inward.

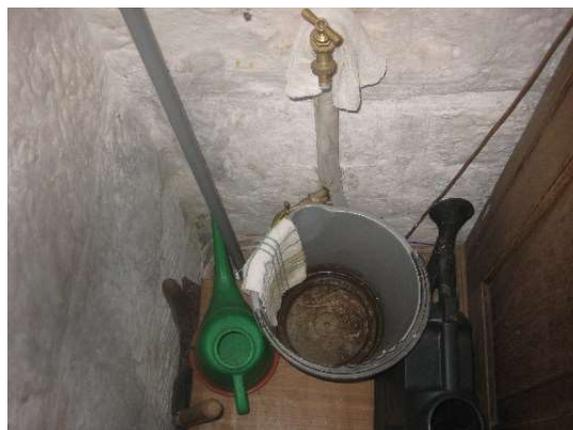
90. Only a cold water polyethylene supply rising in NW corner of Nave to a lagged internal stand tap. No gully or drain under tap.

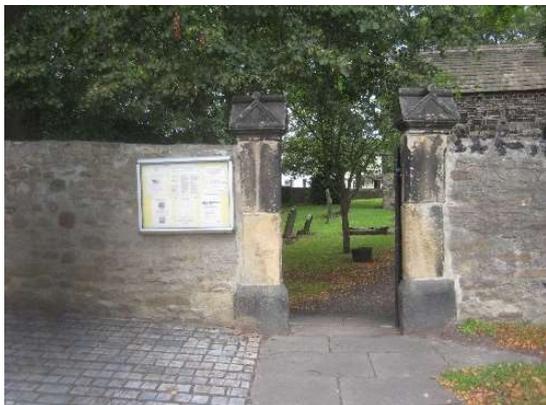
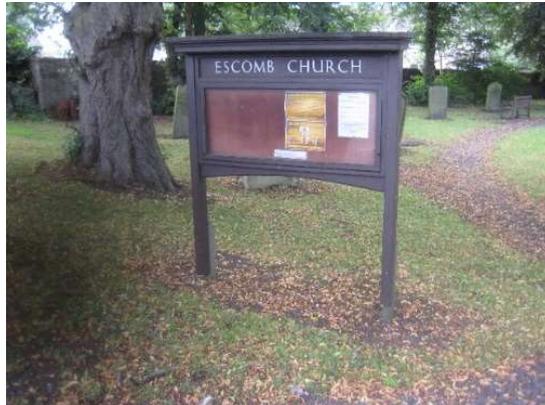
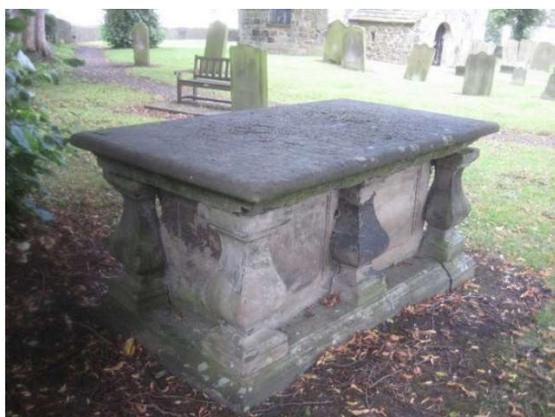
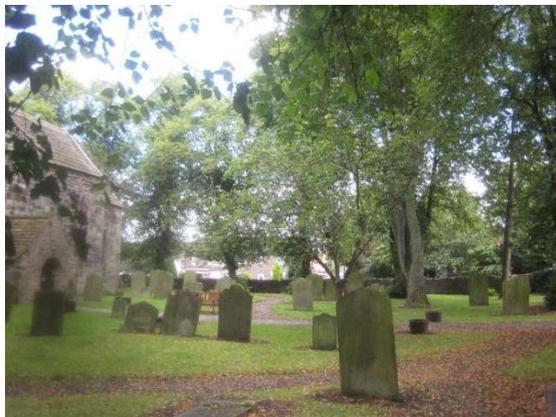
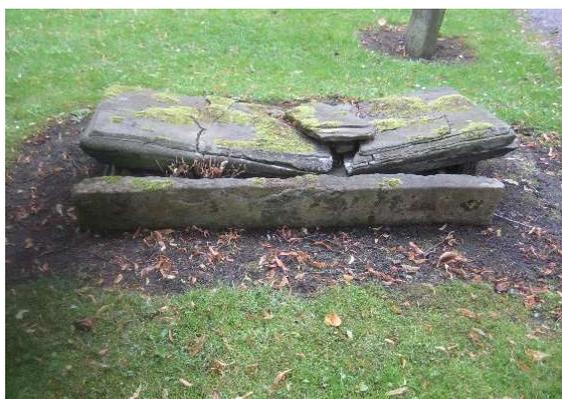
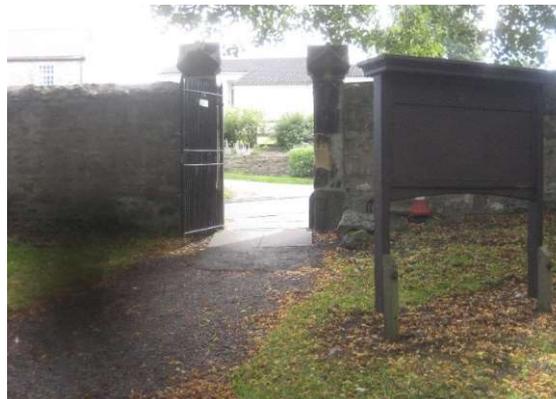
96. Grass and gravel paths good but large stone chippings at NW may be difficult for wheelchairs. Some top dressing of small chippings may be enough to reduce mud in church.

97. The separately listed curving wall retains parts of the churchyard above the surroundings and is generally sound. Plants grow in SE parts of the wall and isolated copings at E and NE. 19th century stone gate piers weathered but sound.
