**Quinquennial Inspection Report  
St George's Church, Fatfield, Washington  
Deanery of Chester le Street  
Archdeaconry of Sunderland  
Diocese of Durham**

26 March 2025

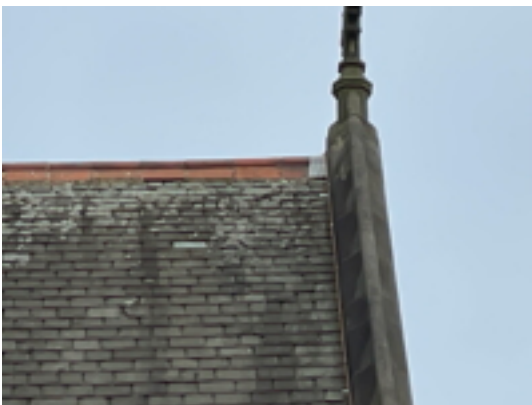
**Slipped Slate South Elevation East  
End**

Several chipped slates and a few missing and slipped slates to south elevation and north elevation east end. Not all areas are visible from ground level and should be inspected on a yearly basis by a reputable roofing company. The ridge tiles are generally uneven.

Replace all loose and missing slates. Cost Band 1–£0.00-£1,999.

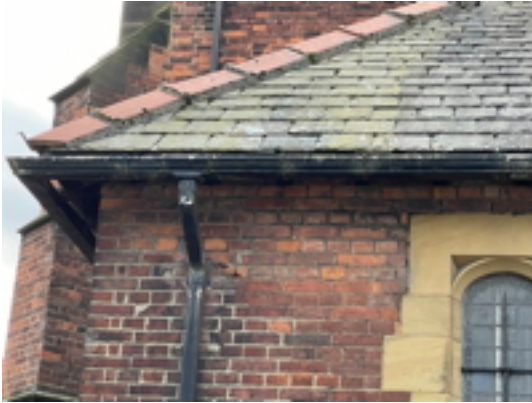
The rainwater goods all require redecoration.

**North Elevation Gutters and Rainwater Pipes in Need of Decoration**

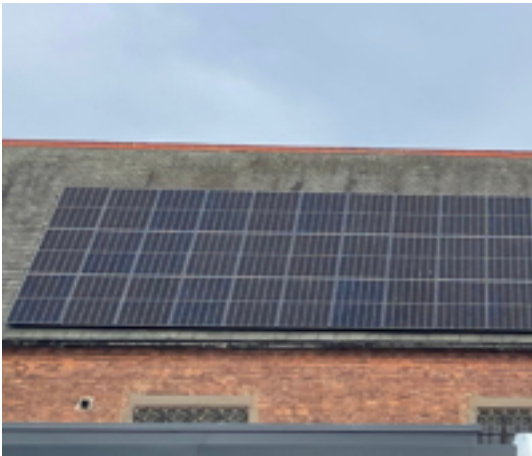
The north aisle gutter west elevation and the south elevation gutters are misaligned.

**South Elevation Misaligned Gutter**

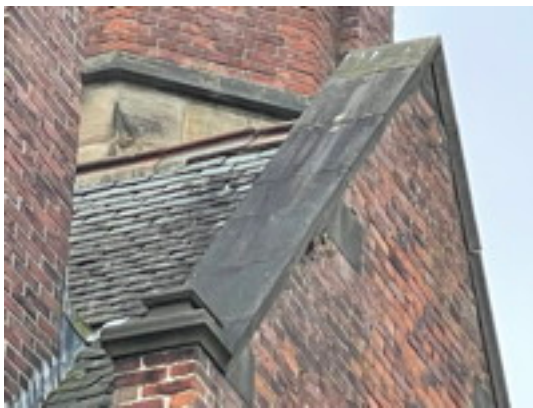
**Fern Below North Gable Parapet**

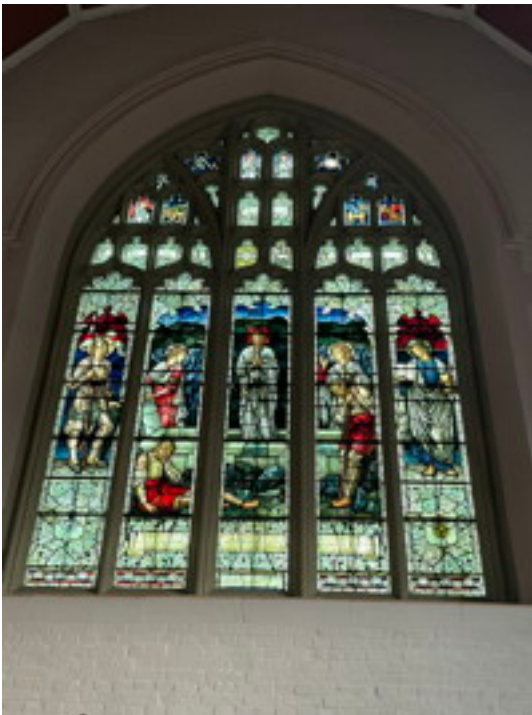
**East Window**

The external ferrementa is rusting.

Undertake full inspection of ferrements by stained glass specialist. Cost Band 1-£0.00-£1,999.

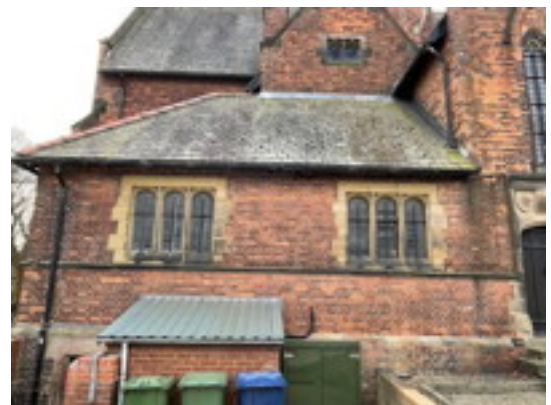
**Vestry and Vestry Corridor Windows**

Broken pane to vestry window east elevation.

Repair broken panes to Vestry window. Cost Band 1-£0.00-£1,999.

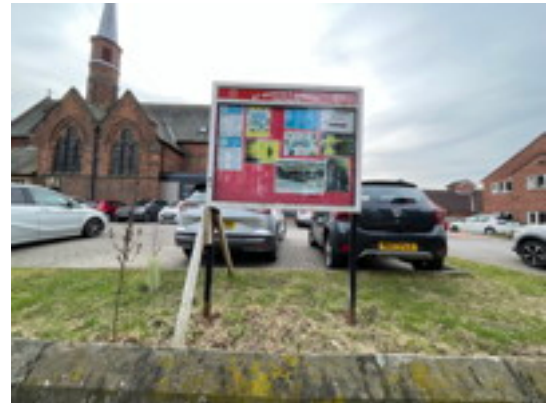
The Noticeboards to the east approach and north west corner are in satisfactory condition. The noticeboard to the north boundary is propped with wooden struts.

**North Boundary Notice Board**

Undertake repairs to north boundary noticeboard or replace. Cost Band 1-£0.00-£1,999.

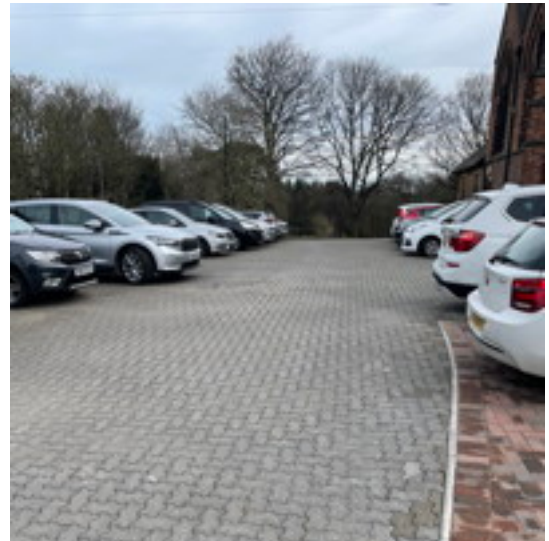
**North Elevation Parking**

All is generally in satisfactory condition and well maintained. The block paving to the north of the site is uneven following building works and needs to be re-levelled. The closed graveyard has suffered from the building works and is partly being used as storage for materials.

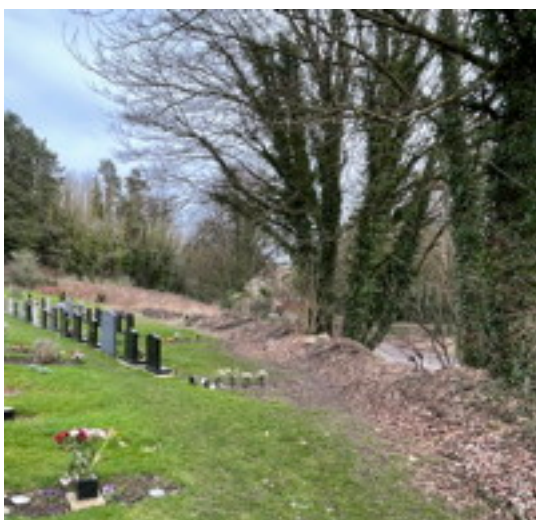
**Eastern Boundary Trees**

The trees generally all appear in satisfactory condition. The trees should all be inspected by a qualified tree surgeon every five years and pruned in accordance with their recommendations. They should specifically advise on the conifer to the south elevation.

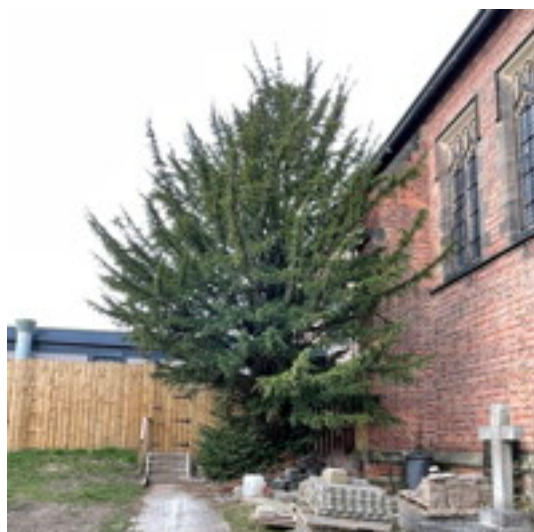
**South Elevation Yew Tree**

There is a coniferous tree, possibly a yew, immediately to the south elevation of the church and adjacent to this large shrub with a sycamore seeding growing through it. Some fruit trees have been planted in the closed graveyard to make a future orchard.
