**Quinquennial Inspection Report  
Christchurch, Felling  
Deanery of Gateshead  
Diocese of Durham**

David Jowett - Architect, BA, DipArch, RIBA  
25 Roseworth Avenue  
Gosforth  
Newcastle upon Tyne  
NE3 1NB  
Tel: 07788 710 204  
email: [david@davidjowett-architect.co.uk](mailto:david@davidjowett-architect.co.uk)

13 November 2025

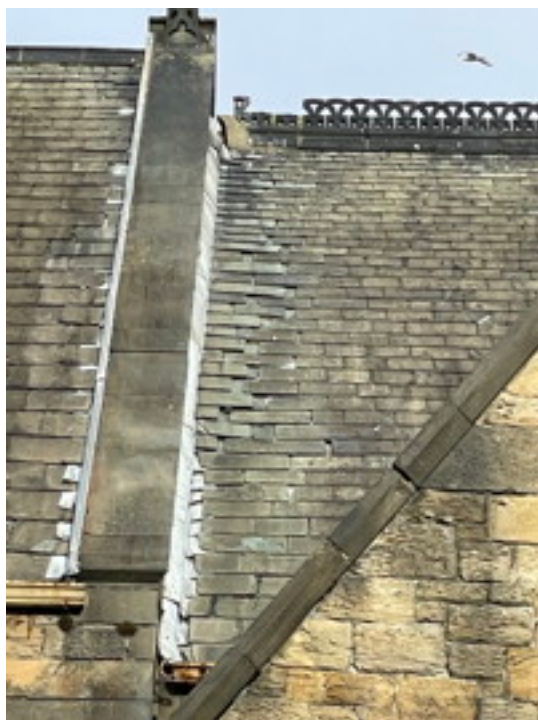
**Chancel Roof South Elevation**

The slating appears in generally in reasonable condition to the nave, organ chamber, north tile and vestry and vestry store roof with a few missing and slipped slates. The south elevation of the chancel has pulled away from the nave quite substantially. The priest in charge reported that the work carried out above ground in the 1990s as part of the underpinning of the east end was unsatisfactorily carried out and the movement seen here may either date from then or may be more recent.

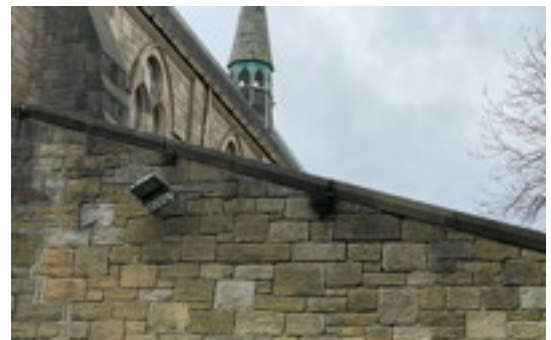
**Plant growth at Vestry East Elevation**

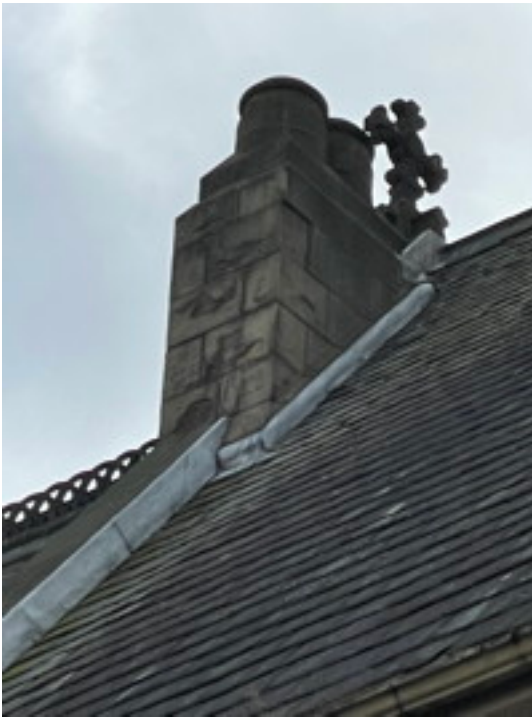
**Chimney Nave East End**

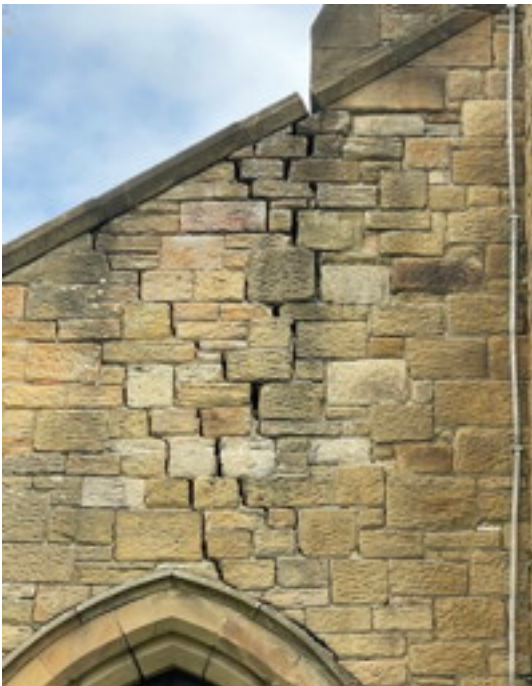
**Severe Displacement Over Door to West Elevation North Side**

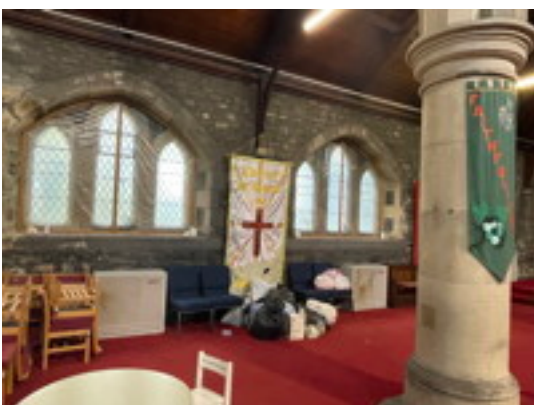
**Plastic Sheeting to North  
Elevation Glazing Internally**

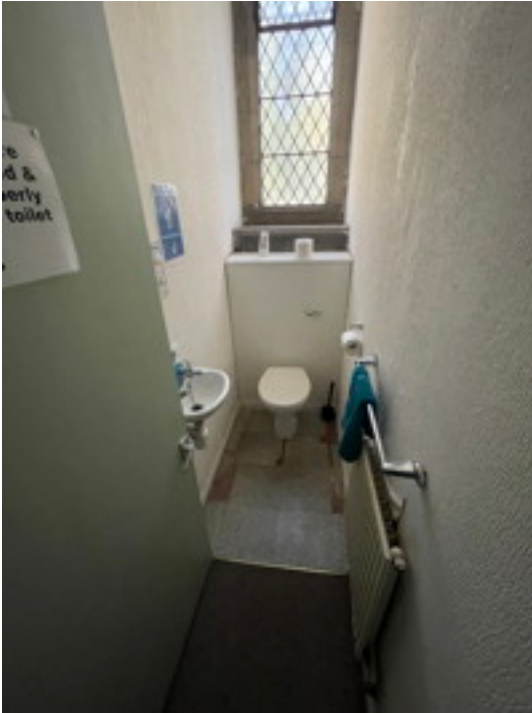
One accessible WC and one WC. Baby change unit to lobby Vinyl flooring throughout, some sheet and some tiles, not all matching. The walls are stonework to the north and a mixture of painted textured wallpaper and painted plasterboard to the south, west and east. The ceiling is artex finish on plasterboard. The fittings are basic. The lighting is inadequate.

WC Looking North

Access WC Looking North

WC Lobby Looking South East

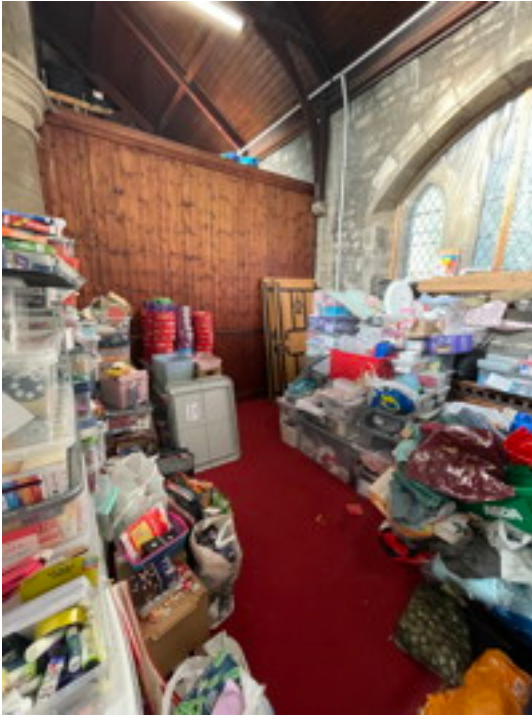
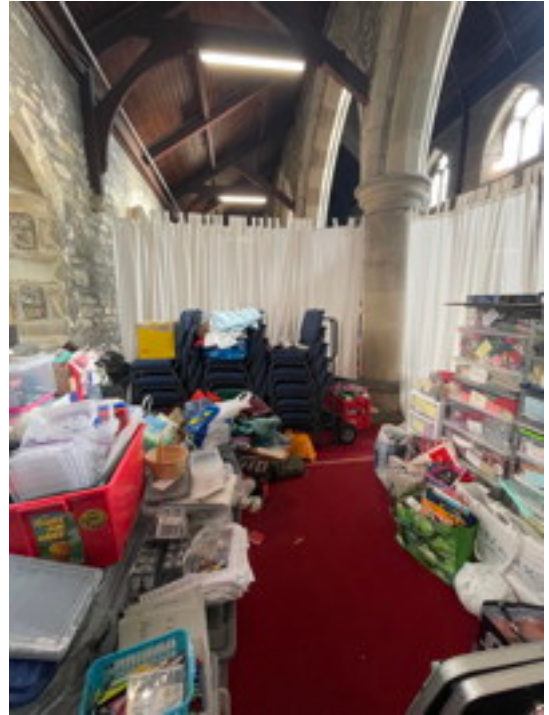
**Storage Area Looking West**

**Storage Area Looking East**

The curtained off storage area is all in fair condition.

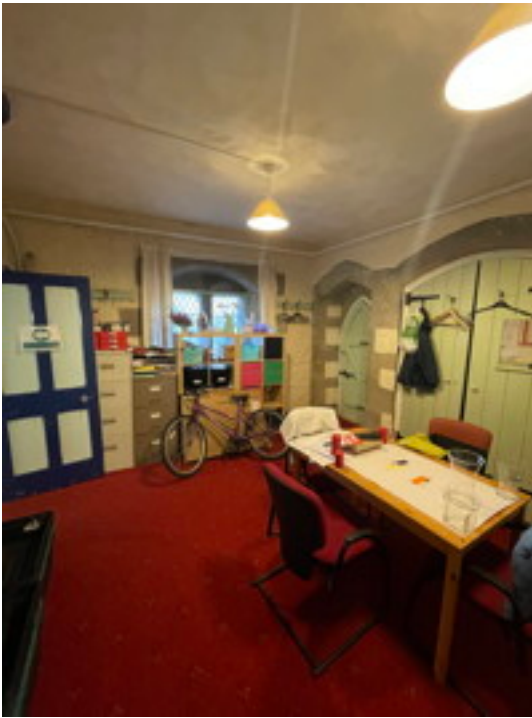
The vestry is all in fair condition.

**Vestry Looking East**

**Vestry Looking South West**

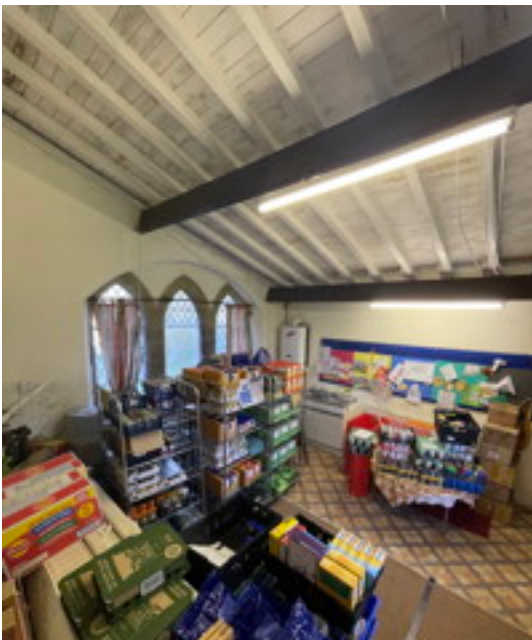
**Vestry Store Looking North West**

**Vestry Store Looking South West**

**Vestry Store East Door**

The vestry store is all generally in fair condition accept for the ceiling which shows signs of rot. The priest in charge reported that the joist ends had been replaced some years ago and the roof repaired following water penetration. Unless there is still water penetration due to the very low pitch, approx 14 degrees, causing wet rot, there is real possibility of dry rot which like a moisture content of around 20%

Arrange a timber survey with a reputable timber preservation company to establish whether the timbers are suffering from wet rot or dry rot. Cost Band 1– £0.00-£1,999.

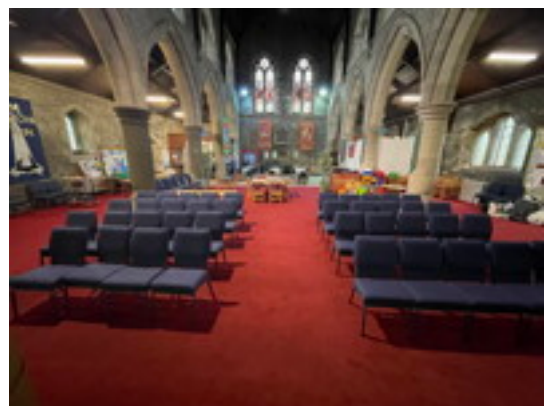
**Chancel and Sanctuary**

**Pulpit**

**Altar**

**Brass Lectern**

**East Nave Seating**

**Font**

**West Nave Tables and Chairs**

All are in good condition.

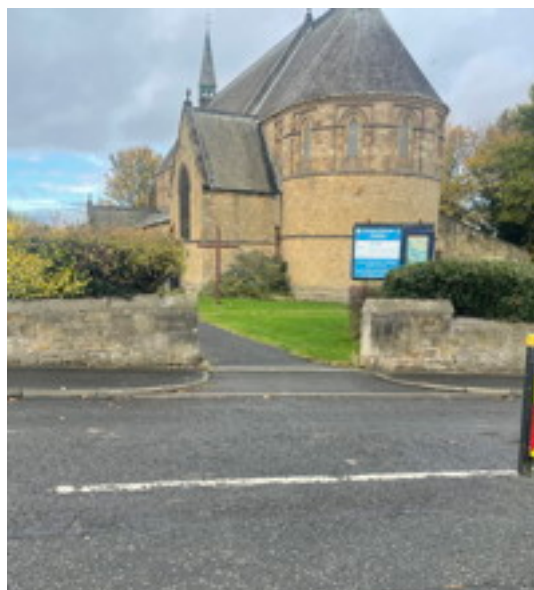
**East Boundary Wall**

**East Boundary Wall Entrance**

The walls are generally in satisfactory condition with some major exceptions. A very large section of wall has collapsed along the southern boundary following a tree falling. Neither the council or the insurers will accept responsibility. A considerable amount of the stone has been removed. To the eastern elevation, a section of wall has started to collapse due to tree growth within the wall. Similar tree growth has occurred at the south east corner.

Reinstate railings to lower sections of walls and gates to entrance to improve security and reduce vandalism prior to repair works to previously vandalised areas. Cost Band 4– £30,000 - £50,000.

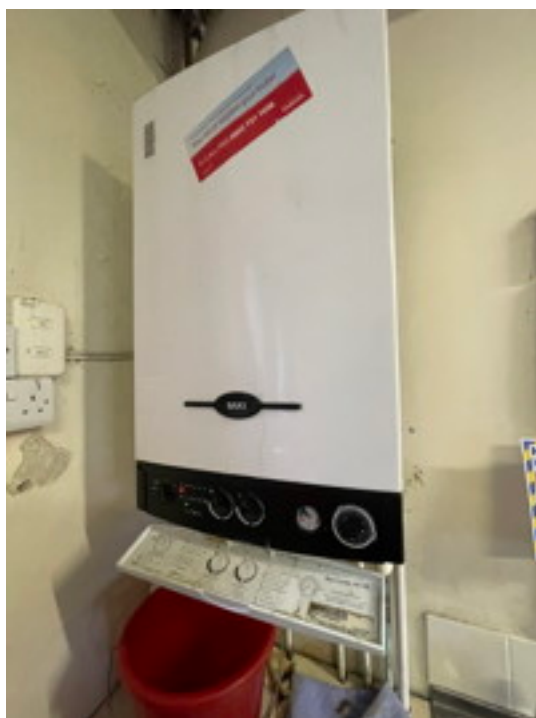
**Vestry Store Boiler**

**Typical Church Heater**
