**QUINQUENNIAL INSPECTION REPORT
OF
ST. EDMUND'S CHAPEL, HIGH STREET, GATESHEAD, NE8 1EP**

QUINQUENNIAL INSPECTION AND REPORT

DATE OCTOBER 2020

David Beaumont BA (Hons) Grad Dip, RIBA, AABC

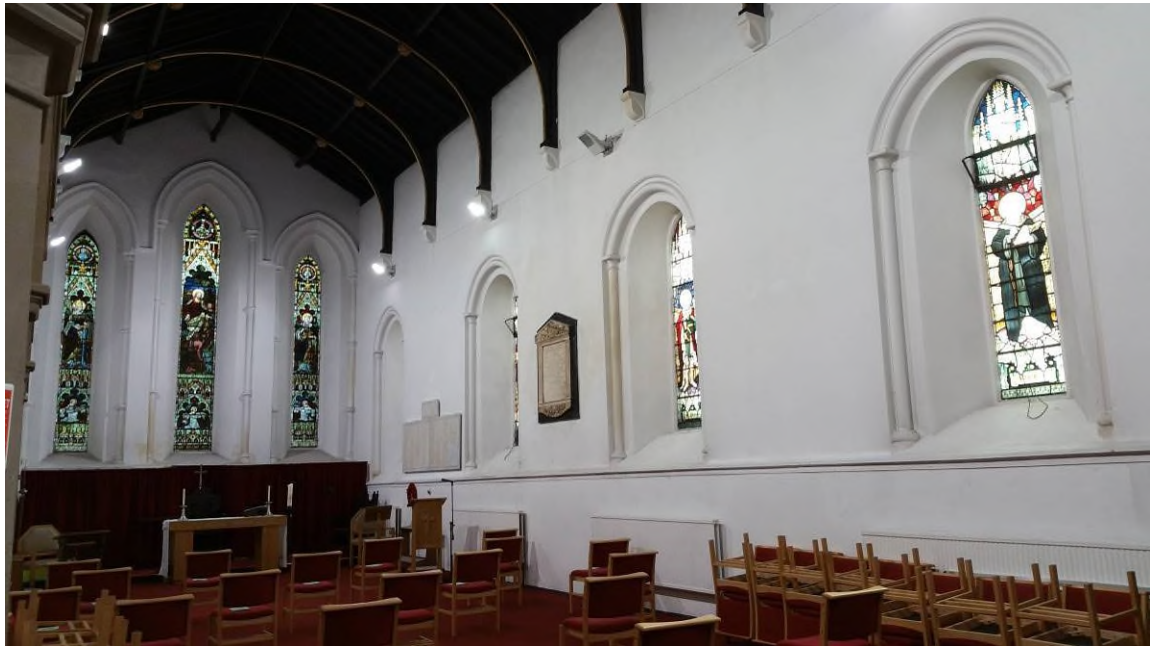
The church is very well presented internally, there is water marking and damp patches and it is planned for further redecoration. The walls below the box gutter outlets show signs of their blockage and overspill inside. There was an active leak at the east end box gutter during the inspection, which was attended to the next day by Ferguson.

The walls have been previously coated in contract matt emulsion and the church intend to do the same again.

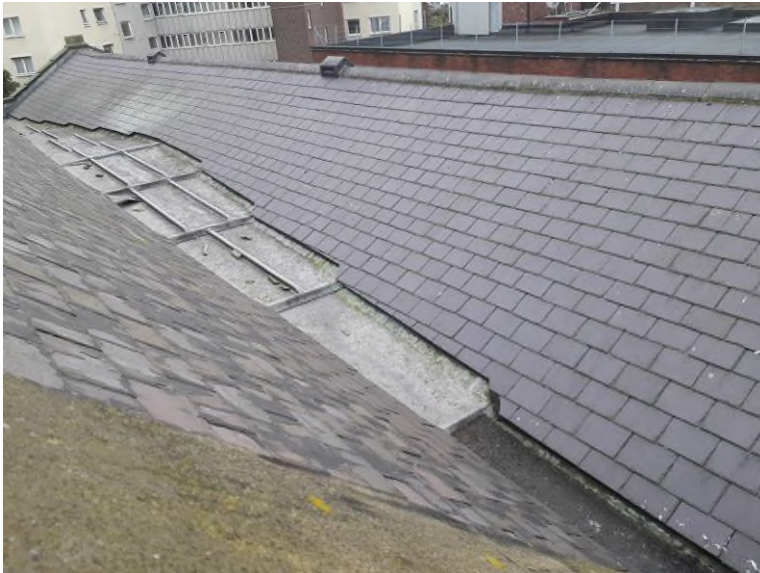
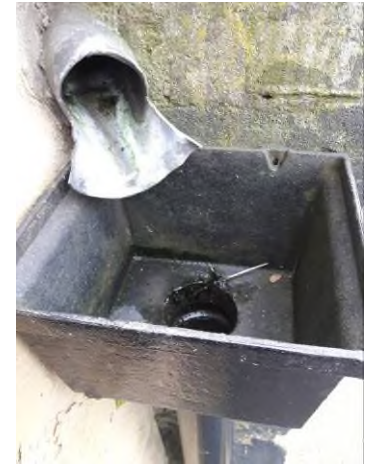
Note narrow pipe outlet from box gutter sump to box gutter

The box gutter has outlets at both ends.

It was a blocked east outlet. Again. Caused by detritus from Trinity's poor roof and the products and bodies of pigeons. The outlets had lead covers with holes which formed a dam and these have been removed to let the wind and rain assist their passage. There must have been 80 pigeons on Trinity roof at the QI.

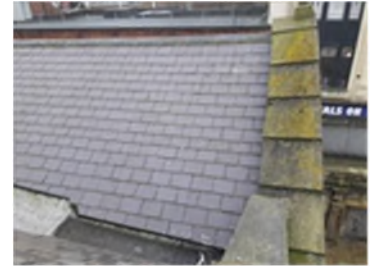
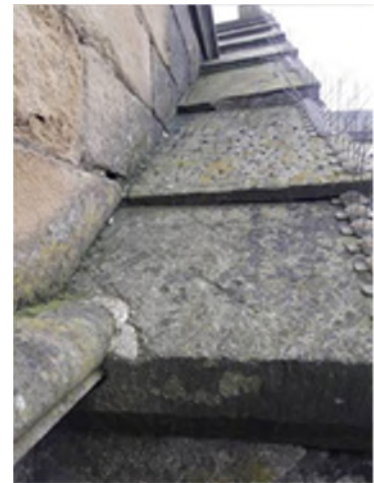
B West side –

There doesn't really seem to be much change from the 2013 QI.

The observations made by the 2015 report by Classical Masonry are still relevant.

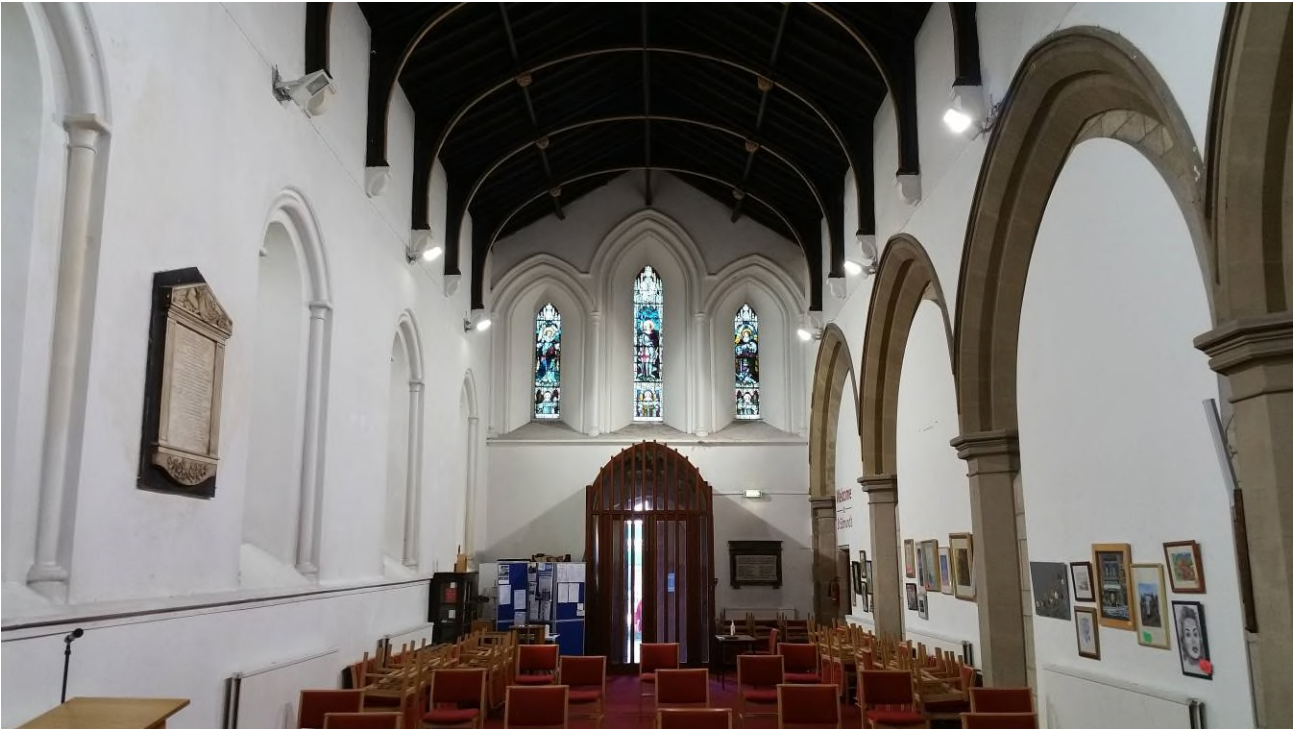
7.5.1 ROOF TIMBERS

- Curved roof trusses with extended struts down to stone corbels and these support purlins and flat rafters. There is a slight bit of pull-out of the purlins at the E end and might there be a touch of that also on the W? I can't imagine that this is active.

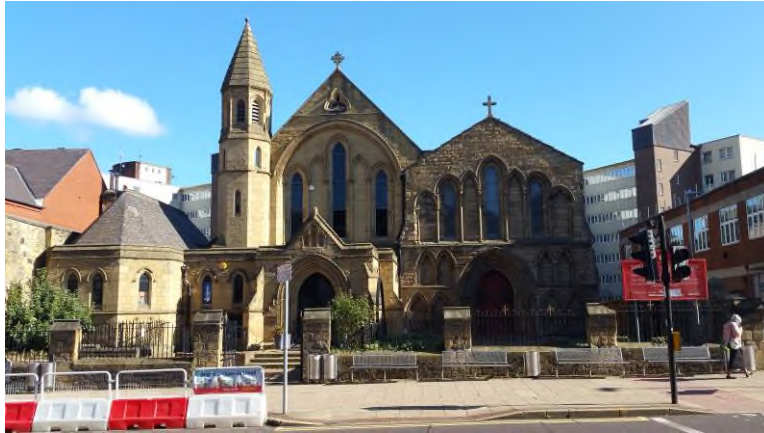
C Churchyard:

There is no churchyard and the church is surround by hard landscaping on all three sides. The N is the Trinity Centre.

It would be wise for the PCC to establish which areas and walls are within their ownership and thus responsibility.

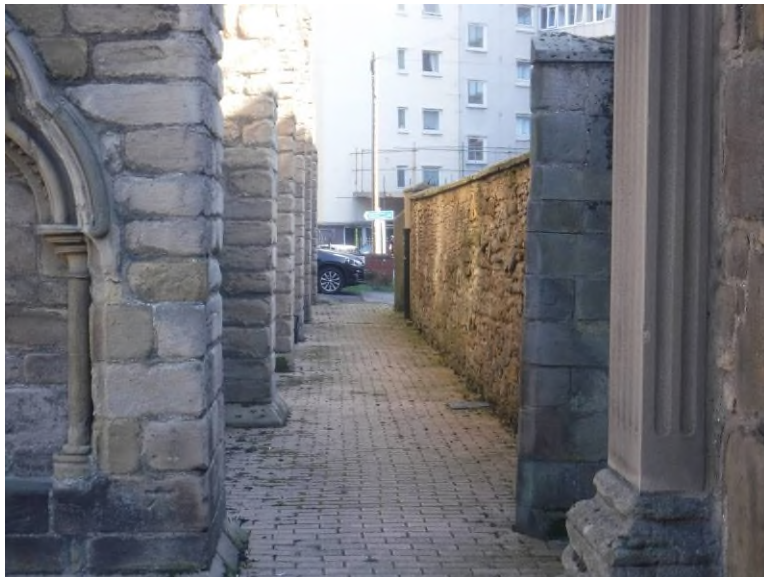
N side – The paving continues round, undulates and wanders and is looking scruffy. There is also a very poor bit of work where it

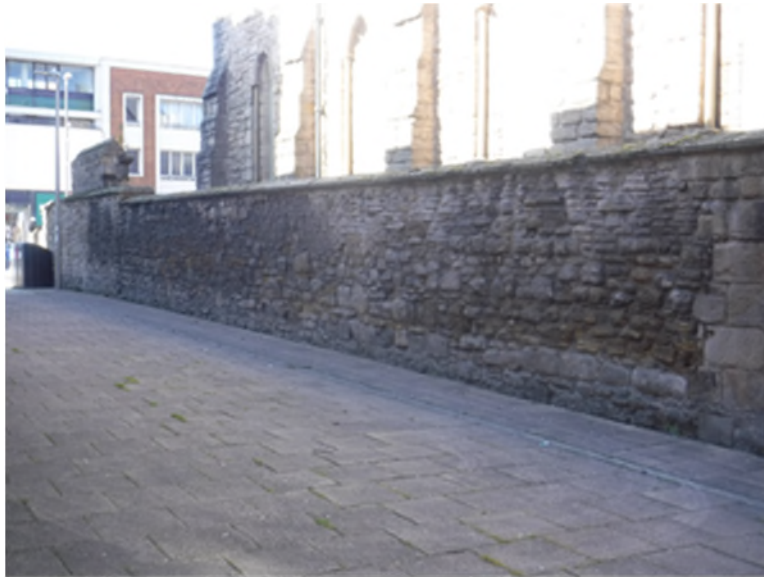
- **South**

is a random stone wall and ancient, has some big ashlar quoins and has a modern possibly saddle back coping in stone, it looks ok but a bit moss and pigeon muck covered, then there is a brick bit at the E end which is a bit incongruous and has been backed in cement render with graffiti.

There is an iron gate that separates these two areas which is probably part of the design of the original, it almost latches and if it does then how do you open it, it doesn't make sense, I think that it is a gate that is to be locked or unlocked rather than a passing gate and it has no hold back on it and it seems as if its function is now redundant.
