QUINQUENNIAL INSPECTION

Document Title:	Quinquennial Inspection
Address of Inspection:	St George's Church 1-9 Inskip Terrace Low Fell Gateshead NE8 4AJ
Date of Inspection:	20 th October 2021
Weather Conditions:	Dry and overcast
Date of Report:	8 th November 2021
Date of Previous Report	Unknown
SIGNED BY:

Mrs. Philippa Ramsay BA (Hons) MArch.
REF:	29430-NNA-2021-11-08-PR-Quinquennial_Inspection
PREPARED BY:	Philippa Ramsay Nicholson Nairn Architects, Bishops Court, Rectory Lane, Whickham, Newcastle, NE16 4PA

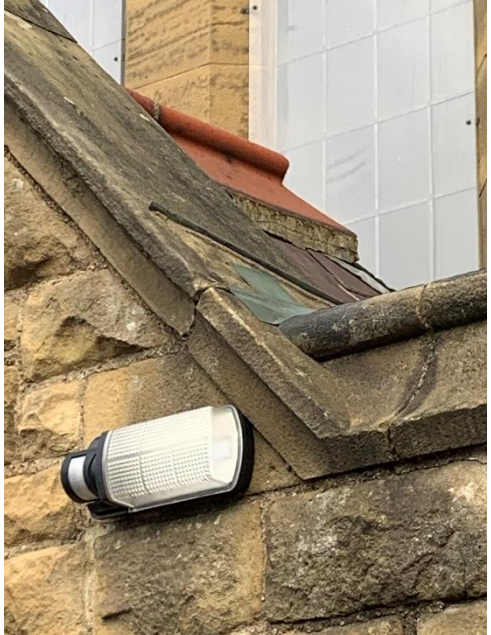
<p>3.4 - Water table, North elevation</p>	<p>Evidence of missing mortar at junction to water table and history of leaking</p>

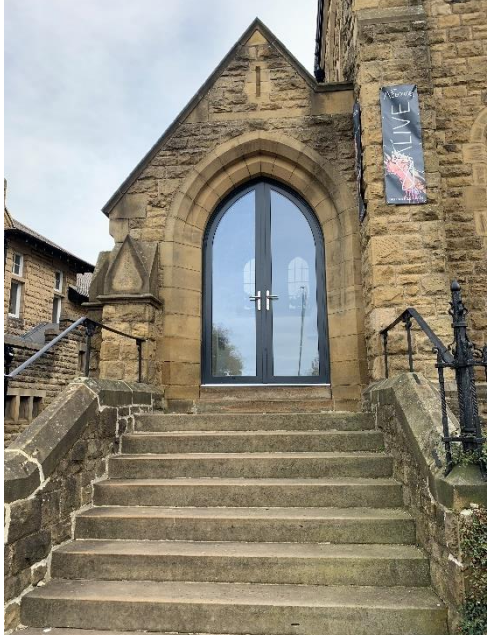
<p>5.2 – Door to historic entrance, West elevation</p>	<p>Door has been fixed shut and appears to be in a serviceable condition</p>	<p>General maintenance including decoration.</p>	<p>M</p>
<p>5.3 – Door to side entrance, South elevation</p>	<p>Door appears to be in a serviceable condition</p>

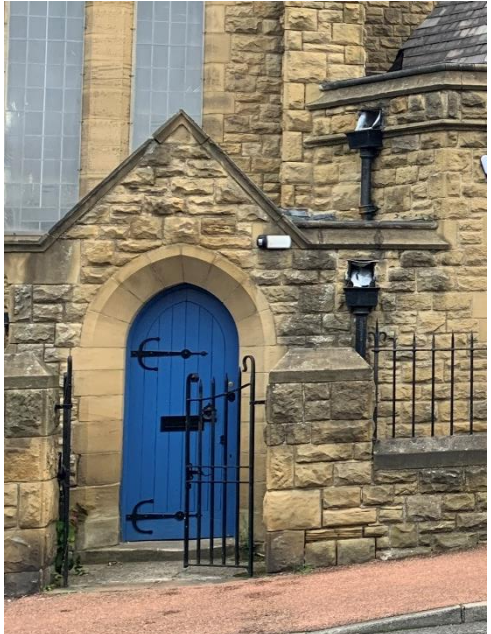
<p>General maintenance including decoration</p>	<p>M</p>
<p>5.4 – Windows Generally, All elevations</p>	<p>Many windows have a film/Perspex sheet external protection</p>	<p>Film and Perspex to be removed and replaced with a more heritage appropriate solution.</p>	<p>E</p>

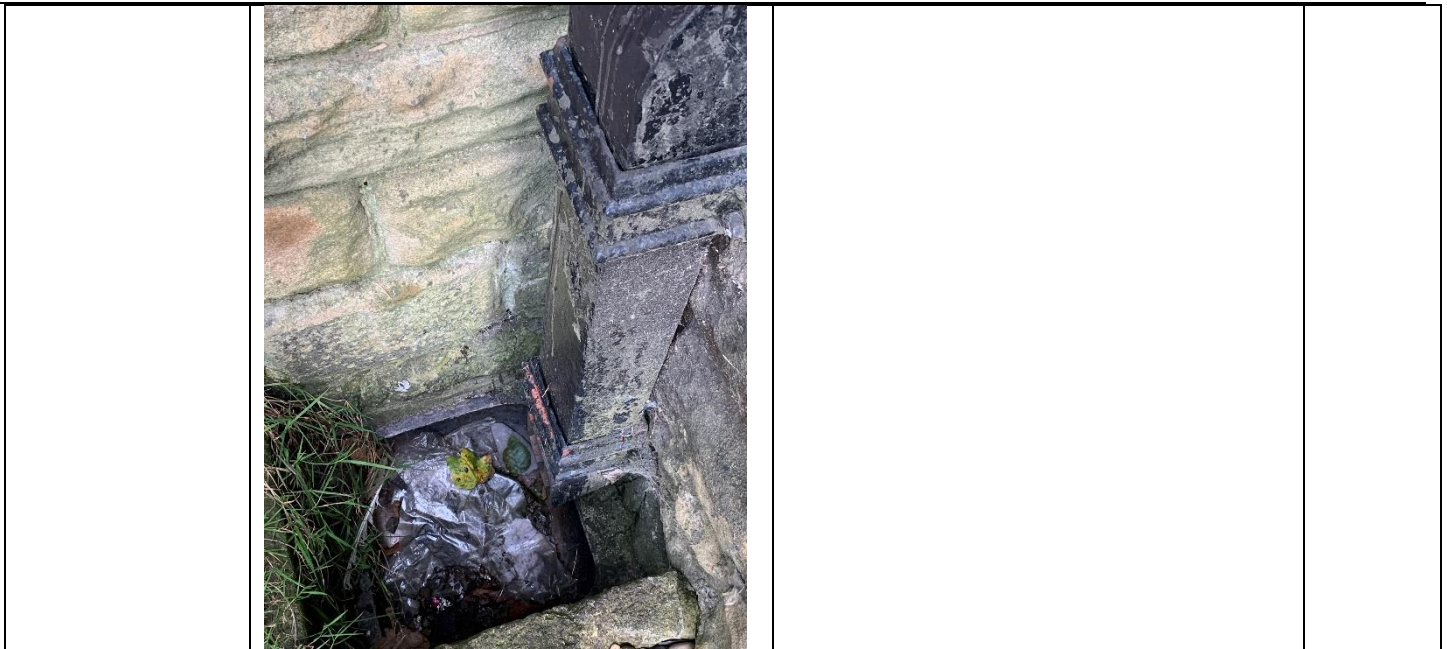
Item 6 Below Ground Drainage			
Location	Condition	Repairs Needed	Category
6.1 - General	Below ground drainage could not be accessed		
6.2 - Gulleys	Visible signs of debris	Debris to be removed and cleared	M

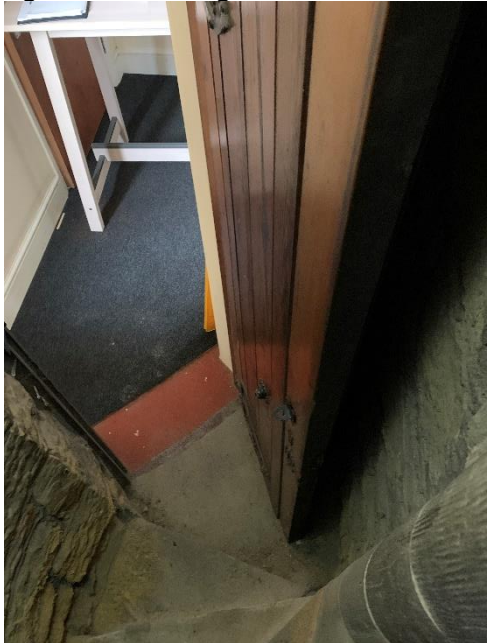
Item 7	Tower/Spire		
Location	Condition	Repairs Needed	Category
7.1 - Base of tower, South-west corner	Dry Stone steps appear serviceable. No visible signs of rainwater goods.

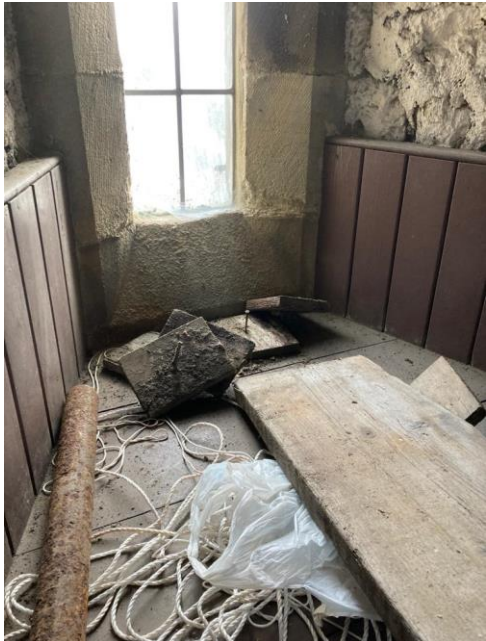
7.2 - Upper levels of Tower, South-west corner	Inaccessible due to H&S concerns

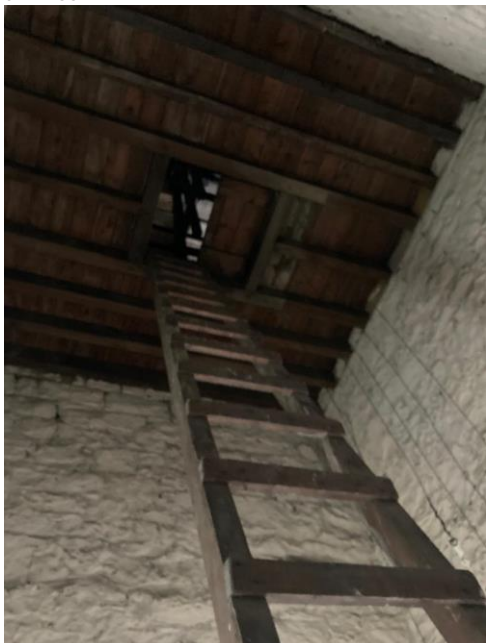
Item 8	Clocks, bells and frames		
Location	Condition	Repairs Needed	Category
8.1 - Bell Tower	Inaccessible due to H&S concerns over access

Advisable that when main roof is inspected an internal inspection of the interior particular the south side is undertaken	D

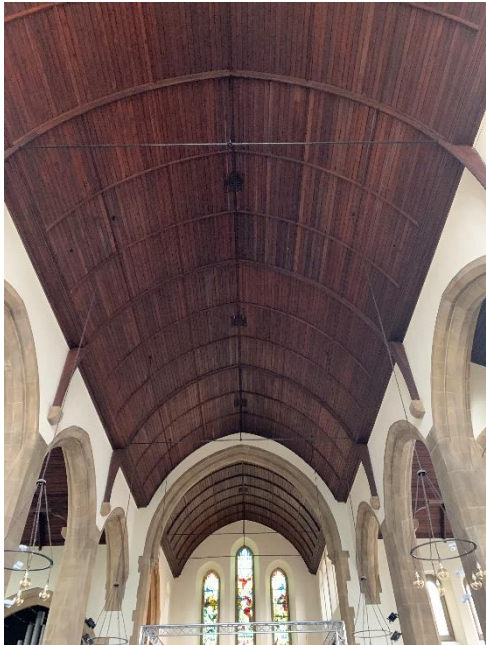
Item 11		Roof structures, ceilings	
Location	Condition	Repairs Needed	Category
11.1 - General	<p>Overall roof structures appear to be in a serviceable condition</p>

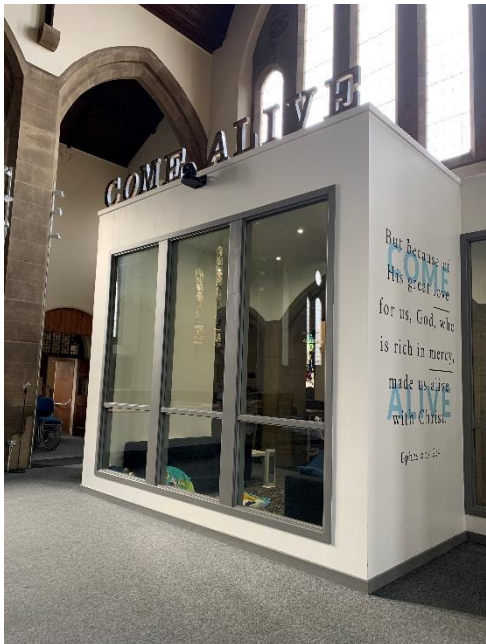
Item 12	Partitions, screens, paneling, doors, internal walls/ceiling finishes		
Location	Condition	Repairs Needed	Category
<p>12.1 - General</p>	<p>All internal partitions have been installed since the last Quinquennial and appear to be in a serviceable condition</p>

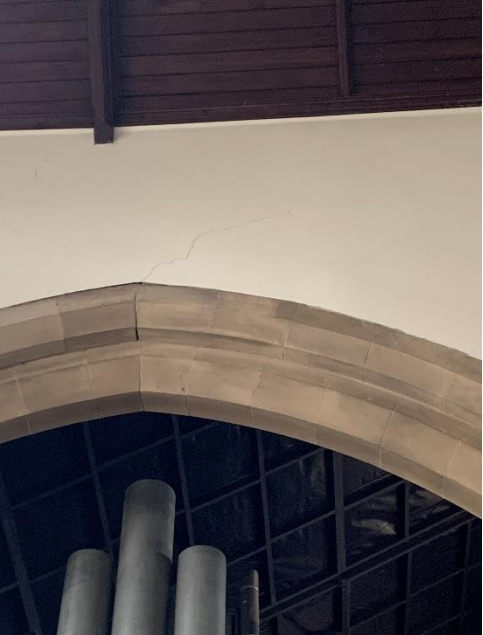
<p>Pointing of stonework to be checked and any areas of defective pointing to be replaced with appropriate mix mortar. Once resolved decoration to be completed internally.</p>	<p>A</p>
<p>12.3 – Arch above Organ, North-east side</p>	<p>Arch above organ has some cracking</p>

<p>Crack to be monitored and any significant worsening to be review by a structural engineer</p>	<p>M</p>
<p>12.4 – Boiler room, East side of church</p>	<p>Significant damp and cracking</p>	<p>Condition of damp to be monitored once external rainwater goods have been repaired (see Item 2.3). Once dry condition of plaster to be assessed and replaced if appropriate and make good decoration.</p>	<p>A</p>

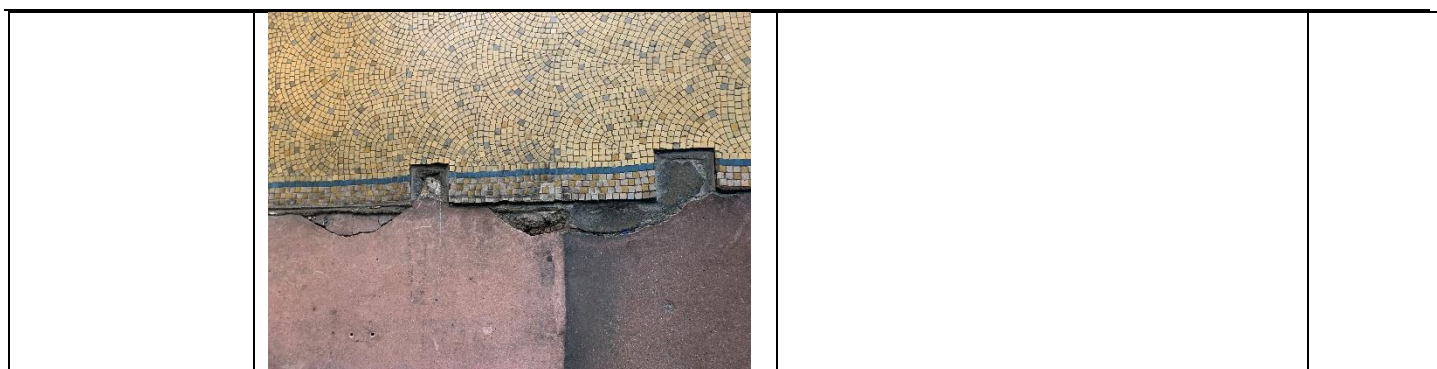
Item 13	Floors, platforms		
Location	Condition	Repairs Needed	Category
13.1 - General	Floors covered with carpet and therefore cannot be inspected	N/A	
13.2 - Moasic Floor, Altar	Junction of screed with tiled mosaic floor is cracking	Cracks appear to be historic, consideration given to an conservation appropriate clear self-leveling screed to be overlaid to mitigate any trip hazards. Cracking to be monitored.	E

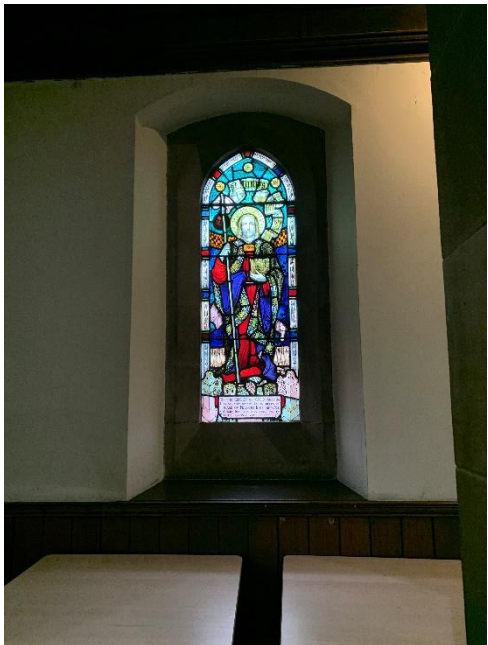
Item 14			
Monuments, tombs etc			
Location	Condition	Repairs Needed	Category
14.1 – Stained glass	Stained glass appears to be in a serviceable condition

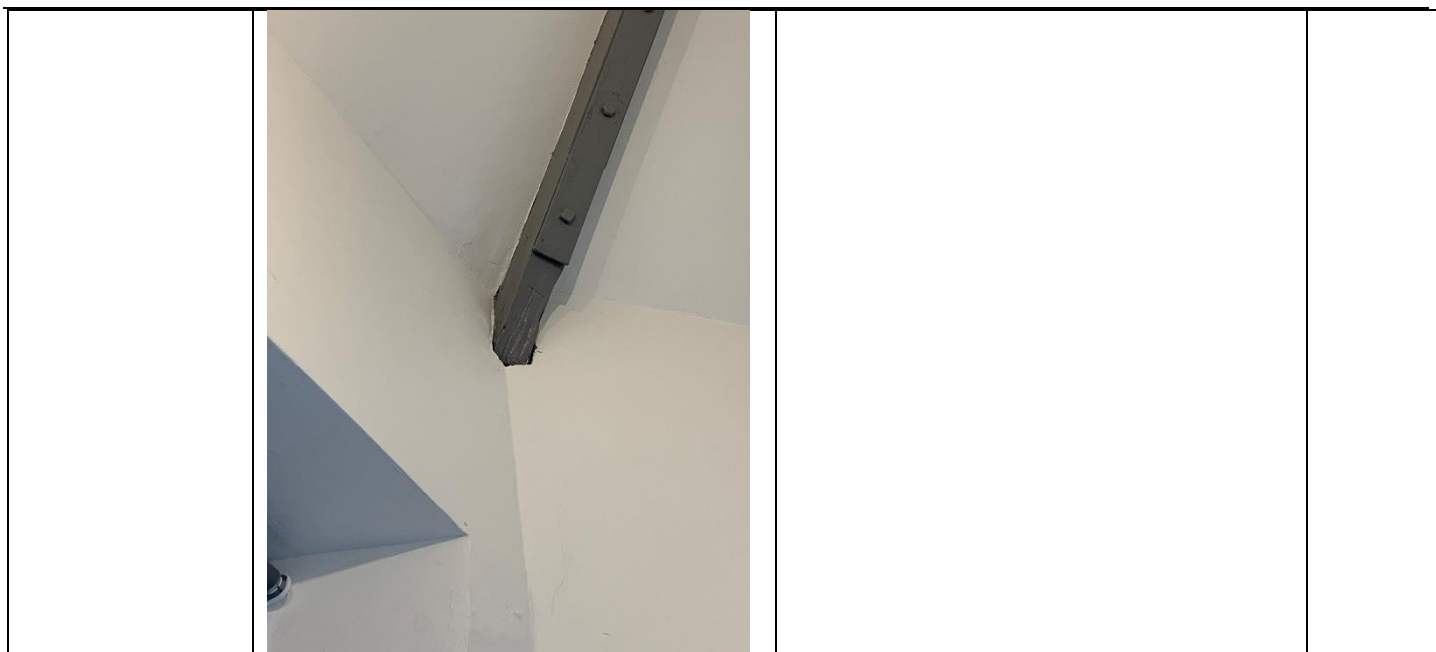
Item 15			
Toilets, kitchens, vestries			
Location	Condition	Repairs Needed	Category
15.1 – Kitchen, South elevation	Overflow from kitchen causing external issues refer to Item 4.3	Ref to Item 4.3	Refer to Item 4.3
15.2 – Main toilets, South-east corner	Roof timbers appear to have a coat of paint over what appears to be decayed timber.	Roof timbers to be inspected by specialist timber contractor.	M

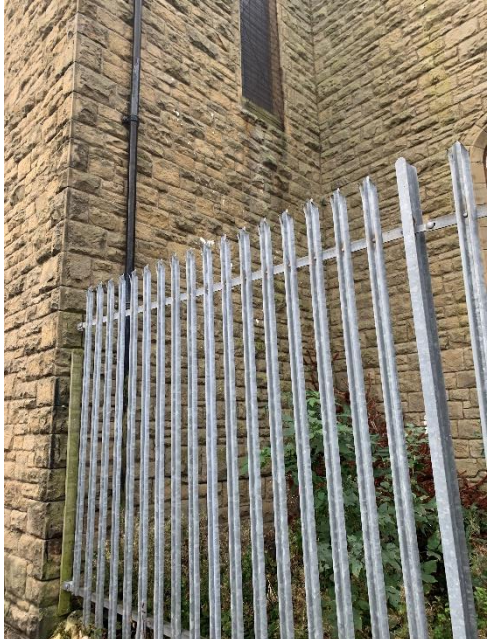
18.2 - Fencing	<p>Fencing appears to be new and in a serviceable condition. Secondary metal fence is in a serviceable condition.</p>

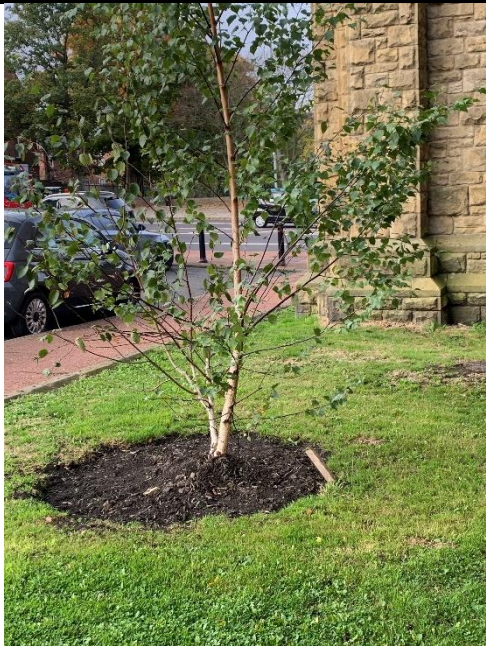
Item 21	Trees		
Location	Condition	Repairs Needed	Category
21.1 - South elevation	Tree appears to be in a good condition and have been newly planted	N/A	M
