**QUINQUENNIAL INSPECTION REPORT  
OF  
HARTLEPOOL, ST. LUKE**

**DIOCESE OF DURHAM  
ARCHDEACONRY OF DURHAM  
DEANERY OF HARTLEPOOL**

**2017 QUINQUENNIAL INSPECTION AND REPORT  
November 2017**

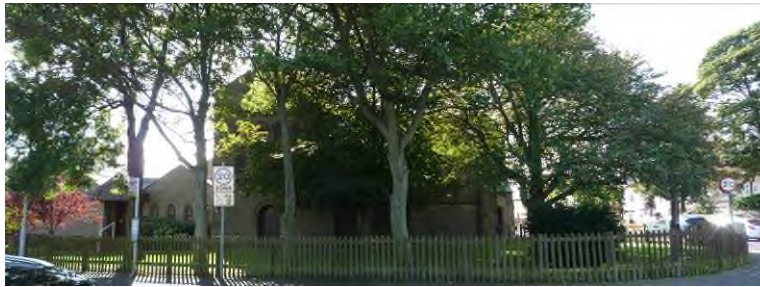
- B** **Trees:** The engineer's report identifies three trees at the west that are influencing ground movement of the north part of the building. They recommend that the beech is be removed and the sycamore and ash to be pruned significantly to reduce their influence.

I would go further and say that the whole elevation is obscured by trees and would benefit from a significant pruning back all round. Recent lead theft may have been assisted by poor visibility of intruders hidden by the tree canopy.

**Recommendation:** PCC to contact the Local Authority and advise them of the engineer and architect recommendations.

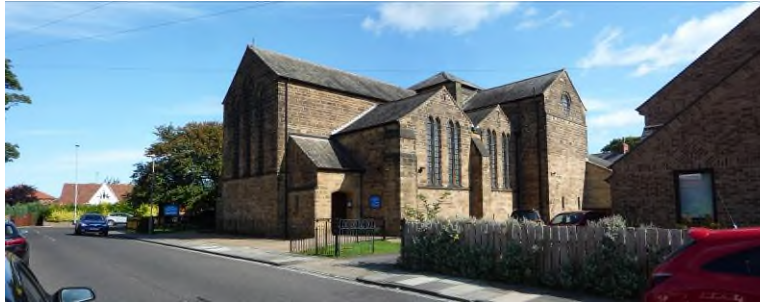
### SOUTH SIDE

- Ridge – Open joints to the bedding and junctions.
- West abutment – Pointed verge, some slight cracking and mortar missing.
- East abutment – Lead flashing against the tower looks fine.

- Ridge – Same condition as south.
- West abutment – Lead flashing, view partially obscured.
- East abutment – Pointed verge same as south.
- General – West Moreland slating, seems to be in fair condition.

**Recommendation:** repoint ridge bedding but save up for when other works are required

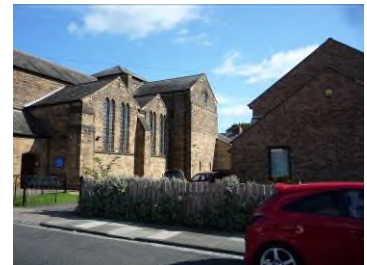
This consists of two roofs, the eastern facing sides are hard to be seen from the ground.

- Ridges – Western most ok. The eastern most has some pointing missing.
- Abutment to Nave – Still in lead work and that is sound.
- South abutment – Is a pointed verge and this is ok for both roofs.

East Face:

- West abutment – Is a verge and ok.

**Recommendation:** repoint ridge bedding but save up for when other works are required

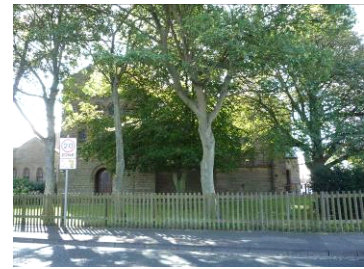
### 7.4.3 RAINWATER GOODS

**B** Half round cast iron downpipes generally to the building and these are supported by gutter brackets onto timber fascias (mostly) or exposed rafter feet (tower). The timber fascia and exposed rafter feet require decoration.

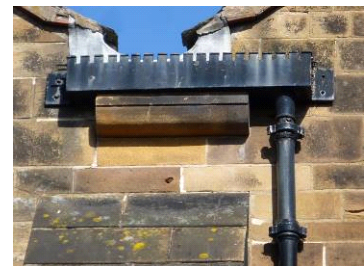
**South Porch** – The downpipe is rusting and loose and the back of the gutter is rusting heavily.

**South Side** – The middle of the aisle downpipe is missing its bottom collar.

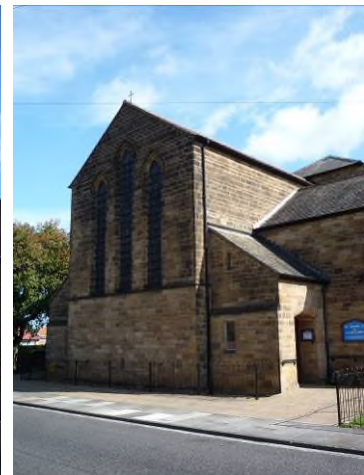
This has three sides to it.

North – Some parts are obscured by the aisle. The walling above the north entrance looks ok.

South – Partially obscured by the aisles. Some cement pointing. Slight open joint at the quoin.

**Recommendation:** monitor

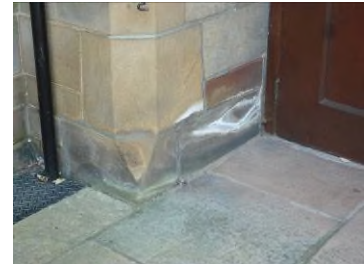
**SOUTH ELEVATION**

- West Side – Slight open joints to the sloping moulding on the first stage.
- South Side – OK, door locked at time of inspection but the bottom bolt keep has split the door slightly and there is some slight damp showing at the bottom of the door reveals and the stonework, and there is a ramp here.

**Recommendation:** none

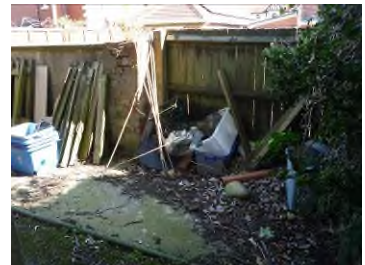
#### E East Side:

This is a gated area with a combination of grass and old tarmac which has become a dumping ground for lumber towards the south end.

The boundary wall is a rendered cement wall, the render is coming away in places, it is topped with barbwire and some parts of it has ivy and overgrowing shrubs on it. This could well be church ownership wall as the buttresses are on the church boundary side.

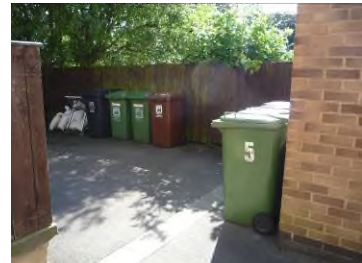
**South side:**

Laid to tarmac mostly and this is all in fair condition. There is a timber boundary fence to the adjoining vicarage that is greening up now.

**Recommendation:** redecorate fence

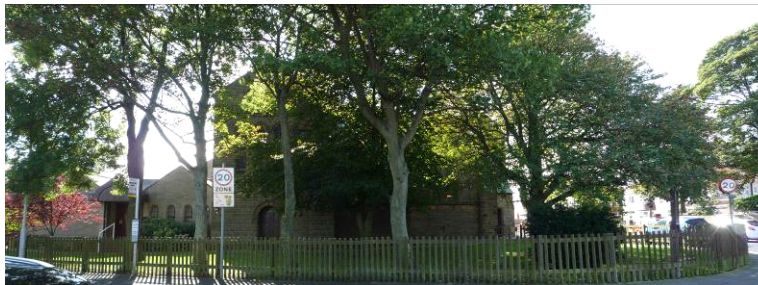
The church is at the junction of Tunstall Avenue and Hart Road and this is a very busy location. The view of the church is significantly obscured by the Beech tree and others. They have hanging lights within them. The trees should be significantly pruned so that you can see the church. Sign board is ok though the joinery is greening up a bit at the base.

**Recommendation:** attend to tree matters

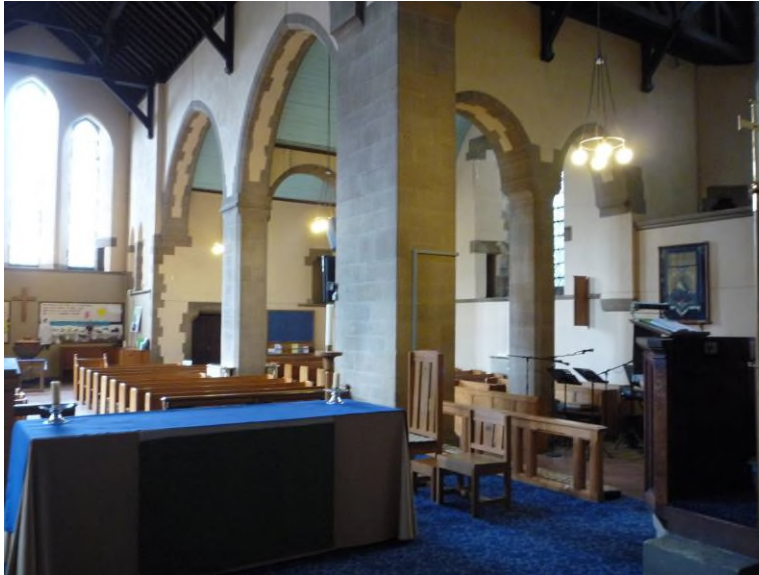
**D****South Aisle:**

This is made up of two bays with a box gutter between them.

- Ceiling – Barrel vault painted boarding, gaps are showing but as a consequence of age.
- Walls –
  - West, painted plaster with stonework dressings exposed are ok.
  - North, these are the arcade arches leading into the nave as previously commented on, except the eastward there is a more evidence sign of a 2mm crack in board of the arch in the aisle.
  - East, hairline cracking close to the apex of the arch. The wall has been stained as a consequence of water penetration from lead theft.
  - South, this features twin lancet arch windows, not able to see because of the glare from the sun but the glass looks slightly dirty at the saddle bars. The walls themselves appear fine.

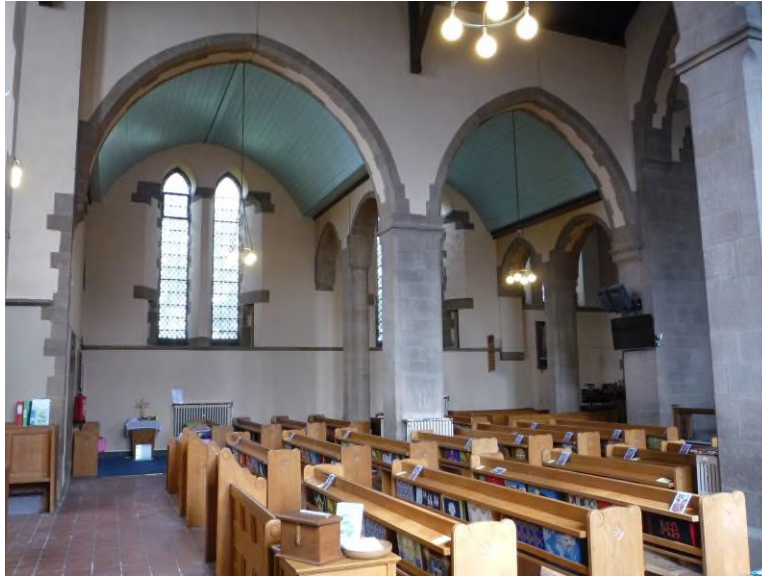
### North Aisle:

This is a mirror of the south.

- Ceiling – Barrel vault painted boarding, gaps are showing but as a consequence of age.
- Walls –
  - West, same as South Aisle.
  - North, same as South Aisle apart from slight cracking at the lower wall at the reveals this is hairline cracking perhaps it's the plaster or potentially a slight touch of heave. There's a greater amount of damp penetration in the window reveal to the eastern most lancet reveal.
  - East, minor cracking to the arch closest to the nave but nothing problematic, water staining to the arch and the pier.
  - South, this is the arcade that leads to the nave, both arches have approximately 1-2mm joints at the apex.

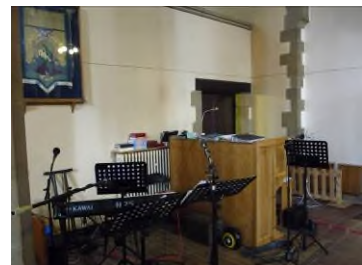
- Ceiling – Curved boarded ceiling, painted with open joints as the aisle, with two horizontal trusses with posts supporting the ridge and these trusses also support the gallery stair access.
- Walls –
  - South – This arch leads onto the tower crossing, this has been commented on earlier.

- East – Slight hairline cracking on the inboard truss approximately 2mm wriggling down to the blind arch leading onto the Parish Centre where there is a 1mm crack in the stone.
- North – Large arrangement of two tier windows, these have rusted in ventilators but they are in accessible as there is a room built below them, some cobwebs on the wall.
- West – Arcade leading onto the north aisle.

**Recommendation:** none

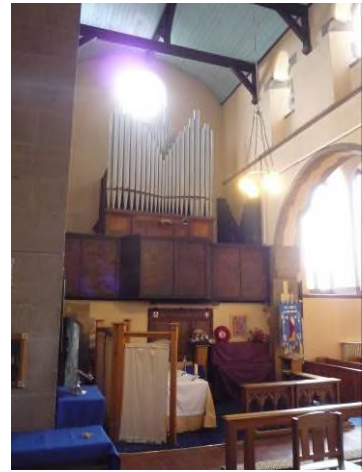
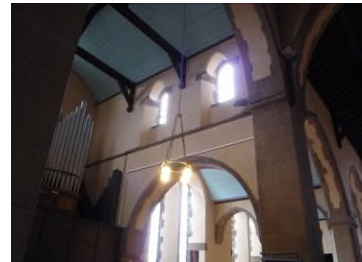
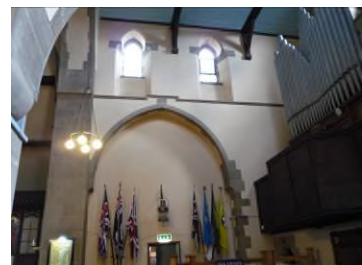
- East – The southern window has cracking identical to its opposite but this cracking runs down the bottom of the window masonry and onto the arch of approximately 3-4mm and a bit looks to have broken away more recently possibly since the last QI and that also runs around the edge of the arch at the wall infill.

- North – This is the arch into the tower crossing as previously reported.
  - West – Approximately 3mm crack to the apex of the south southern window and this has significantly buckled glazing to the bottom part of the ventilator. The window to its right has a lot of efflorescence on the reveals and this has been reported at the last QI. Below that the arch has had some fracture to it but has been pointed in.

**Recommendation:** brush off efflorescence, repair window glass

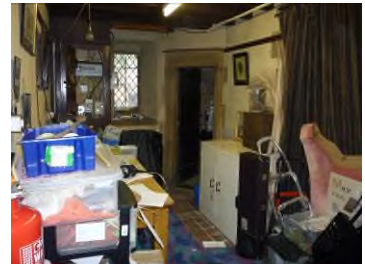
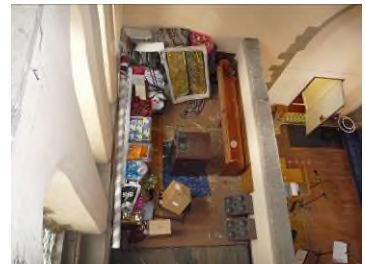
- Ceiling – Boarded with large section joists ok.
- Walls – Decorated plaster.
- Floor – Combination of small format terracotta tiles and stone flags with some slight salting showing to the terracotta.
- General – Room is rather full of lumbar. Cobwebby needs sweeping out. A lot of stuff stored on its flat roof

**Recommendation:** remove lumber and sweep up

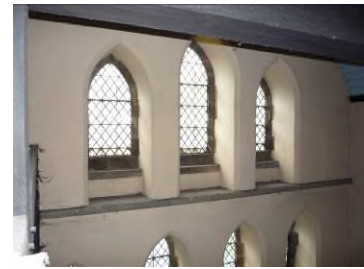
This leads up onto the top of the warden's vestry and this area is used for rough storage, you also get a closed view of the windows and it can be seen that they are quite heavily cobwebbed and a bit dirty, there is a little damp coming through the window reveals.

Condition is ok however there is some slight cracking to the walling by the window heads but this is historic, it is all rather cobwebby it could do with a sweep down.

**Recommendation:** sweep down glass

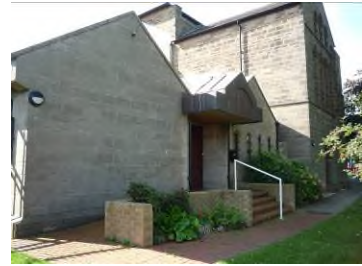
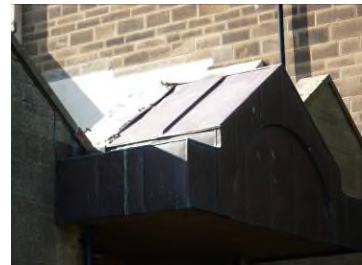
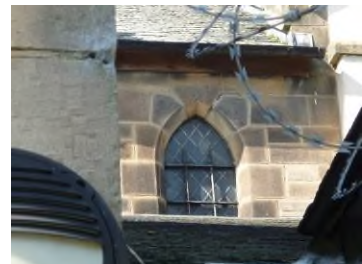
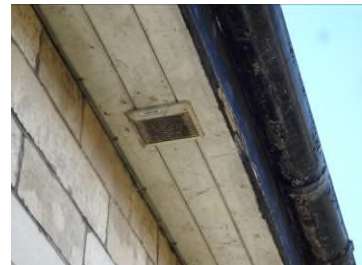
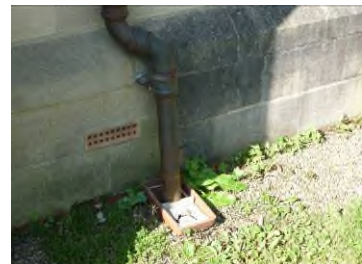
Are all cast iron gutters with cast iron downpipes and they all require decoration. They discharge into gulleys. The timber fascia boards are in poor condition now.

**Recommendation:** redecorate rainwater goods and timber fascia and soffits

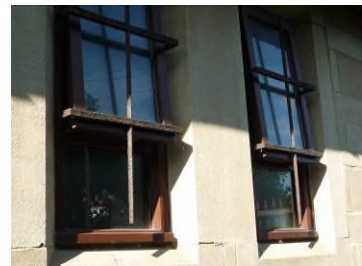
Stonework is the same as the Parish Centre and appears to be in fair condition.

The timber joinery of the gable windows in the Parish Room is beginning to break down now. The W.C. block ferramenta is rusting badly now.

The north side is in fair condition. Though the windows are losing their decoration now and the ferramenta is rusting badly.

**Recommendation:** remove rust and decorate the ferramenta, repair joinery, redecorate windows

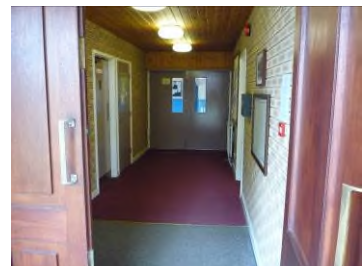
- Ceiling – Stained boarding ok.
- Walls – Exposed recessed joint brickwork ok.
- Floor – Part suspended, part solid. Carpet rucking up slightly.

**Recommendation:** fix down carpet

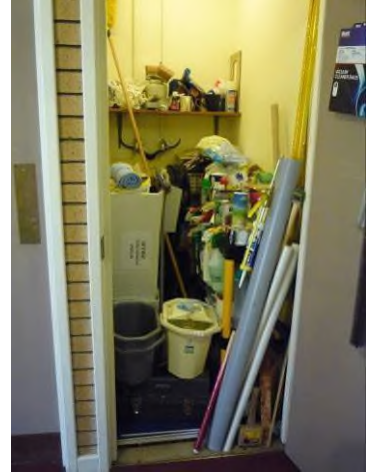
The lever handle is loose on the frame.

**Recommendation:** repair door handle

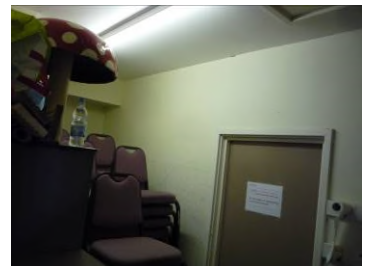
Doors a bit scratched when moving chairs in and out.

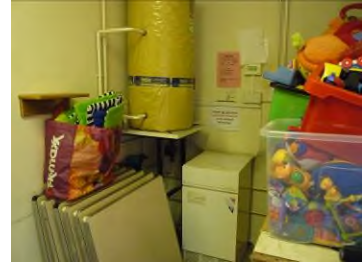
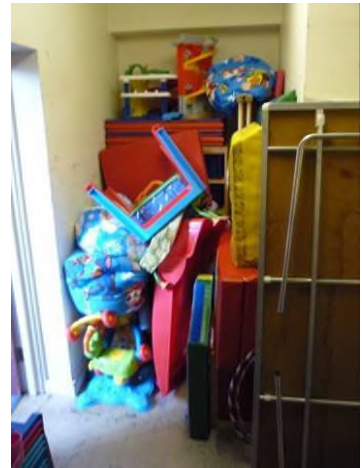
Slight hairline cracking around the doorway into the parish room. Contains the Ideal Mexico 2 boiler and cylinder. A lot of storage for children's activities here, play mats etc. rooms fairly full.

The flooring has been marked.

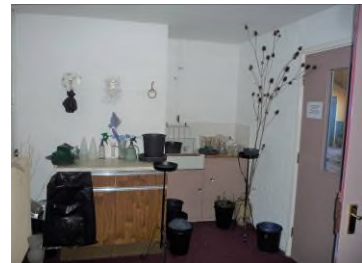
- Ceiling – Plastered painted.
- Walls – Painted brickwork, these are all in fair condition.
- Floor – Carpeted slight uneven. There is a step down into the south Aisle. This is the disabled access route into the Parish Centre from within the church.

Door ok. Door to parish room catches

**Recommendation:** ease door

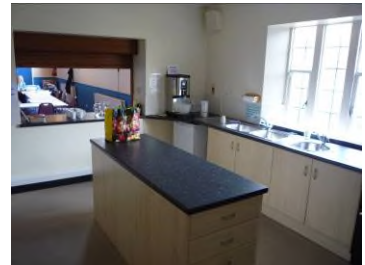
The rooms contains kitchen fitments installed 20 years ago and they are in very good condition, there is small hot water boiler. Roller hatch to the parish room is a bit stiff to operate, it also has serving hatches to the choir vestry and these catch slightly and have to be fiddled with to close

**Recommendation:** ease roller shutter and hatch doors
