Church of St Thomas, Heatherycleugh

QUINQUENNIAL INSPECTION REPORT 2017

Crosby Granger Architects Ltd

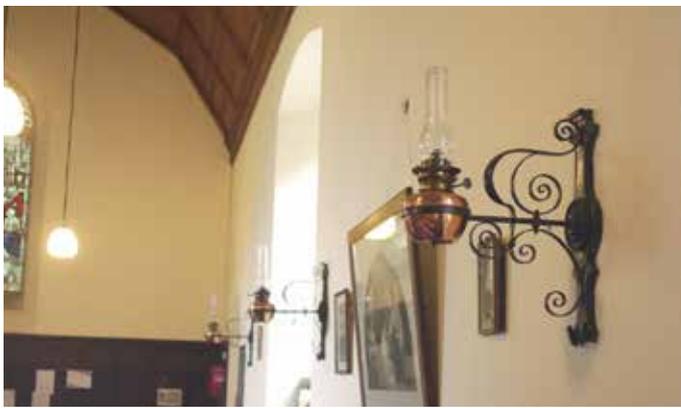
Copper lanterns in nave

The wall mounted light fitting are marvellous; are contemporary with the build, and are still in wonderful condition. They would have burnt oil, and are in two designs, made from brass and copper, with wrought iron holder and bracket. These should be treasured.

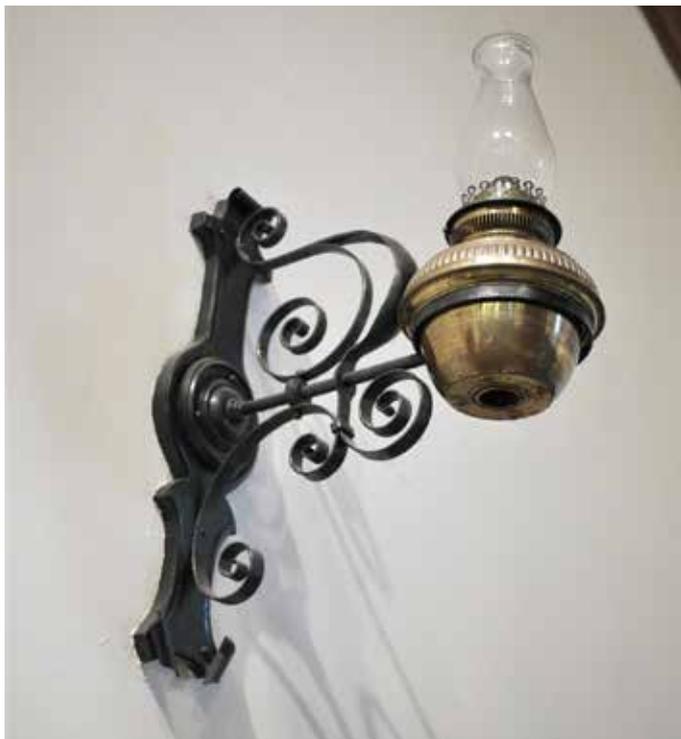
More decorative brass lanterns in chancel

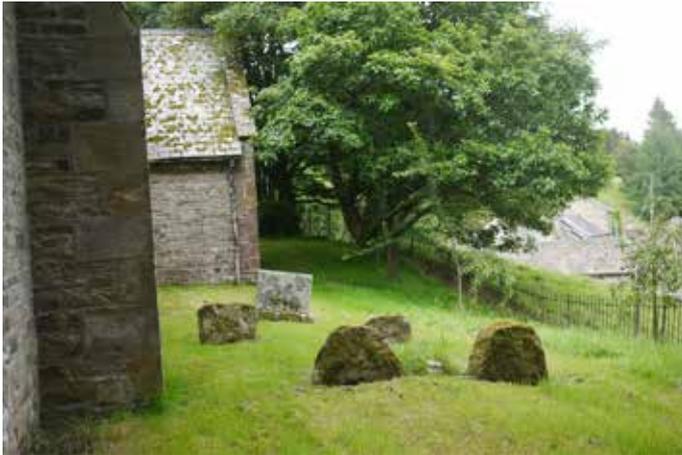
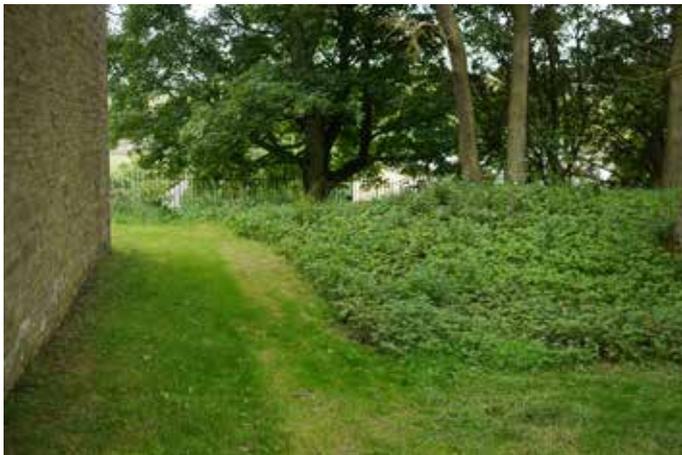
Churchyard generally well kept

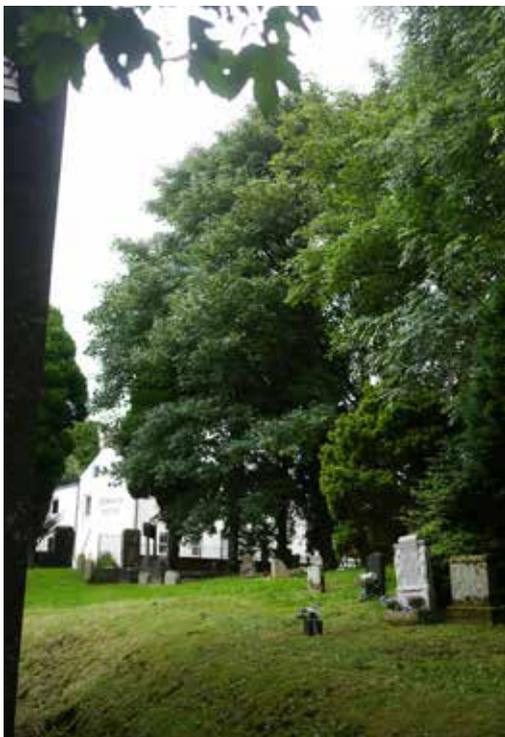
There are a large number of mature trees within the relatively small churchyard. The trees are an asset to the churchyard and help to create a safely guarded nestled structure. It is believed that the trees along the road side boundary could potentially be removed. This is a real shame as they add some privacy to the churchyard and create a softer boundary, but it is understood that there are safety concerns. A tree surgeon should offer proper advice. If the trees could be cut back and then inspected on a yearly basis by a tree surgeon that would be preferable to cutting them down altogether.

Trees to the road create a buffer and enhance the site

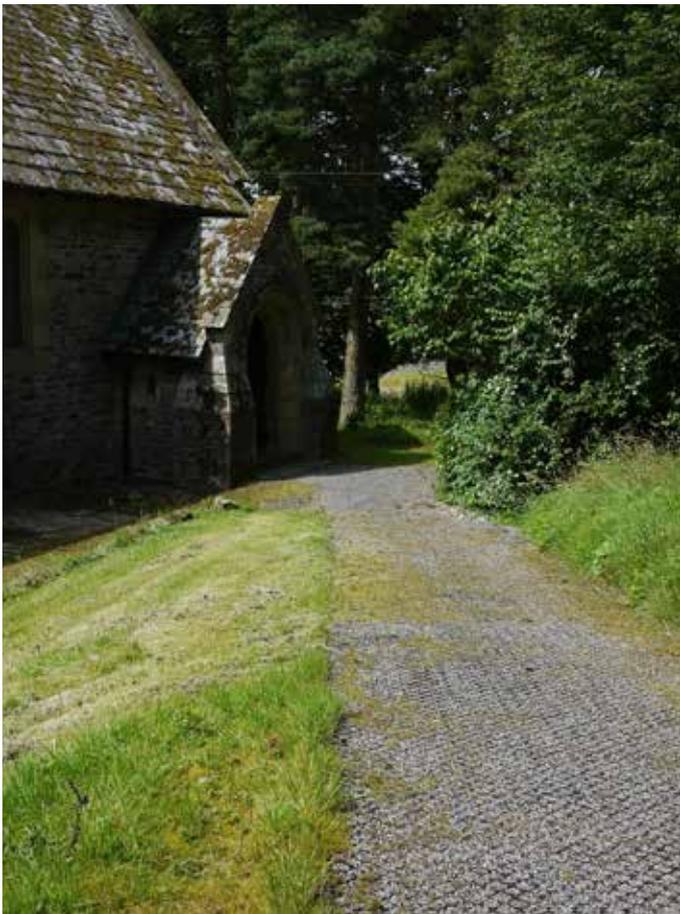
The recent introduction of a plastic matted pathway filled with gravel has been a success and provides safe access for less able-bodied people and wheelchair bound people to approach the North-west porch. There is one step to be negotiated at the entrance to the Northwest porch but it is understood that the parish have purchased a temporary ramp which can be utilised if any wheelchair bound person would like to enter the church.

Gravel path works really well
