# QUINQUENNIAL INSPECTION REPORT

## CHURCH OF CUTHBERT, HEBBURN

**Date of inspection:** 07.04.2022

**Date of report:** 11.04.2022

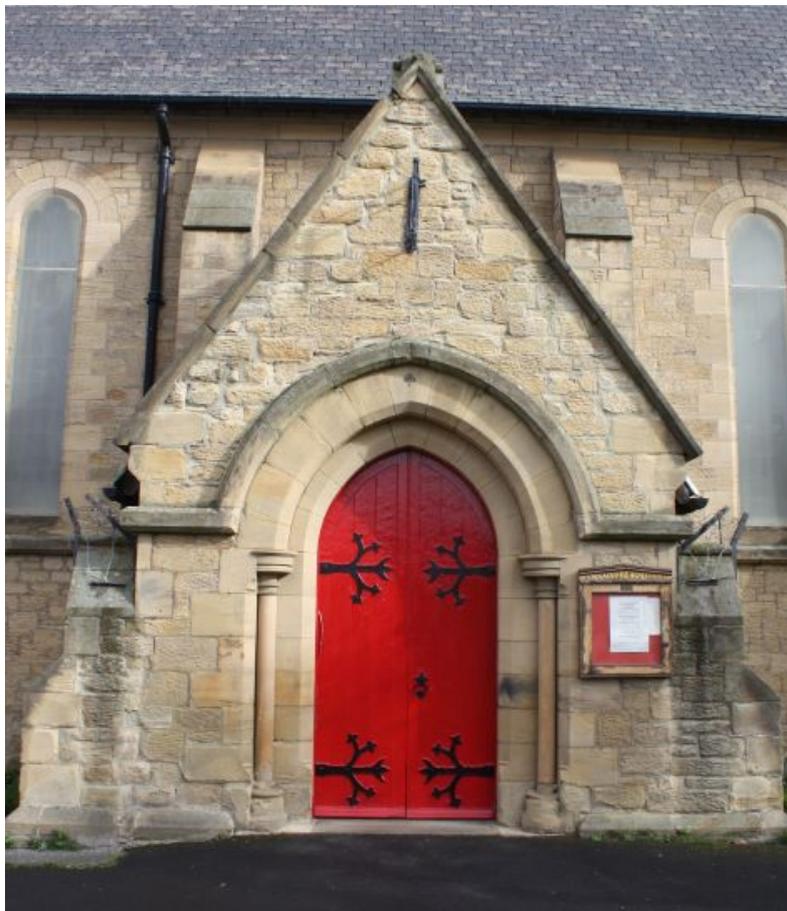
## 7.7 External Doors:

The external framed ledged braced and battened timber doors are solidly constructed. The doors have been redecorated since the previous inspection and are in good condition. External door security appears robust and appropriate for use.
