QUINQUENNIAL INSPECTION REPORT OF

ST. MARY, BLACKHILLS ROAD, HORDEN, SR8 4LJ

CARE OF CHURCHES & ECCLESIASTICAL JURISDICTION MEASURE 1991QUINQUENNIAL INSPECTION AND REPORT

DATE JULY 2021

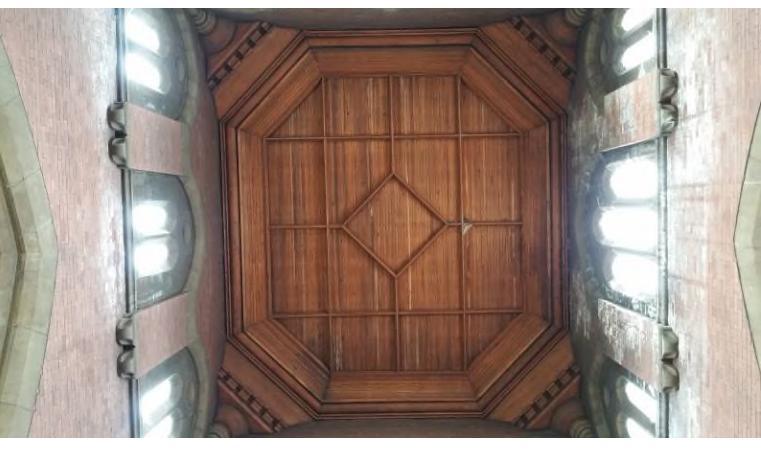
The ceiling looks to have some white marking within the centre square suggesting that there might be some water ingress there (it's not on the line of a hip). There is also another area on the N side in the N W corner of the octagon and there is also a cobwebby bit towards the E.

The ceiling is inset and forms an octagon which is supported by spandrel corbels all in timber and these in turn are connected to arch shafts.

Recommendation: create attic access, investigate wall construction, repoint exterior, repair glass, remove inside salts and staining

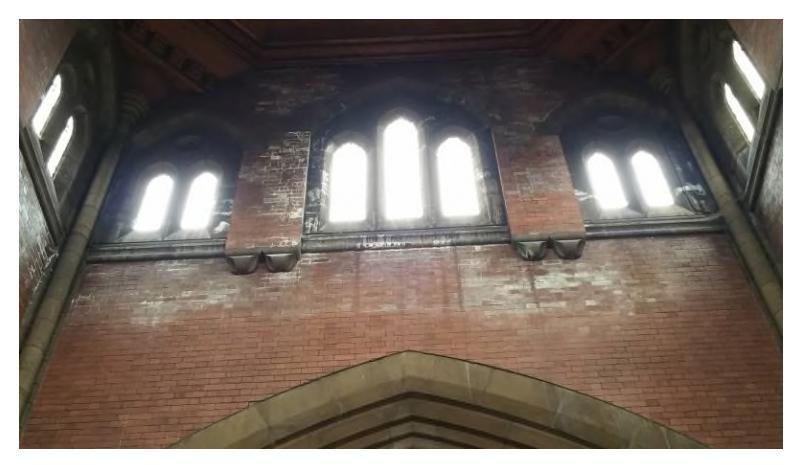
The upper part of the tower has a clerestory arrangement of three double lights. The e has a central three light with doubles either side. Their concrete surrounds have white patches.

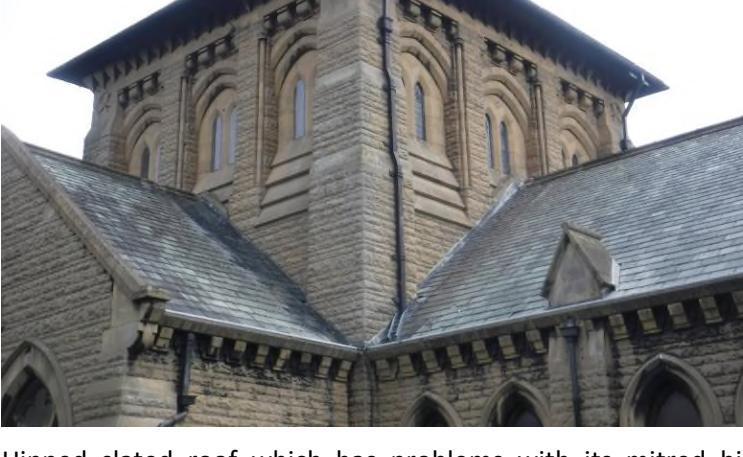
Hipped slated roof which has problems with its mitred hips occasionally and last repaired in 2020. It had its gold cross replaced 2013.

Taylor Hastwell Steeplejacks in their report of 2020, attached at the rear of this report, identify: cracks to the walling at the east; south east buttress has movement and cracks, failed cast stone unit, flashing dislodged and missing, patch pointing required.

Recommendation: repair glass, repoint masonry, repair buttress back gutter drainage.

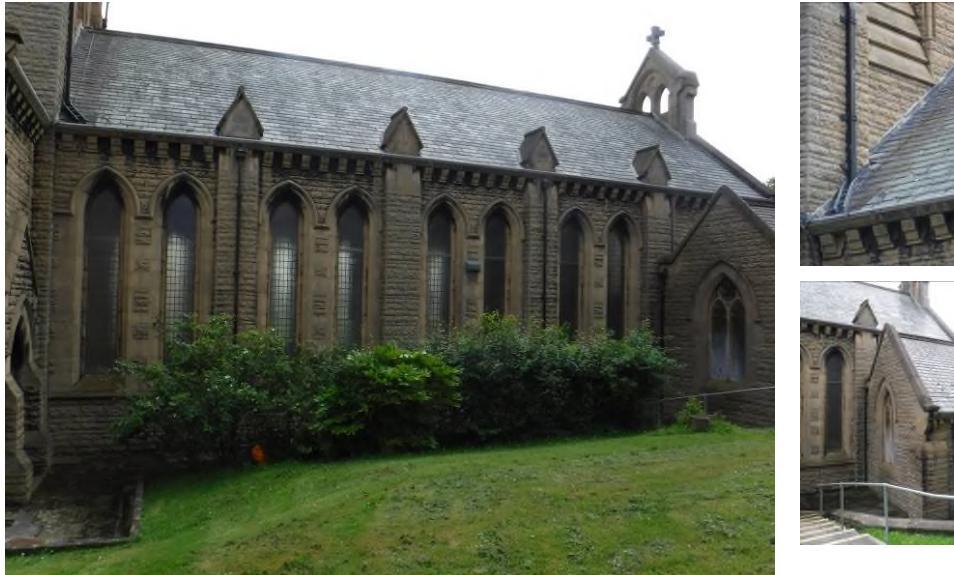
Original Westmoreland slating on all of the hipped roofs with mineral felt on the flat roof.

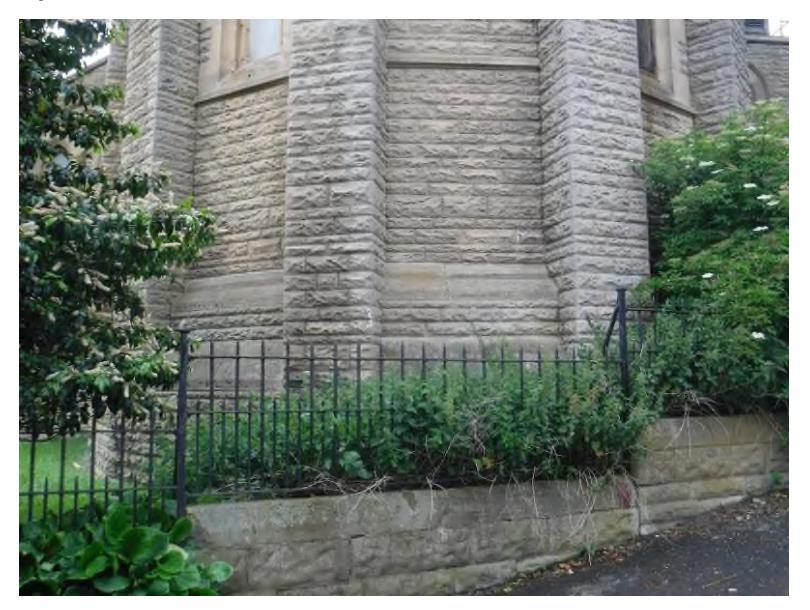
Apse:

Looks much as it was on the last QI. We know there is some efflorescence showing on S side at high level so there might be a problem here with the parapet gutters.

Recommendation: repair window guarding

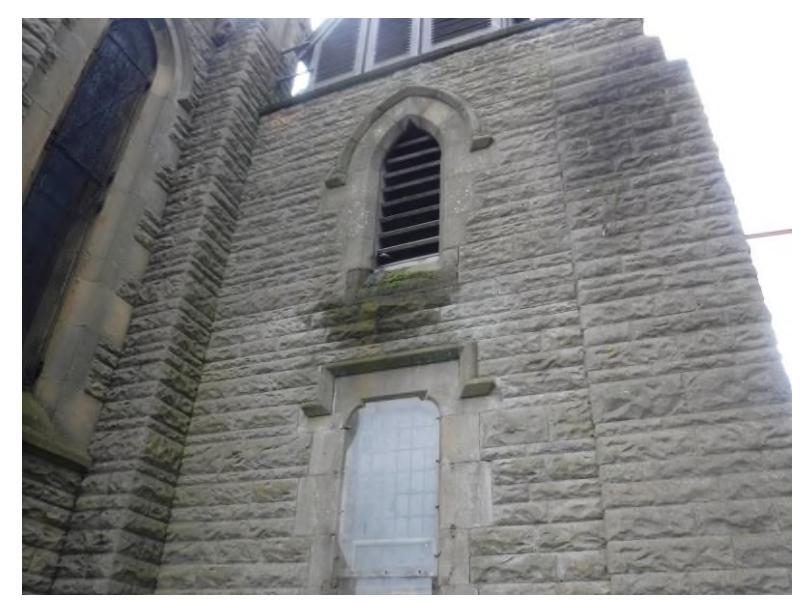
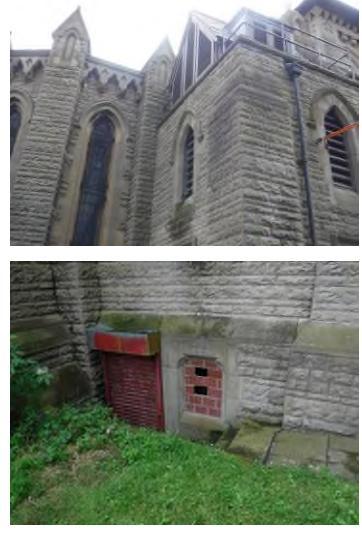
Vestry Corner:

Basement boiler house (see separate entry below). Poor polycarbonate window protection that has been burnt in the past

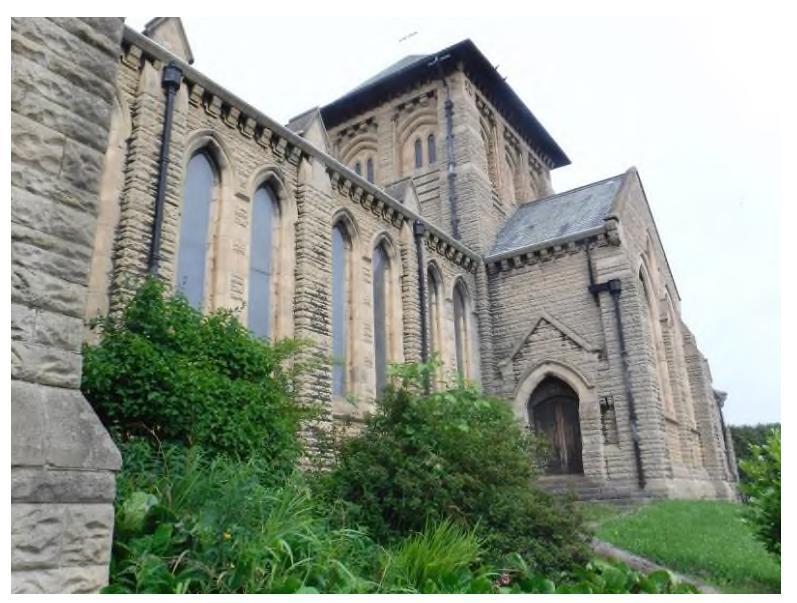
Nave:

The S side of the nave looks generally ok, polycarbonate is clean on this side.

Recommendation: none

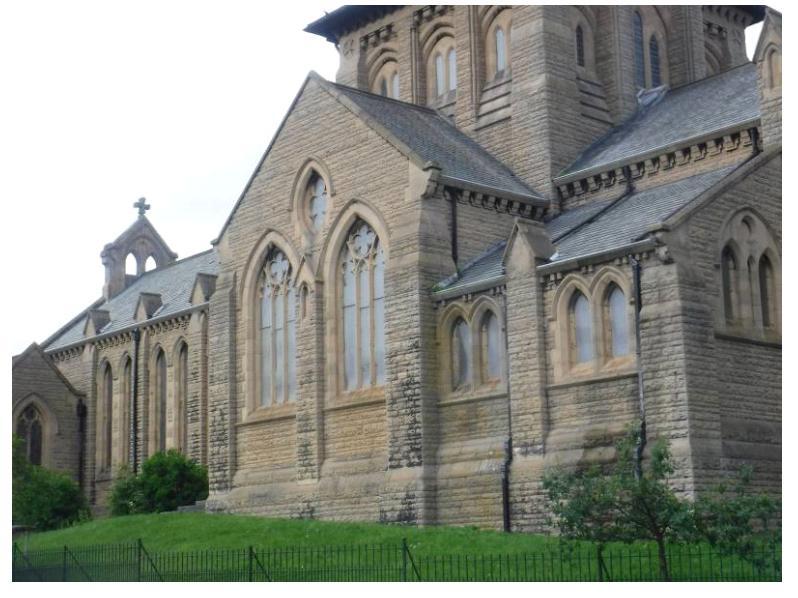
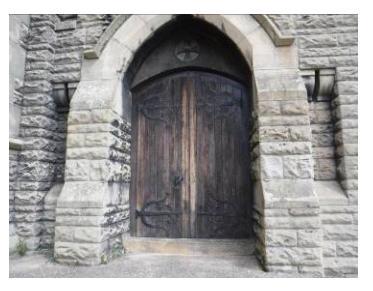
South Transept:

Same design as the S with no obvious defects. Door decoration breaking down.

Recommendation: none

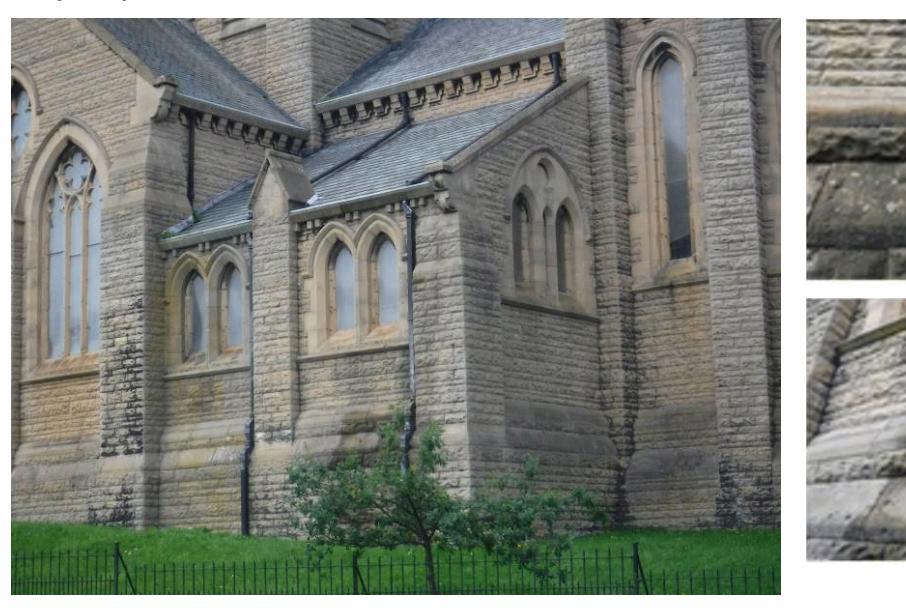
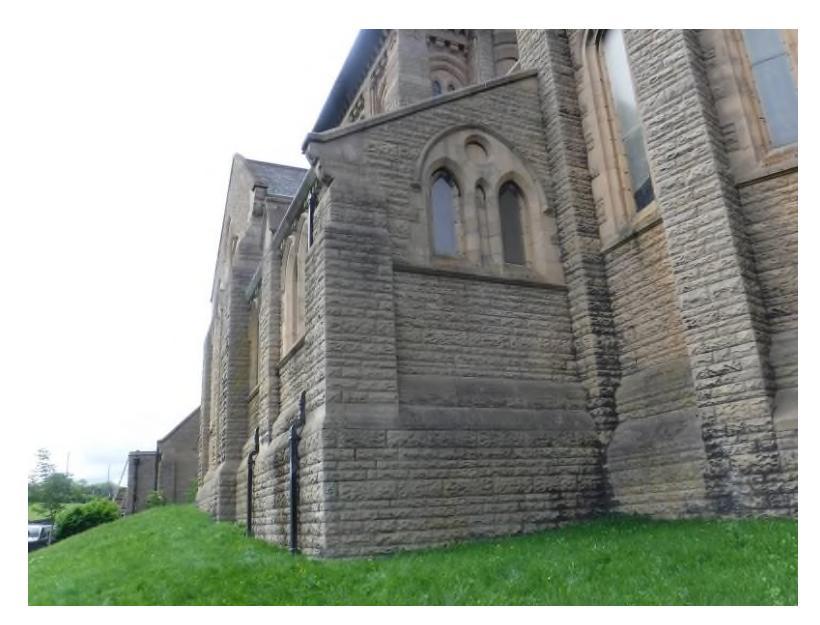
Lady Chapel:

The downpipes block with regularity and wet the wall at the plinth. You can see here a good example of the observation that where ever there is a sloping surface the pointing is coming out.

Probably because of the shape of the faces that abut each other. They are rebated here but not for example at the Ladies' Vestry.

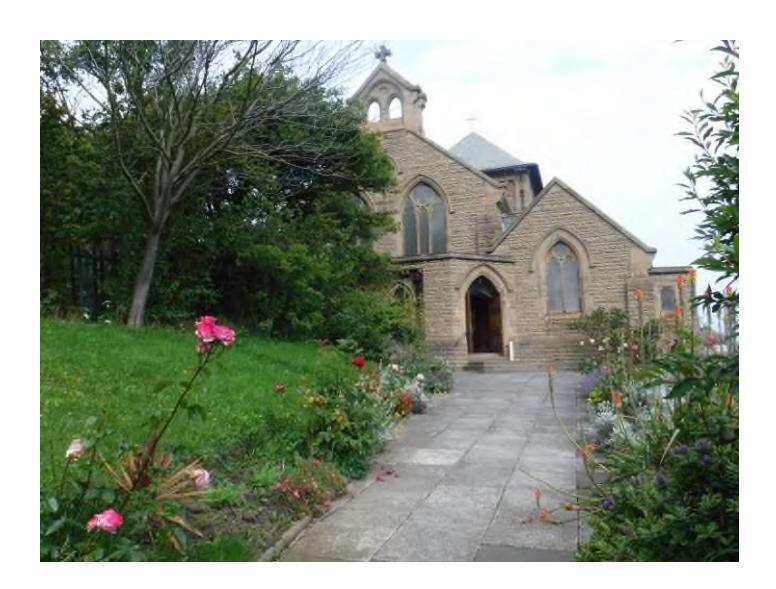
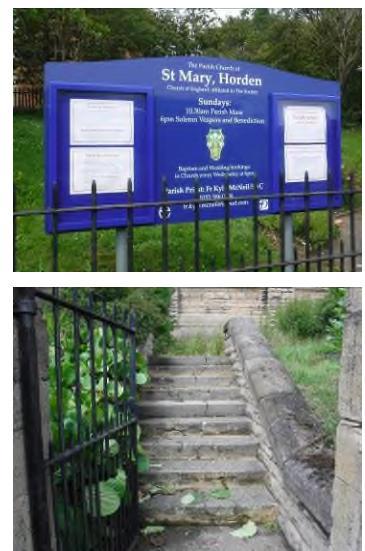
The paths have been swept up at the foot of the nave on the N side and the gulleys cleared out, there has also been some drainage works done here. The paving is still uneven.

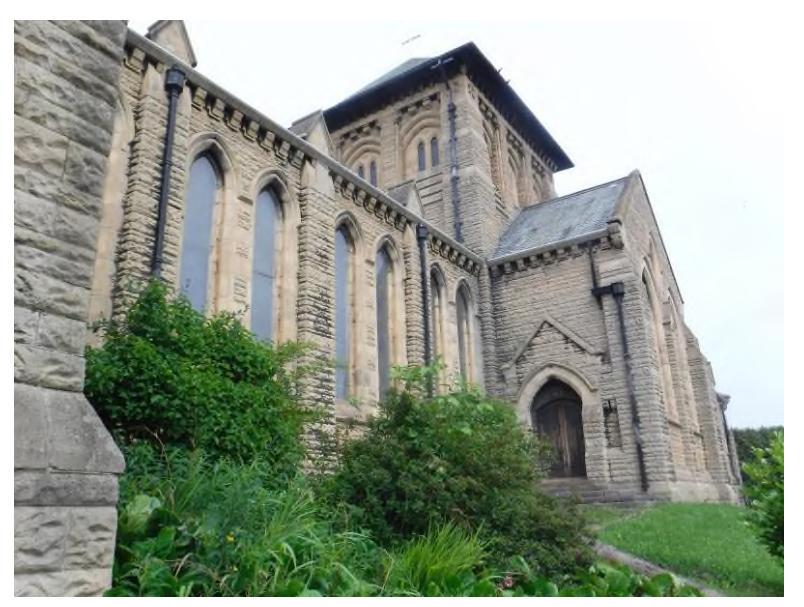
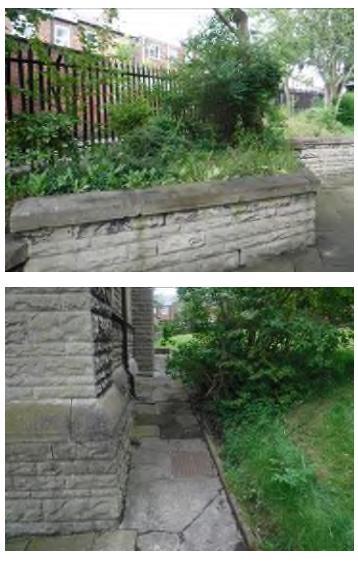
The south transept entrance steps are overgrown and there are bushes to clear away close to the S Vestry. The church have this in hand.

Recommendation: none

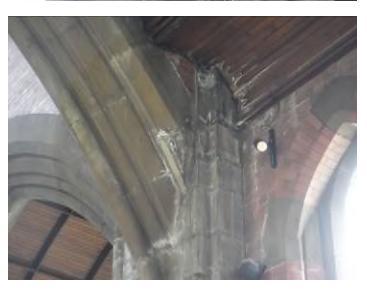
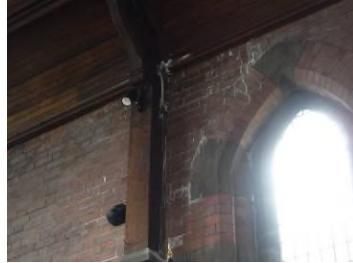
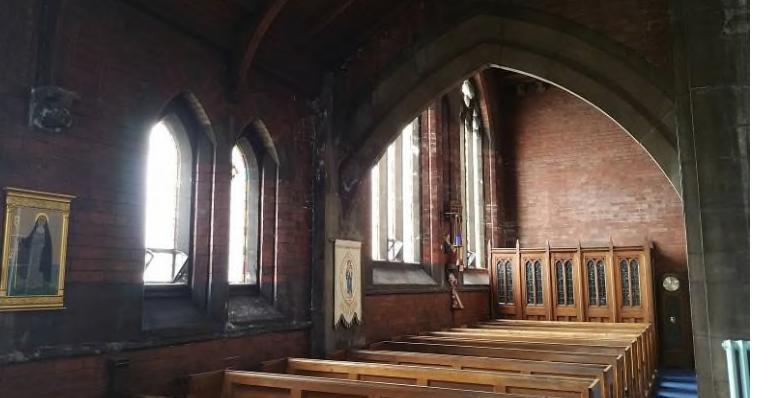
• **Ceiling** – open rafter roof, boarding is in good condition, some water marking at eaves at tower and west gable ends Clear finish has darkened with age.

Up at the eaves the major damp item in the nave is at the further most truss on the N W side and that I think is historic as well.

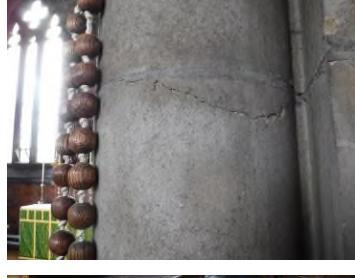
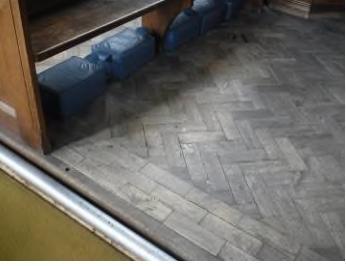
- Walls Walls are fair faced engineering brick and look a severe compared to the lighter 'stone' colour of the outside.
- There is salts to them. Damp showing at low level particularly to the South side (oddly as it is higher out of the ground on the south).

- The window reveals are in cast stone, also has water staining and should be cleaned in the future. There is some need for repair but this is a low priority.
- The church has a bitumen damp proof course It is being compressed and droplets of bitumen are exuding from the joint. It is unknown if this continues the full width of the wall.
- Floor The floors are generally concrete, with carpet to circulation spaces and woodblock floor under pews. The woodblock is loose and lifting, particularly at the choir stalls by the organ, where there are holes that need infilling.
- Fixtures and Fittings Oak pews in reasonable condition on raised pew platforms.

Recommendation: repair woodblock flooring

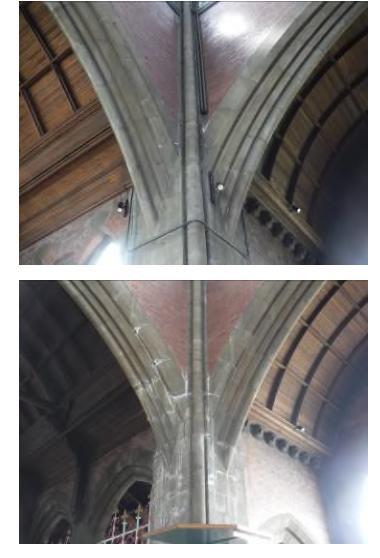
Tower Crossing:

Ceiling – At the tower crossing, the tower ceiling is timber boarded in an octagonal layout with corbels at the corners. The timber looks to be in good condition with no signs of decay or leaking. There is access above this ceiling via roof hatch on the E roof slope and it is not known if the void has been inspected in recent years. It would be worthwhile to do this when the tower roof covering repairs are carried out.

Recommendation: inspect void

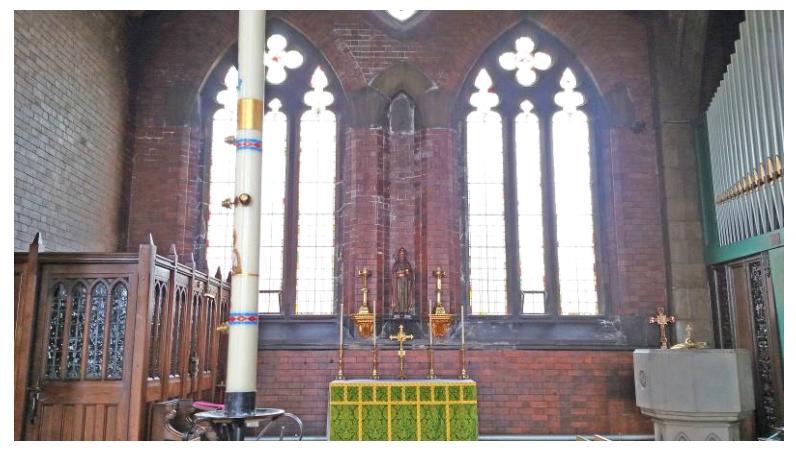
Transepts:

- **Ceiling** The Transepts and Lady Chapel ceilings have exposed rafters and purlins with boarding and these appear to be in good condition.
- Walls Same as the nave. Salts at the window reveals
- Floors Same as the nave.
- Doors The external doors to the transepts are no longer used for general access. They have been forced in the past by intruders and are now heavily guarded. They are draughty and could do with sealing better.
- Windows The transept windows are in coloured glass and were restored in the last 10 years. Glass is protected externally by polycarbonate that is now showing its age. All the glass and guarding requires cleaning.
- Fixtures and Fittings The pews have been removed, leaving a large open space at the S. There is a large stone font supported on a cluster of Frosterley marble shafts. Three steps up to copper lined font bowl. Separate wooden cover with metal straps.

Recommendation: improve draught stripping of doors

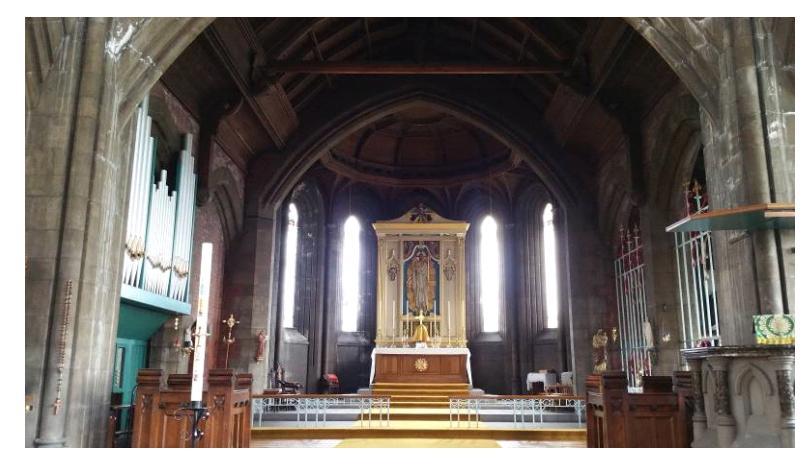
Chancel:

- **Ceiling** Boarded and there is a void over that hasn't been inspected since 1993. The last QI identifies periodic leakages through this roof up to a time when the roof was recovered and that there were no reports of leakage since then. But there are some salts outside at high level so the parapet gutters need checking.
- Walls Same as the nave. The cast stone elements have been treated with a wax finish and there is water staining to it.
- High level of salts on the N E corner reveal and there is also one area which has loss of facing.
- Floor The chancel flooring is carpeted and covers what is thought to be a stone and marble floor. The high altar has a marble floor.

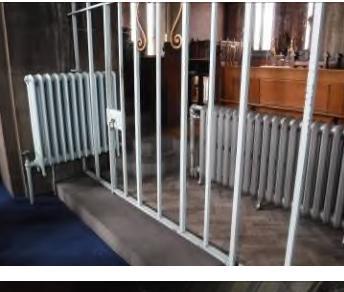
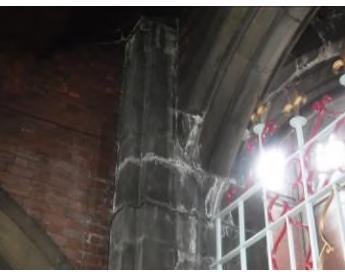
Lady Chapel:

- **Ceiling** exposed rafters and purlins with boarding and these appear to be in good condition.
- Walls Same as the nave.
- **Floor** crack to the floor, left of the altar of the Lady Chapel.

Recommendation: repair floor

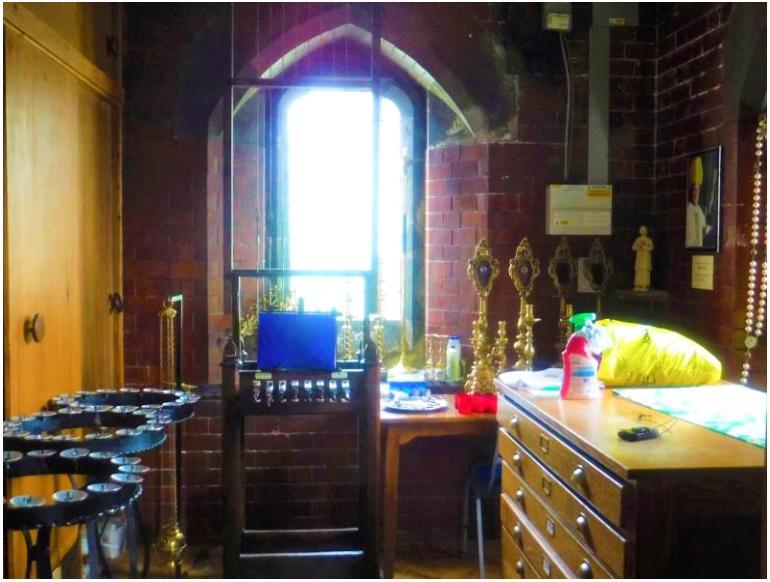
Sacristy:

- Ceiling ok
- Walls Same as the nave.
- Floor –in good condition.
- Fixtures and Fittings Contains built-in cupboards and vestment chests, wash basin with cold water supply, safe, amplifier and controls.

Recommendation: none

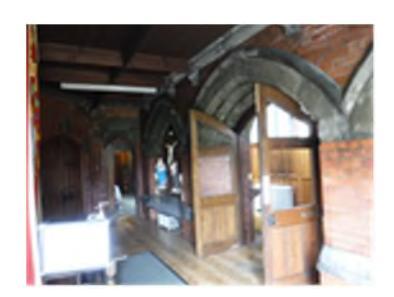
D West Entrance Lobby:

Bit of wear at the entrance double doors where the floor finish could do with a bit of a tidy up.

Recommendation: update floor finish

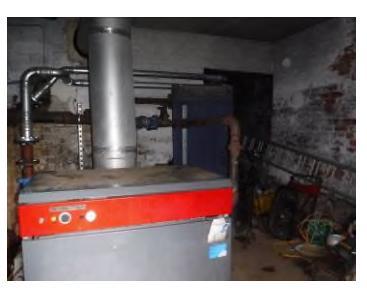
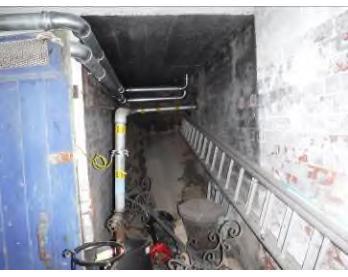
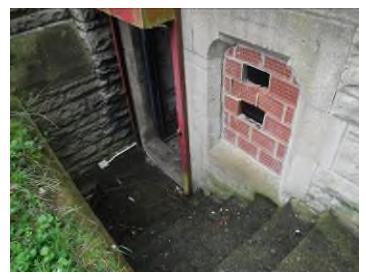
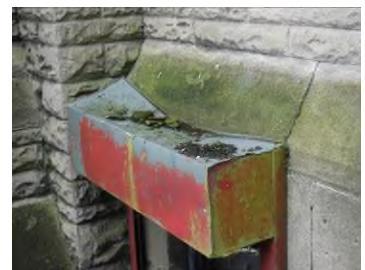
Boiler room:

- ٠
- **Ceiling** Cracking to the concrete ceiling with some holes in it. But not troublesome.
- Walls Painted brickwork, the paint is coming off.
- Floor Concrete floor is ok.
- **General** It's a little adhoc here with a poor external appearance and this is an invitation for intruders.

Recommendation: improve security
