**St ANDREW
LAMESLEY**

QUINQUENNIAL REPORT

on the architect's inspection on

11 October 2021

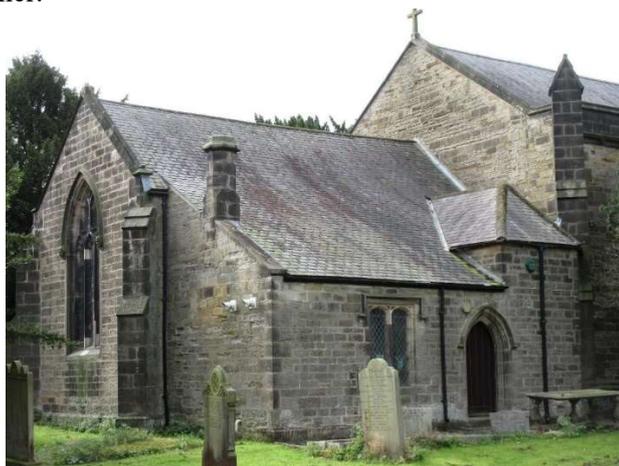
12. Nave slates probably fully relaid in 1957 when it is recorded the parapet gutters were reformed on concrete. Large welsh slates with lead soakers and tall lead cover flashings. Access to slates by door from Tower with hand rail.
13. The lead parapet gutters have centre roll joints, and two sumps with large side outlets. Minor silt in gutter ends. At N gutter two lengths of lead cover flashing are loose or fallen into the gutter so some risk of leaks.

Cover flashing at centre of N Nave fallen out

Refix loose lead cover flashings at N Nave roof gutter	13
Obtain new periodic electrical test report	74 and Addendum
Obtain new Lightning Conductor test report	81 and Addendum
Service fire extinguishers	82

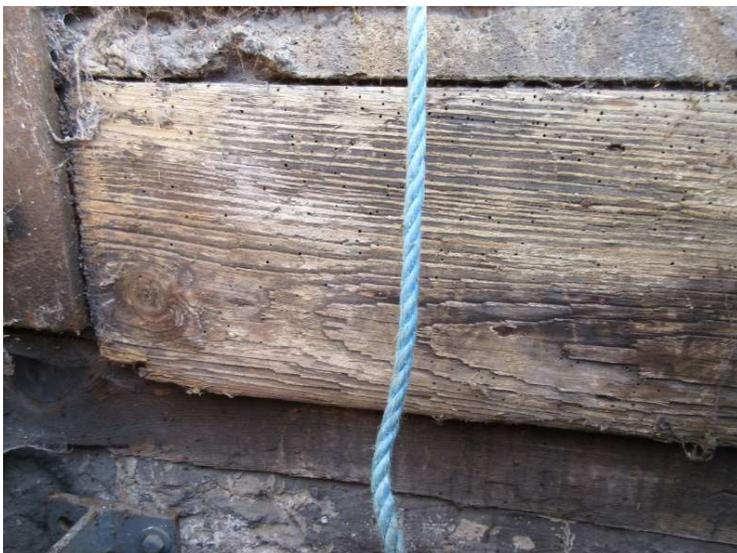
Woodworm by the Tower hatch, may be historic

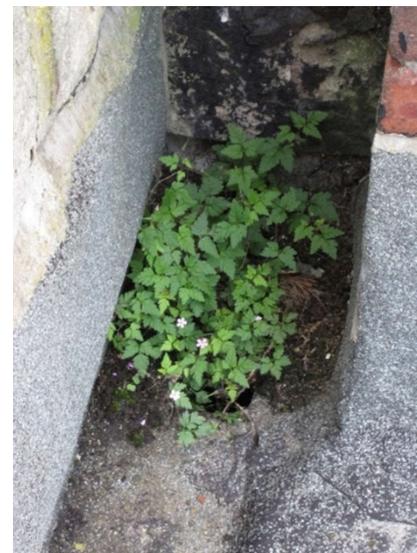
26. The Tower roof is flat felt falling E to a box gutter with bottom outlet through wall to a hopper. Plants at the outlet removed at the inspection. Silt may need removal every other year. Felt slightly mossy but appears sound except a small blister next to the turret. High upstands well pointed into parapets. The hatch covered with sheet metal, tied down.

Outlet from Tower roof, before plants removed at inspection
