Ref: 466-0101 LP  
Date of Quinquennial Inspection: 16<sup>th</sup> June 2022

St Mary's PCC  
St Mary's Church, Norton

## QUINQUENNIAL INSPECTION 2022

**SHAW &  
JAGGER**  
ARCHITECTS

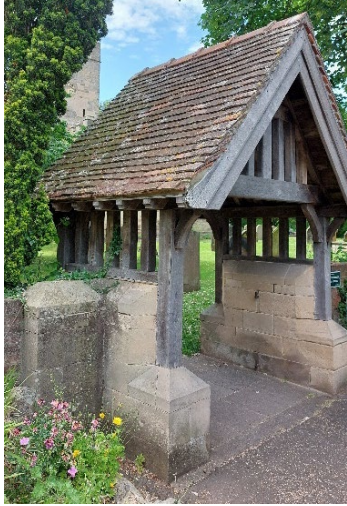
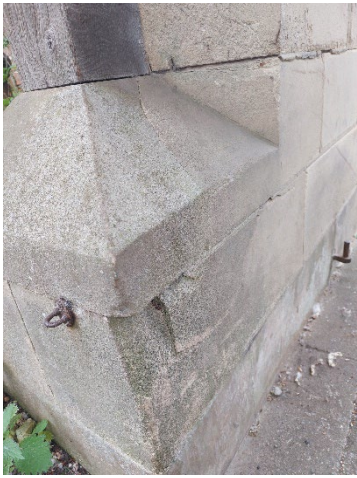
<p>D</p>	<p>Lychgate and railings <i>Dated 1948 by Thompson of Kilburn</i></p>

<p><b>Roof:</b> Clay rosemary tile and clay ridge roof, timbers, etc., all in sound condition.</p> <p>Previous QI Report noted that there were a number of missing tiles which have subsequently been replaced.</p> <p>Bedding mortar missing to verges.</p> <p><b>Walls:</b> Stonework split in places. Pointing missing in some areas.</p> <p><b>Gate:</b> Missing.</p>	<p>Repoint where necessary.</p> <p>Some stone replacements may be needed in the next 5 to 10 years. To monitor.</p>
	<p>Seating/abutting furniture to the church</p>	<p>Timber bench in good order.</p>	<p>No action required.</p>

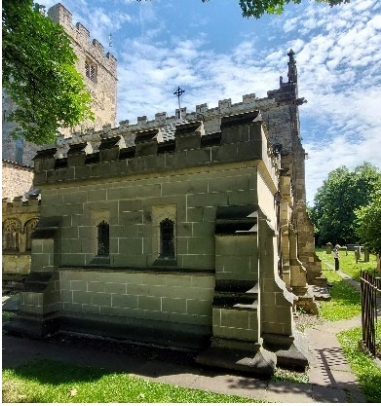
Urgency	Item	Condition	Recommended Repairs
E	Kitchen extension (north face)

Stonework: Recent extension in good condition  Glazing/ window openings: Good condition  Abutment with the ground: Good condition	Clean glazing
E	Kitchen extension (west face)

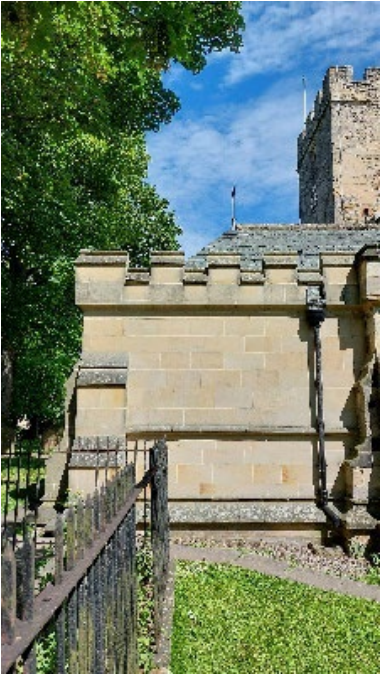
Stonework: Recent extension in good condition  Abutment with the ground: Good condition  Downpipe: Good condition	Ensure downpipe is clear

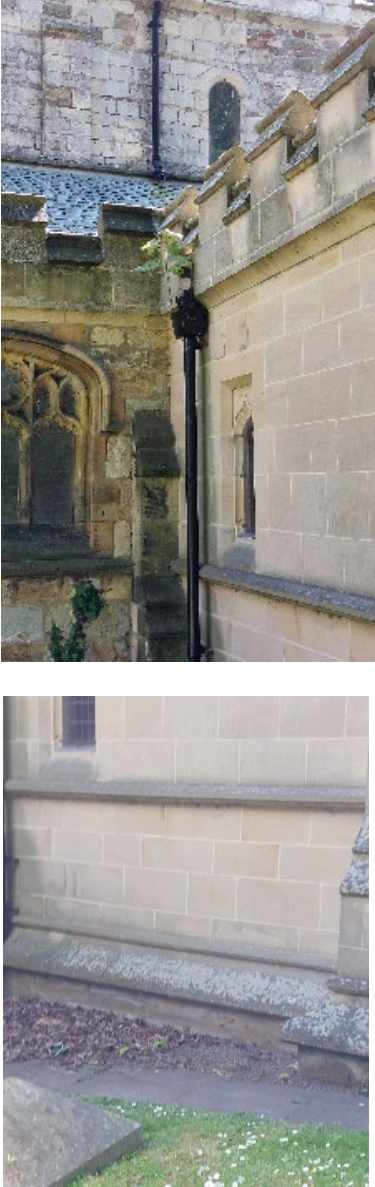
<p>E</p>	<p>Kitchen extension (east)</p>

<p>Stonework: Recent extension in good condition</p> <p>Abutment with the ground: Good condition</p> <p>Downpipe: Good condition</p>	<p>Ensure downpipe is clear</p>
----------	--------------------------------------------------------------------------------------------------------------------	--------------------------------------------------------------------------------------------------------------------------------------------------	---------------------------------

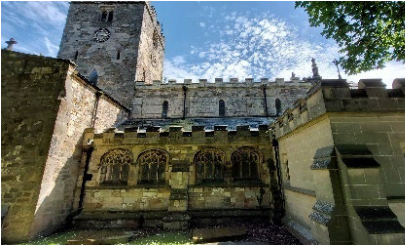
<p>Stonework: Some decay to the tracery</p> <p>Small pockets of loss of mortar</p> <p>Glazing/ window openings: Fair condition</p> <p>Abutment with the ground: Good condition</p>	<p>Monitor stone decay</p> <p>Re-point locally</p>

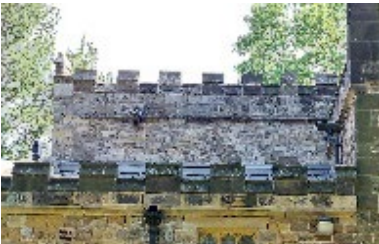
<p>Stonework: 7 no. stone faces missing.</p> <p>Some open joints</p> <p>Parapet: Good condition</p>	<p>Replace stones</p> <p>Repoint</p>

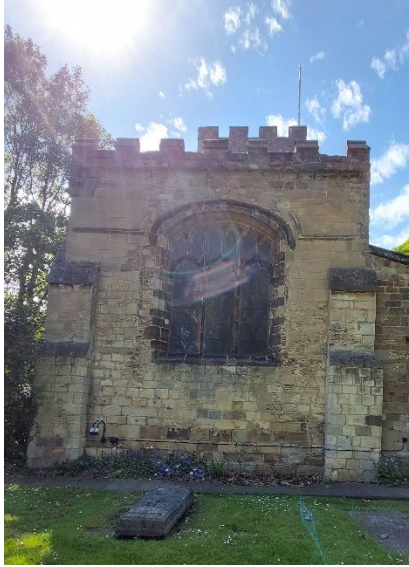
Urgency	Item	Condition	Recommended Repairs
D	<p data-bbox="375 226 584 253">East face chancel</p>

<p data-bbox="810 226 1059 327">Stonework including buttresses: Good condition</p> <p data-bbox="810 371 1059 506">Glazing/ window openings: Protective glazing in good condition</p> <p data-bbox="810 551 1075 651">Parapet: Lots of later repairs in good condition</p> <p data-bbox="810 685 1059 712">2 no decayed stones</p>	<p data-bbox="1129 685 1374 712">Replace 2 no stones</p>

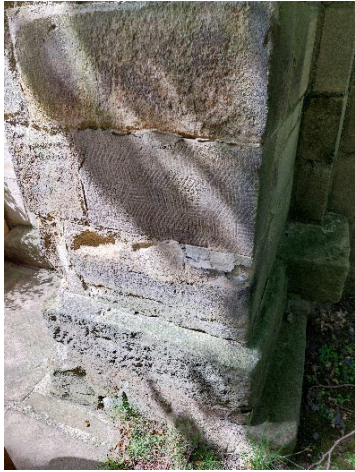
<p>Stonework: Decay to the base</p> <p>Glazing/ window openings: Good condition</p> <p>Downpipes: Blocked</p>	<p>Replace</p> <p>Unblock down pipe</p>

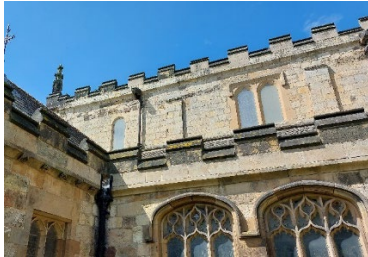
<p>Stonework: 3 no. decayed stones</p> <p>Some open joints</p> <p>Parapet: Decay to some stones</p> <p>Glazing/ window openings: Good condition</p> <p>Abutment with north aisle roof: Flashings appear in reasonable condition</p>	<p>Repoint</p>

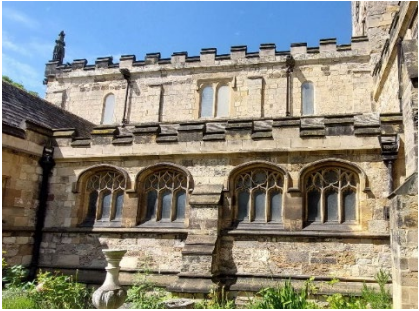
B	<p>South side aisle</p>

<p>Stonework: Delamination to stone surround on window</p> <p>Glazing/ window openings: Good condition</p> <p>Abutment with the south aisle: Good condition</p>	<p>Replace 2 no. stones</p> <p>Localised repointing</p>
E	<p>Porch (south face)</p>

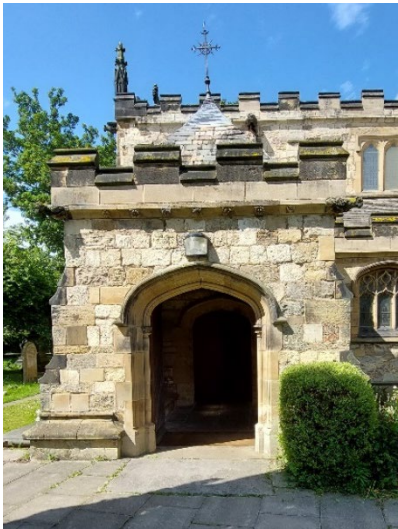
<p>Stonework: Some decay, but no concern</p> <p>Abutment with the ground: Good condition</p> <p>Entrance door: Good condition</p>	N/A
D / I	<p>Porch (east face)</p>

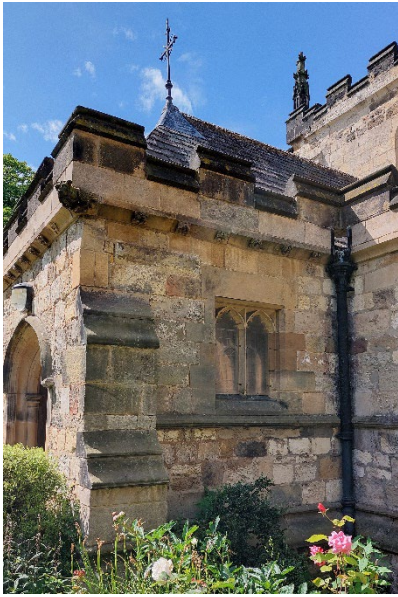
<p>Stonework: Good condition</p> <p>Glazing/ window openings: Good condition</p> <p>Abutment with the ground: Good condition</p> <p>Downpipe: Possibly blocked</p>	<p>Check downpipe for blockages</p>

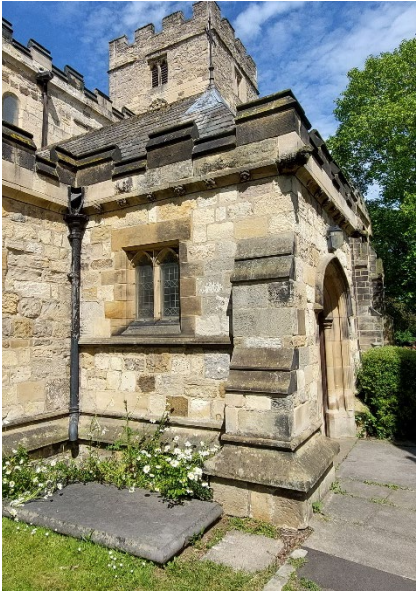
<p>D/ I</p>	<p>Porch (west face)</p>

<p>Stonework: Good condition</p> <p>Glazing/ window openings: Good condition</p> <p>Abutment with the ground: Good condition</p> <p>Downpipe: Possibly blocked</p>	<p>Check downpipe for blockages</p>
-------------	------------------------------------------------------------------------------------------------------------	------------------------------------------------------------------------------------------------------------------------------------------------------------------------------------	-------------------------------------

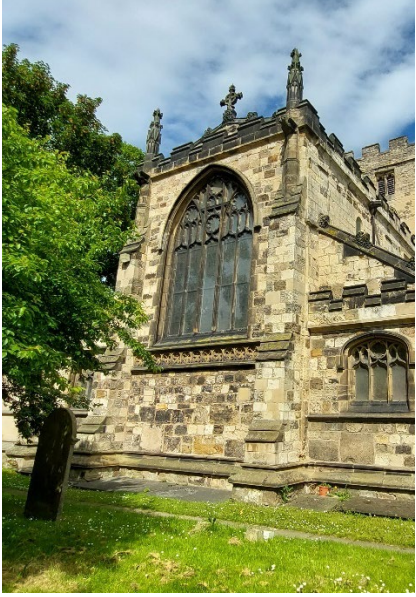
<p>Stonework: Good condition</p> <p>Minor pointing loss</p> <p>Finials and parapet: Some historic decay, but appear sound</p> <p>Glazing/ window openings: Good condition</p> <p>Abutment with the ground: Good condition</p>	<p>Localised repointing</p> <p>Inspect for stability</p>
C	<p>South Aisle (west face)</p>

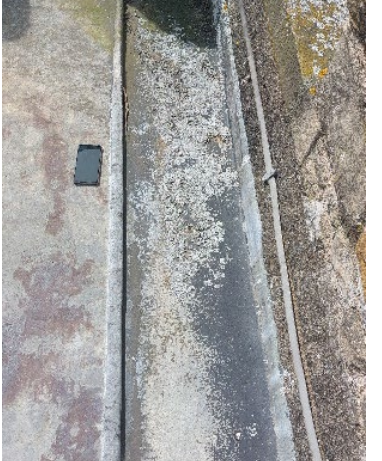
<p>Some Lichen to lead finish.</p>	<p>Remove lichen from roof</p>

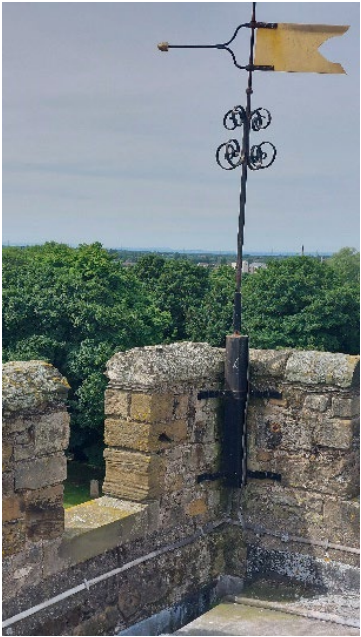
<p>Weathervane: Fair condition</p>	<p>N/A</p>
<p>C</p>

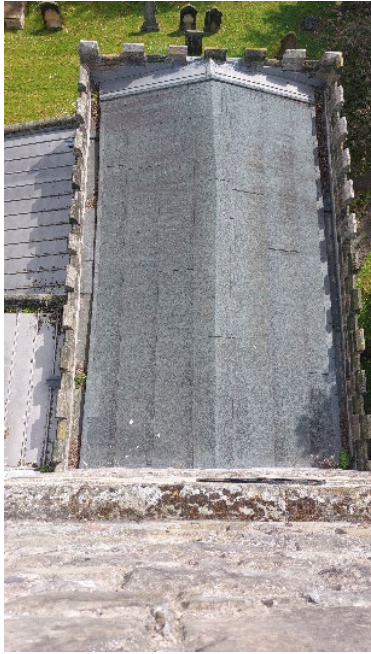
<p>Generally, pitched felt roof, ten to fifteen years old, in good condition. <i>(Installed 1999)</i></p> <p>Part steel to east wall abutment. Steel/lead flashings. <i>(Installed 2008)</i></p> <p>Felt gutters, clogged with dead leaf collection and some vegetation growth.</p> <p>Unable to inspect abutment junction with tower.</p>	<p>Check date of felt roof installation</p> <p>Clear gutters of debris.</p> <p>Ideally roof finish and gutters need replacing with a more robust material</p>
<p>A</p>	<p>Nave</p>

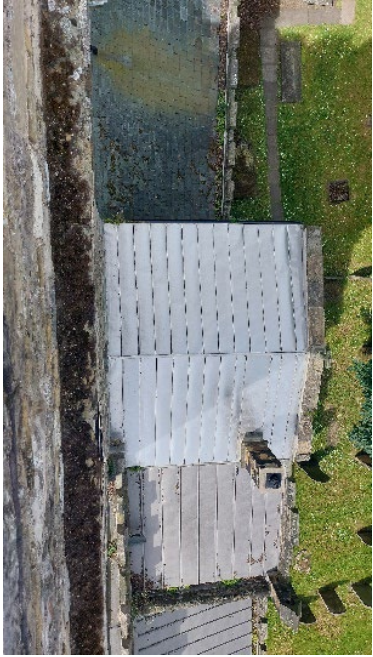
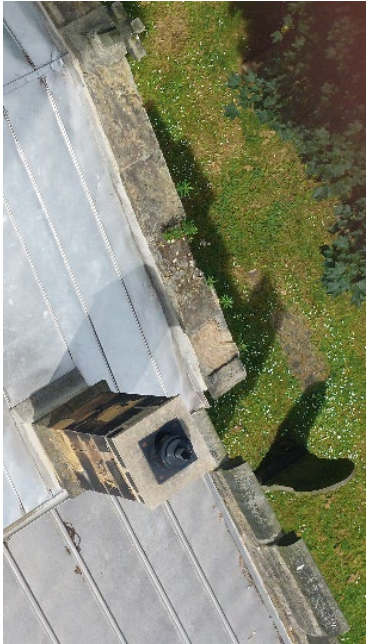
A	<p>North Transept</p>

<p>Generally, pitched steel roof in good condition.</p> <p>Gutters have debris build up</p> <p>Boiler flue/stone stack: Fair condition</p> <p>Coping stones: Vegetation growth and open joints</p>	<p>Clear gutters</p> <p>Remove vegetation and repoint copings</p>
A	<p>South Transept</p>	<p>Generally, pitched felt roof, ten to fifteen years old, in good condition. <i>(Installed 1999)</i></p>	<p>Check date of felt roof installation</p> <p>Check gutters for debris and clear as necessary</p>

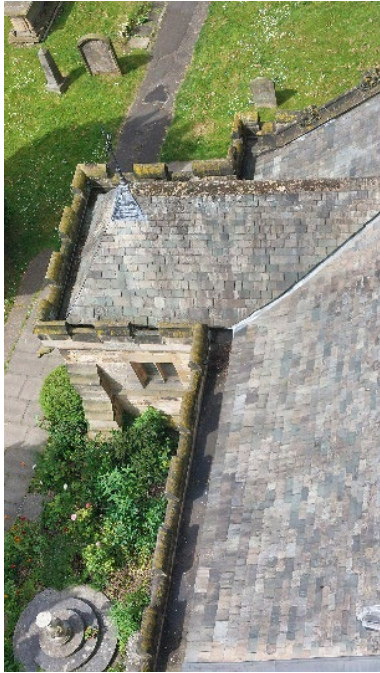
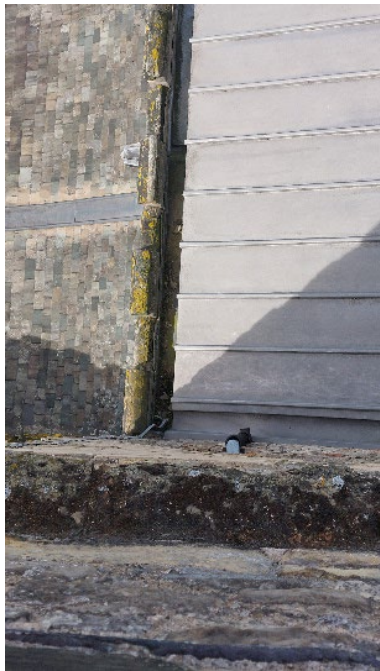
South Aisle

Slate Roof in good condition.

Clear gutters

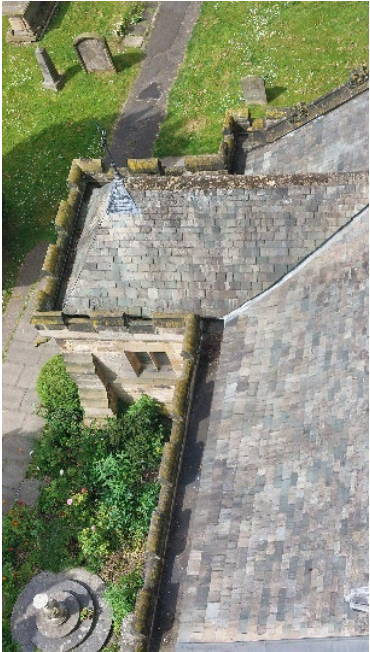
An aerial photograph showing a section of a slate roof. The roof is covered in grey and blue-grey slate tiles. A concrete porch area is visible on the left side of the roof, with some greenery and a circular feature. The surrounding area includes a lawn and a paved path.	<p>Slate Roof in good condition.</p>	<p>Clear gutters</p>
---	--------------------------------------------------------------------------------------------------------------------------------------------------------------------------------------------------------------------------------------------------------------------------------------------------------------------------------------------------------------------------------	--------------------------------------	----------------------

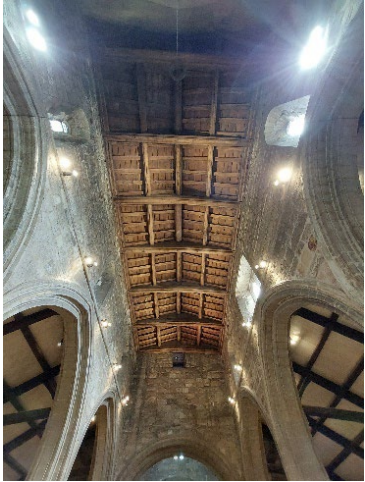
<p>Timber low pitch boarded</p> <p>Some evidence of water ingress</p> <p>No change since 2015 Q1</p>	<p>Monitor</p>
E	<p>Nave floor</p>	<p>Modern underfloor heating with stone finish in good condition</p> <p>Some localised areas of open joints</p>	<p>Repoint open joints</p>

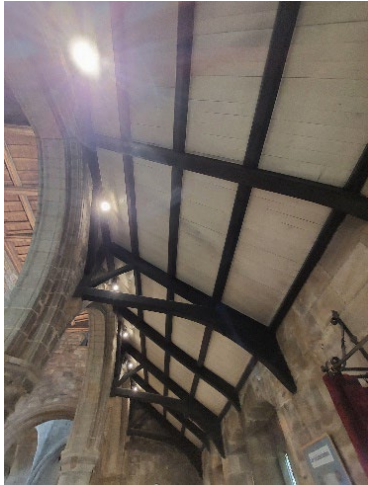
<p>South aisle ceiling</p>

<p>Good condition. Recently repaired.</p>	<p>N/A</p>
<p>E</p>	<p>South aisle floor</p>	<p>Good condition stone flag flooring. Some open joints.</p>	<p>Repoint</p>

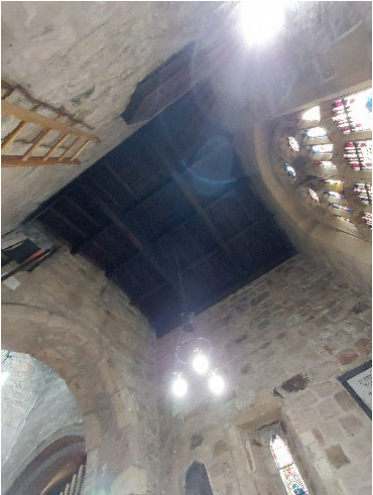
<p>Tower ceiling</p>

<p>Dressed oak beams and boarding in good condition.</p>	<p>N/A</p>
<p>A</p>	<p>Tower access</p>

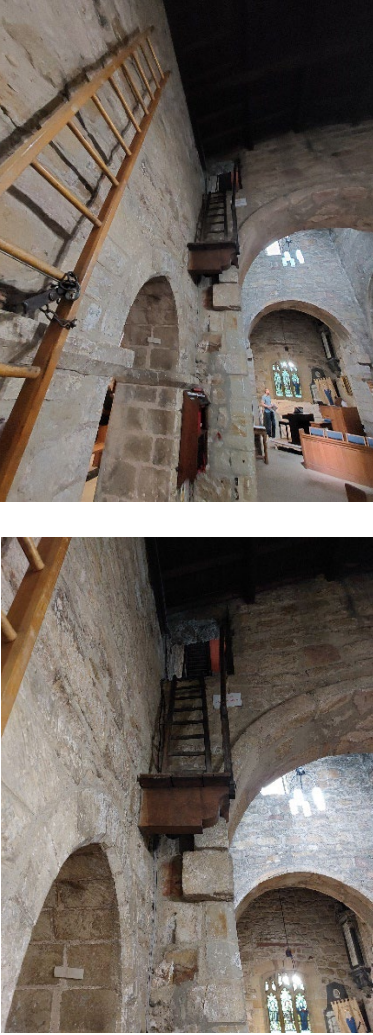
<p>Access to Clock Chamber, Belfry and Tower roof is via a temporary timber ladder and permanent fixed metal ladder at a higher level.</p> <p>Both in satisfactory condition.</p> <p>Currently the timber ladder rests on a board at the bottom of the metal ladder, which is unsatisfactory.</p>	<p>Install fixing points for the timber ladder as recommended in previous QI Report.</p> <p>Make sure ladders are inspected regularly and management of use is in place</p>

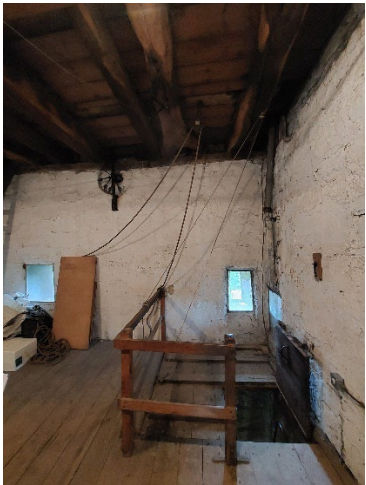
Clock Chamber Floor	Timber floor boarding in sound condition	N/A
	<p>Access from Tower crossing</p>

<p>Timber trap door within larger timber trap door in floor. Generally good condition.</p>	N/A
	<p>Clock Chamber Walls</p>

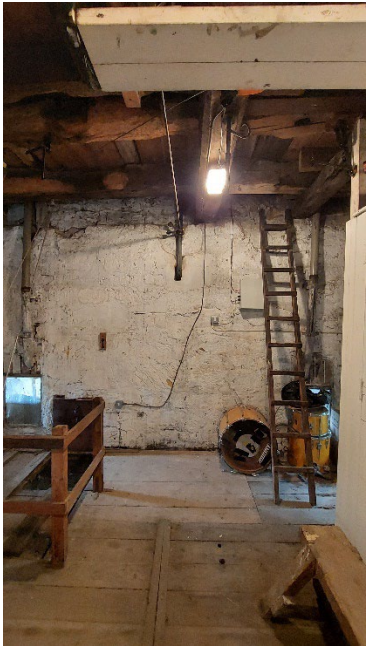
<p>Lime washed stone work in satisfactory condition – some wear</p>	N/A

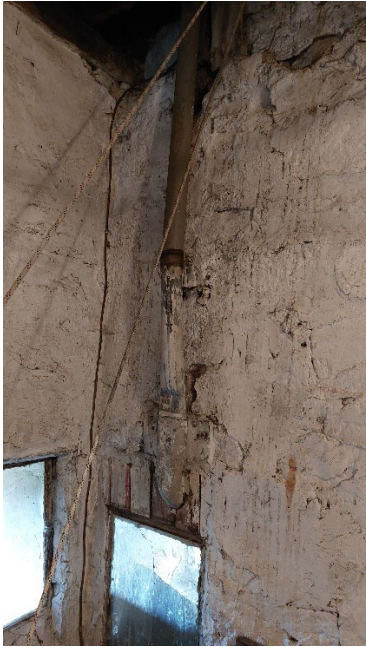
<p>D</p>	<p>Internal rainwater pipes</p>

<p>Two internal plastic downpipes from floor above, connect to lead pipe and discharge through external walls.</p> <p>The previous QI Report observed:  <i>The rainwater pipes are continual on this side; one of them is rather tight. It is lead and has been bent in the past and appears to come out just over the two small windows on the western end.</i></p> <p>No evidence of water penetration.</p>	<p>A long term replacement should be sought. It should be investigated again during rainfall to ensure they are still operating correctly.</p>
<p>C</p>	<p>Belfry Floor</p>	<p>Timber floor boarding in sound condition – extremely dusty from walls.</p> <p>Some movement but no cracking evident</p>	<p>Clean</p>

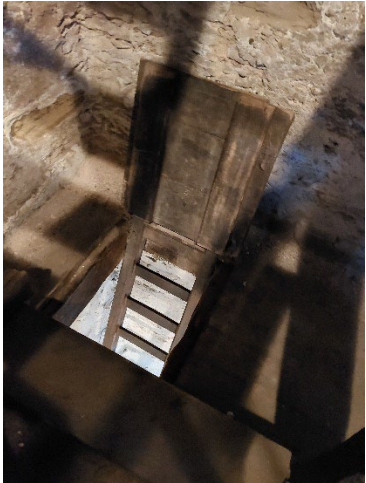
B	<p>Stair from Clock Chamber</p>

<p>Timber stair, fixed to wall below timber trap door</p>	<p>Add grab handle at top of stair</p>
D	<p>Belfry Walls</p>	<p>Partial lime washed stone work in satisfactory condition</p> <p>3. no stones decayed</p>	<p>Replace stones</p>
E/I	<p>Belfry Ceiling</p>	<p>Timber structure of principal beams supporting purlins and boarding, with some decay</p> <p>Previous QI Report observed: <i>Slight water staining in north west corner (where lead patch to roof is failing)</i></p>	<p>Monitor</p>
A	<p>Belfry Bell Frame</p>

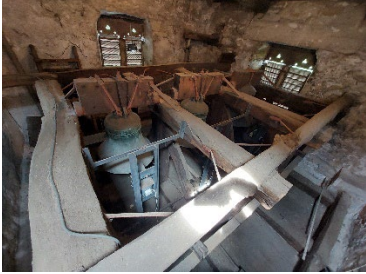
<p>Oak frame timber structure generally in sound condition</p>

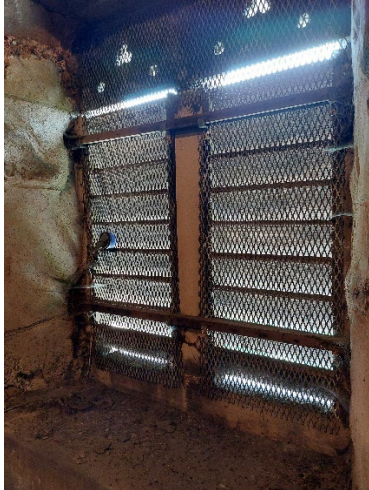
<p>Timber louvres to openings with expanded metal mesh in reasonable condition</p>	<p>N/A</p>

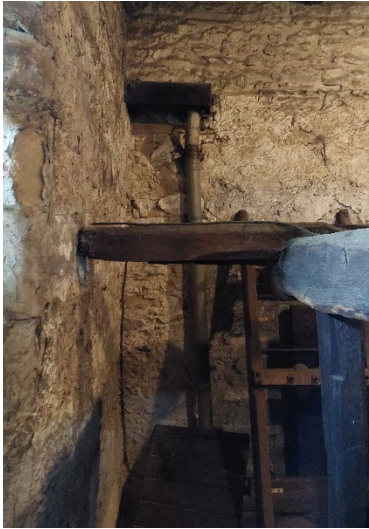
D	<p>Internal rainwater pipes</p>

<p>Two internal hoppers from parapet roof above, discharge into plastic downpipes, through floor to Clock Chamber below.</p> <p>No evidence of water penetration.</p>	<p>Should be replaced within next five years</p>
	North transept floor	Good condition	N/A
	North transept walls	Good condition	N/A
	North transept ceiling	Good condition	N/A
D	South transept floor	<p>Good condition.</p> <p>Modern finish.</p> <p>Few open joints.</p>	Repoint
	<p>South transept walls</p>

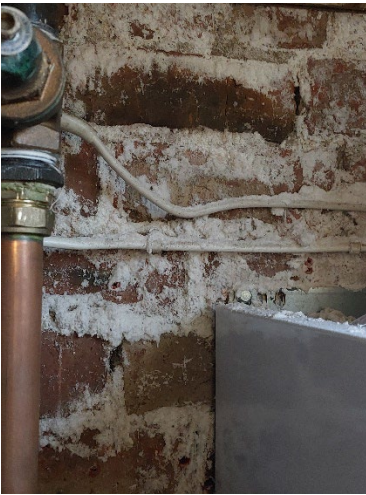
<p>Significant efflorescence to brick joints</p>	<p>Brush back and monitor.</p> <p>Re-inspect to ascertain whether permanent ventilation required to cupboard space.</p>

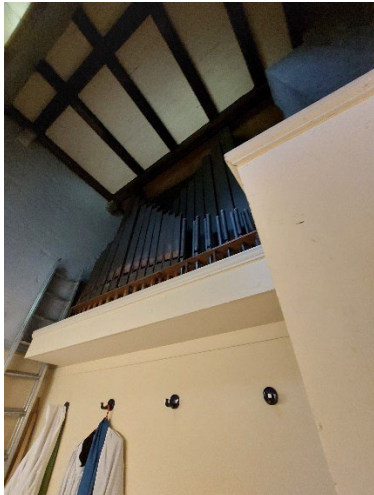
<p>Timber and plaster in good condition</p>	<p>N/A</p>
	<p>Vestry Office floor</p>	<p>Carpet in good condition</p>	<p>N/A</p>

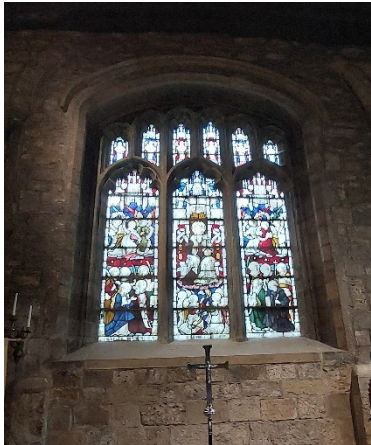
<p>Good condition</p>	<p>General clean</p>
	<p>Chancel door opening</p>	<p>Good condition</p>	<p>N/A</p>

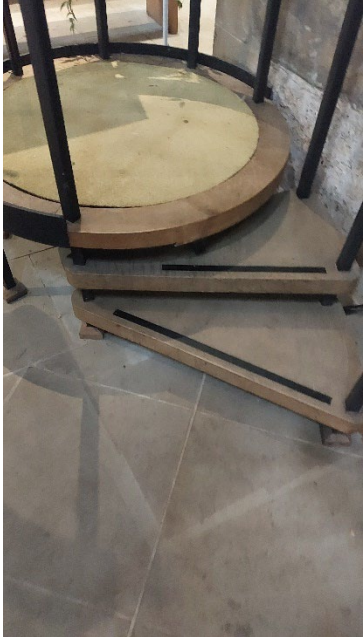
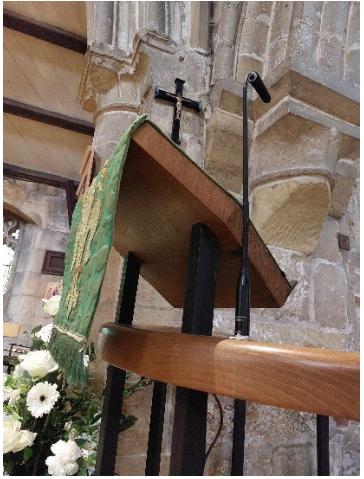
Urgency	Item	Condition	Recommended Repairs
E	<p data-bbox="375 226 448 255">Pulpit</p>

<p data-bbox="790 293 1078 360">Pulpit generally in good condition.</p> <p data-bbox="790 405 954 434">Issues noted:</p> <p data-bbox="790 472 1094 577">Inadequate tread depth to steps and Inaccessible to lower mobility users</p> <p data-bbox="790 972 1067 1077">Lecturn is too high and obscures view of congregation</p>	<p data-bbox="1120 472 1425 577">Consider reconfiguration as an improvement project</p>
	Pews	Pews in good condition	N/A
	Memorials	Generally good condition	N/A
E	Organ	Not operating.	A solution should be sought.

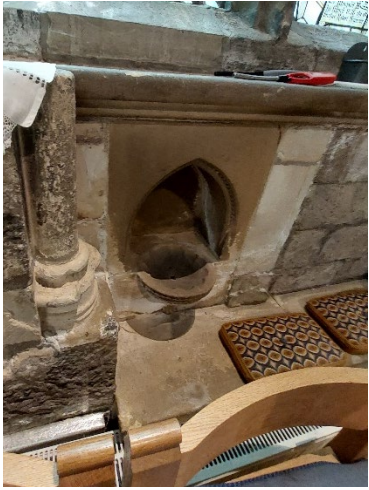
<p>Font</p>

<p>Good condition</p>	<p>N/A</p>
	<p>Boards</p>	<p>Good condition</p>	<p>N/A</p>
	<p>Ironmongery</p>	<p>Good condition</p>	<p>N/A</p>
