**St James the Apostle
Owton Manor**

Care of Churches and Ecclesiastical Jurisdiction Measure 1991

Quinquennial Report
on the architect's inspection on

5th October 2023

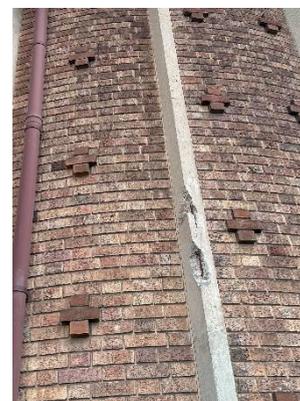
Figure 11 – south fin

4.2 **Apse:** Semi-circular brickwork in good condition with projecting crosses in brickwork, some of these have chipped corners. The structure has reinforced concrete fins leading up to the concrete frame within the roof. These are spalling in many locations, as it would appear that the reinforcement was installed too close to the surface. It has been patch repaired in the past, those have come away and so this requires a greater level of intervention than just patching. At several locations the rusting reinforcement is showing which will only worsen the spalling, all of the fins see this issue to varying degrees. It is suggested that a concrete specialist is consulted. Concrete also spalling at soffit in several locations to the apse.

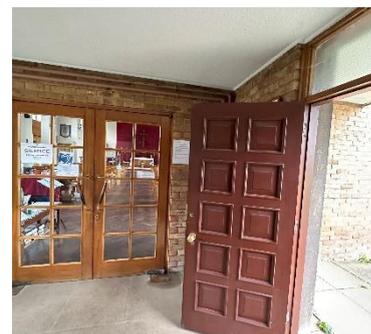
Figure 21 – Lobby and front doors

- 6.1 Ceiling – Relief paper
- 6.2 Walls – exposed brickwork in fair condition.
- 6.3 Floor – stone slabs. Recessed matwell at entrance.
- 6.4 Doors – glazed 10-pane double doors into nave in good condition but closers need attention, and they catch slightly. Front doors as per item 4.5) i.

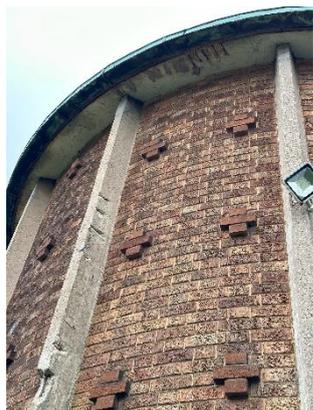
Figure 34 –Apse Concrete fins

28.1A characterful church, with interest added from the concrete curvilinear forms and generous level of lighting. The most pressing issue is the deterioration of the reinforced concrete fins at the apse and soffits throughout the rest of the Apse, Chancel and Nave. Specialist advice should now be sought to create a strategy for their repair. Secondly, with a drive to more sustainable churches, the large windows would benefit from replacement, alongside the smaller windows to the ancillary rooms.
