Care of Churches and Ecclesiastical Jurisdiction Measure 1991 – Quinquennial Inspection
ALL SAINTS, EAGLESCLIFFE

Diocese: Durham
Archdeaconry: Auckland
Church Code: 613 312

Date of Inspection: 23rd June 2022
Inspection undertaken by: Jamie Holden BA (Hons) RIBA RIAS
Previously Inspection: Nov 2014 by D Beaumont

Studio Tamacoco Architects

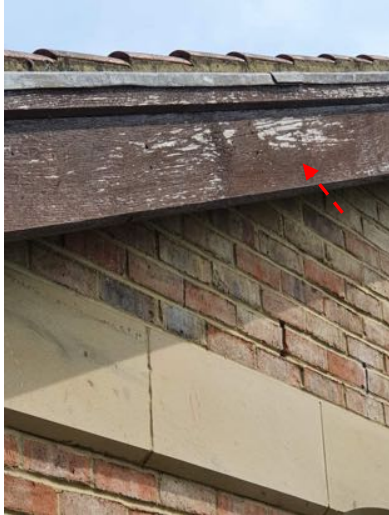
a) Bargeboard to the south gable is ready for redecoration.

2.2.4 There are fascia boards at the eaves and bargeboards to the south facing gable. **2**
The bargeboards weathering and redecoration is now required.

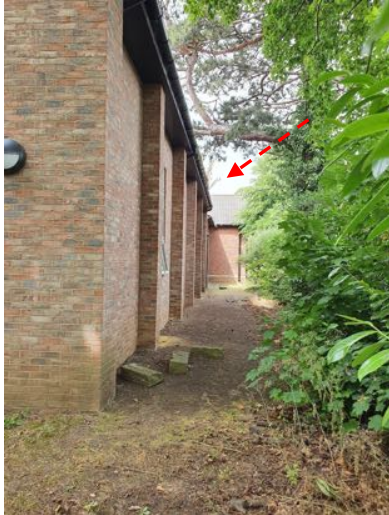
- 2.4.6 The Hall has a shallow duo-pitched roof which is irregular in plan. The Hall roof directly adjoins that of the Library and in doing so forms a valley gutter. Solar panels have been installed on the south slope. The Hall roof appears in good order generally but the guttering, particularly on the north side, has some quite well-established vegetation growing and needs prompt attention and regular maintenance.

a) Vegetation growth in guttering to the north side of the Community Hall needs to be removed

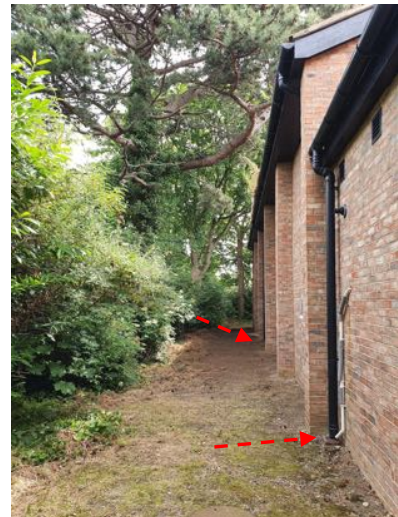
2.6.3 The downpipes on the north side of the Community Hall are quite large in diameter which reflects the size of roof area they are required to drain. It is noted that they do not connect directly to their respective gullies which stand proud above the ground with no means to capture and channel any excess rainwater that might discharge at speed during heavy rainfall. It would be advisable to observe/ check discharge from the downpipes is properly collected in the gullies during heavy rain. **O**

b) Check gullies capture discharge from the large north slope of the Hall roof during heavy rainfall.

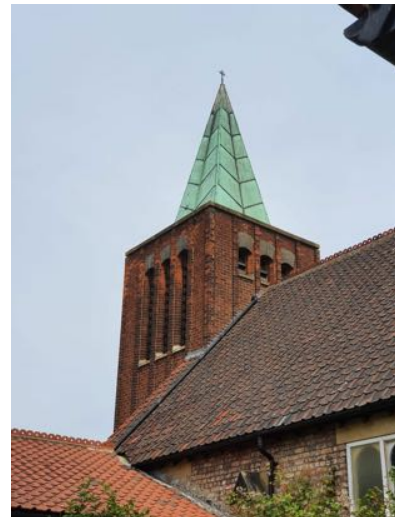
b) A rainwater pipe which drains the Tower roof penetrates the east elevation and is laid over the south slope of the Nave roof.

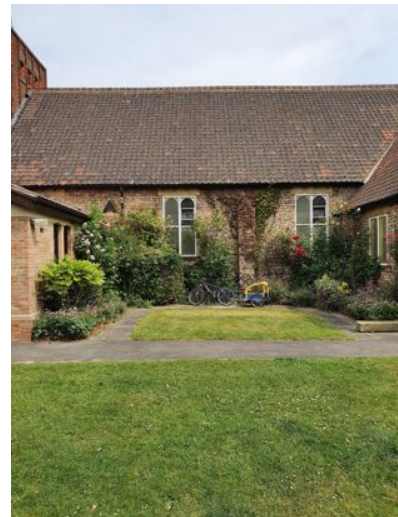
3.3.2 The two remaining windows are fitted with external secondary glazing. In each case one panel is removed to allow the ventilation hopper of the original window to function. Although the secondary glazing probably makes some contribution to reducing heat loss they are very unsightly and the opaque sheeting used will diminish the quality of natural daylight within the building. If secondary glazing is deemed necessary, the introduction of a better quality system would be a welcome improvement. **5**

b) South elevation. Secondary glazing is unsightly.

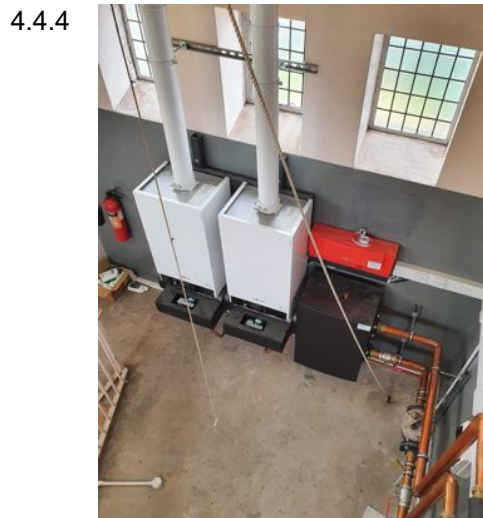
a) Boiler fixed to the north wall

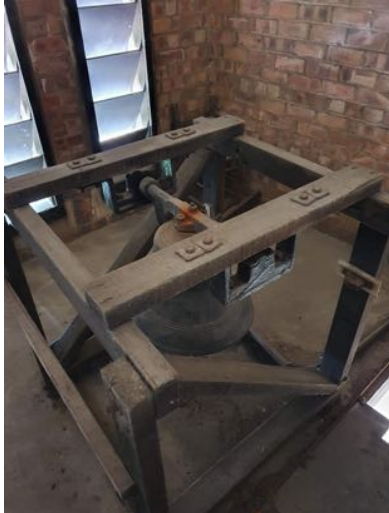
- 4.5.3 A single bell dated 1902 and made in Loughborough is set in a timber bell frame. There appears to be some corrosion where the bell is connected to the metal headstock. The bell ought to be inspected by a suitable specialist. Enquire with the DAC to see if it has an Advisor who can assist. **2**

a) Bell frame and bell to be inspected by a suitable specialist.

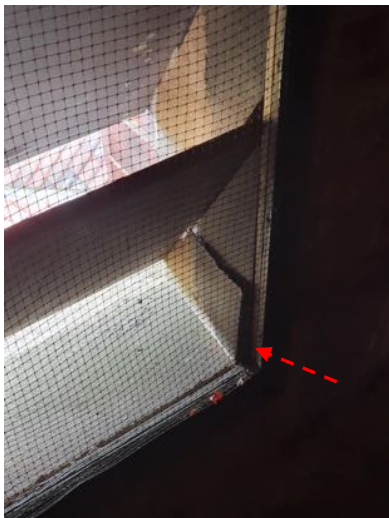
a) Eroded jamb

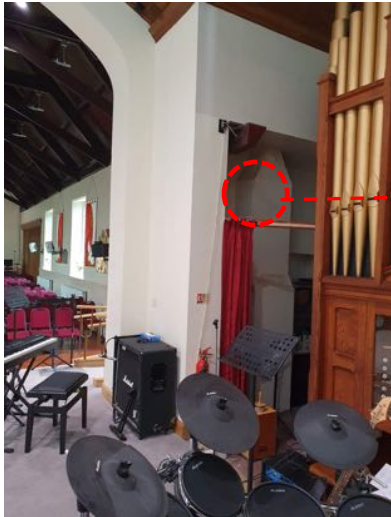
a) Plastered buttress from the original build.

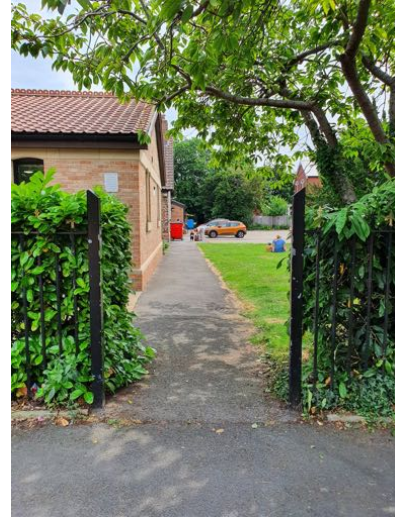
b) Access through the churchyard from the west boundary (shown) to Yarm Rd on the east side.
