ROWLANDS GILL St BARNABAS
(22A)

QUINQUENNIAL REPORT

15 May 2018

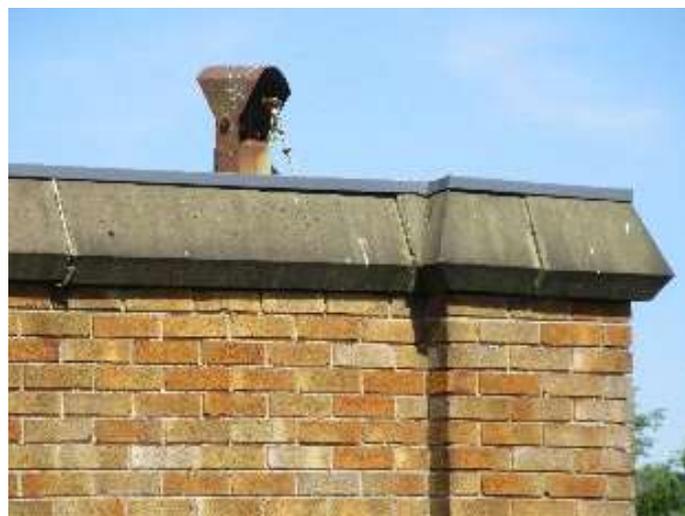
41. A single bell in a steel frame on hardwood legs stands by its own weight in the Tower parapet gutter with a rope through a raised collar in the gutter. Working order.

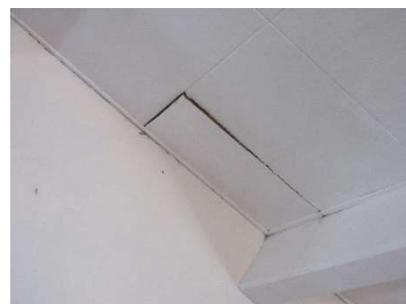
53. **Vestries** have sound plaster on softwood joists with thin insulation quilt over part only. Adding thicker quilt throughout for economy and comfort would be easy.

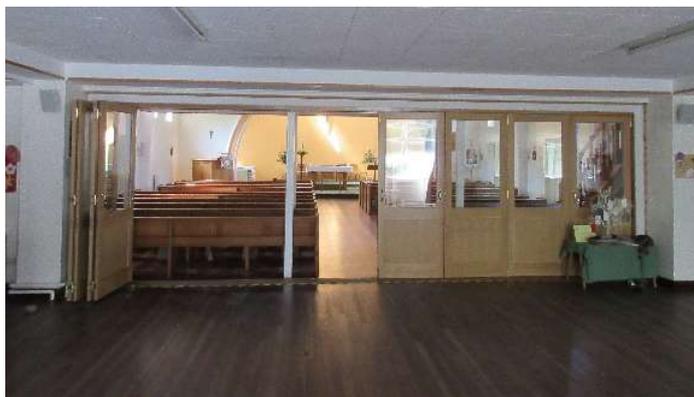
64. A wide masonry arch, fully plastered with a scotia mould on the Chancel side and roll moulds on the Nave side.
65. All partitions sound plastered masonry.
66. All doors are sound glossed flush ply. Good quality bronze lever or knob handles but some lever springs are weak. Aluminium handles at the Hall.
67. In the wide opening between Nave and Hall new bi-fold oak doors, part narrow gap double glazed. Bottom track makes minor hazard despite oak ramps both sides. Limited sound separation.

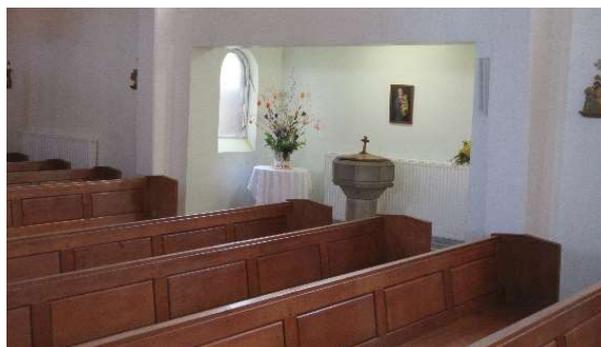
85. Light oak furnishings generally including an unusual 'boat' section altar, low rails tall candlesticks and an elegant lectern.
A second older oak open table pattern altar with frontals as a Chapel at one side of the Chancel.
86. An unfixed oak pulpit. A cast stone font with rather loose cross on the oak cover.

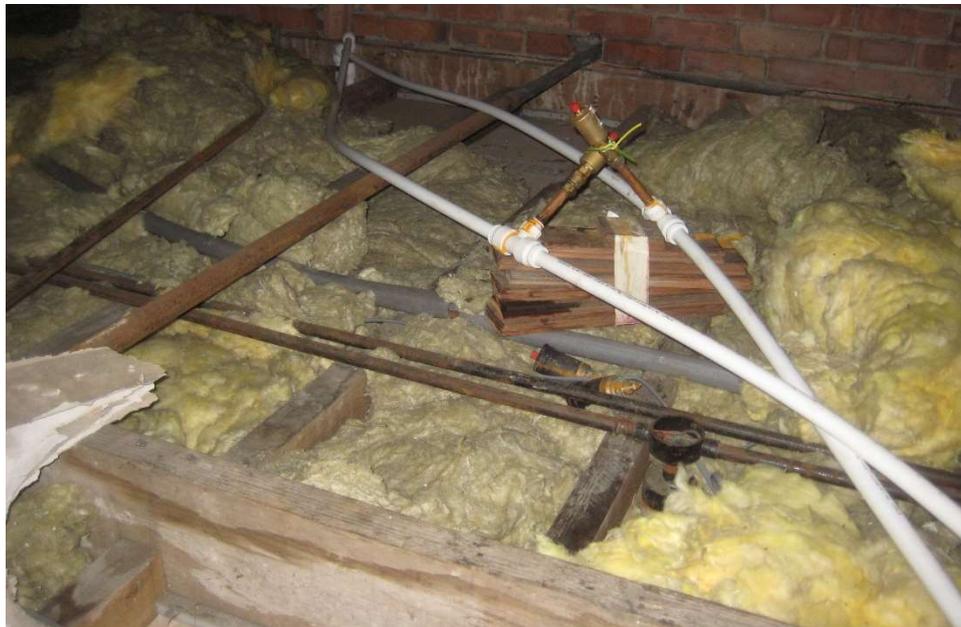
89. Gas entry and meter in the Pantry backing onto the Boiler house. Two gas wall boilers and balanced wall flues. Pressurised circuits so remaining feed and expansion tank over the landing seems redundant. Separate zones for Church and Hall each with 7 day multi-period timers in the Boiler room. Froststat.
90. Waste of energy due to incomplete lagging of heating circuits in the ventilated Boiler room and uninsulated plastic heating pipes in cold ceiling voids over the Vestries. There may be more.

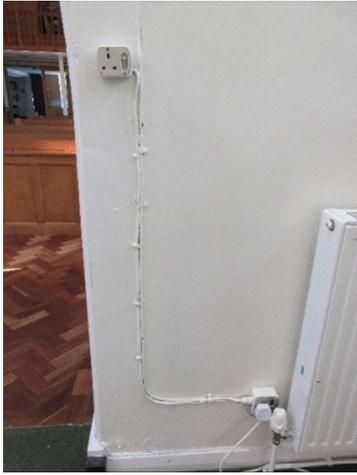
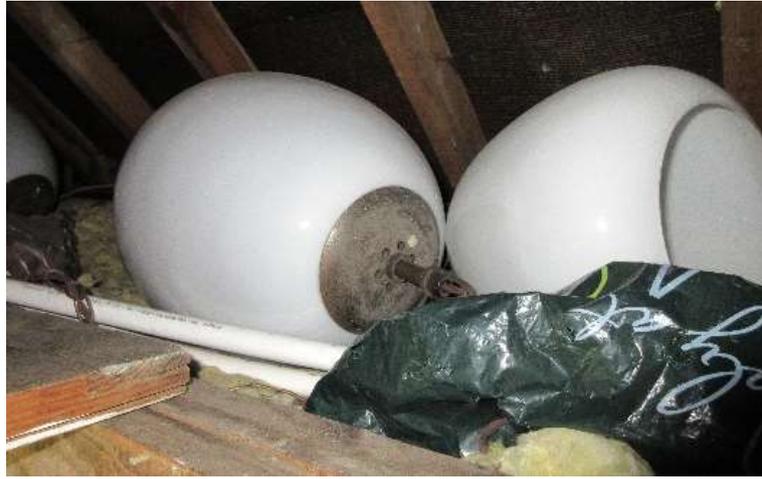
100. In Nave four halogen floods and two over the organ. Slow run up and light cold white. Light rather flat and some glare looking E. Inflexible for liturgy such as Maundy Thursday and Easter. Four graceful glass pendant shades remain in the vestry loft.
