Sadberge St Andrew
(CH. No 215)

Quinquennial Report
On the architect's inspection of

25th November 2021

Sarah Harrison RIBA

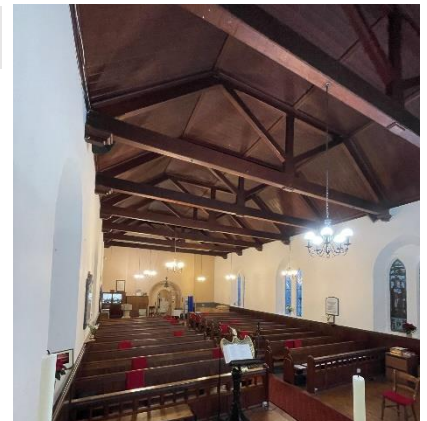
13.1 – internal view of Nave

- 13.1 Nave & Chancel** - Stained timber kingpost trusses with raking struts. 7 in the nave and 1 in the chancel, supported on projecting timber corbels. Rafters are concealed behind boarding.
- 13.2 West Porch** - Diagonally boarded flat ceiling with raking sides on purlins.
- 13.3 Vestry** - boarded ceiling with diagonal boarding in pitch pine which is fair.
