## St John, Seaham

Church No 94

### Quinquennial Report

**25<sup>th</sup> July 2023**

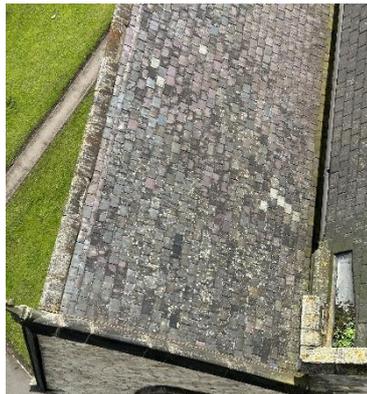
*Figure 2- N Aisle roof*

7.4 Aisle N gutter bracketed from the rafters is rusting. Silt and plants in E end and a birds nest at the W end. The downpipes are rusted at the rear.

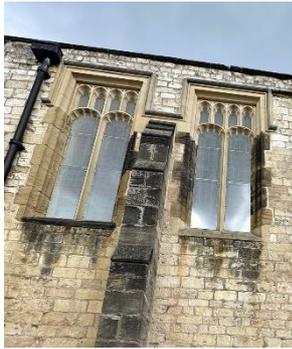
*Figure 8 – Replacement stone*

8.1 In generally good condition after replacement of the most decayed mouldings at the Chancel and limited high level pointing at the S Nave and Chancel.

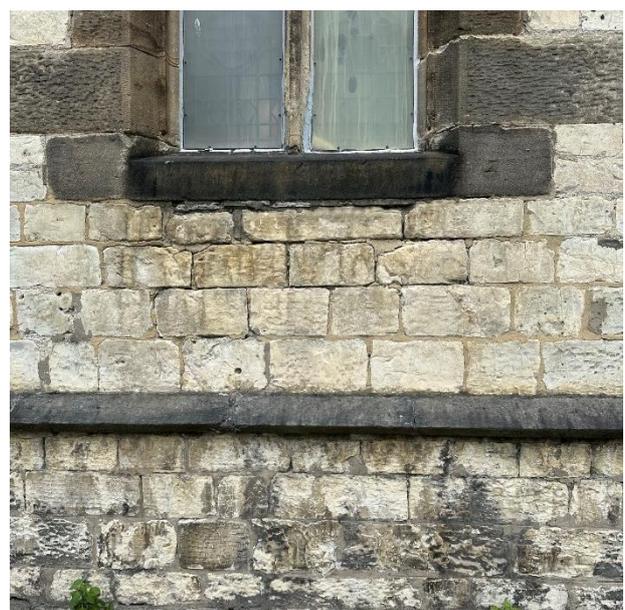
*Figure 7 – S Nave beneath window*

8.6 The watertable to the south Nave is delaminating and has large loose pieces.

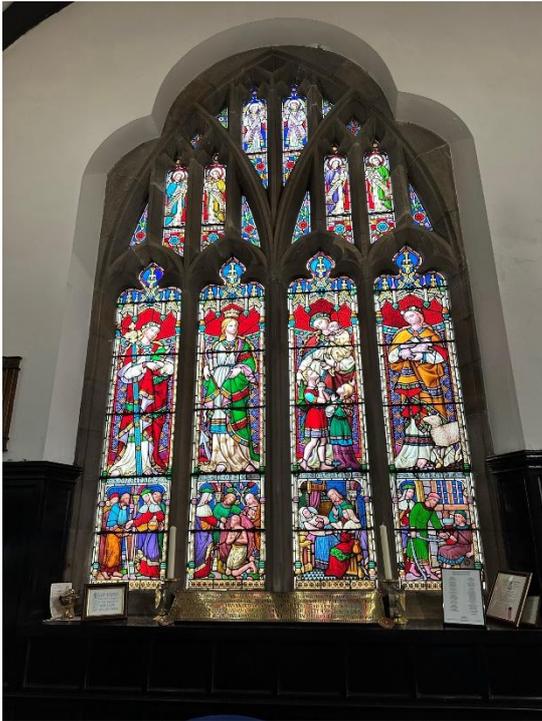
Figure 28 – E Chapel 'Frances Anne' window

18.1 All glass except the 'Frances Anne' in the Chapel was destroyed in the war and replaced to new design in the 1950's. good daylight due to white glass with inset stained glass or patterned leads and coloured glass. Light reduced by dirt and clouded protection in places.

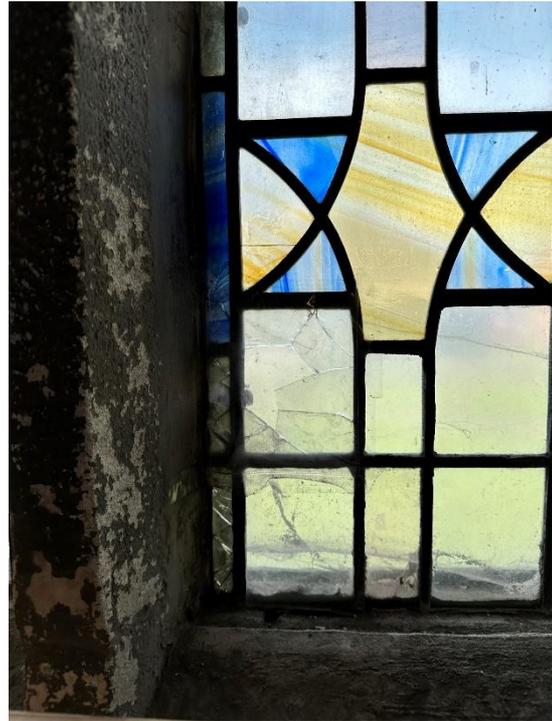
Figure 29 – broken glass to N Aisle Hall

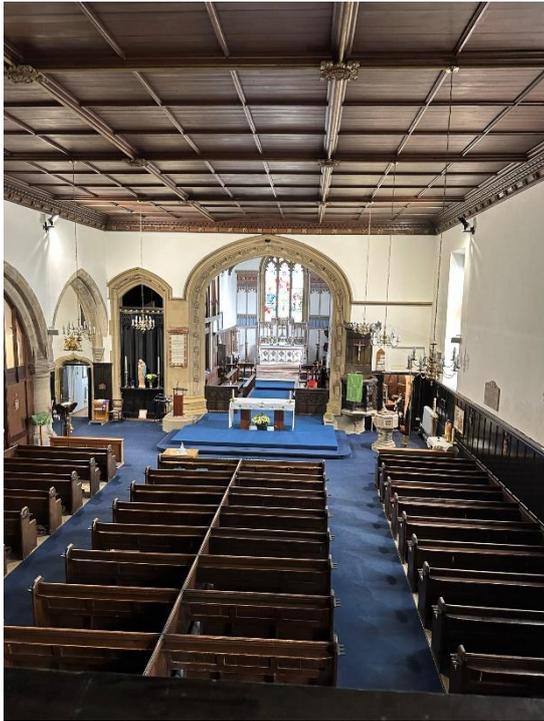
*Figure 32 – Nave and steps to altar*

19.5 The Nave floor has been simplified with good carpet over the worn stone in both walkways and on the renewed stone at the Nave E end.

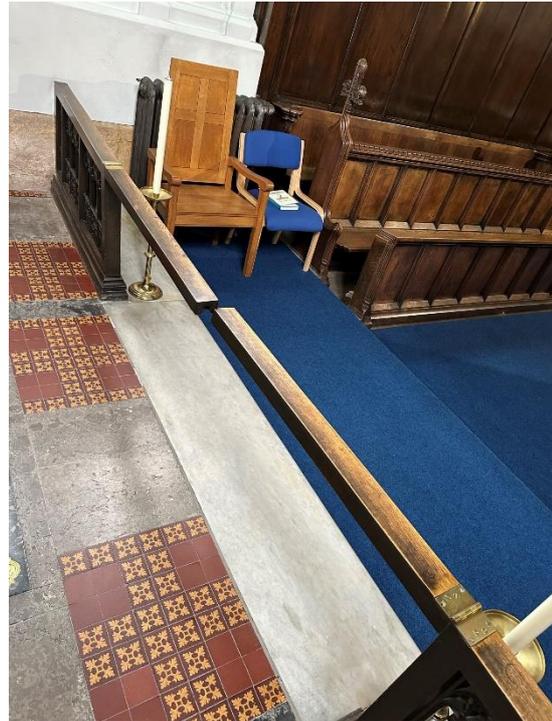
*Figure 33 – Sanctuary mosaic, new carpet, and rails*

19.9 Sanctuary mosaic, marble steps and a chequer of frosterly marble. A few tiles raised by distortion. Oak communion rail with long centre rails hinged up. S half a little loose and leans back so the hinged rails don't meet. Sandstone steps at altar serviceable but eroded and worn in patches with open joints. Two steps down to Vestry have worn sandstone treads and risers pushed out a little due to damp at item 16.2.

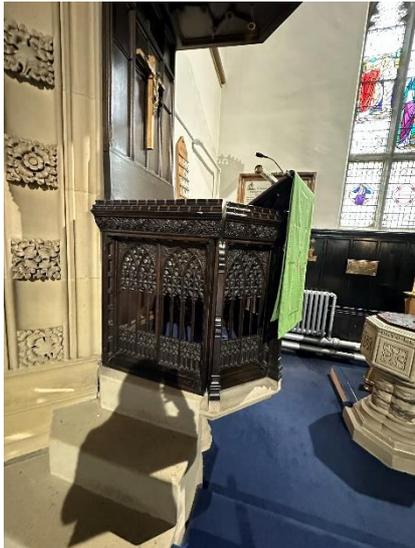
Figure 34 – Pulpit

20.3 Carved oak pulpit on stone base has a slight chip to the door. Marble and sandstone font with oak cover in SE corner. Coat of arms. Modern lectern in steel on a stone base. Original numbered varnished pine pews. Chapel altar with 'coal and port' relief carving, good oak chairs and frontal.
