**QUINQUENNIAL INSPECTION REPORT
OF
SEDGEFIELD, ST. EDMUND**

**INSPECTION OF CHURCHES MEASURE 1955
CARE OF CHURCHES & ECCLESIASTICAL JURISDICTION MEASURE 1991**

January 2021

Beaumont
Brown
Architects LLP

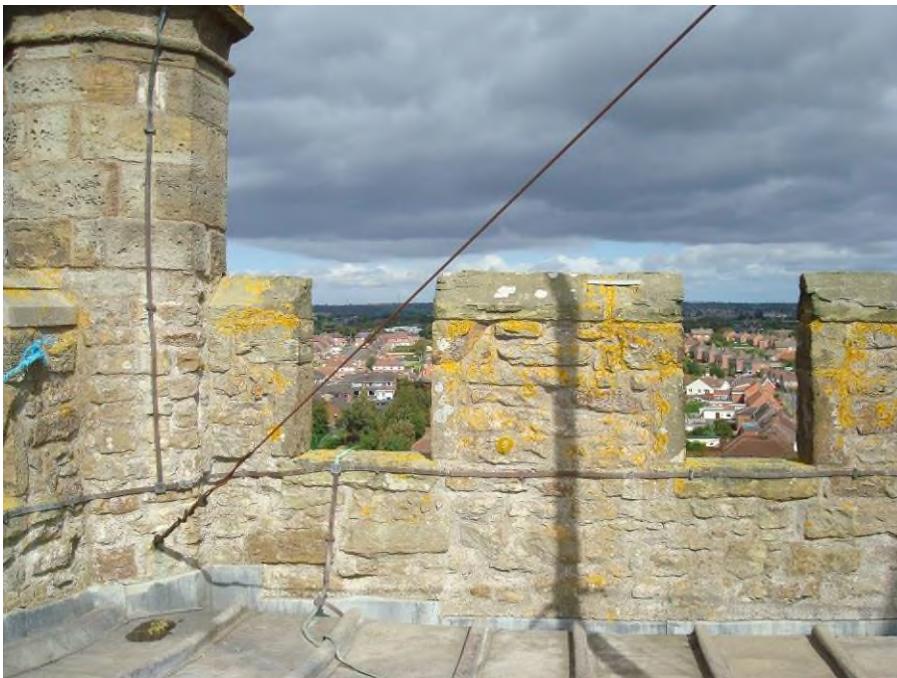
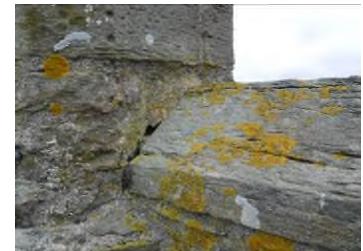
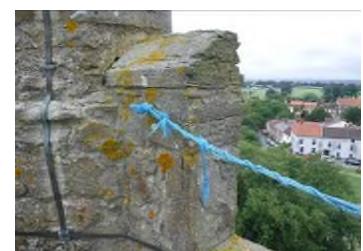
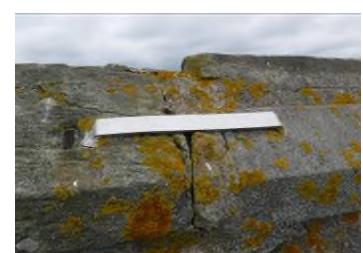
C Tower Roof:

Leadwork is all sound, the flashings are pointed in well though on the N and S sides there is a little bit of a gap but they are not coming out there is just a bit of shrinkage on the mortar.

The crenelated parapet is sound, there is cramping to the moulded copings and some lamination to them but they are generally sound. In the S W corner there is an open joint as the coping meets the pinnacle.

The flashing solder is coming away at the pole lead joint so there may be a bit of water going down, we will have a look on the inside next. The stay cables are rusting, the shackles are generally ok, and the collar is a bit rusty. It all depends on the bolt whether that is good enough it looks ok and the ropes are fixed to the corners and there is some oil cloth on them just to try and keep the rust off.

Recommendation: carry out minor repointing and pole flashing works

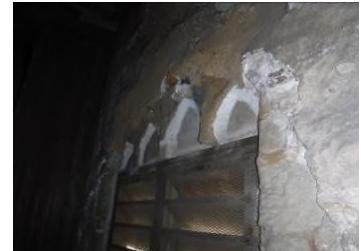
- **Bell Chamber:**

- **Ceiling** – The roof is in good condition, there is no obvious leaks through it. Apart from some staining on the pole beam from leaking pole flashing.
- **Walls** – The walls are a bit patchy, the render is coming off but not significantly, there has been some repairs to the tops of the belfry openings on three sides, E is the one left undone and it's been parched up with a bit of mortar and looks ok. Some pockets in the wall from previous beams, odd bit of funny patching that isn't so good but it will do in here I think.
- **Floor** – The floor has got a mineral felt covering that seems ok, there is a bit of water that gets through.

General – The timber louvres are all good as is the mesh backing it so there are no birds in here. Access is exceptionally good to the roof space. There is a redundant clock weights cupboard in the corner and the room is quite tidy. The bell frame is timber 1770, the bells were rehung in 2000.

- **Recommendation:** none

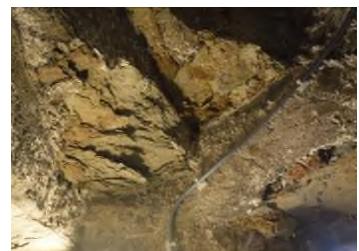
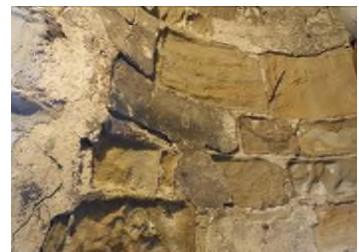
Spiral stair with stone treads, the majority are reasonably good and those are either the originals or have been repaired with concrete toppings of variable quality and the top ones aren't as good as the lower ones.

It is the bottom eighth that has the worst of the walling and there is a crack at around about eight risers up in the wall which looks ancient. Not mentioned in last QI. Monitor the crack

Recommendation: Monitor the crack

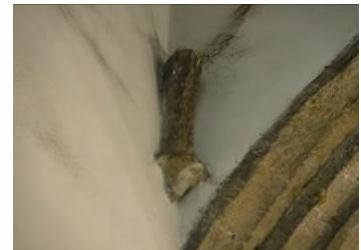
D Tower Meeting Room Attic:

This double height space has a meeting room at ground level and an open attic space above it. The following describes the attic space.

- **Ceiling** – Is boarded and in need of decoration.
- **Walls** – The walls are plastered and there is evidence of previous springing point for a stone vaulted roof and there are remnants of damp up at high level.
W window centre panel bottom part- the wire tie is coming away from the glazing and on two of the three windows, the bottom pointing has come away. Ironically the draught coming through it probably helps disperse the mechanical ventilated air from the room below.
- **Floor** – The ceiling of the meeting room below is overboarded and provides a storage space for large items such as ladders.

Recommendation: repair window

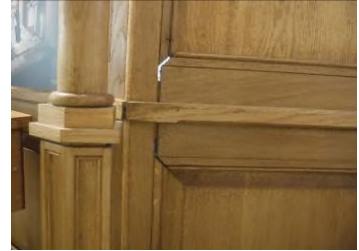
C Tower Meeting Room:

- A single storey room at the bottom of the tower, which is all reasonably serviceable, it has had some damp at its low walls in the past, and there are thoughts of updating fittings. Walls are generally ok though there is some slight damp showing.
- The door just catches the sill slightly. The frame is coming apart.

Recommendation: ease door, repair panelling

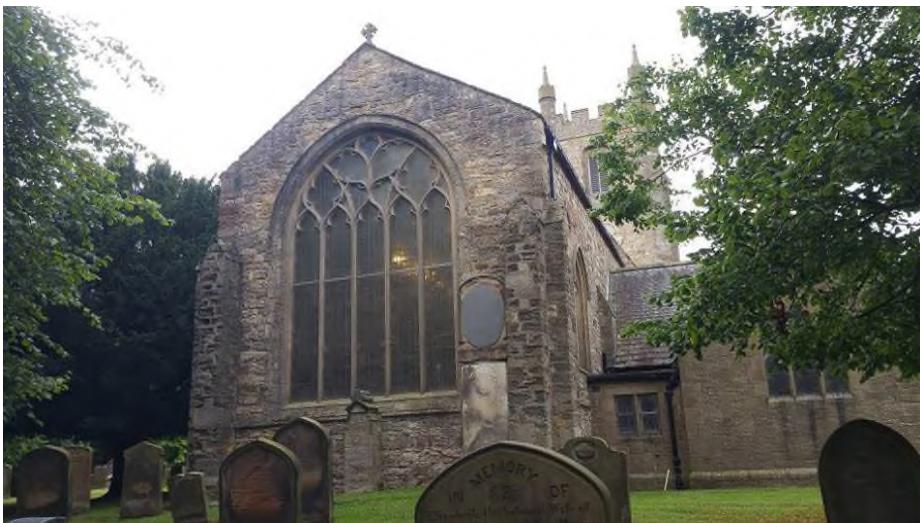
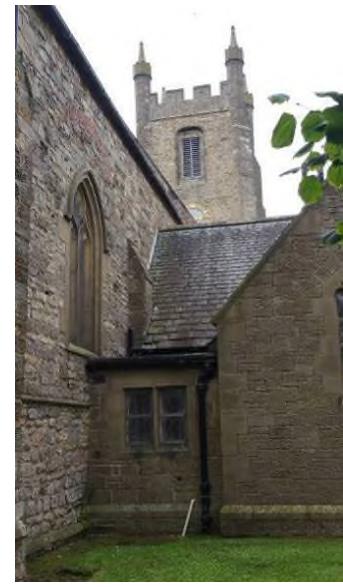
North – Random walling looks ok, relieving brick arch over window is sound.

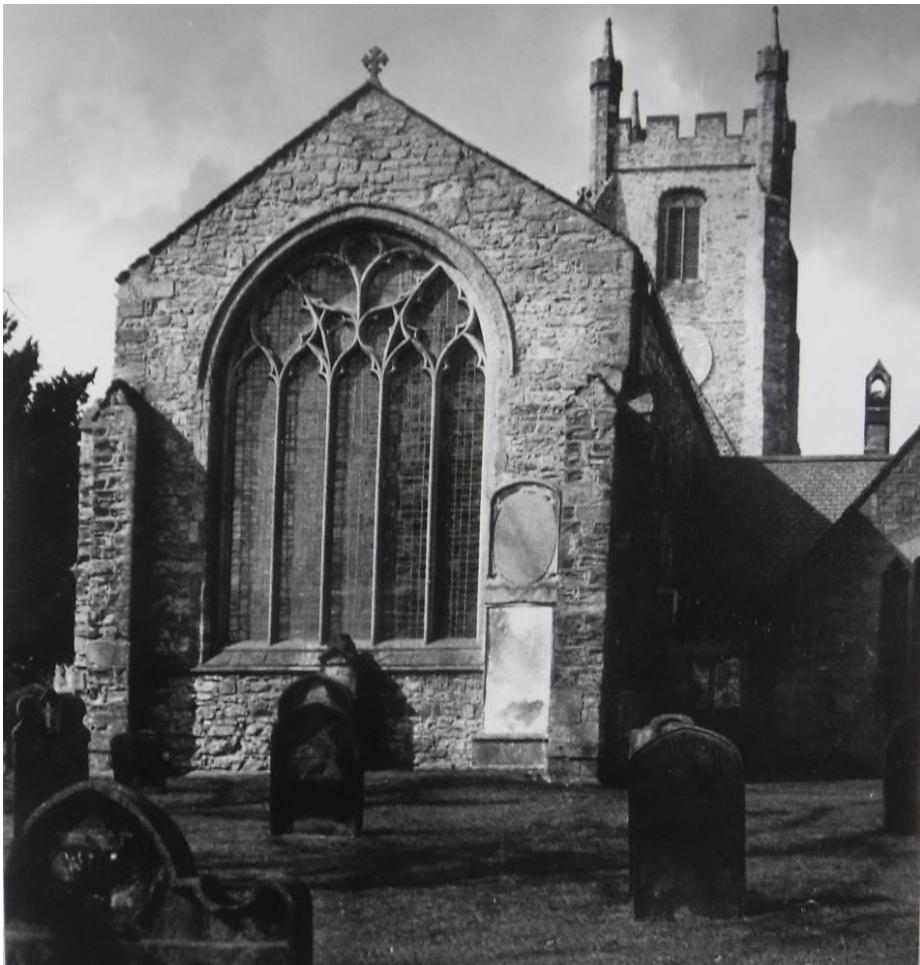
Earlier image, date unknown. Compare erosion on S buttresses

East – Water table looking gnarled. The walling is sound but there is some honeycomb to it, particularly the reveal of the window which has been patched up with cement in the past. The buttresses on either side are honeycombing but they are structurally intact, they are more eroded on the S side. Comparison with the historical picture suggests the decline is slow.

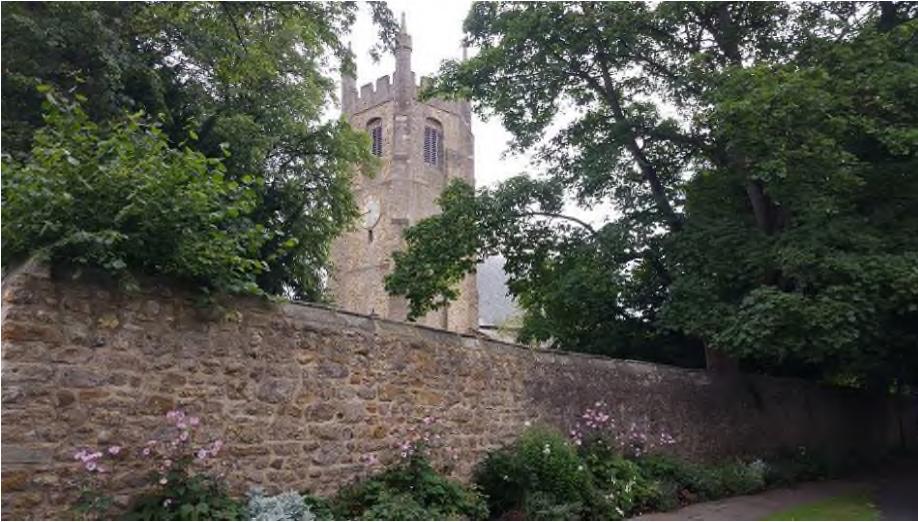
D South Boundary:

High stone wall in good order but regrettably smeared cement pointed so it is very hard, some areas are in lime but the majority cement, it is all reasonably stable. One large Sycamore close to the S W corner, is it beginning to influence the wall? The other trees are of significant size.

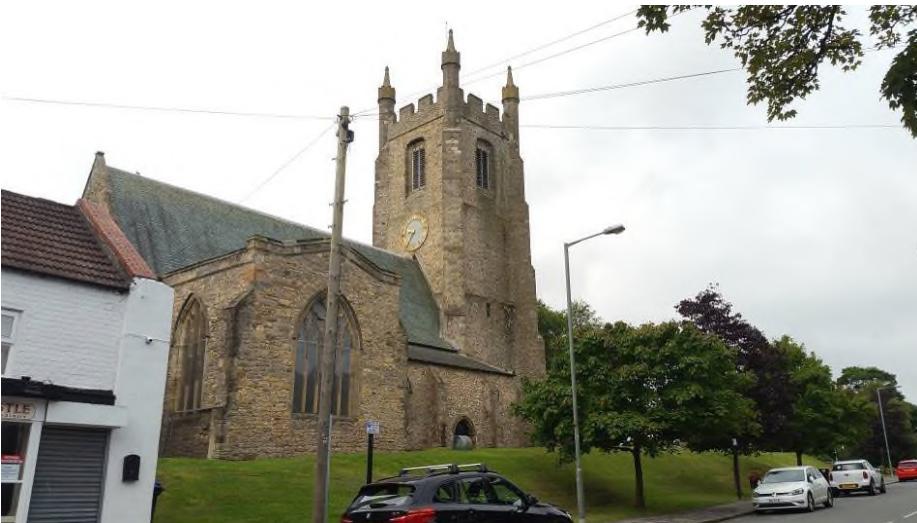
- **North Boundary:**

There is no boundary here, the graveyard which is raised to the pavement is grass that is banked down.

Recommendation: none

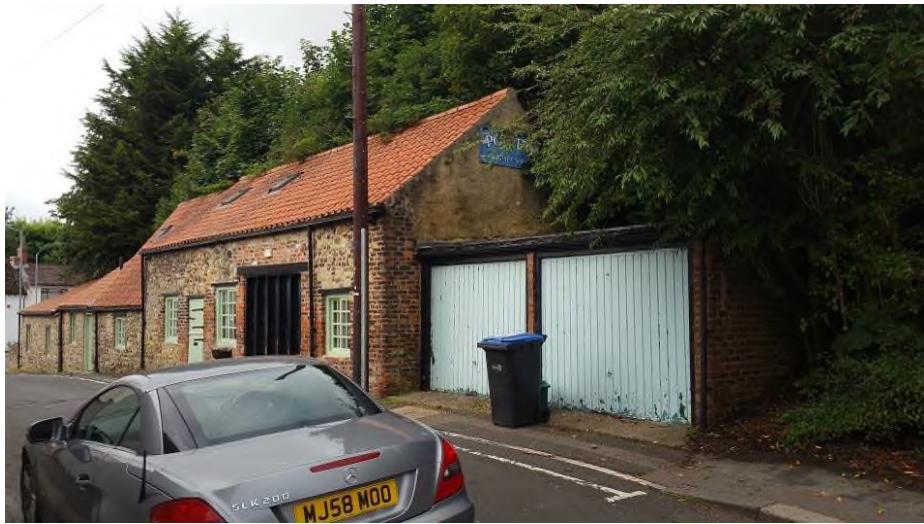
- **East Boundary:**

There is a collection of shops built up against it, they all seem recently renovated and are reasonably tidy, a mixture of stonework with brick dressings looks like it goes onto a stone wall

Recommendation: none

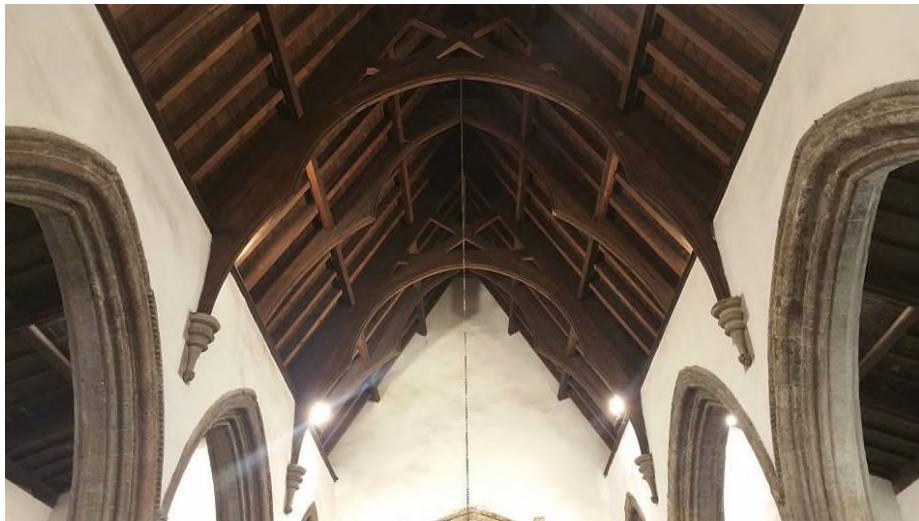
Nave:

Nave – Tall trusses with arched braces and scissors ties to the apex with purlins, deep rafters and boarding, no evidence of staining, slight markings of cobwebs at some points on the trusses.

Aisles – Simples angle trusses on to timber corbels looks as if they have been modified where they hit a window opening, they support a purlin which in turn holds up the rafters and the boarding which is no doubt sarking boarding. Staining to the general width of the S and at the N it is more to the ends and there is also some modern panelling up at the apex in the N W corner.

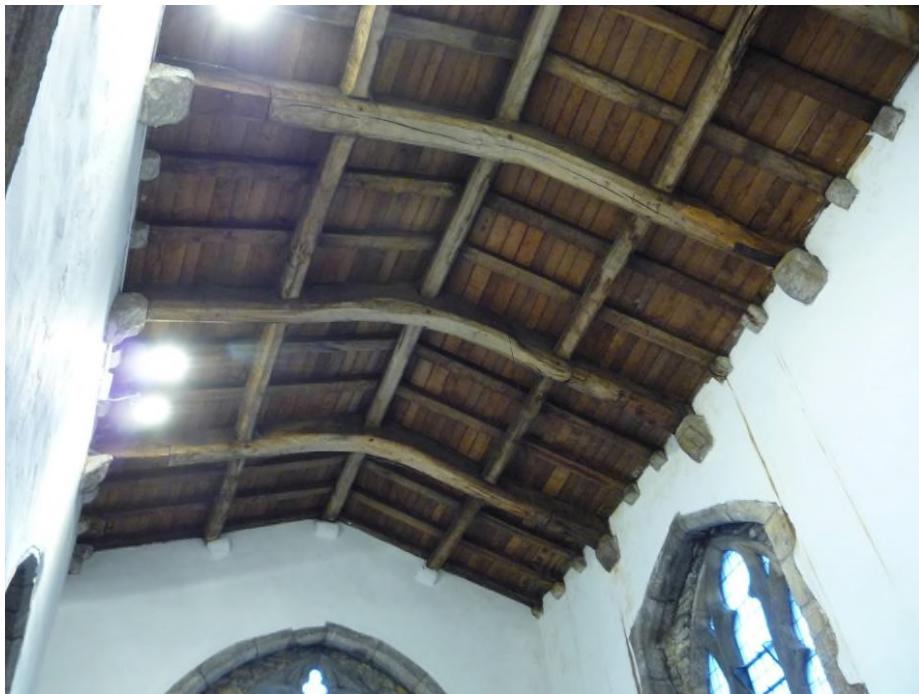
North Transept – Original exposed heavy timber angled trusses, supporting purlins and sarking boarding. This roof now has a stainless steel roof above it

and at the time of the repairs a timber inspection was carried out and all was ok. The staining is from former leaks.

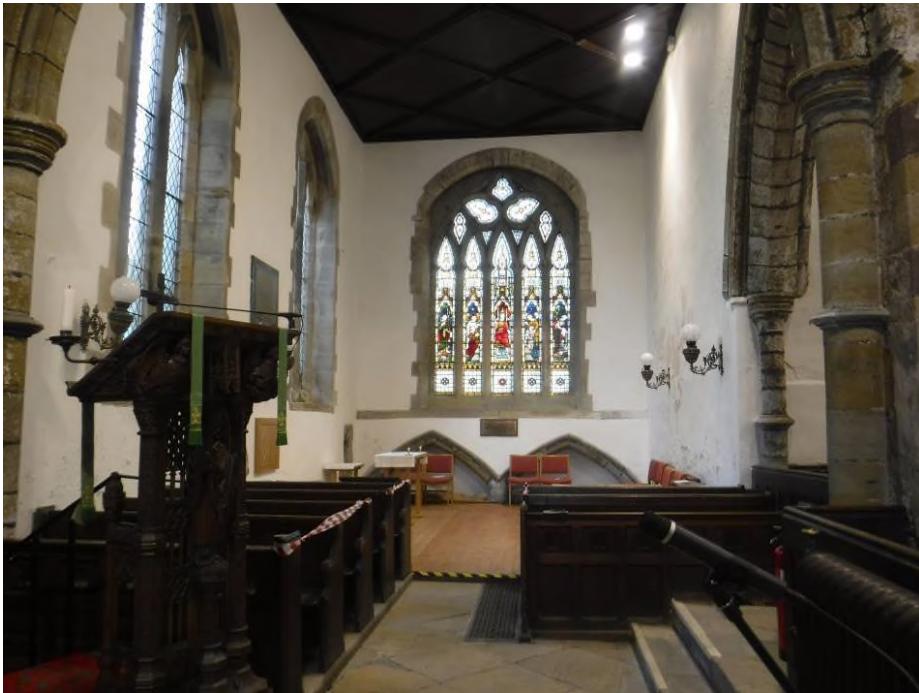
South Transept – This has a diagonally ribbed and boarded ceiling looks quite modern and this is blemish free.

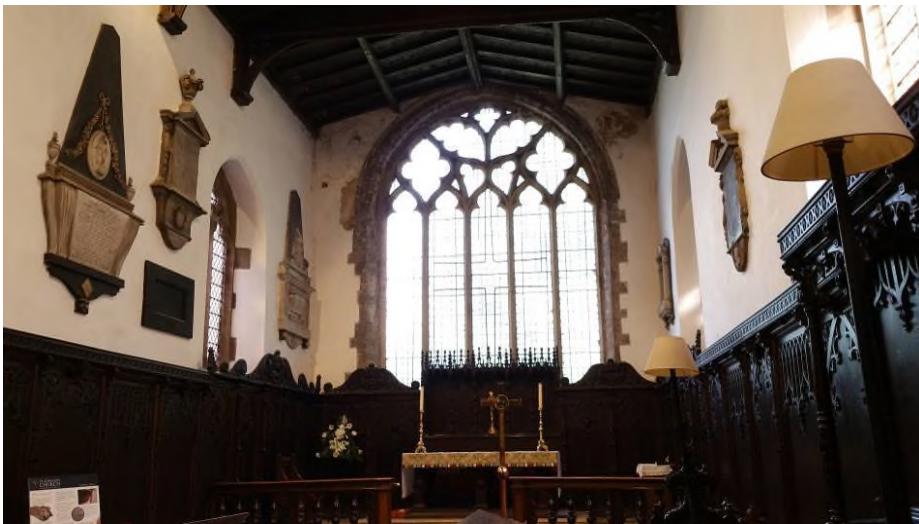
Chancel – Six heavy horizontal trusses supporting purlins, wide rafters and in some cases wide boarding, markings appear to be in the N W corner.

Recommendation: none

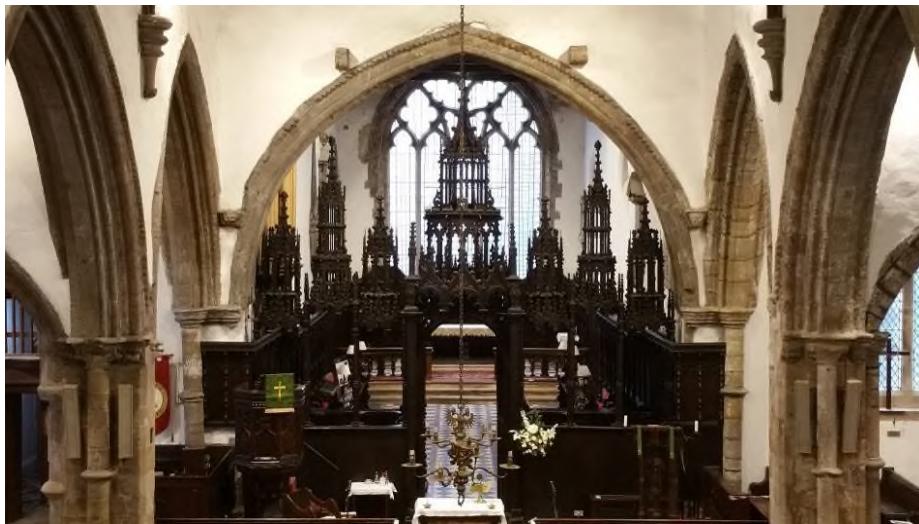
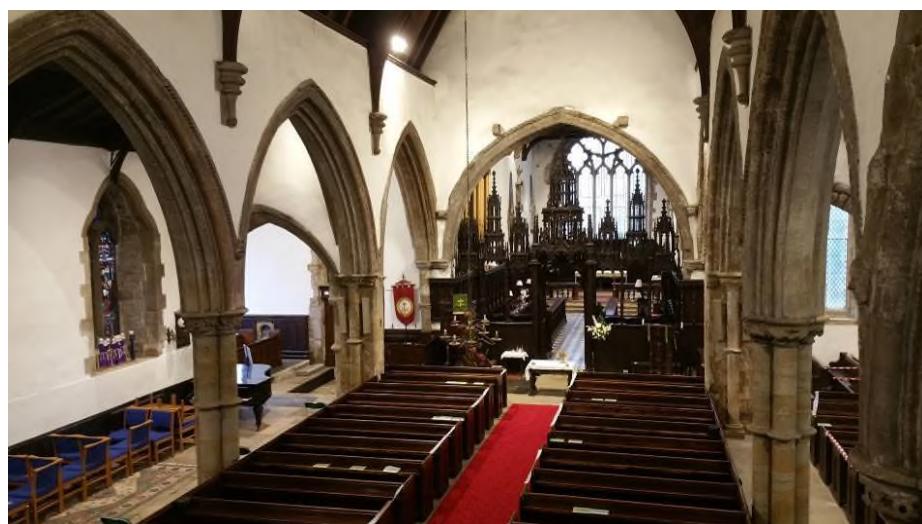
Arcades – Are a combination of four shafts with capitals and ring mouldings and towards the W end; a square column with two circular columns either side, they are attached at with single shaft responds at both ends, the W is rather worn, they have square bases which seems to have been much messed about with and there are salts to them.

The N side is slightly out of perpendicular particularly at the W end but there is no evidence of distress, all of the arcade stones are sound, there is the odd minor open joint but they don't need attention presently.

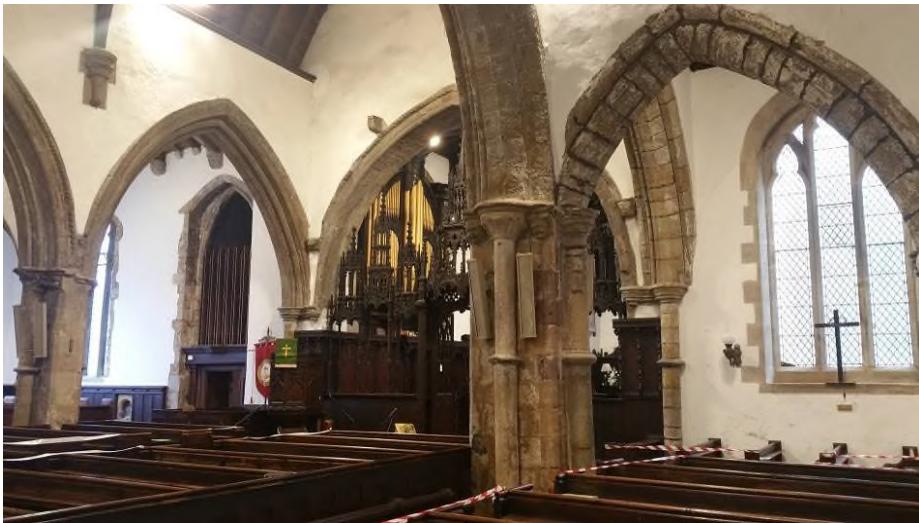
There are arches between the two transepts though they are of different styles and whilst they were alleged to have been built at the same time they are different in that the capitals are higher on the S but they line up with the arcade but are lower on the N and also the column doesn't quite come into the arcade correctly and so it has a shoulder to it. More evidence of previous lime wash on the S.

Recommendation: none

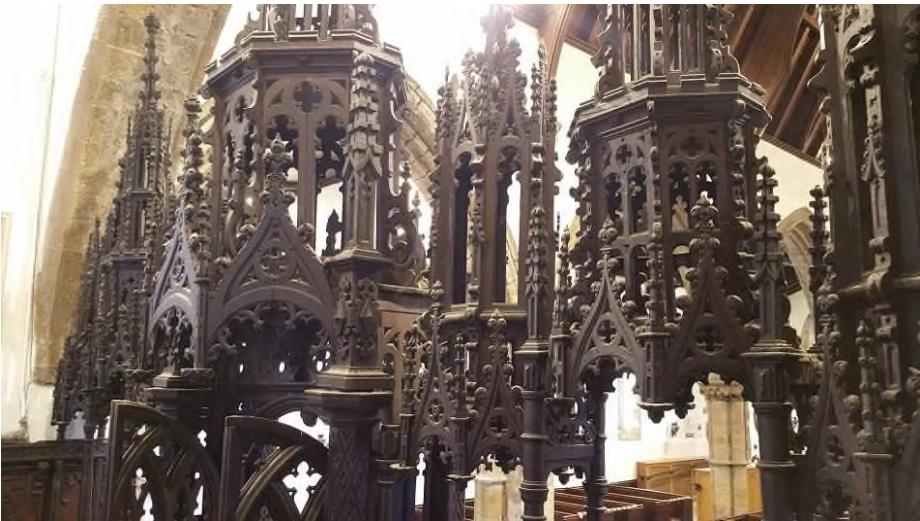
Chancel – Has significant Cosin panelling in excellent condition and all appears intact. The whole chancel is lined with misericord seating and panelling and also a significant reredos

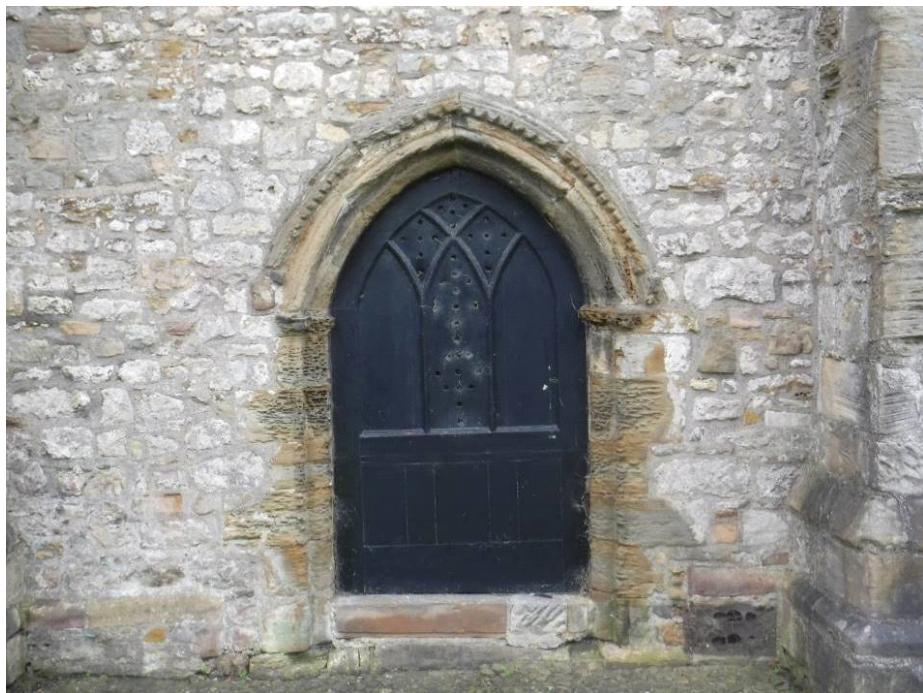
At N aisle mesh over an apparent external vent stone W of the door, not appearing through the dado inside.

Recommendation: none

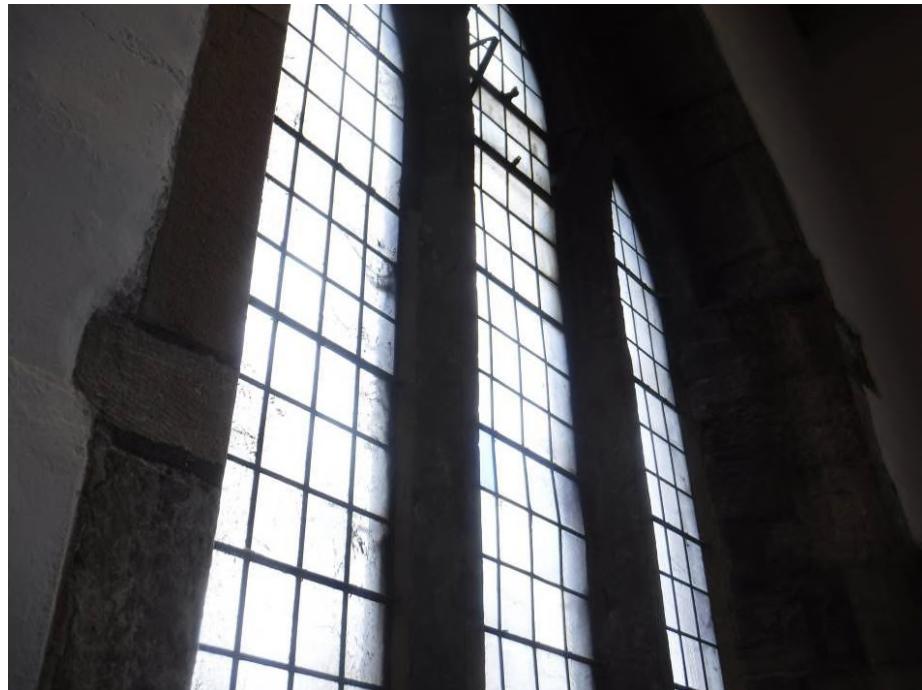
All glass except upper tower windows protected with good ventilate polycarbonate with joints aligned to saddle bars. Widespread clouding by

light and dirt in voids, except mainly the S windows in transept and aisle.
Fixings at tracery of both aisle W gable lights poor due to stone decay.

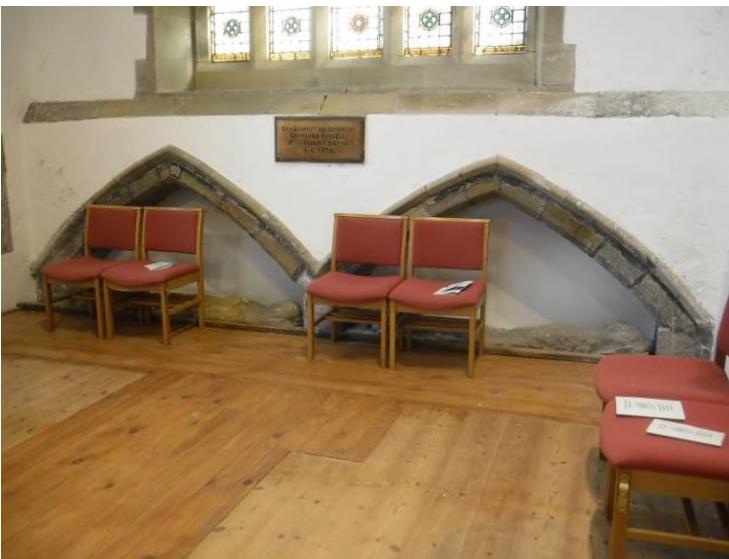
S Transept – Cleared, old pew platforms sanded and the passage between filled to match and raised to make a level softwood chapel floor with batten skirt. Good condition.
