QUINQUENNIAL INSPECTION REPORT

St. MARY THE VIRGIN

FRONT STREET, SHERBURN VILLAGE, DURHAM, DH6 1QU

Michael Atkinson Architecture + Heritage

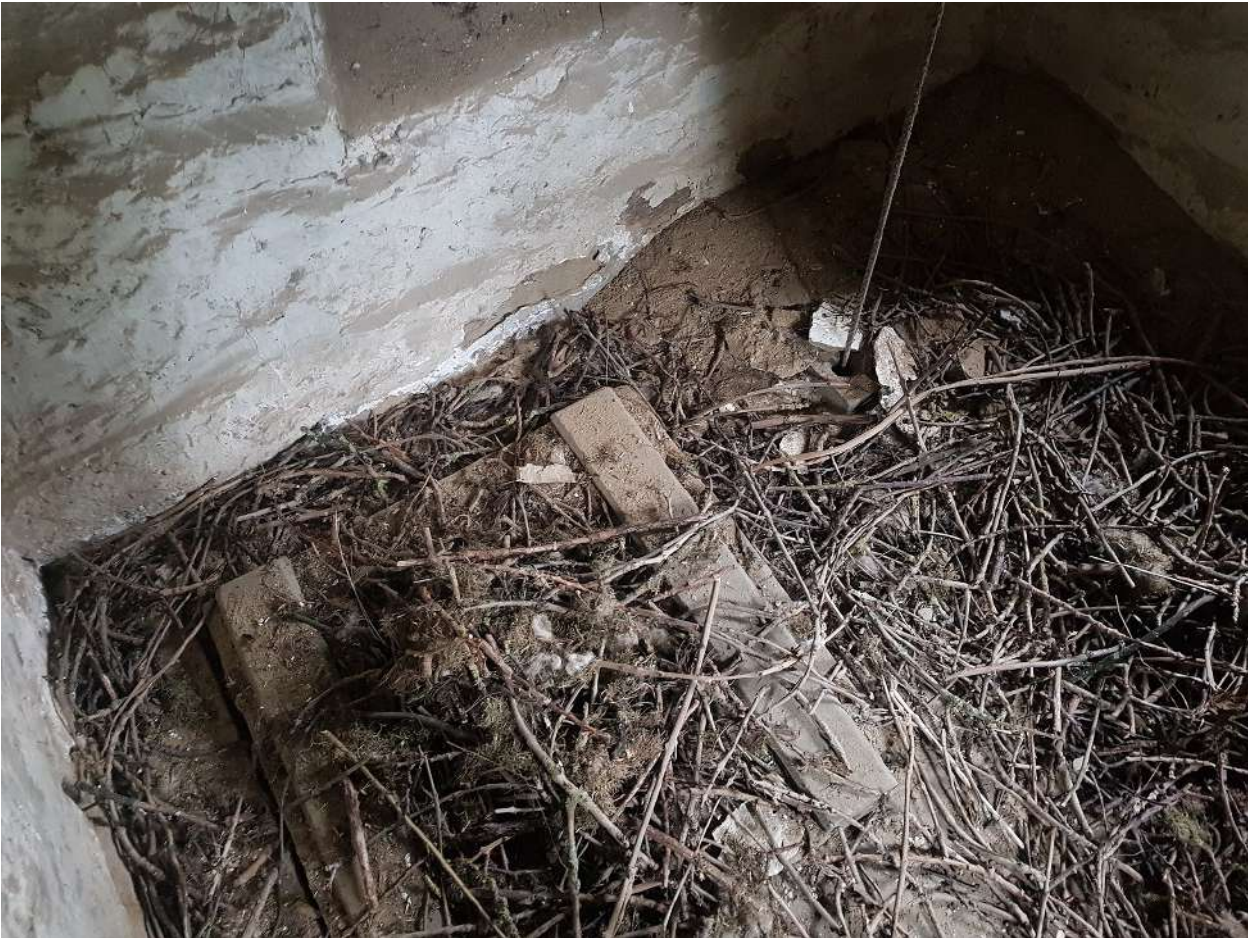
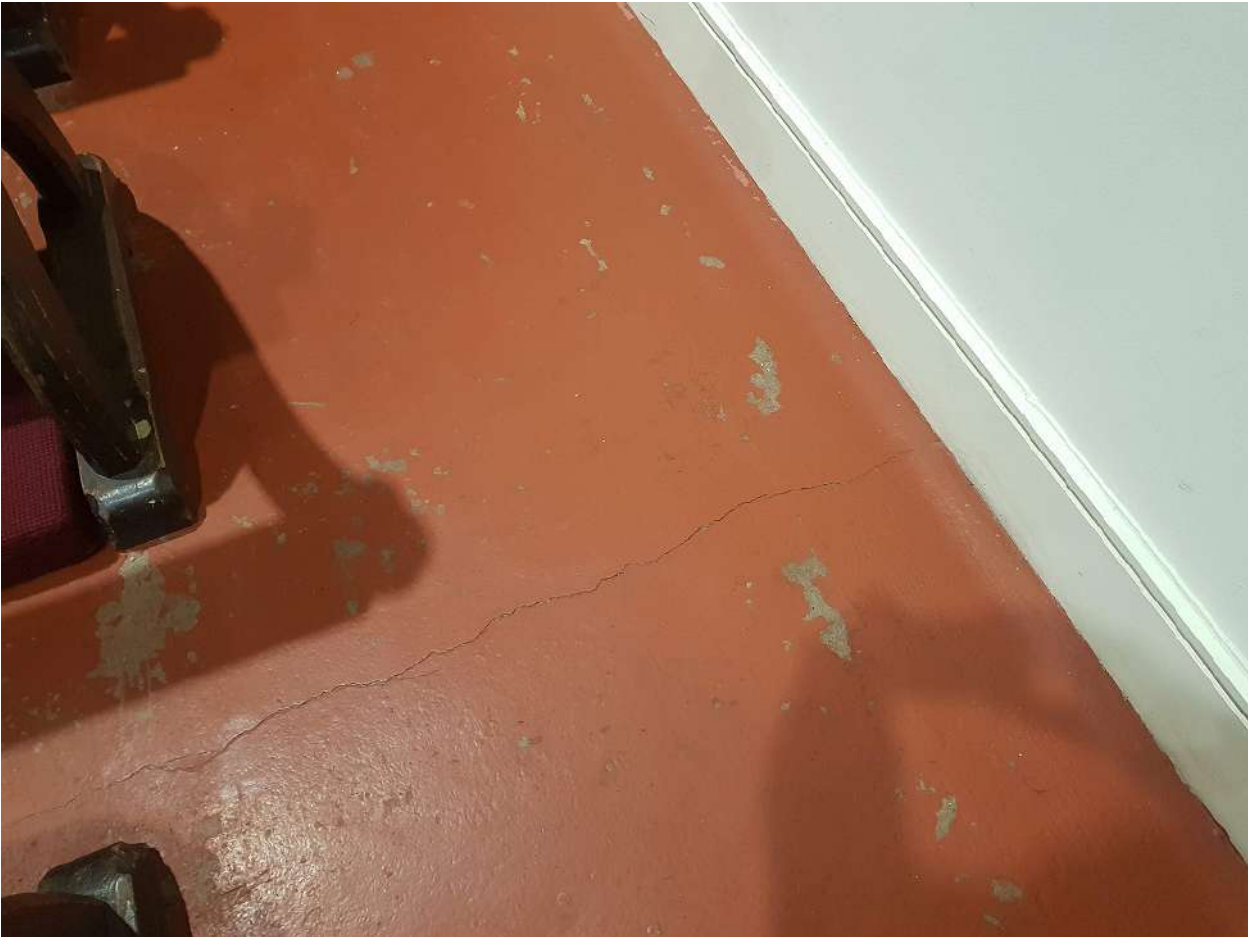
Full examination of the floor covering was difficult due to the presence of the loose carpet.

R1 It is recommended that the floor condition is assessed in detail once carpet is lifted and in conjunction with tower floor structure above.

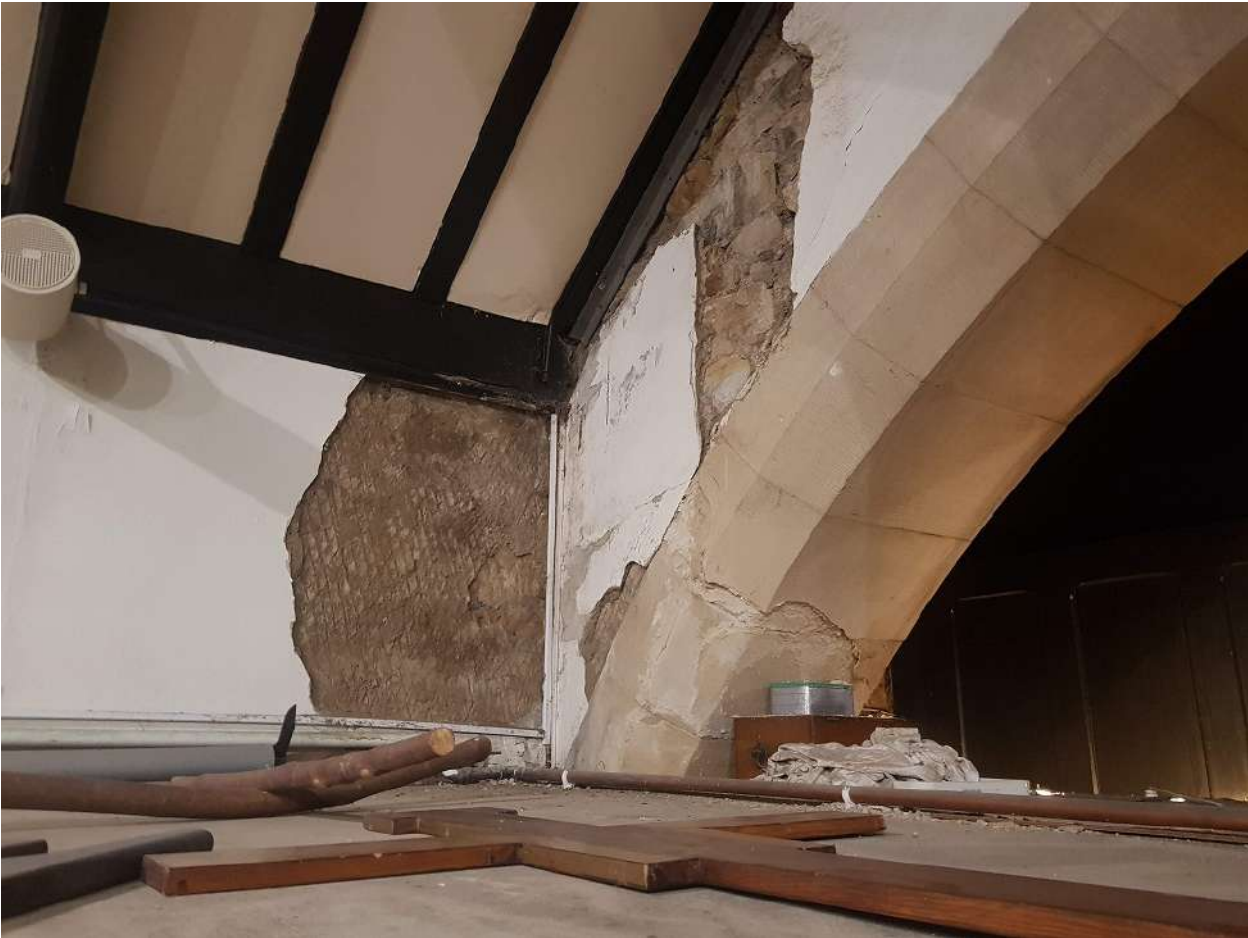
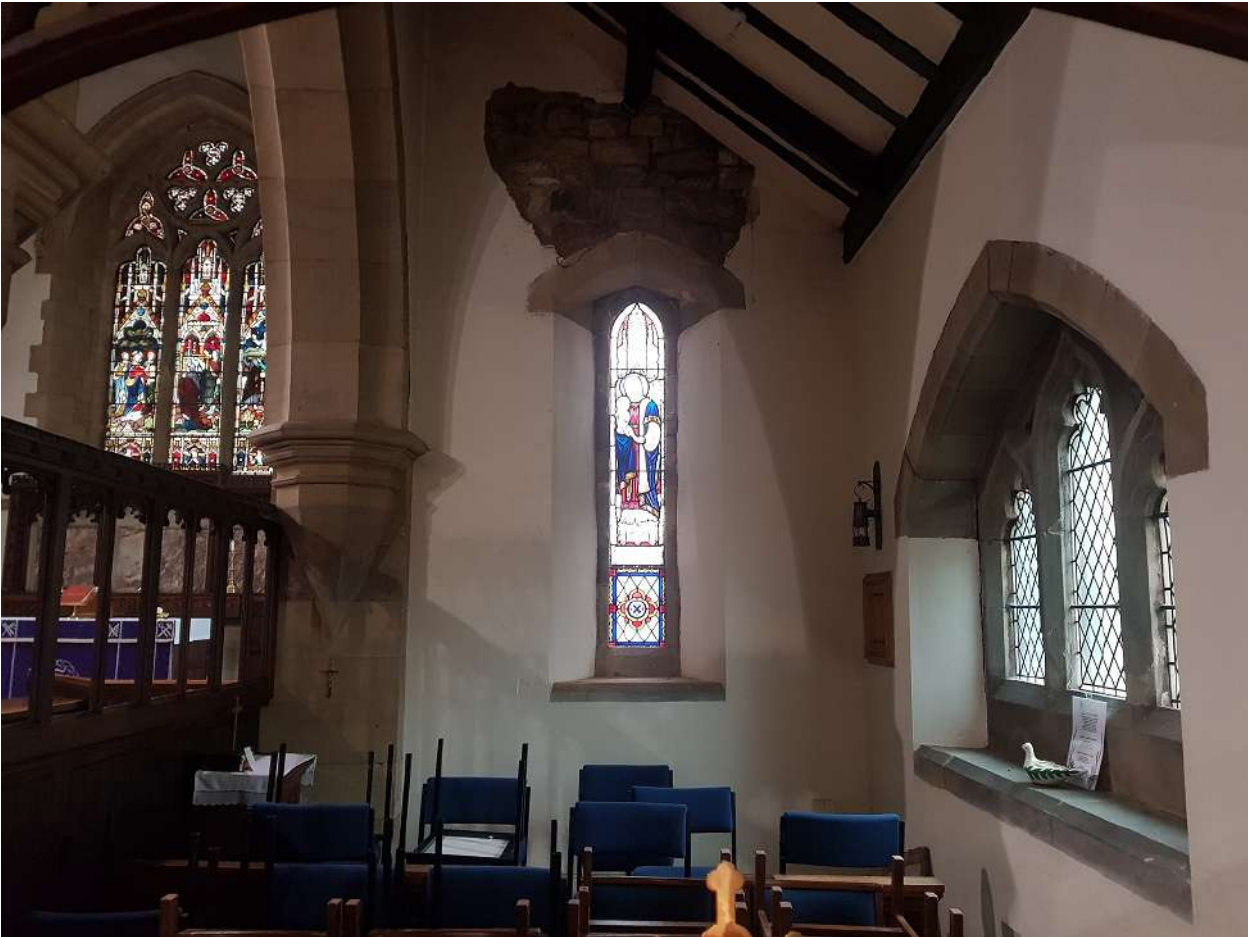
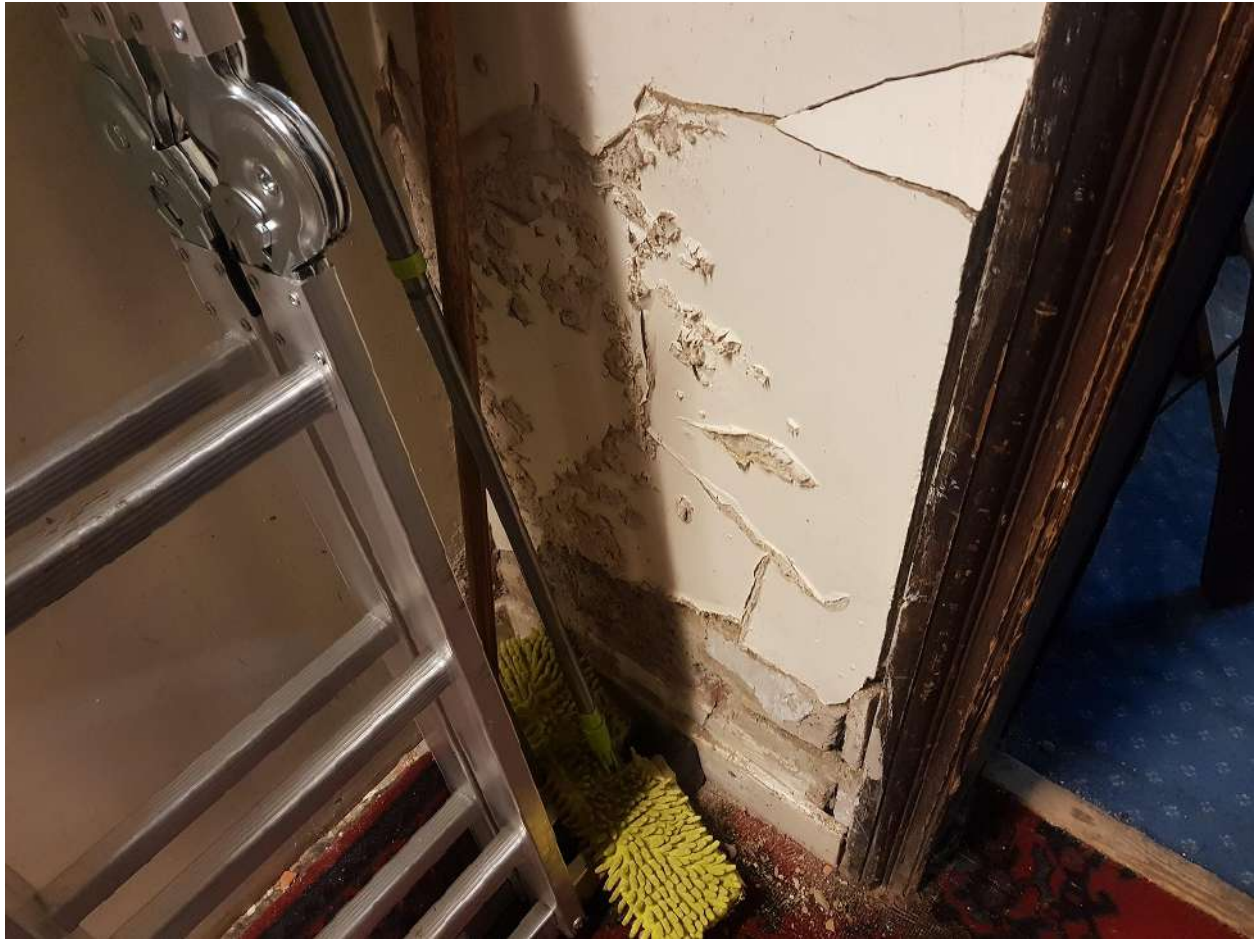
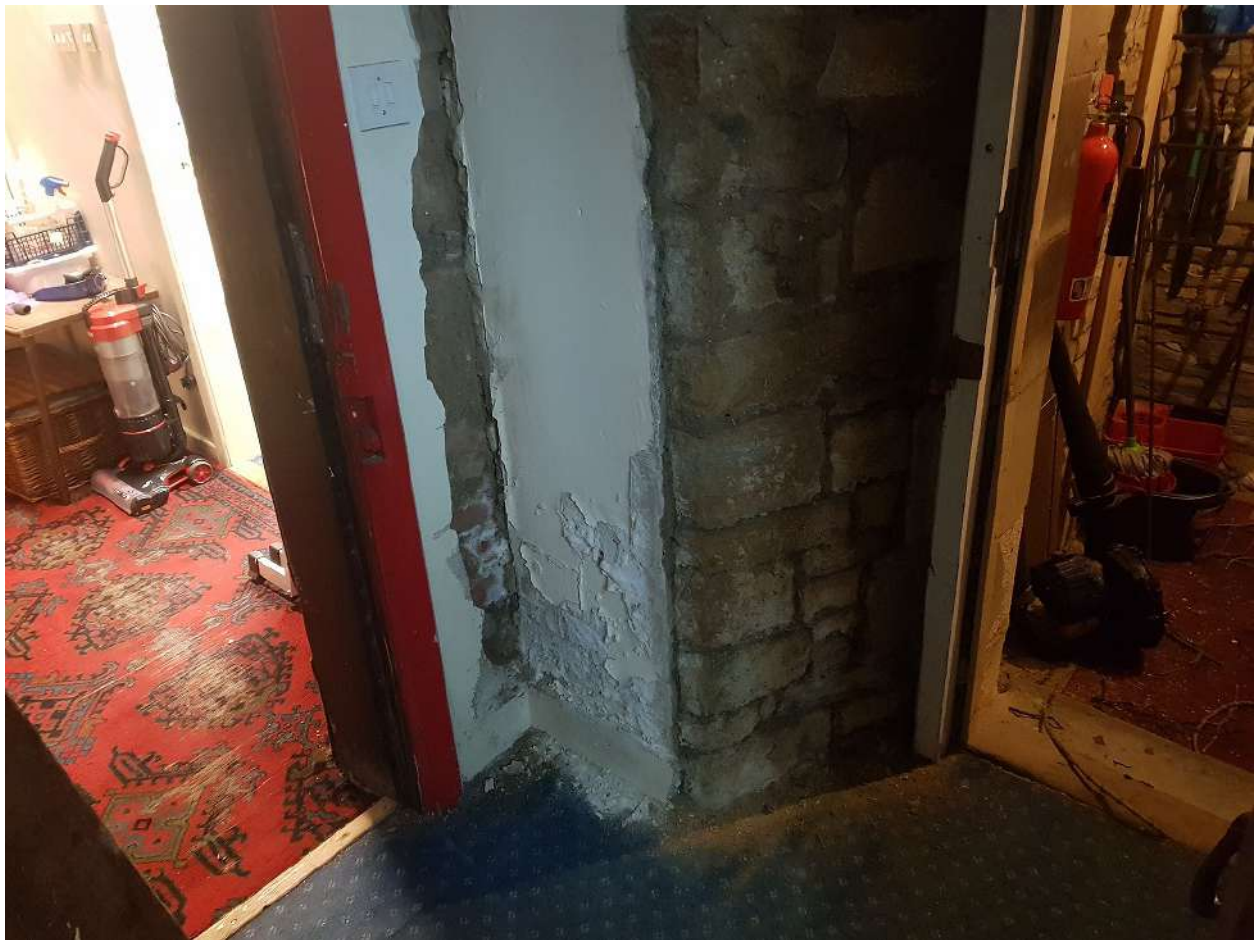
17.5 SOUTH AISLE

17.5.1 Walling looks to be in a sound, satisfactory condition with no signs of any structural issues. There are signs of movement within the walling fabric, noted in previous QI reports and are recorded as follows:

- a. South window with slight historic displacement Within Lady Chapel.
- b. Historic and slight movement to Lady Chapel arch and window closest.
- c. At entrance area there is movement to the keystone above entrance door.
- d. Cracking at junction between external walling and partition walls forming Male WC and narthex.

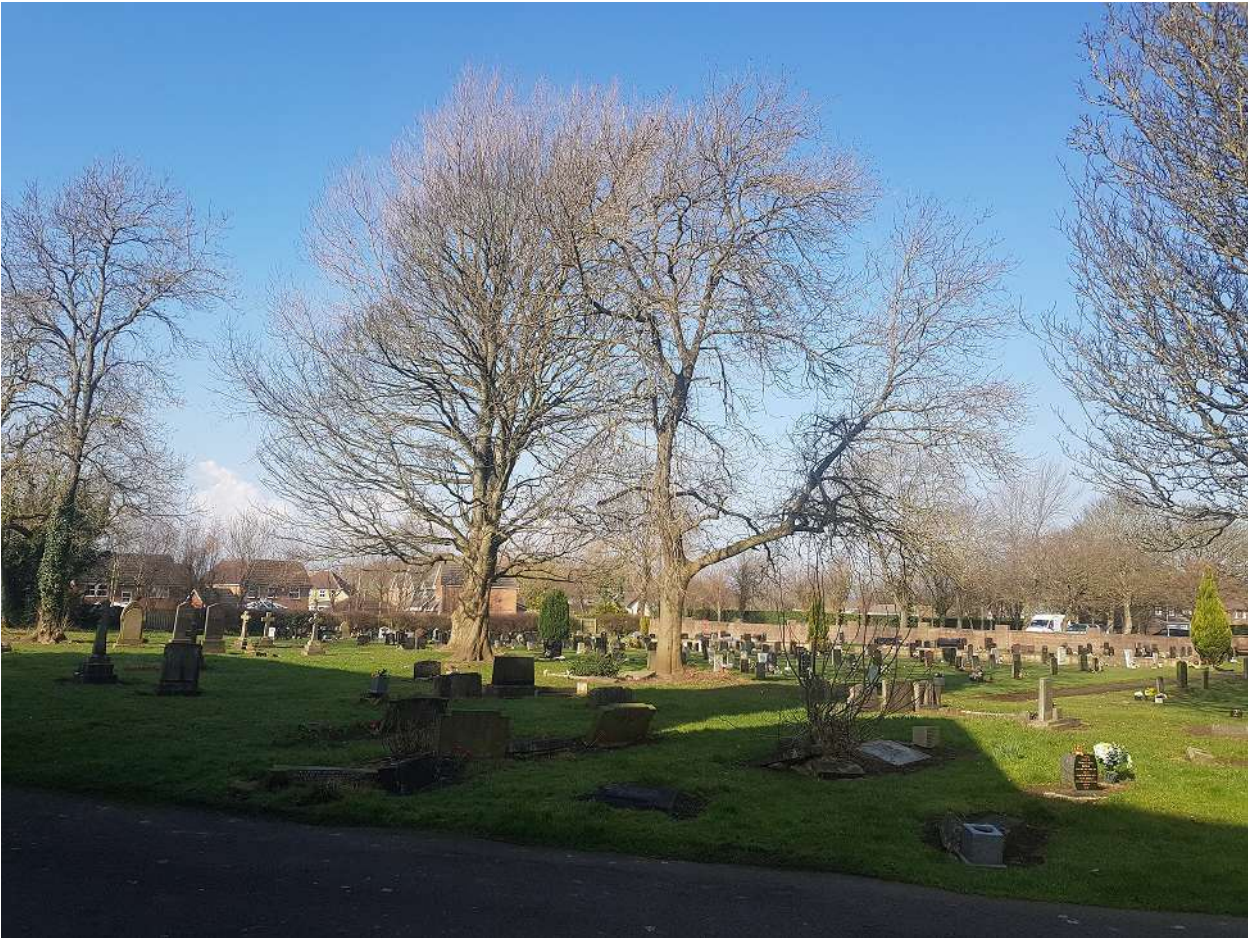
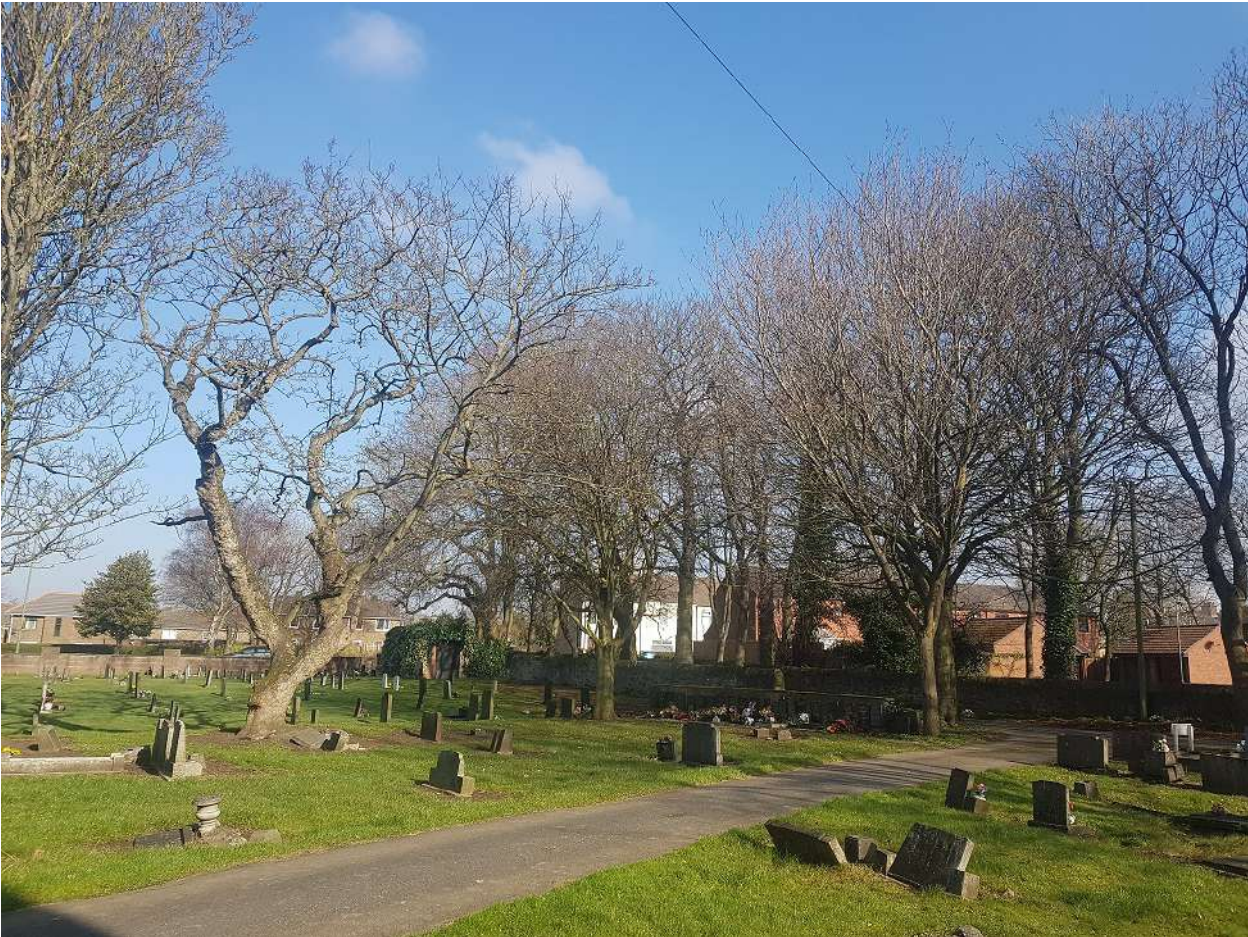
38. TREES AND SHRUBS

38.1 There is a substantial number of mature trees within the Churchyard. By virtue of the church grounds designation within a Conservation Area these trees will be all under Tree Preservation Order's. Should the PCC wish to undertake any works to any of the trees then permission is required from Durham County Council.

38.1.1 The date of the last tree condition inspection is not known.

R3
