Diocese of Durham

SHOTTON
St SAVIOUR
(58)

QUINQUENNIAL REPORT
on the architect's inspection on

9 October 2017

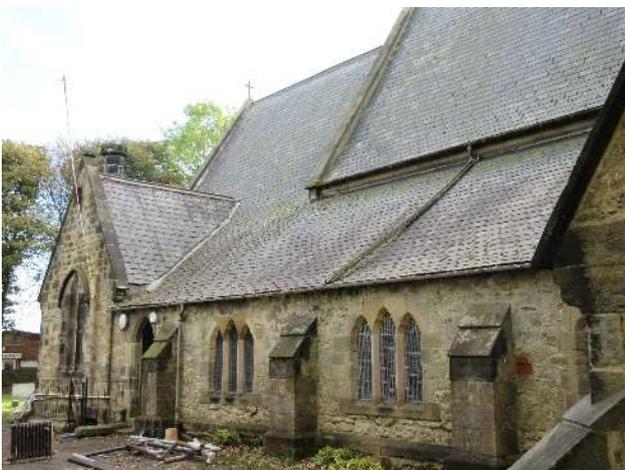
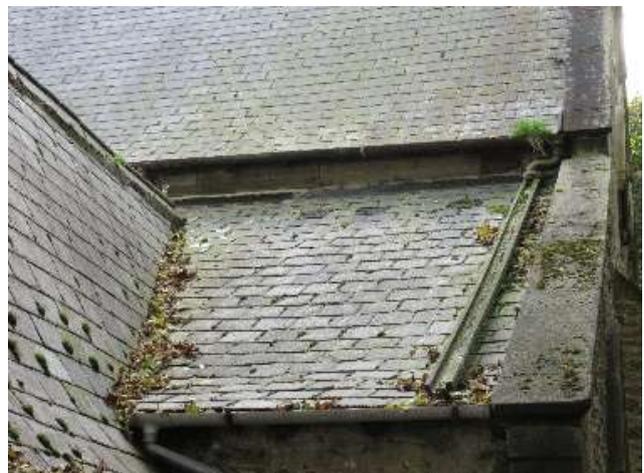
14. No clerestory. The Aisle roofs rise nearly to Nave eave level but are not continuous with the Nave. Instead the Nave has eaves and gutters above a stone corbel course and flashings on the top of the Aisle slates. This makes Nave slate repair and gutter cleaning difficult. Added wooden rain water channels cross the Aisle slates.

28. Water from the Nave gutters drops into wooden troughs across the Aisle slates held in place by galvanised straps. The troughs are decaying and do not reach the Aisle gutters. They will not function much longer.

29. The Nave and Aisle roofs so nearly meet that there is a case for removing the inaccessible Nave gutters and troughs, letting the Nave water fall onto the Aisle slates, with higher flashings covering the Nave eave stone corbels. If kept dispersed the Nave water should not leak through Aisle slates with sufficient laps.

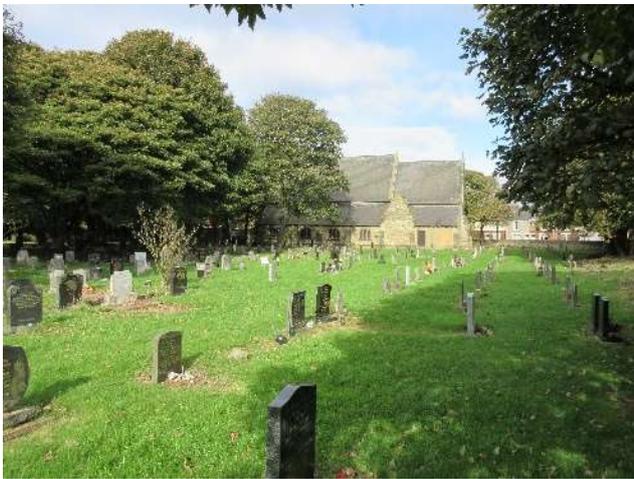
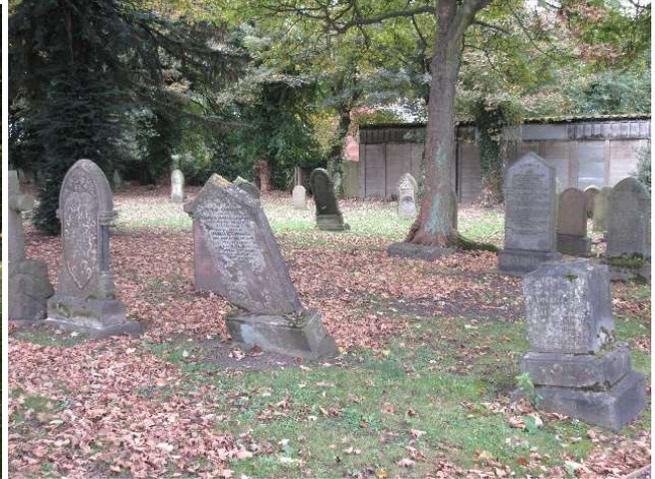
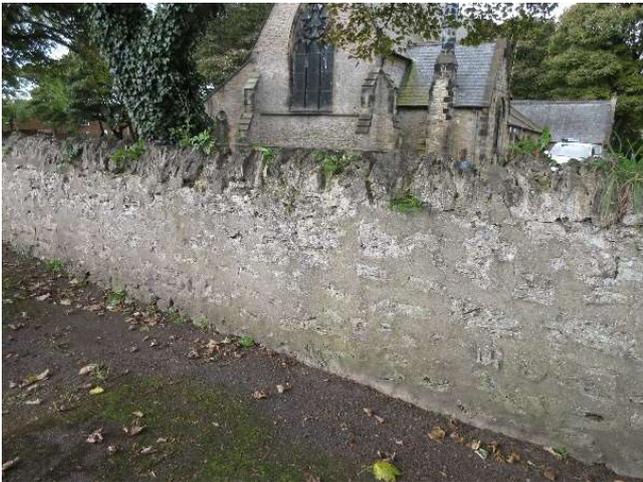
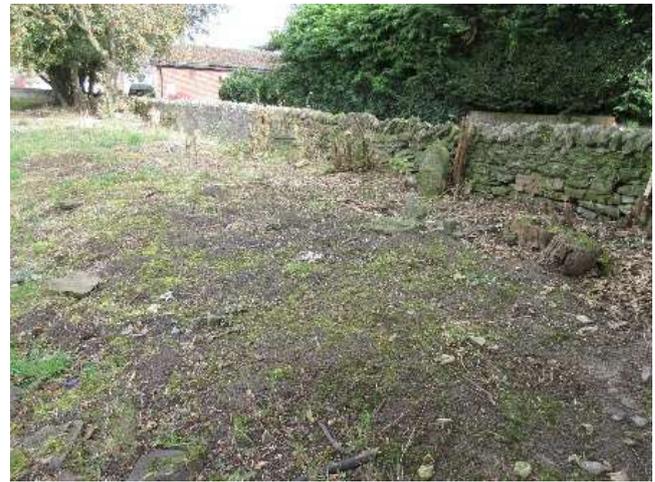
130. Large square flat churchyard closed and maintained by the County Council. Wide level tarmac drive to the Porch and Vestry. Tarmac path past W end of Nave. Flag paths at E and S and a block paved path to the S boundary, all in good condition. Rose beds N of the church designated as a Garden of Remembrance.
131. Stone boundary walls at W, E and N along the pavement with steel gates. Plants in the E wall show need for pointing. Some chain link fencing at W. Steel railings along the S boundary. Many gravestones, some laid flat or moved to the W wall. Remainder mostly sound but some leaning and some restrained by the County.

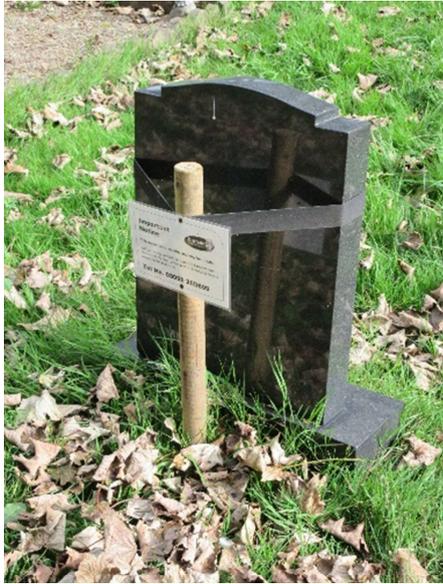
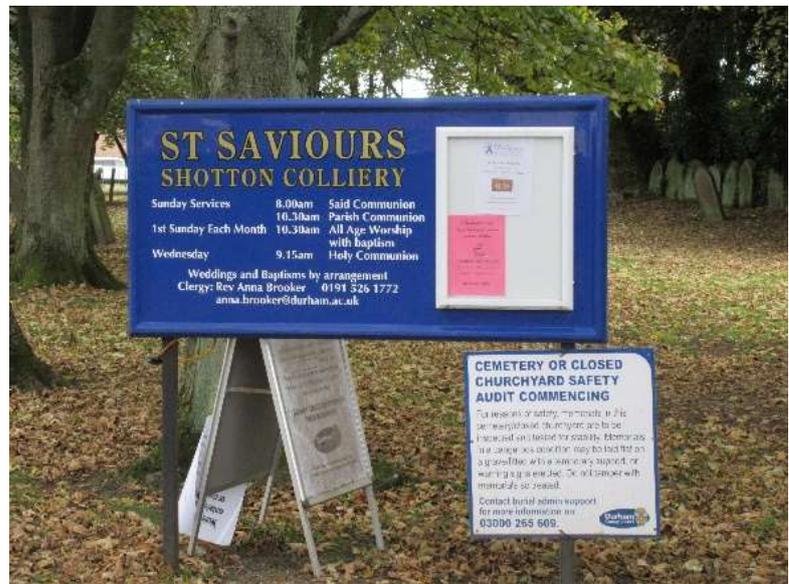
132. Mature trees along the boundaries and through much of the churchyard. Four large trees close to the church W end reduce light at the W window and may influence the walls, especially at the SW corner which has subsided. Persistently damp ground and very little grass under these trees, despite some thinning.
133. External sign at entrance and a good sign next to the drive.
