QUINQUENNIAL INSPECTION REPORT - MAY 2023

# HOLY TRINITY CHURCH

FRONT STREET, SOUTH HETTON, CO. DURHAM, DH6 2UA

Report prepared by

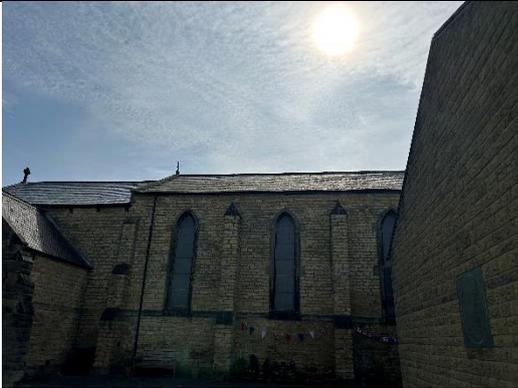
Northern Pitch of the Nave Roof

<p><b>Description</b></p> <ul style="list-style-type: none"> <li>• Natural Slates</li> <li>• Profiled terracotta ridge tiles</li> <li>• Water tables to both sides</li> <li>• Stone cross on water table to eastern side of roof.</li> <li>• Bell Tower to the western side of the roof.</li> </ul>	
	<p><b>Condition</b></p> <ul style="list-style-type: none"> <li>• A detailed inspection of the bell tower could not be carried out however the PCC advice that the bell is not working.</li> <li>• There are some open joints in the ridge tiles.</li> <li>• There are some slipped slates at higher level.</li> <li>• Water table appears sound and well pointed.</li> </ul>	
	<p><b>Repair Needs</b></p> <ul style="list-style-type: none"> <li>• Monitor slates and re-fix any which continue to slip, or are blown off.</li> <li>• PCC to arrange specialist to advise on Bell repair.</li> </ul>	<p>M E</p>

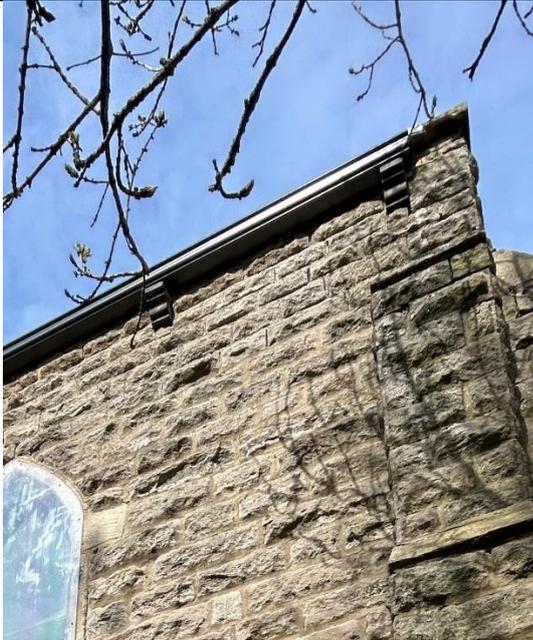
**10.2. RAINWATER GOODS AND DISPOSAL SYSTEMS**

<p><b>Condition</b></p> <ul style="list-style-type: none"> <li>• Shoe of Rainwater down comer is still missing on community hall north elevation.</li> <li>• An assessment of the rainwater run off suggests that the existing gutters are only just sufficiently sized for the roof. They are also in poor condition, with numerous ad hoc repairs.</li> <li>• Downpipe adjacent to the vestry door on south elevation is discharging into a gully which appears blocked.</li> <li>• Downpipe on west elevation, next to boiler house has been replaced with a new white downpipe.</li> </ul>

<p><b>Repair Needs</b></p> <ul style="list-style-type: none"> <li>• Continue to clear gutters of debris and leaves.</li> <li>• Replace shoe of down comer to community hall, water discharging onto the pavement can cause a slip hazard in freezing weather. PCC might consider using grit and salt in freezing weather until the repair can be made and also around the Organ Chamber where the gulleys discharge onto the footpath.</li> <li>• Unblock gulley next to vestry door.</li> </ul>

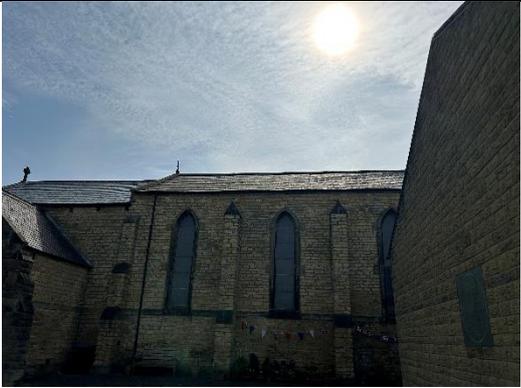
**North Elevation of the Nave**

<p><b>Condition</b></p> <ul style="list-style-type: none"> <li>• Generally, sound with some individual stone weathering</li> <li>• Unsightly Cement pointing below the sill level string course.</li> <li>• Slight delamination of stones in places.</li> <li>• Pronounced weathering of buttress and coping stones</li> <li>• Some efflorescence below string course in the bay next to main entrance still present.</li> </ul>	
	<p><b>Repair Needs</b></p> <p>none</p>

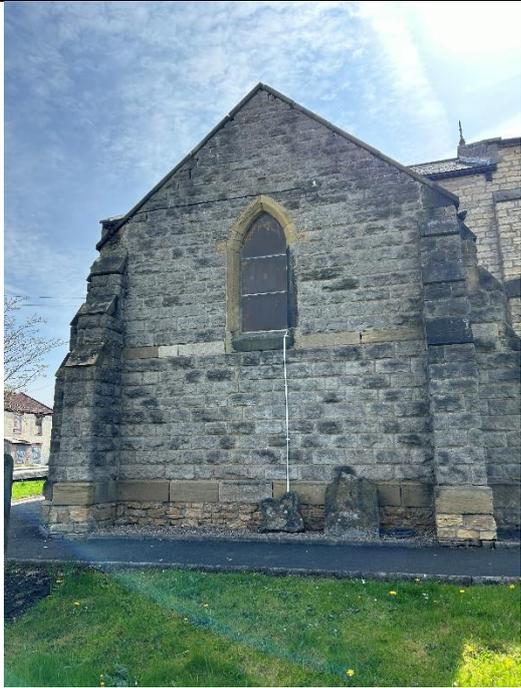
**Organ Chamber**

<p><b>Condition</b></p> <ul style="list-style-type: none"> <li>• Some areas of re-pointing required to vertical joints in plinth and string course stones and to stones on the east facing buttress.</li> <li>• Some stones showing weathering</li> <li>• There is a hole in the wall adjacent to the cap stone of the buttress on the west elevation.</li> <li>• There is a settlement / movement crack below the window on the east elevation to the left-hand side.</li> <li>• There are some signs of movement below the coping stones on the east roof pitch side, resulting in open vertical mortar joints present within the stone at high level on the north elevation.</li> <li>• There is a crack below the window on the north elevation to the left-hand side.</li> <li>• Mortar bedding to the coping stones is weathered.</li> </ul>

<p><b>Repair Needs</b></p> <ul style="list-style-type: none"> <li>• Some vertical mortar joints to plinth stones and string courses require re-pointing, using a suitable lime mortar.</li> <li>• Re-pointing required to vertical mortar joints below the coping stones in top left (north side)</li> <li>• Re-point mortar bed below coping stones on north side.</li> <li>• Monitor cracking below the windows on both north and east elevations. They don't appear to have worsened since last QQI.</li> </ul>	<p>D</p> <p>C</p> <p>C</p> <p>M</p>

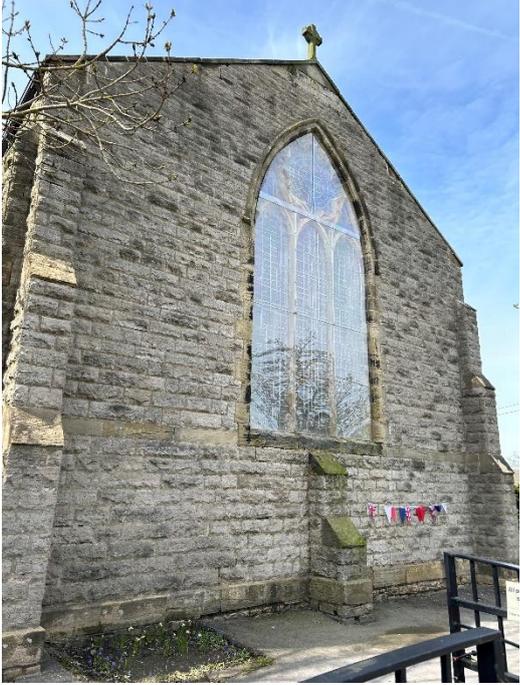
**East Elevation**

<p><b>Description</b></p> <ul style="list-style-type: none"> <li>• Coursed Limestone rubble with ashlar detailing generally sound.</li> <li>• Stone buttresses with ashlar stone caps.</li> </ul>	
	<p><b>Condition</b></p> <ul style="list-style-type: none"> <li>• A crack below right-hand side kneeler stone is still present.</li> <li>• Some pointing has been renewed below coping stones, possibly since re-roofing of Chancel.</li> <li>• Cracks to left hand side kneeler stone and buttress are still present.</li> </ul>	
	<p><b>Repair Needs</b></p> <ul style="list-style-type: none"> <li>• Monitor cracking to kneeler stones.</li> </ul>	M

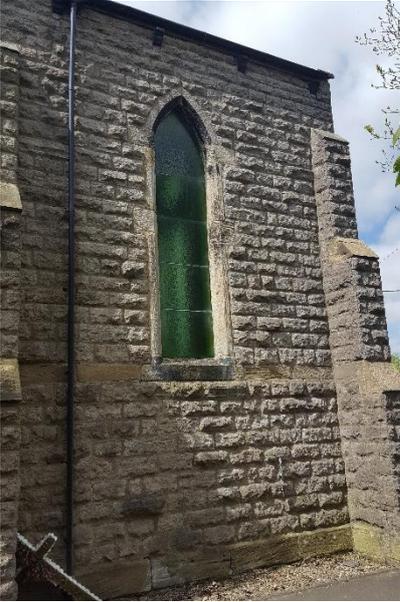
South Elevation of Chancel

<p><b>Condition</b></p> <ul style="list-style-type: none"> <li>• Stone and pointing generally sound.</li> <li>• Movement crack along left-hand side of window W.03 are still present, to wall above and below the window and also in the quoins. They do not appear to have worsened since the last QOI.</li> </ul>	
	<p><b>Repair Needs</b></p> <ul style="list-style-type: none"> <li>• Monitor cracking to walls above and below W.03</li> </ul>	<p>M</p>

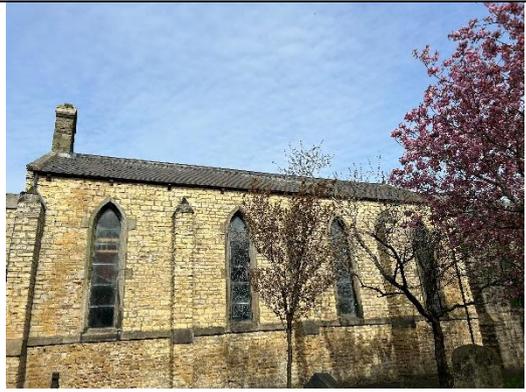
South Elevation of the Nave

<p><b>Condition</b></p> <ul style="list-style-type: none"> <li>• Pointing is weathering out in areas, particularly below string course.</li> <li>• Stones below string course are weathering.</li> <li>• Some modern cement mortar present but has mostly come away.</li> <li>• Efflorescence present on base stones below string course, but to lesser extent to previous QQI.</li> <li>• Buttresses have weathering to stones particularly corner stones.</li> <li>• There are some holes behind the RWP which could do with filling to prevent water ingress.</li> </ul>

<p><b>Repair Needs</b></p> <ul style="list-style-type: none"> <li>• Some areas of repointing required below string course and to holes behind RWP, using a suitable lime mortar.</li> <li>• Brush off the worst of any remaining efflorescence if required</li> </ul>	<p>D  M</p>

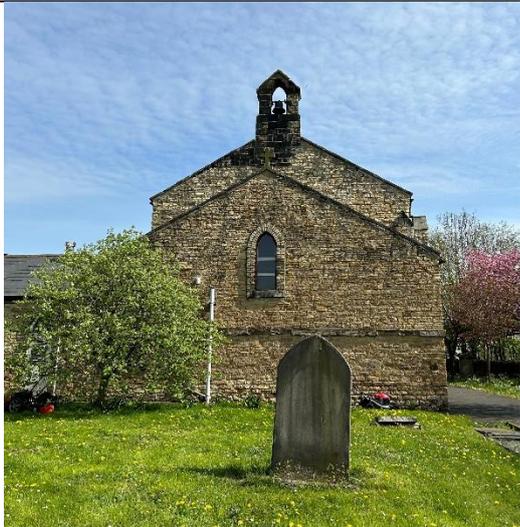
Vestry / West Elevation

<p><b>Condition</b></p> <p><u>South Elevation of Vestry</u></p> <ul style="list-style-type: none"> <li>• Ashlar stone to right hand side of door behind the RWDP is considerably eroded.</li> <li>• There is signs of movement above the door archway (D.01), with mortar cracking visible.</li> <li>• Modern cement mortar is cracking and coming away.</li> </ul>

<p><u>West Elevation of Vestry</u></p> <ul style="list-style-type: none"> <li>• Heavily eroded stones at the base.</li> <li>• String course stones are also heavily eroded.</li> <li>• The mortar joint below the stone copings are in poor condition and largely missing. Stone pinning's are visible where mortar has weathered.</li> </ul>

<ul style="list-style-type: none"> <li>• The bottom coping stone on south side of roof appears to have moved / slipped.</li> </ul> <p><u>West Elevation of Nave (High Level)</u></p> <ul style="list-style-type: none"> <li>• There is some atmospheric staining to the stone at high level, including on the bell tower.</li> <li>• Some coping stones on north pitch appear to be broken / missing and pointing below appears to be weathering.</li> </ul>

<p><b>Repair Needs</b></p> <ul style="list-style-type: none"> <li>• Some areas of repointing required, using a suitable lime mortar.</li> <li>• Monitor cracking above Door D.01</li> <li>• Consider replacing and/or re-pointing copings stones, to nave roof.</li> </ul>	<p>D  M  E</p>
--	--	--------------------------------

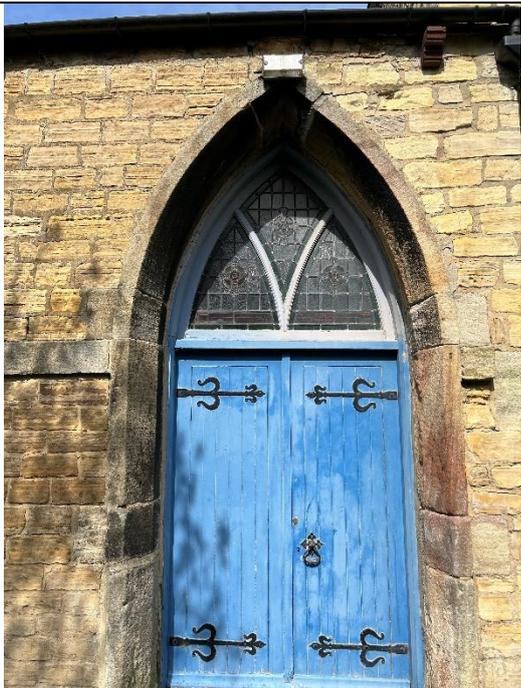
**Exterior Doors**

<p><b>Condition</b></p> <ul style="list-style-type: none"> <li>• D.01 is in reasonable condition, paintwork appears to have been renewed at high level since last QQI.</li> <li>• The paintwork on D.02 and D.03 has been renewed since last QQI, however could do with an additional coat.</li> <li>• The timber at the bottom of D.02 and its frame remains badly deteriorated.</li> </ul>

<p><b>Repair Needs</b></p> <ul style="list-style-type: none"> <li>• The timber frame of door D.02 requires a splice repair to the bottom, suggest 30cm of door frame to prolong its lifespan.</li> <li>• Consider an additional coat of paint to external doors to prolong lifespan</li> </ul>	<p>E</p> <p>D</p>
---	--	-------------------

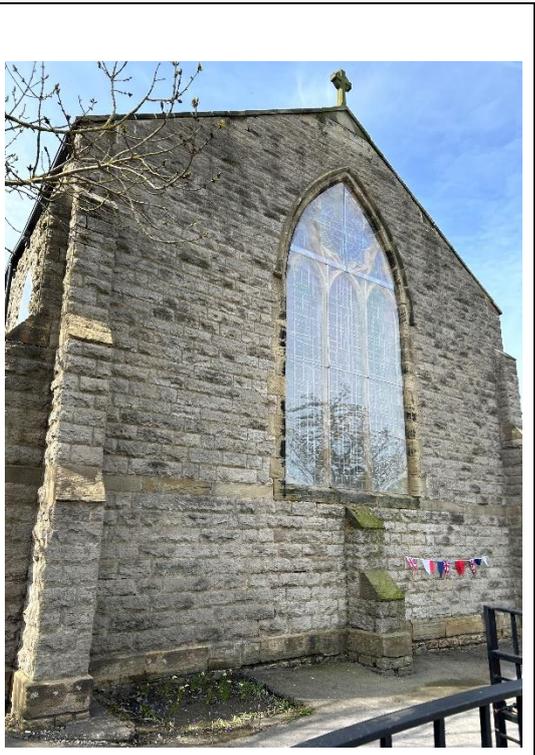
**Windows**

- Windows W.01 and W.13 have had replacement panes and polycarbonate covers added since last QQI.
- Generally stone surrounds (externally) are sound although some are weathering and have staining at varying degrees present.

- There is a gap at the head of window W.07 between the stone and silicone appears to be missing in places externally. Internally there is staining and blistering to plaster surround.

- The stones below the arch of W.06 appear to be out of line with the arch stones, which indicates some movement has occurred.
- W.02 appears to have had repairs and a polycarbonate cover added since last QQI.

- There is some cracking on left hand quoins to W.03 and some holes which are likely to be from previous fixings.
- There is a broken stone below the arch at W.05.

- Plaster reveals to windows internally have varying degrees of cracking and bulging of plaster / paint.
- W.05 has small pieces of stained glass broken and missing.

- W.04 some stained-glass pieces are missing and some areas appear to be bulging.
- The stained glass on W.06 appears to be bulging at the top.

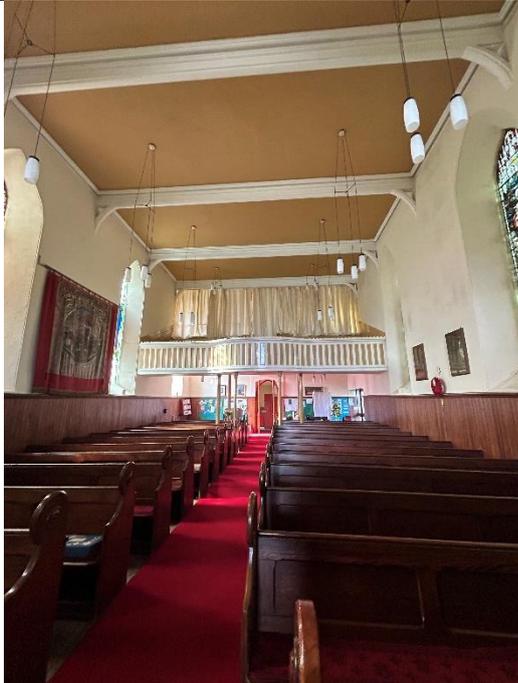
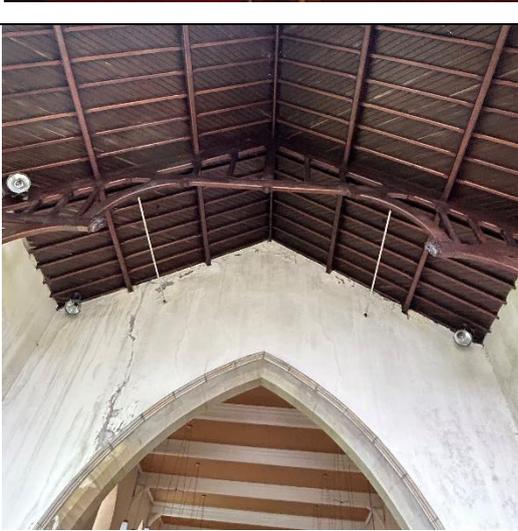
11.2 ROOF STRUCTURES AND CEILINGS

<p><b>Condition</b></p> <ul style="list-style-type: none"> <li>• All ceilings appear to be in good condition.</li> <li>• The timber ceiling to the underside of the Chancel roof has had past water ingress issues but appears to be dry and in good condition, since the re-roofing.</li> <li>• Paint is flaking to the ceiling above the balcony.</li> </ul>

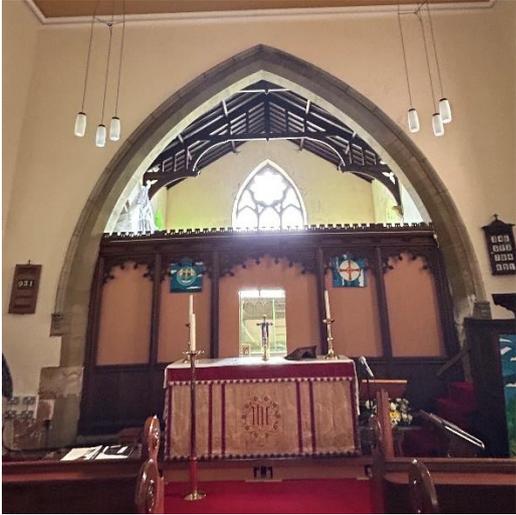
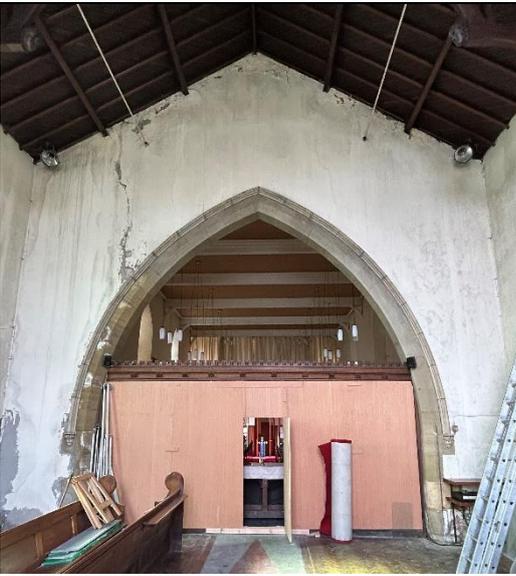
Partitions, Screens and Panelling

<p><b>Condition</b></p> <ul style="list-style-type: none"> <li>• Timber wall panelling and decorative screen within arch all appear to be in good condition and stable.</li> <li>• The decorative timber screen has been boarded up with plywood on the Chancel side, presumably as protection during the re-roofing works in the Chancel.</li> </ul>	
	<p><b>Repair Needs</b></p> <ul style="list-style-type: none"> <li>• None</li> </ul>

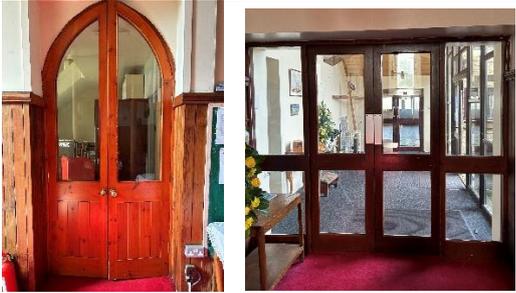
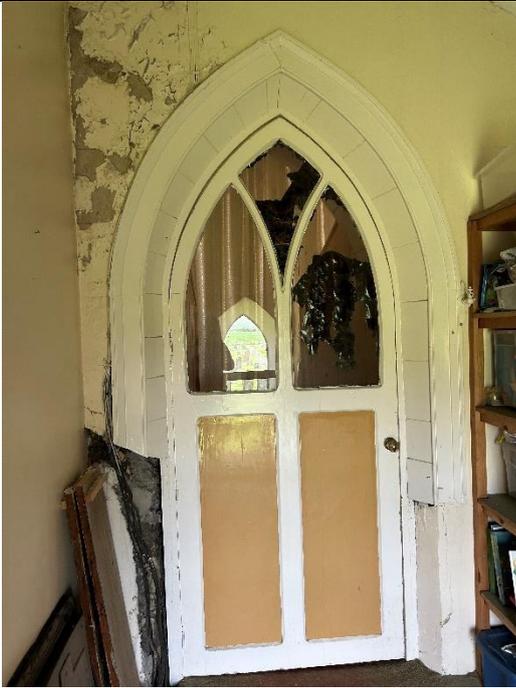
**Interior Doors**

<p><b>Condition</b></p> <ul style="list-style-type: none"> <li>• Doors on the ground floor appear to be in good condition.</li> <li>• The architrave of the door at the top of the stairs into the balcony has been cut away on the left-hand side of the door at low level.</li> </ul>	
	<p><b>Repair Needs</b></p> <p>PCC may consider re-instating the architrave to the upstairs door to hide wiring.</p>	<p>E</p>

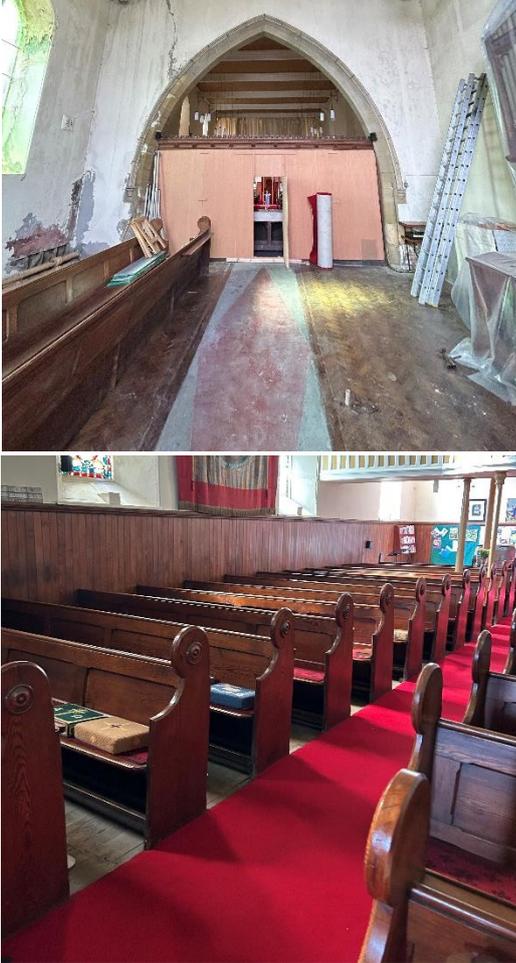
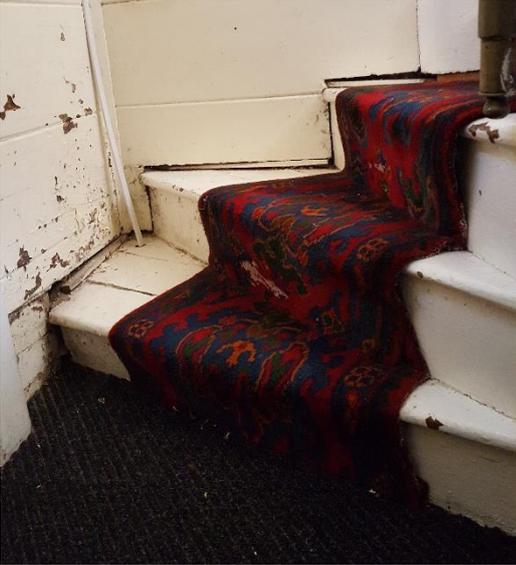
11.5 FLOORS AND PLATFORMS

<p><b>Condition</b></p> <ul style="list-style-type: none"> <li>• All flooring appears to be in good condition.</li> <li>• The carpet in the Chancel has been removed during the re-roofing works, leaving concrete base exposed. There are exposed metal anchors on the herringbone flooring from the removed pews.</li> <li>• The bottom step of the access stair has settled to one side, which is a safety hazard.</li> <li>• Staircase is otherwise in sound condition.</li> </ul>

<ul style="list-style-type: none"> <li>• Suggest the bottom step is taken apart and re-built level.</li> <li>• Metal anchors to be removed from floor in Chancel prior to public accessing the space again.</li> </ul>	<p>B</p> <p>E</p>
--	--	-------------------

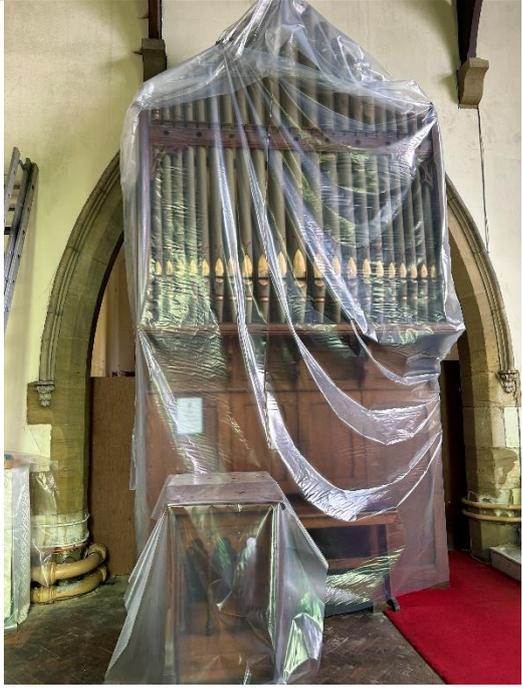
**11.8 ORGAN**

<p><b>Description</b></p> <p>The organ, labelled Harrison &amp; Harrison, is located within the Organ Chamber to the north side of the Chancel.</p> <p><b>Condition</b></p> <ul style="list-style-type: none"> <li>• The organ was covered for protection during the re-roofing works. The PCC advised the organ is not working.</li> </ul> <p><b>Repair Needs</b></p> <ul style="list-style-type: none"> <li>• Arrange for repair and tuning by a specialist.</li> </ul>	E
--	---	---

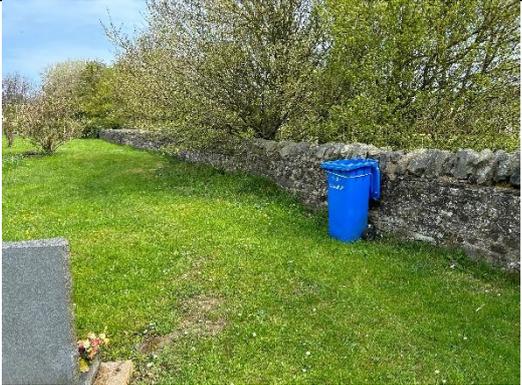
<p><b>Description</b></p> <ul style="list-style-type: none"> <li>• The perimeter boundary to the south is a random rubble stone wall with stone coping and mortar joints.</li> <li>• Along the western boundary is a post and wire fence with a few trees.</li> <li>• The northern boundary has a mix of random rubble stone wall with Stone coping, close boarded timber fence and red brick low level walls with metal railings on top.</li> <li>• The eastern boundary facing the public highway and footpath consists of a very low random rubble stone wall with stone coping.</li> <li>• Footpaths around the church are of tarmac finish with pin kerb edging.</li> <li>• Gravel margins between buttresses along southern façade and around Organ Chamber.</li> </ul>	
---	---	--

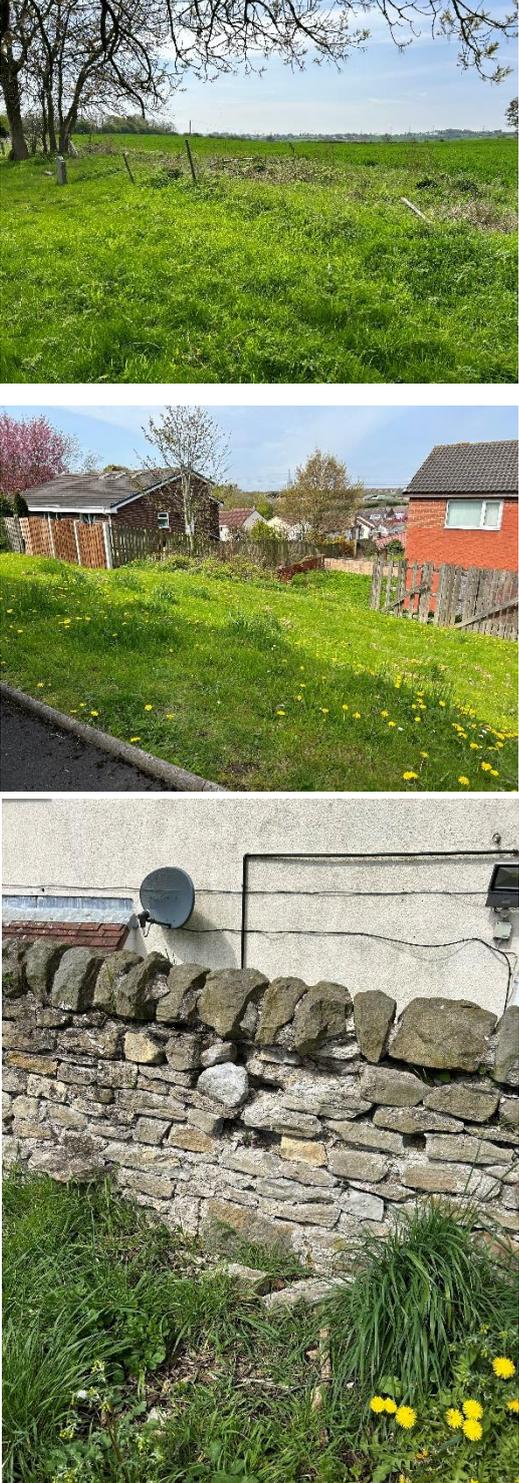
<p>The top photograph shows a wide, grassy field with bare trees in the background under a blue sky. The middle photograph shows a residential garden with a wooden fence, a brick house, and a paved area. The bottom photograph is a close-up of a stone wall with a satellite dish and a light fixture on a wall above it.</p>	<p><b>Condition</b></p> <ul style="list-style-type: none"> <li>• The random rubble walls are generally sound, with some vegetation growing up it on northern and southern sections. There are sections of stone crumbling.</li> <li>• The northern boundary wall is leaning outwards in some locations, into adjacent gardens.</li> <li>• The post and wire fencing to the west is mostly missing leaving the boundary open to fields beyond.</li> <li>• The close boarded fence on the northern boundary is in very poor condition with sections missing.</li> <li>• Weeds to tarmac surfaces and between tarmac and pin kerb.</li> <li>• The low stone wall along the eastern boundary is sound.</li> </ul>

<p><b>Repair Needs</b></p> <ul style="list-style-type: none"> <li>• Weeds to be kept in check on tarmac footpaths. This will prolong its life.</li> <li>• Monitor northern boundary wall for further movement.</li> </ul>	<p>M</p> <p>M</p>

<ul style="list-style-type: none"> <li>• Consider a new close boarded fence along the northern boundary, depending on ownership.</li> <li>• New post and wire fencing to be installed along the western boundary to match existing.</li> <li>• Consider removal of all plant growth from Stone walls, to prolong their life.</li> </ul>	<p>E</p> <p>E</p> <p>M</p>
--	---	----------------------------

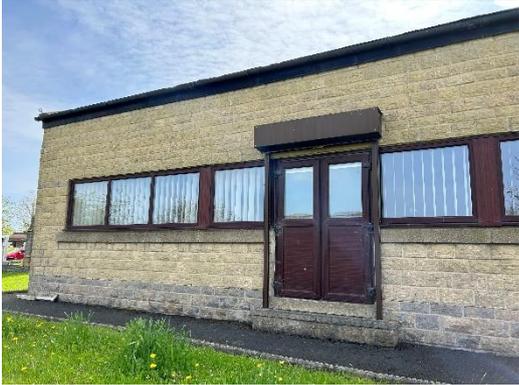
<p><b>Condition</b></p> <ul style="list-style-type: none"> <li>• The lintels above the north facing windows either side of the door appear to be bowing over the last 3 window bays, there are also vertical cracks present which indicates movement of the wall.</li> </ul>	
	<p><b>Repair Needs</b></p> <ul style="list-style-type: none"> <li>• Monitor cracking above the window lintels.</li> </ul>	<p>M</p>

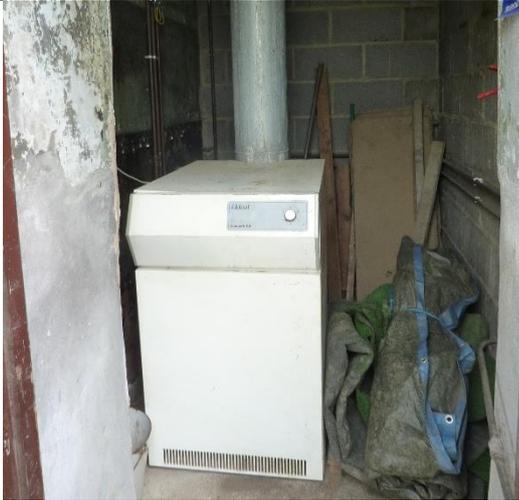
<p>on a constant background setting to maintain a minimum background level.</p> <ul style="list-style-type: none"> <li>• The main electrical supply is a single phase 500 volts with 60amp loading. The system is protected by an 100amp current operated leakage circuit breaker. Wiring distribution to lighting and power is mainly in M.I.C.C cable. Artificial lighting is by Tungsten pendants to the nave and high wattage flood lights to the chancel.</li> <li>• There are 2 cast iron radiators in the Sanctuary.</li> <li>• There are several fire extinguishers in the building.</li> <li>• There is no evidence of a lightning protection system on the roof.</li> </ul>	
	<p><b>Condition</b></p> <ul style="list-style-type: none"> <li>• The log book indicates the gas boiler was last serviced in August 2022.</li> <li>• The log book indicates the fire extinguishers have been regularly checked.</li> <li>• The heating and lighting systems are in working condition.</li> <li>• The log book indicates PAT testing of electrical equipment have been completed regularly.</li> </ul>

<p><b>Repair Needs</b></p> <ul style="list-style-type: none"> <li>• PPC to consider seeking specialist advise on installation of lightning protection.</li> </ul>	<p>E</p>
