QUINQUENNIAL INSPECTION REPORT - MAY 2017

HOLY TRINITY CHURCH

FRONT STREET, SOUTH HETTON, CO. DURHAM, DH6 2UA

SAMANTHA DIXON

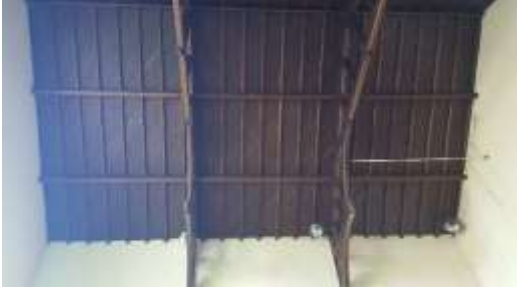
<p>Condition</p> <ul style="list-style-type: none"> • All ceilings appear to be in good condition. • There is a known source of water ingress in the Chancel roof however the timber ceiling appears to be in good condition. 	
	<p>Repair Needs</p> <ul style="list-style-type: none"> • None

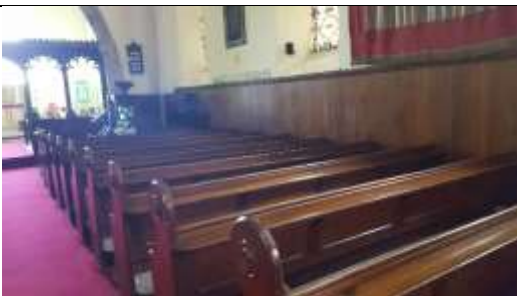
<p>Condition</p> <ul style="list-style-type: none"> Timber wall panelling and decorative screen within arch all appear to be in good condition and stable. 	
	<p>Repair Needs</p> <ul style="list-style-type: none"> None

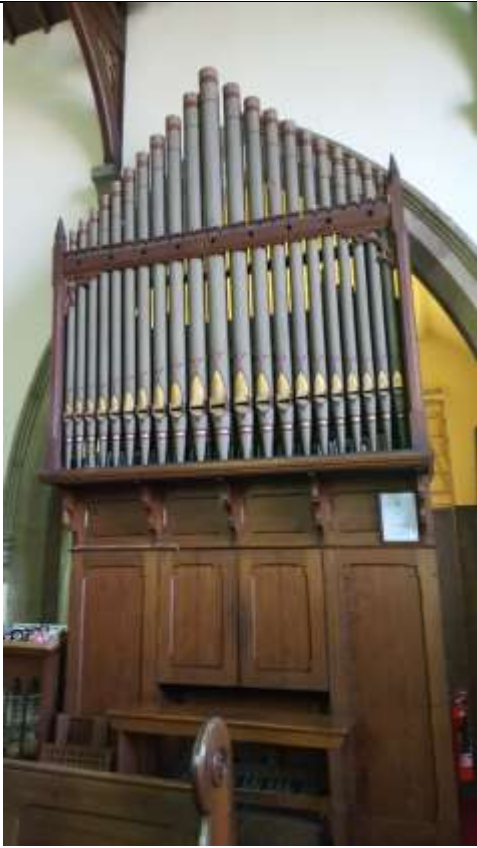
<p>Description</p> <p>The organ, labelled Harrison & Harrison, is located within the Organ Chamber to the north side of the Chancel.</p> <p>Condition</p> <ul style="list-style-type: none"> • There is no evidence in the log book that the organ has been serviced or tuned. <p>Repair Needs</p> <ul style="list-style-type: none"> • Arrange for tuning and inspection by a specialist. 	<p>M</p>
-------------------------------------------------------------------------------------	---------------------------------------------------------------------------------------------------------------------------------------------------------------------------------------------------------------------------------------------------------------------------------------------------------------------------------------------------------------------------------------------------------------------------------------------------	----------

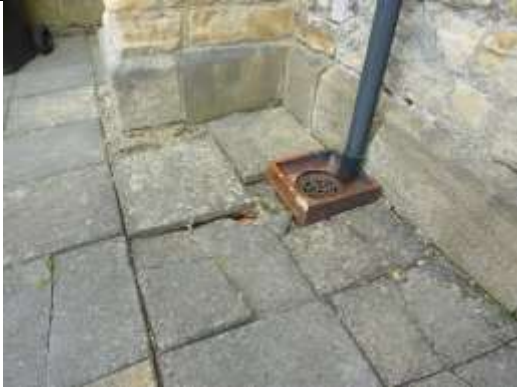
<p>Description</p> <ul style="list-style-type: none"> • The perimeter boundary to the south is a random rubble stone wall with stone coping and mortar joints. • Along the western boundary is a post and wire fence with a few trees. • The northern boundary has a mix of random rubble stone wall with Stone coping, close boarded timber fence and red brick low level walls with metal railings on top. • The eastern boundary facing the public highway and footpath consists of a very low random rubble stone wall with stone coping. • Footpaths around the church are of tarmac finish with pin kerb edging. • Gravel margins between buttresses along southern façade and around Organ Chamber. 	
 	<p>Condition</p> <ul style="list-style-type: none"> • The Random rubble walls are generally sound, with some vegetation growing up it on northern and southern sections. • The post and wire fencing to the west is mostly missing leaving the boundary open to fields beyond. • The close boarded fence on the northern boundary is in very poor condition with sections missing. • Weeds to tarmac surfaces and between tarmac and pin kerb. • There are some broken paving slabs around the gully below the rain water outlet on the Northern façade of the Nave.

<p>Repair Needs</p> <ul style="list-style-type: none"> • Weeds to be kept in check on tarmac footpaths. This will prolong its life. • A new close boarded fence should be installed along the northern boundary. • New post and wire fencing to be installed along the western boundary to match existing. • Remove all plant growth from Stone walls. • The paving slabs on the northern side of the Nave should be replaced as they could cause damage to the pot pipe below. 	<p>M E E M C</p>
-----------------------------------------------------------------------------------	-------------------------------------------------------------------------------------------------------------------------------------------------------------------------------------------------------------------------------------------------------------------------------------------------------------------------------------------------------------------------------------------------------------------------------------------------------------------------------------------------------------------------------------------	----------------------------------

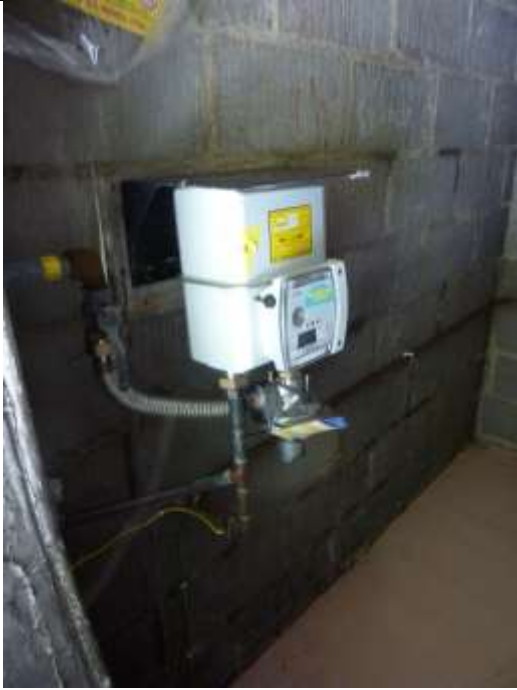
<p>Description</p> <ul style="list-style-type: none"> • Gas fired low pressure hot water system. The boiler is situated in a boiler house accessed externally on the west façade. The heating is run on a constant background setting to maintain a minimum background level. • As reported in the previous QQ report, <i>The main electrical supply is a single phase 500 volts with 60amp loading. The system is protected by an 100amp current operated leakage circuit breaker. Wiring distribution to lighting and power is mainly in M.I.C.C cable. Artificial lighting is by Tungsten pendants to the nave and high wattage flood lights to the chancel.</i> • There are 2 cast iron radiators in the Sanctuary. • There are several fire extinguishers in the building. • There is no evidence of a lightning protection system on the roof. 	
	<p>Condition</p> <ul style="list-style-type: none"> • The log book indicates the gas boiler was last serviced in March 2017. • The log book indicates a new smart meter was fitted in 2015. • The log book indicates the fire extinguishers have been regularly checked. • The heating and lighting systems are in working condition. • The log book indicates PAT testing of electrical equipment was completed in May 2016.

<p>Repair Needs</p> <ul style="list-style-type: none"> The re-roofing of the chancel & nave would create an opportunity for the installation of a lightning protection system. We would encourage the PPC to take specialist advice on this. 	<p>E</p>
