# ALL SAINTS SOUTH SHIELDS

**Boldon Lane West Harton  
(111)**

## QUINQUENNIAL REPORT

**26 June 2020**

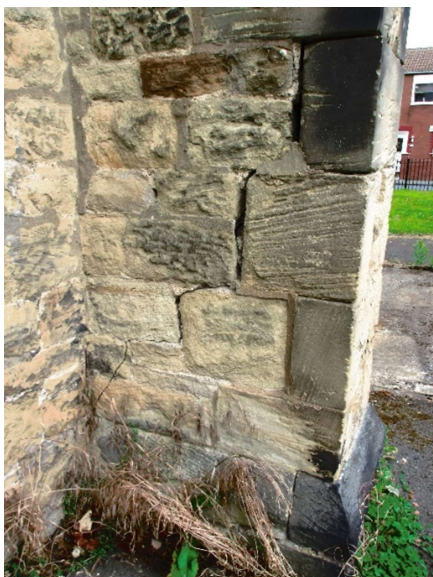
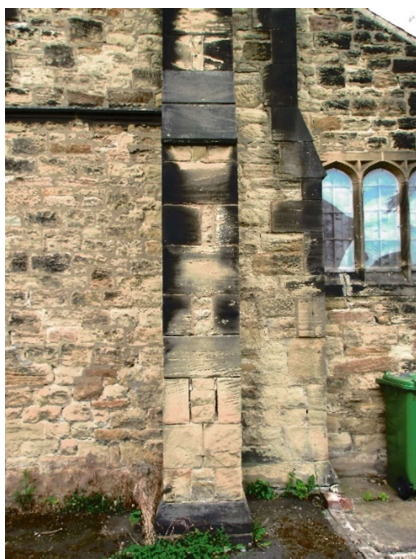
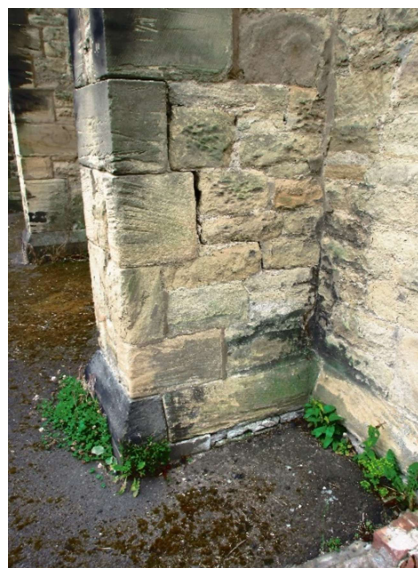
28. The church is squared random sandstone with dressed quoins and set backs. Plinths at buttresses only. Slate and bitumen damp proof course about 75 above tarmac level.
29. At the E gable a minor diagonal crack in joints from the bottom NE corner to the N window cill. A much wider crack in joints and stones through the bottom of the N buttress remains from the local subsidence, needing to be grouted and pointed.

stone decay next to over-hard pointing under the window and under the string course near the N buttress

30. E gable and Vestry E wall stone fair with minor open joints. Hard modern pointing spread over some stones tends to accelerate stone decay. Some stones are losing their whole faces, especially in the buttress sides and at harder pointing. For example the pointing of a patch under the string course near the N buttress is now forward of the decaying stones. Open joints at the exposed gable peak and some watertables. A skilled mason should rake and point the whole gable, buttresses, parts of the window tracery and Vestry E wall in low strength lime mortar to protect the stone and reveal any future movement.

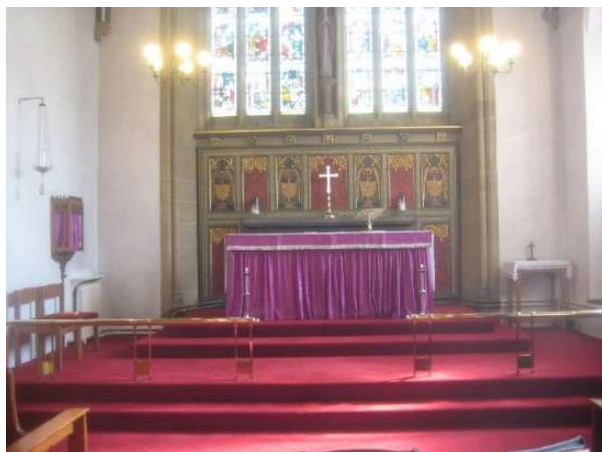
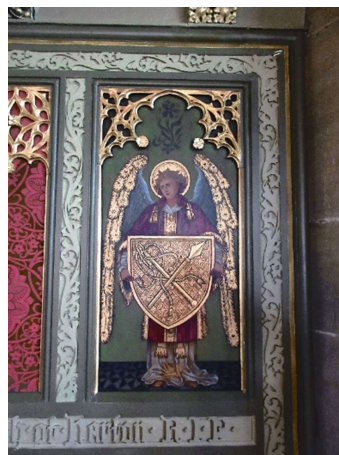
59. A beautiful painted wooden reredos fits into the E window arch which continues to floor level. Small amounts of sinuous fretwork frame panels with carved tracery over alternating painted angels and decorative paper. The composition makes a rich contrast with the now plainer church. Was cleaned and slightly touched up after the church refurbishment in 2010.

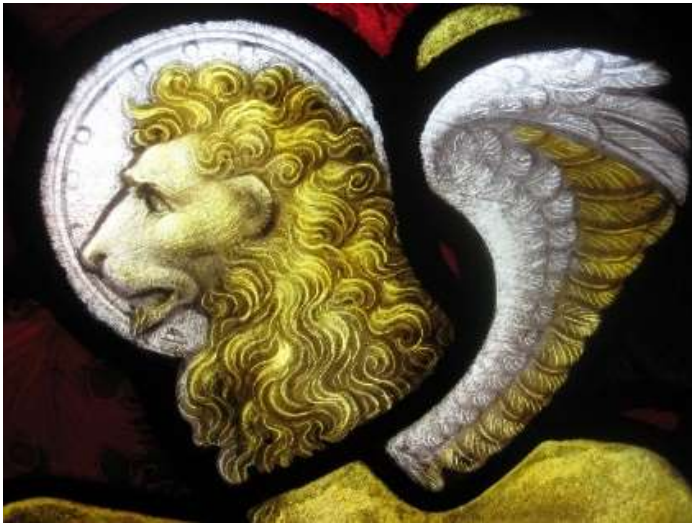
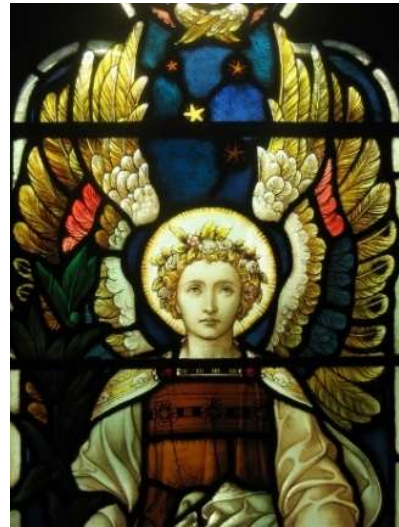
73. E – six light Christ the King and Servant with evangelists in roundel over, Philpott memorial 1888, good condition.

S Chancel and Nave except one S side – reamy glass good but dirty outside especially at N between glass and protection

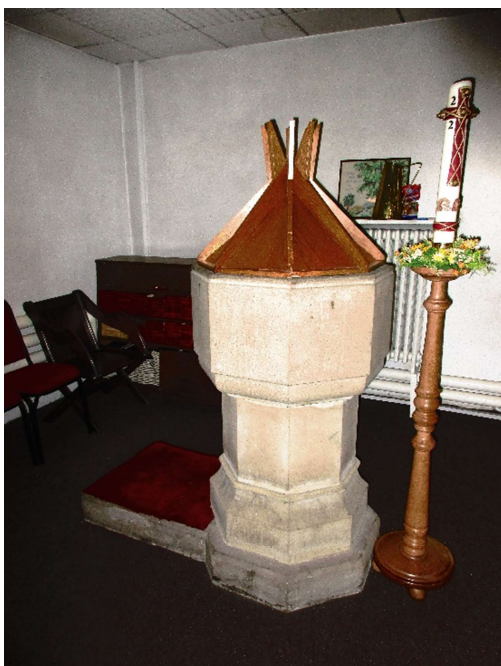
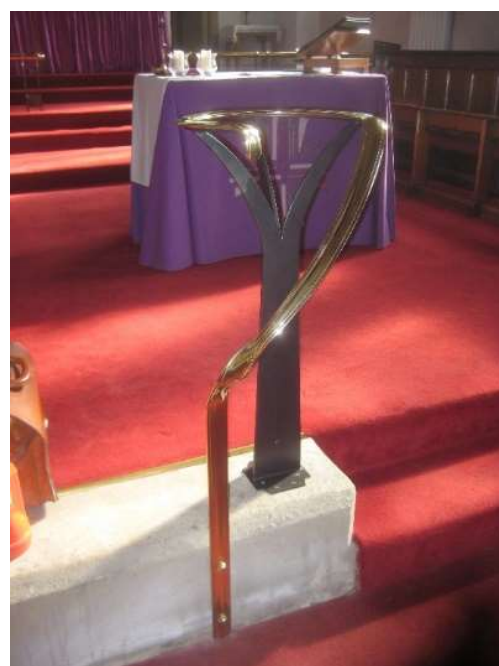
86. One marble, an oak 1<sup>st</sup> war memorial and two brasses, all sound.
87. Modern high altar with carved bas relief 'Lamb of God'. Modern oak credence table.  
Pine choir and clergy stalls with some decoration.
88. Small oak Nave altar. A polished oak pulpit on stone base with floorboards repaired and handrail added in 2010. Painted timber lectern. Comfortable varnished pine pews.
89. In the NW corner a plain octagonal stone font with modern oak cover and fine engraved brass ewer.  
An oak paschal candlestick.
