**Quinquennial Inspection Report
The Church of St Stephen's, South Shields
Archdeaconry of Sunderland
Deanery of Jarrow
Diocese of Durham**

David Jowett - Architect, BA, DipArch, RIBA
25 Roseworth Avenue
Gosforth
Newcastle upon Tyne
NE3 1NB
Tel: 07788 710 204
email: david@davidjowett-architect.co.uk

18 December 2024

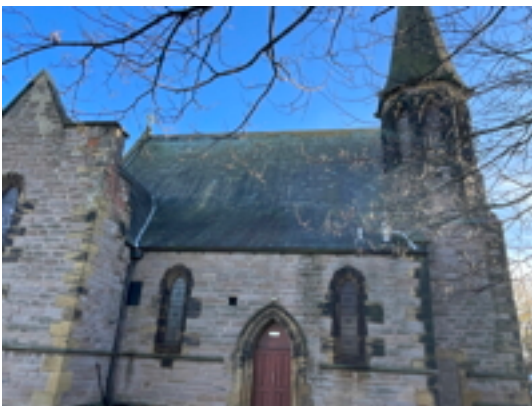
North Elevation Roof

Overall the slating appears in reasonable condition, as are the flashings and most of the ridges. A missing ridge tile to the Chancel should be replaced immediately. There are a few slipped, broken and incorrectly sized slates, notable a broken slate to the nave west end south elevation; an incorrectly sized slate to the Porch west elevation; broken and missing slates to the chancel south elevation; a chipped slate to the organ north elevation. There have been slate repairs in non-matching slates that would be better replaced with Westmorland slate. There was no access to view the flat roof to the meeting room or the hidden lead lined gutters.

Repair/replace all loose, broken and missing slates and arrange inspection of flat roof and hidden gutters. Cost Band 1– £0.00-£1,999.

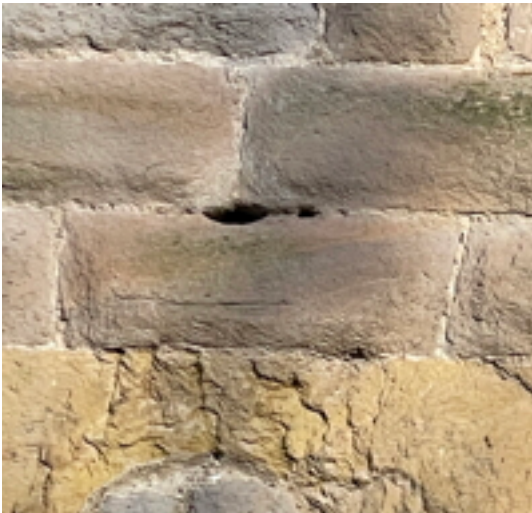
Open Joint to Tower West Elevation

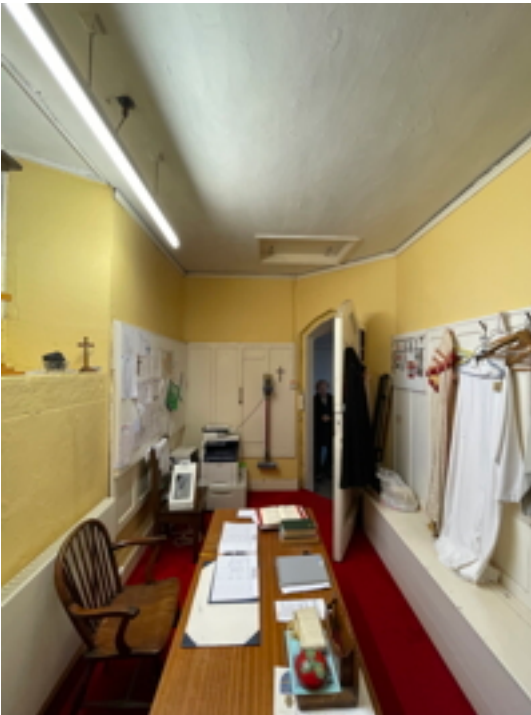
Vestry Looking East

The Vestry is all in fair condition.

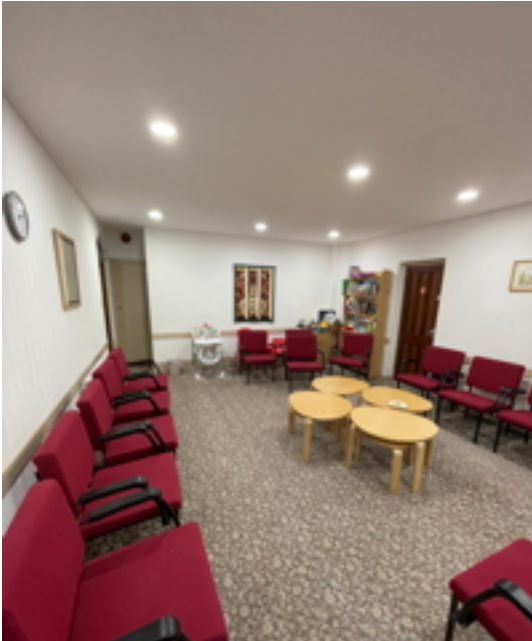
Lounge Looking East

The lounge is all in good condition.

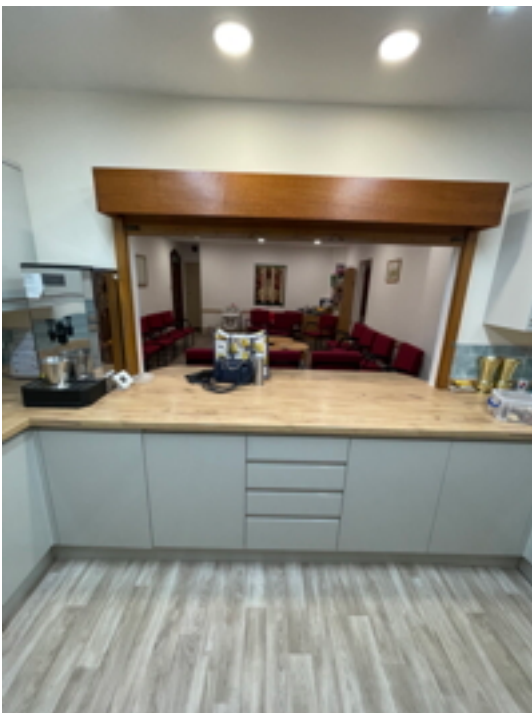
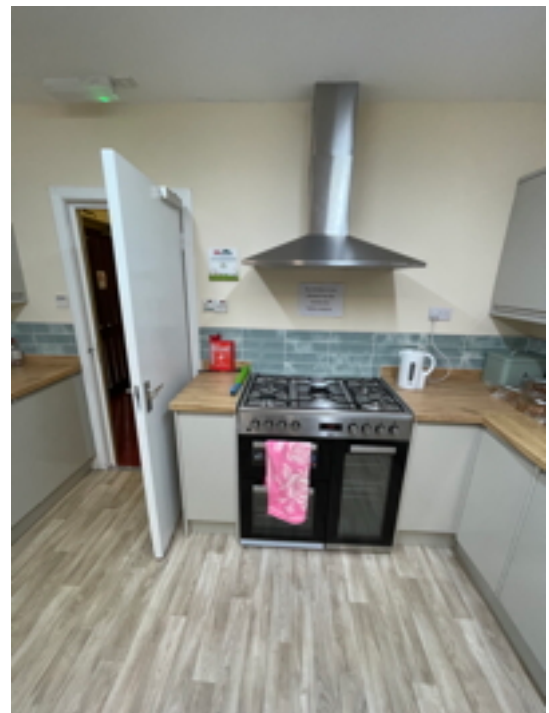
Kitchen Looking East

The kitchen is all in good condition.

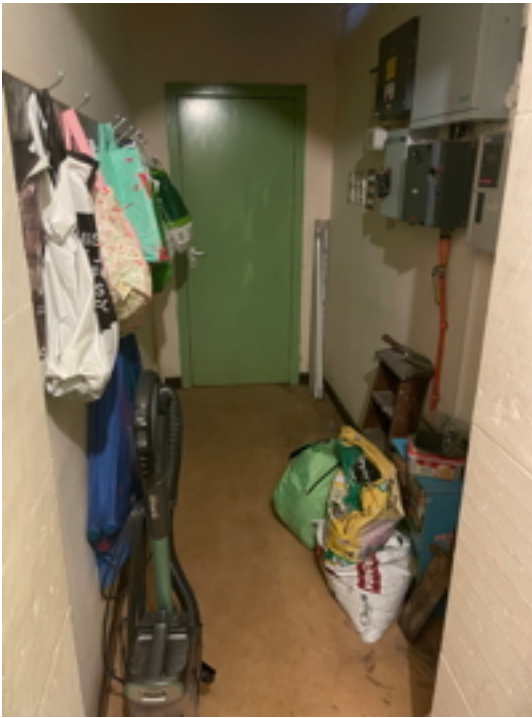
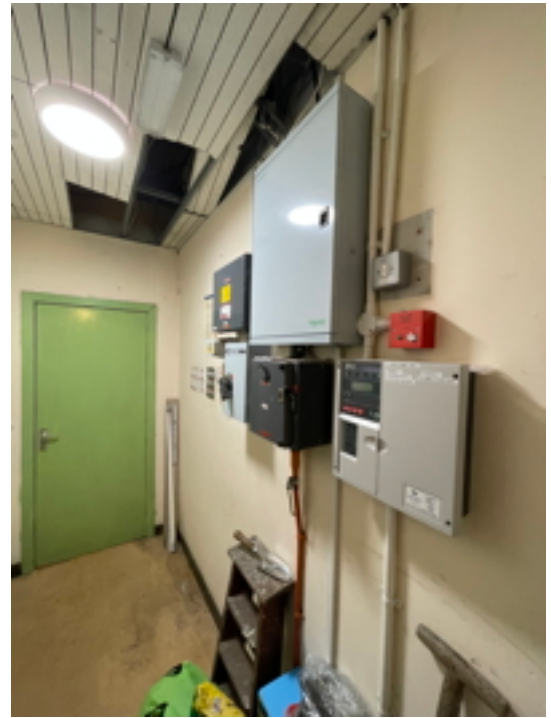
Tower Passageway Looking East

Condition is generally fair but there are some missing suspended ceiling tiles.

Monitor damp around the kitchen lobby external door and ensure roof is watertight above and replace damaged and missing ceiling tiles including those to Store and Tower Passageway. Cost Band 1– £0.00-£1,999.

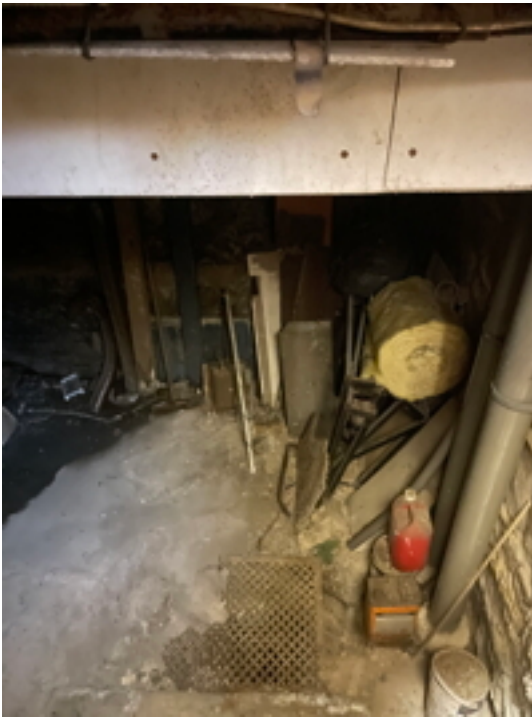
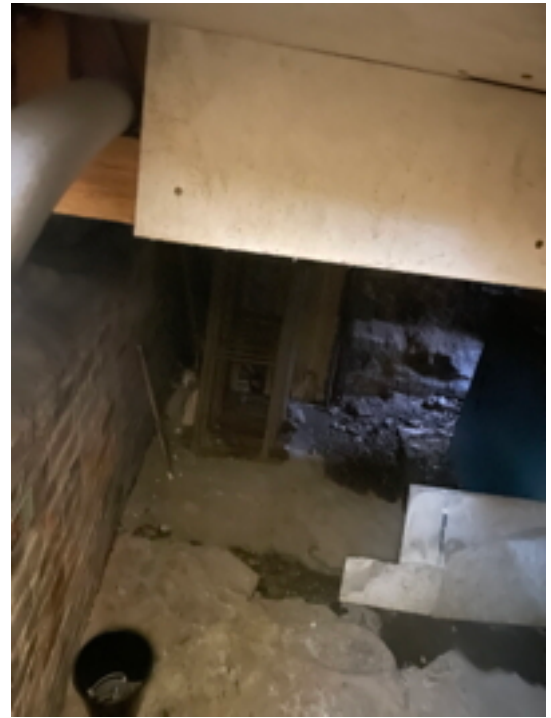
Boiler Room Viewed From Above

The boiler room is inaccessible for normal purposes.

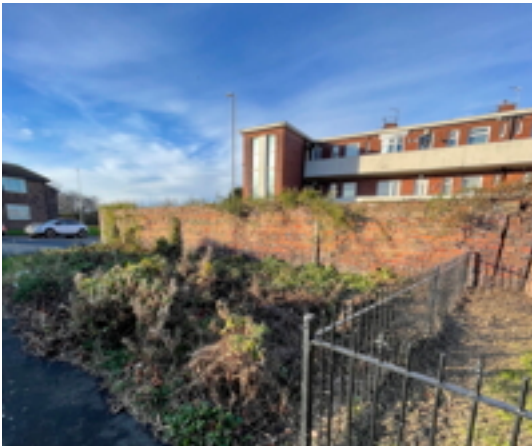
All is in satisfactory condition.

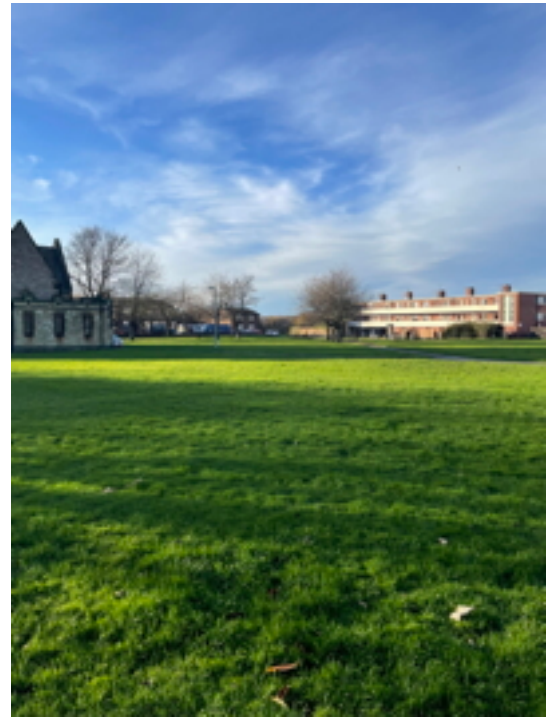
Looking North West

All is in satisfactory condition.
