Diocese of Durham

**St CHAD STOCKTON on TEES**  
**ROSEWORTH**  
(291)

**QUINQUENNIAL REPORT**  
on the architect's inspection on

**9 May 2018**

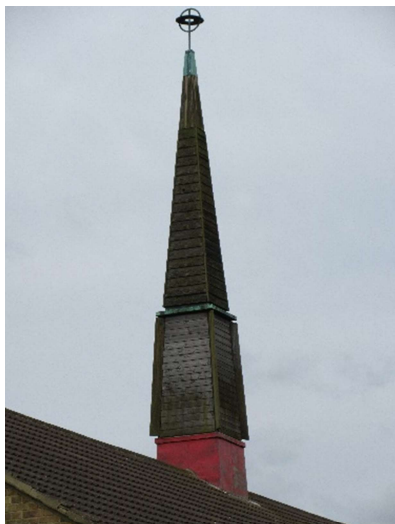
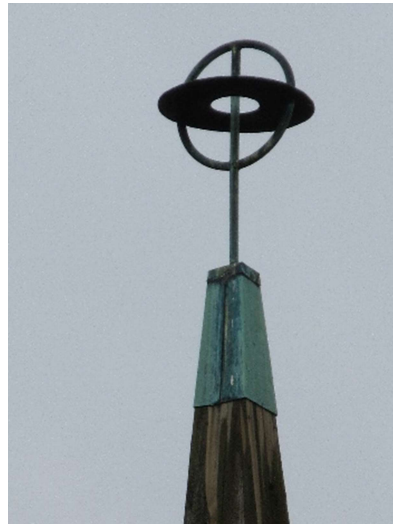
28. The main external feature is the graceful copper finial on the fleche on the middle of the ridge, housing a bell. Its metal angle frame is clad in cedar boards and corner vanes above former louvres, now boarded over. A bell pull hanging at one side of the Nave works the clapper which may be muffled.

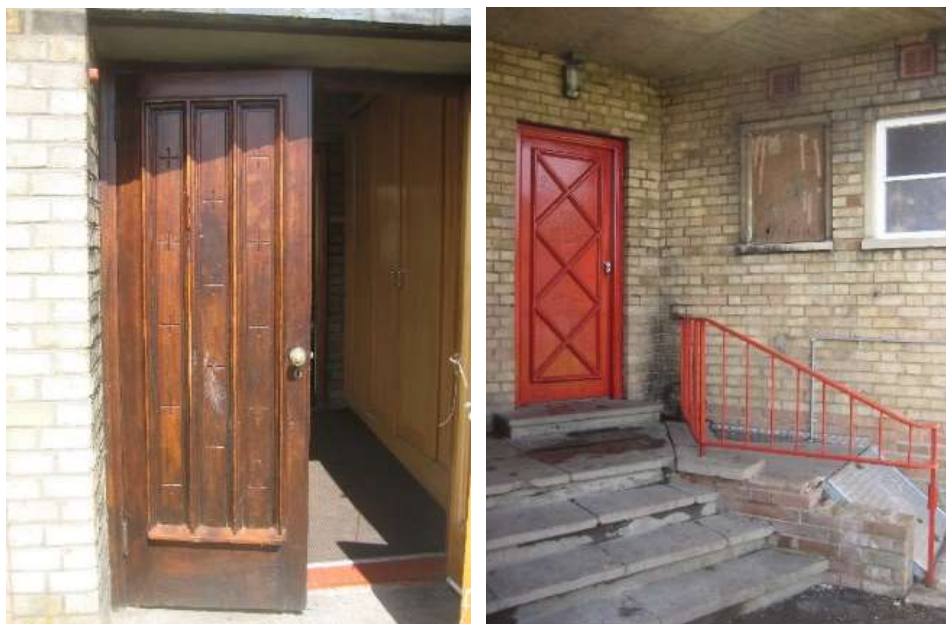
34. Stained hardwood Porch doors have simple incised decoration and projecting mouldings, which have been repaired. If there is need to display notices at the doors a change to toughened glass may be better than pins.

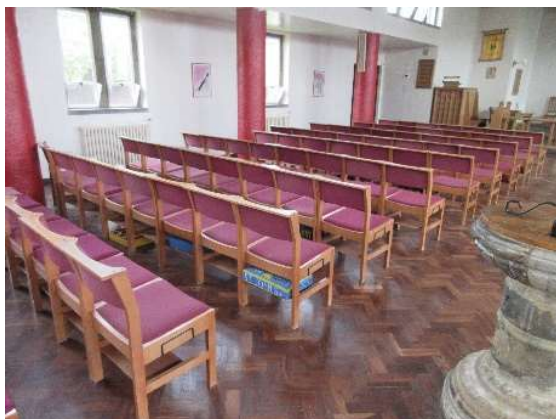
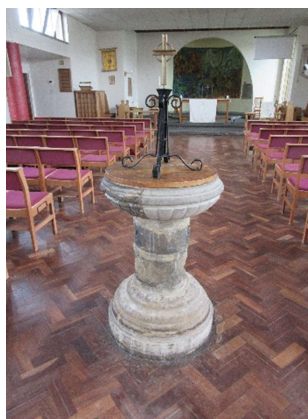
63. An ancient pedestal stone font in the centre of the Nave brought from the medieval St Mary's church Norton, with modern cover. Half of the bowl has been renewed. No monuments or brasses.

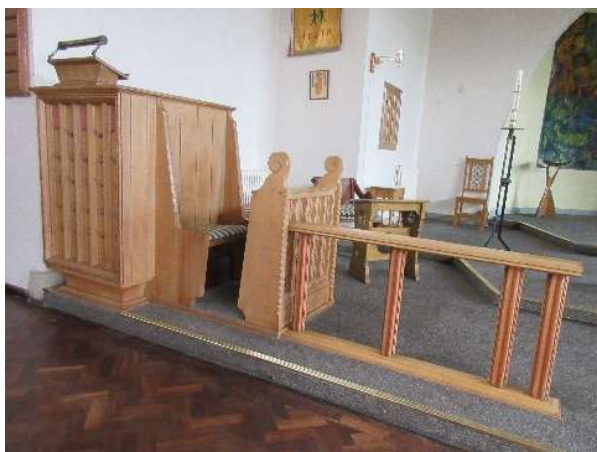
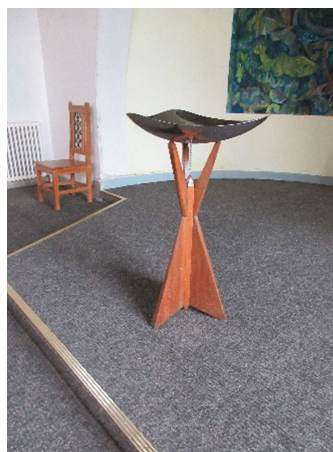
64. A stylish portable font is a simple triangular beaten silver bowl on a hardwood tripod.
65. Two manual Harrison & Harrison pipe organ in a softwood case at the W end which looks well. Serviced for occasional use.

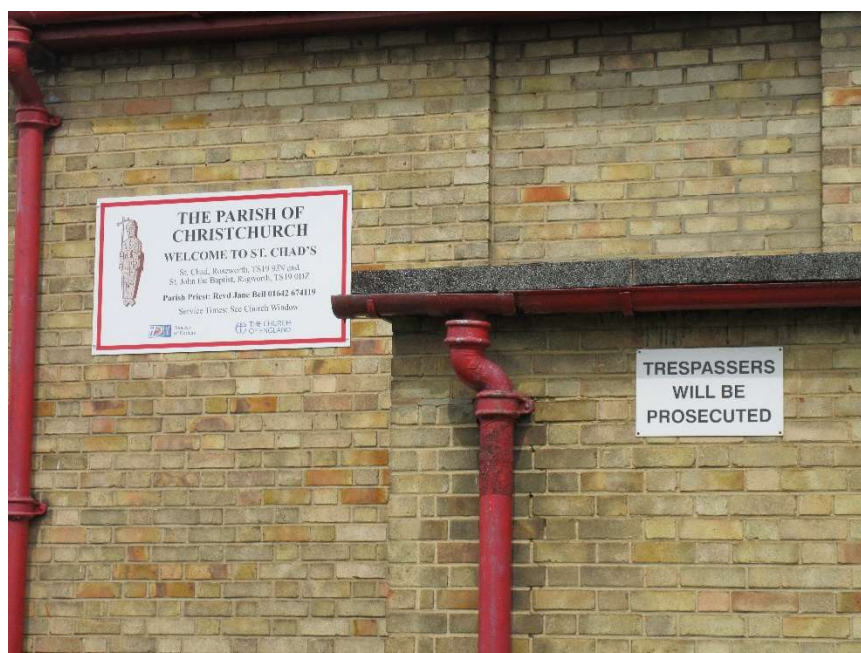
87. In the style of the 1950's the building is centred on an irregular site shared with the former vicarage and its garden.
88. The grassed church grounds are enclosed by hedges. Flag path to Porch in fair condition. Tarmac path to back door worn with weeds growing through.
89. Good sign on the building. The 'Trespassers ... prosecuted' signs are unfortunate.
