Care of Churches and Ecclesiastical Jurisdiction Measure 1991 – Quinquennial Inspection  
**ST CHADS, SUNDERLAND**

Diocese: Durham  
Archdeaconry: Sunderland  
Church Code: 613 181

Date of Inspection: 05<sup>th</sup> May 2022  
Inspection undertaken by: Jamie Holden BA (Hons) RIBA RIAS  
Previously Inspection: July 2015 by Lucy Stewart

**Studio Tamacoco Architects**

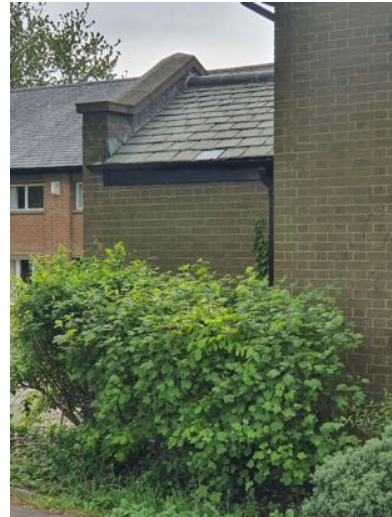
b) Lead flashing to brick parapet

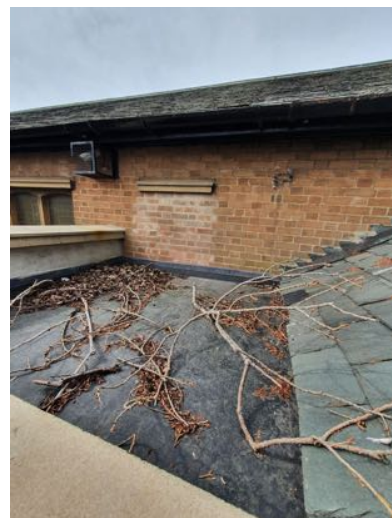
b) Ensure debris is cleared regularly from the flat roof.

2.1.3 The flat roof in catching debris fallen from the trees and ought to be cleared bi-annually as part of routine maintenance. **M**

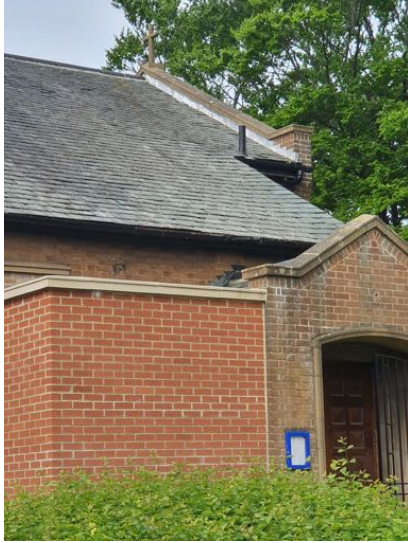
a) West end abutment flashing in good order.

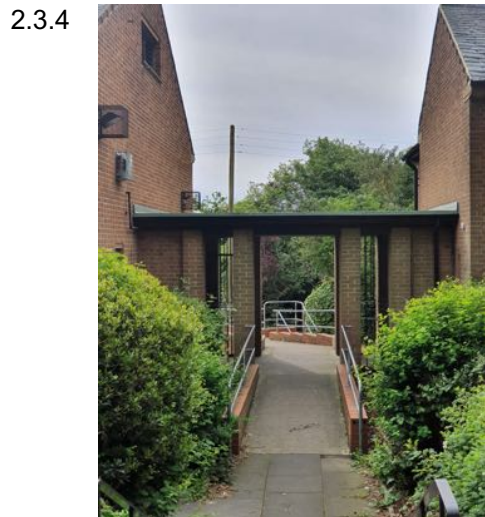
*a) Covered walkway connects the Church and Hall*

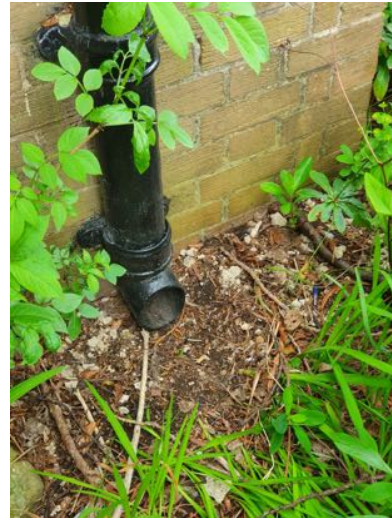
b) Gully is total concealed with debris

2.5.3 A number of the gullies are very difficult to inspect due to vegetation. It is important to keep the area around downpipes free of planting to enable easy and regular maintenance. It is advised that the drains are tested to ensure they are running freely if this has not been done in the last 5 years. If any blockages are found they must be cleared. **2**

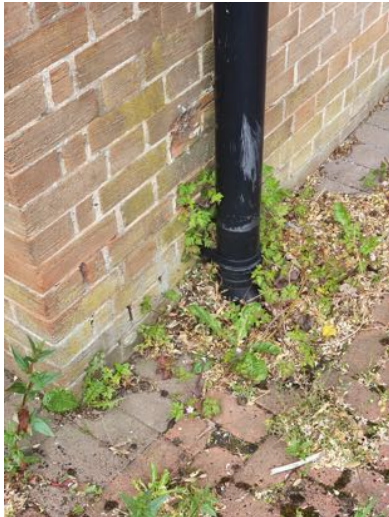
a) Gully infested with vegetation.

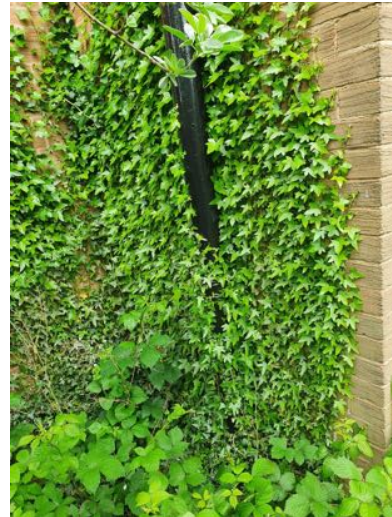
b) The base of the downpipe and gully are total inaccessible due to vegetation.

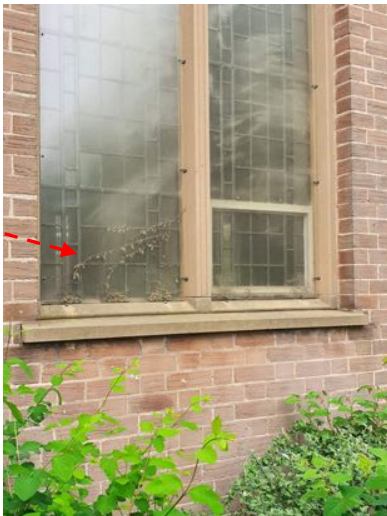
a) Debris trapped behind Perspex security sheet to be removed

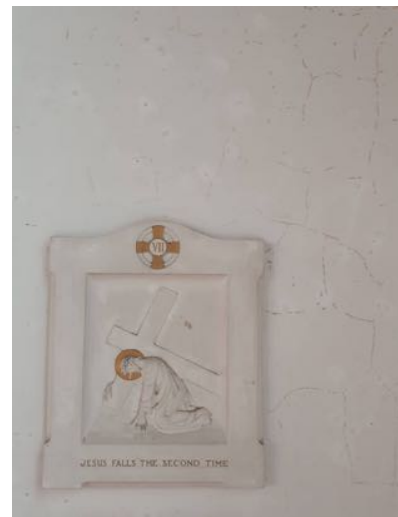
b) Wall monuments appear stable and unaffected by the cracked plaster.

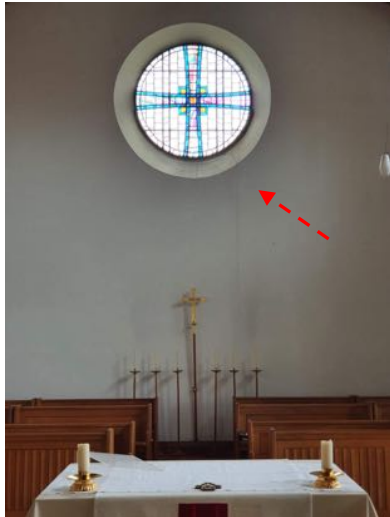
4.5.8

- 4.5.2 In the south wall there is a circular window with some coloured glass at high level. There are runnel marks streaking from the cill of the window indicating that the window is leaking or has leaked in the past. This should be monitored and reported to the Architect if a leak is detected. ○

a) Runnel marks at the cill of the circular window.

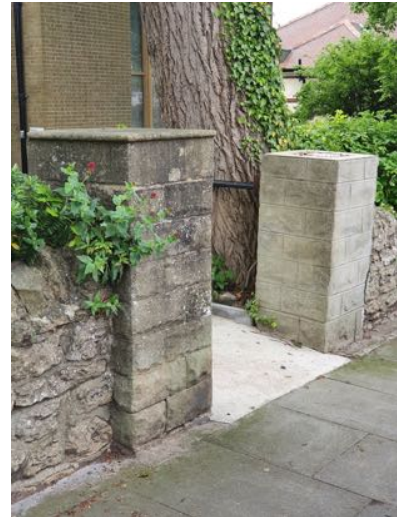
*b) Pier to the south side of the pedestrian access is being pushed over by the tree.*

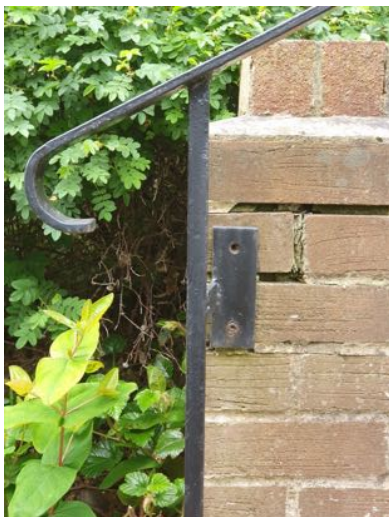
a) Repoint wall.

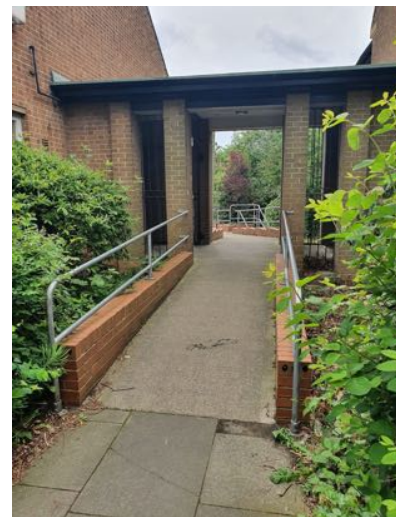
b) Ramp access to covered walkway
