HOLY TRINITY USWORTH
Washington
(19)

QUINQUENNIAL REPORT
on the architect's inspection on

20 March 2017

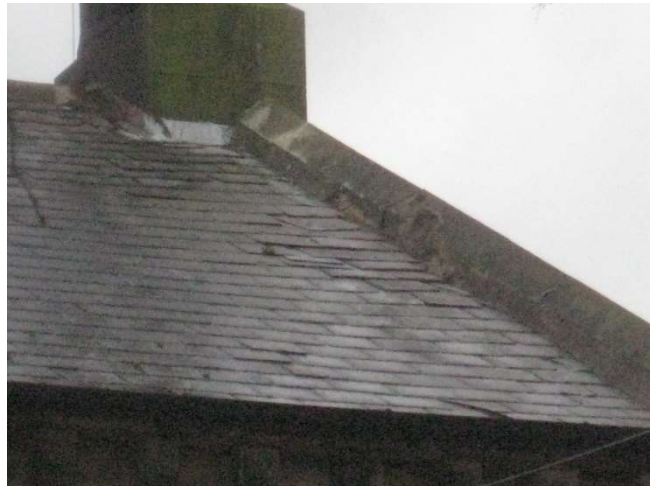
Nave NW

16. **Nave** similar but shallower and unfelted with mortar torching of the slates to the battens. Decaying boards under the eave courses. Ridged watertables with high mortar fillets covering the slates.
SW mortar fillet cracked and part loose. SE fillet breaking down with debris on the slates. NE fillet replaced and fair. NW fillet breaking down and plants growing in the cracks have been removed.
The N slates are very uneven all down the W end and around the bellcote with some slates missing. Uneven all along the ridge. A large patch at the top E end is disrupted and a slate is slipped out mid slope near the E end.
The S slates better but uneven around the bellcote where past patching has been with lead and wire clips. Two have slipped out mid height close to the W end, with daylight inside.

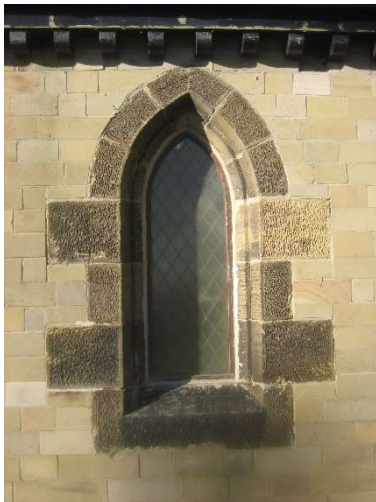
Reused window in Hall

31. At the Hall the reused doorway and five windows are sound although one N window has been patched in cement mortar.

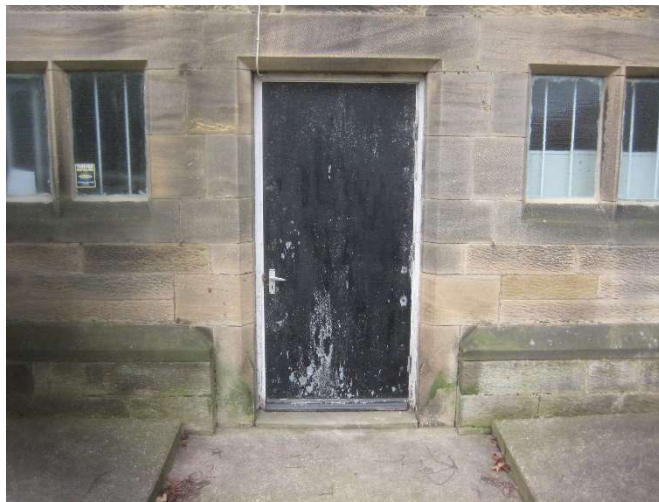
32. The three external doors are solid core flush ply. Main N doors varnished hardwood veneer with mortice bolts in a hardwood frame to fit the reused pointed arch. The S and E doors have painted outer steel sheet covers and softwood frames. The doors are sound and operate well. The E door needs paint. Mastic sealant at S door frame now cracked.
33. The Hall gutter fascias need paint

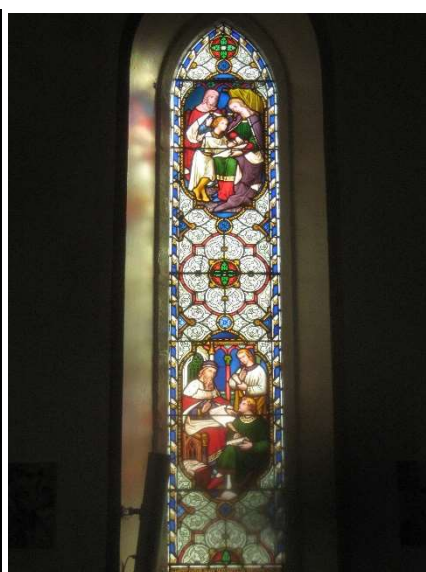
typical nave lancets para 56

56. Six of the eight Nave lancets have well leaded clear diaper quarries in fair condition though the glass is dirty both sides and cannot be properly cleaned without removing the protection. Four hoppers, two of them reglazed in unleaded float glass. The lancet by the pulpit has opal glass (and some clear replacements) with yellow border in good condition. One of the S lancets is another Coxon 1875 memorial stained glass with minor repairs including overglazing and some bowing due to weak lead pattern.

58. Early polycarbonate has limited life before sunlight clouds it. Much better light resisting polycarbonate is now available. When funds allow the sheeting should be replaced and fixed unsealed with ventilating clips all round. For better appearance size to the glass, not the rebates.

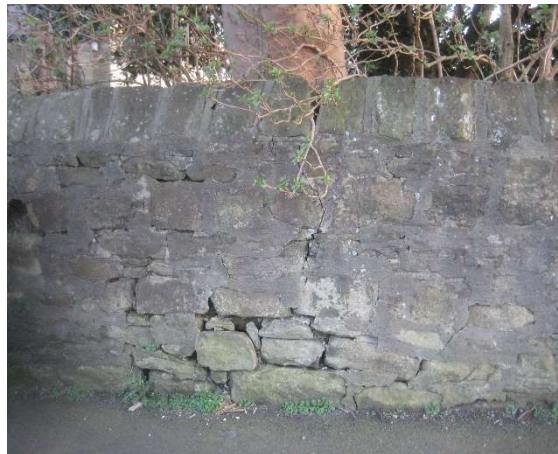
98. At the road a high stone wall, retaining the churchyard at NE. Part loose where pushed by a tree and part of pointing missing. Capped gate piers and fine wrought iron gates. A separate opening gives access to a small stone chipping car park.

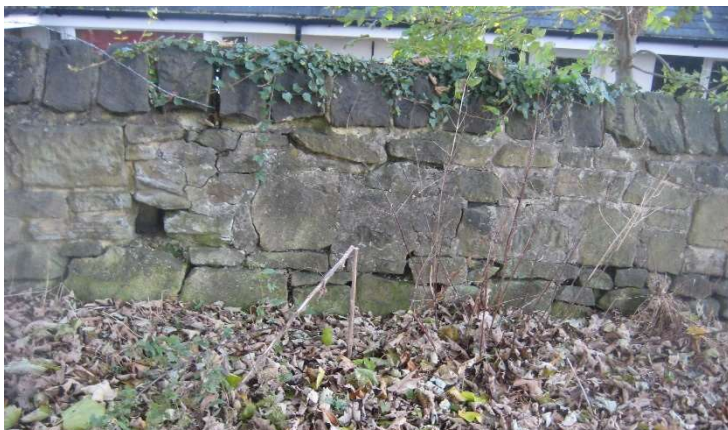
in 2012

99. At E the boundary wall retains the churchyard high above adjoining house gardens. A small gated opening has been formed through the E wall to a neighbour's garden. Many self seed saplings along the church side of the wall need to be removed before they become large enough to damage the wall. Much of the E wall is overgrown and needs to be raked and pointed. The S wall is too overgrown to judge its condition.
