Diocese of Durham

**HOLY TRINITY USWORTH**  
**Washington**  
(19)

**QUINQUENNIAL REPORT**  
on the architect's inspection on

**20 May 2022**

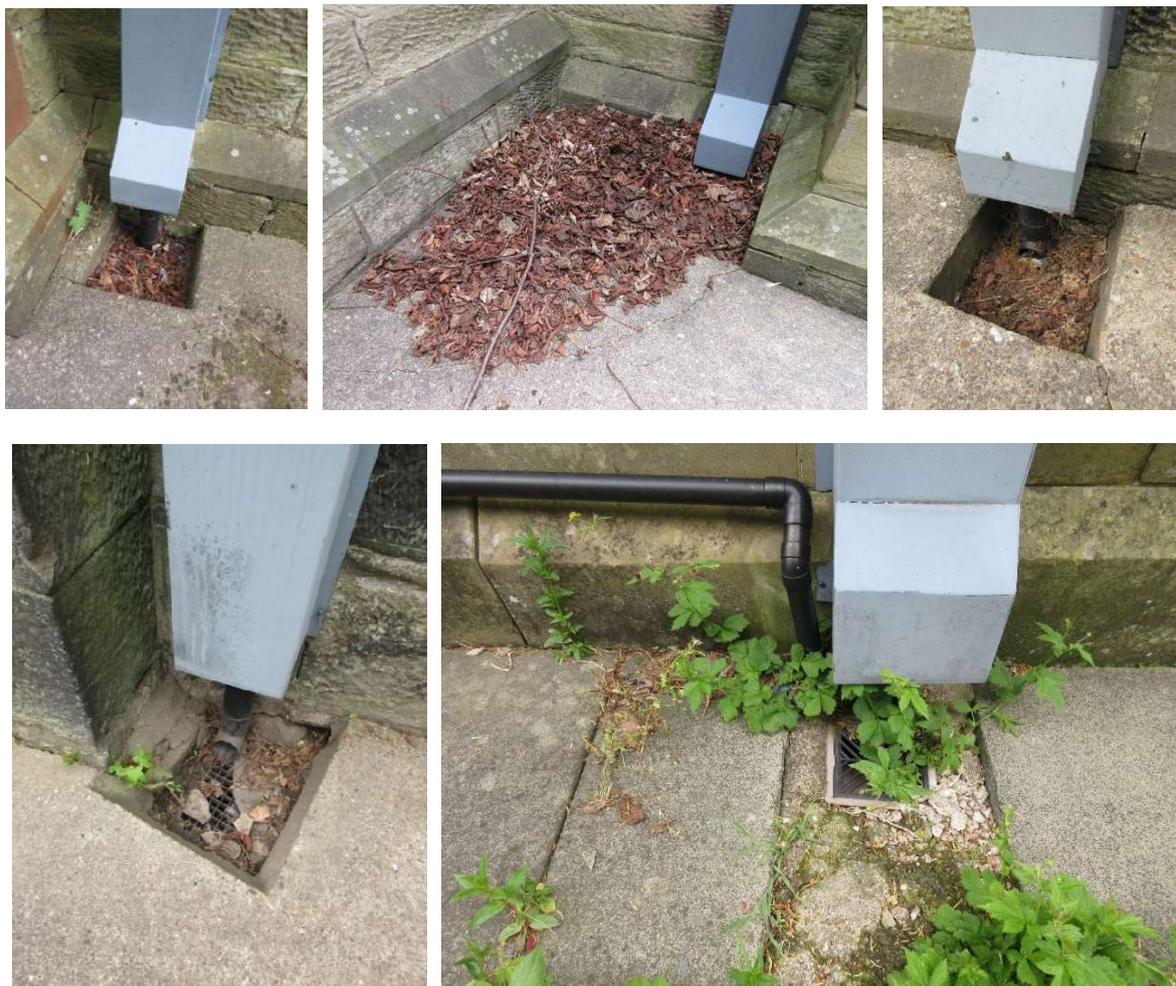
22. Most rainwater gullies are full of leaves. Regular clearance throughout the year is good practice.

23. Complete new rainwater and foul drainage appears to have been installed when the Hall was built. Near the N boundary a very deep collector manhole

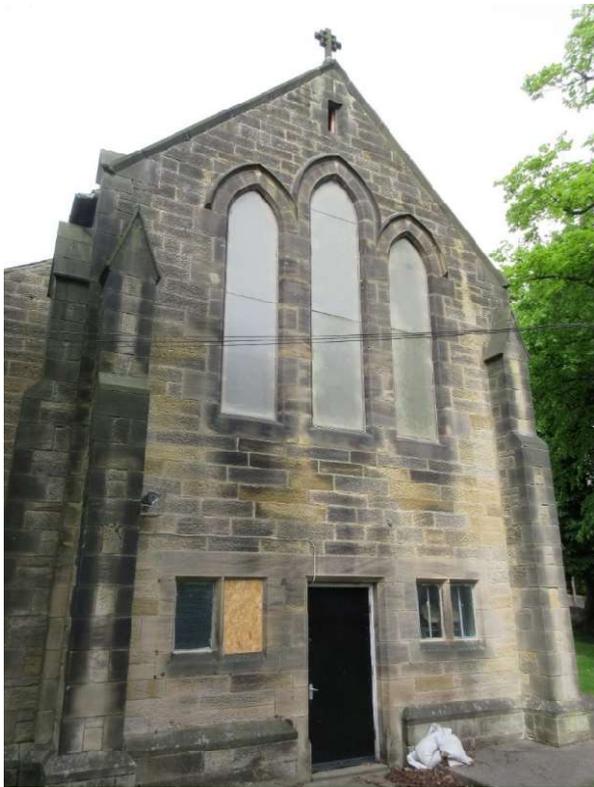
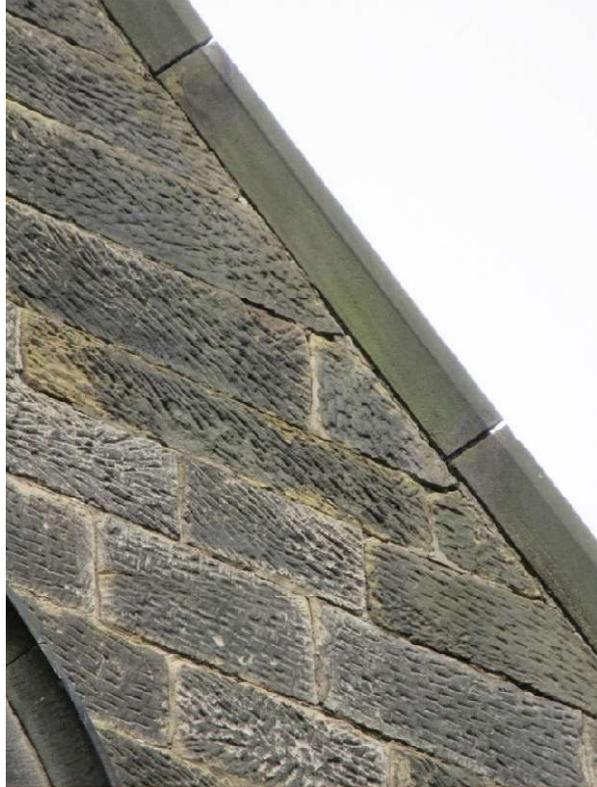
24. The **church** is picked sandstone ashlar with dressed window and door openings. Generally the stone and tight joints are all in good condition.
25. The **Chancel** E gable watertable joints and some joints under are open and should be pointed. Both Chancel NE corner buttresses and one N buttress have open joints and minor stone decay on all three sides and should be carefully raked out and pointed. All pointing to be flush in lime mortar.

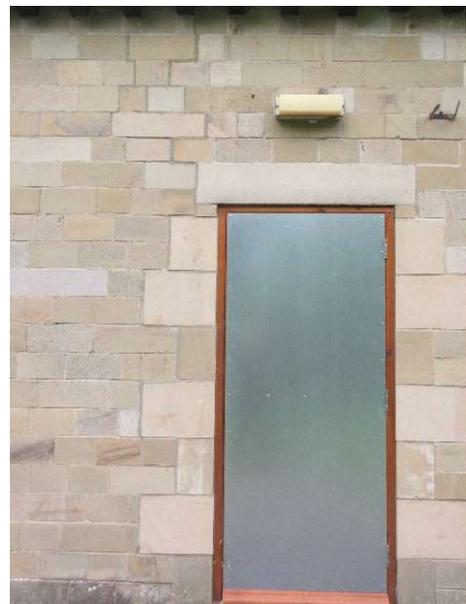
35. The three external doors are solid core flush ply. The doors are sound and operate well.  
 N entry doors varnished hardwood veneer with mortice bolts in a hardwood frame to fit the reused pointed arch.  
 The S and E doors have outer steel sheet covers and timber frames. The S door is good recent metal clad douglas fir with a weathermould. The E door needs paint.

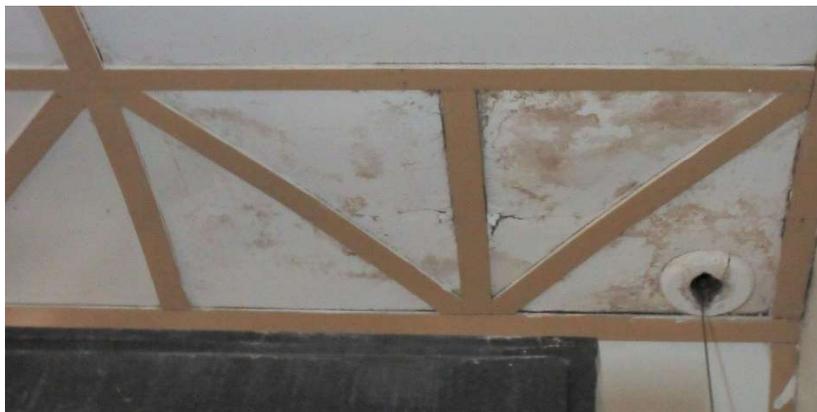
41. The Chancel has a barrel vault of painted matchboards, and the lean-to has exposed timber roof boards, all appearing sound. In the basement room a low stepped ceiling of sound painted plastered concrete.
42. The unusual Nave ceiling seems to be softboard under traditional lath and plaster at the flat outer edges with curved softboard and patterned cover battens in the central vault, both insulated with quilt. The softboard is fixed to curved ply formers in the roof void. The vault appears in the 1907 photo in church so may have been inserted to give more headroom for the new chancel arch. All sound. Water marks are unchanged:
- at the bell rope hole behind the organ,
  - N of the crown of the vault near the middle of the Nave and
  - next to the hatch in the NW corner over the balcony.

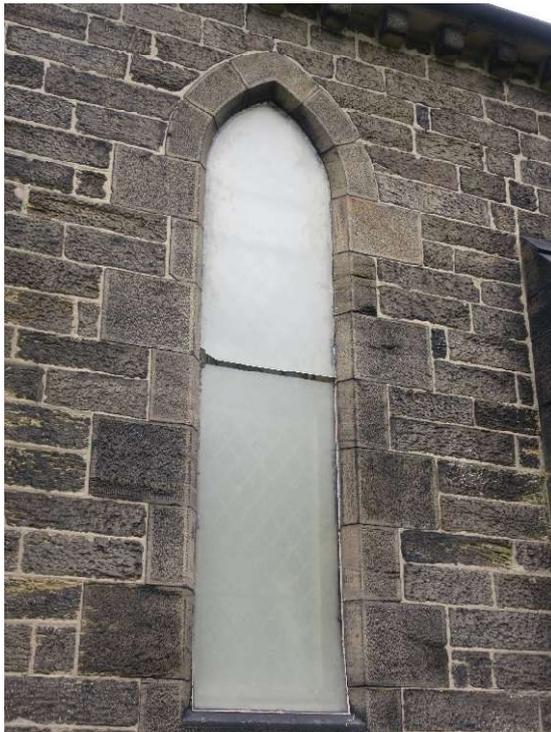
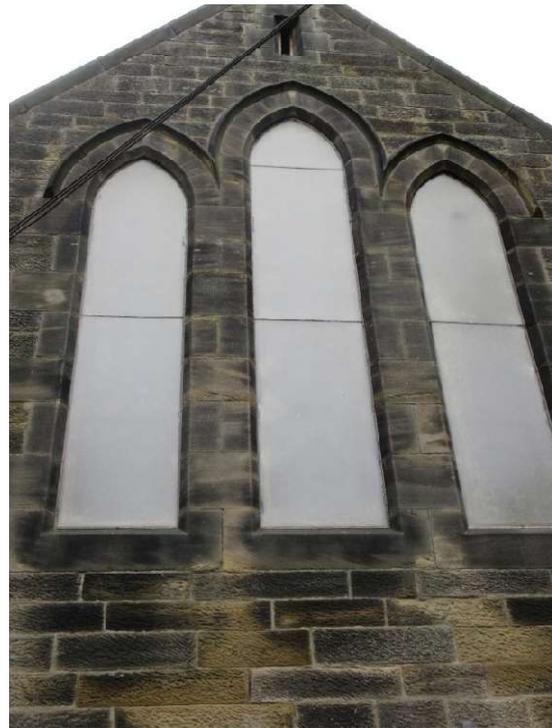
60. All Church windows are protected by polycarbonate sheet cut to fit into rebates in the stone reveals, and 'sealed' with a non-setting compound which does not prevent dirt build up. In the voids both glass and polycarbonate surfaces are dirty. The S sheets especially are clouded by sunlight and light inside is reduced. The outside appearance is fair but looks blank.  
No rebates at the lean-to where the sheets are fixed too close to the glass (para 58).

62. The taller lancets have one or two cross joints with unsealed lead cames,  
The middle two S Nave protections have slipped down opening gaps at the top. Two S cames are missing and one joint has sprung open.  
If general renewal is not possible these sheetings at least should be replaced as above with glass cleaning.
63. All extension windows have unsealed site assembled triple glazing in stained timber frames. The inners and outers are polycarbonate with a mid sheet of unknown material with applied lead diaper patterning.  
The polycarbonate is clouding and cobwebs appear in the voids.  
The outer hardwood frames are not well sealed to the polycarbonate so water and insects can enter.  
Some mortar pointing between timber and stone is lost (para 36).

61. Early polycarbonate clouds in sunlight. Much better sunlight resisting polycarbonate is now available.  
When funds allow the sheeting should be replaced and fixed unsealed with ventilating clips all round. For better appearance size to the glass, not the rebates.

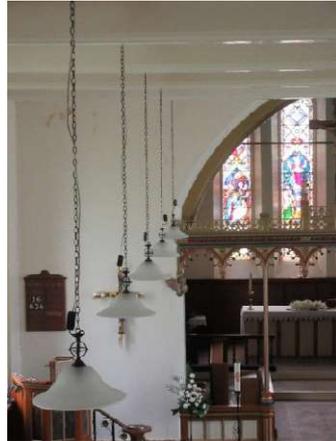
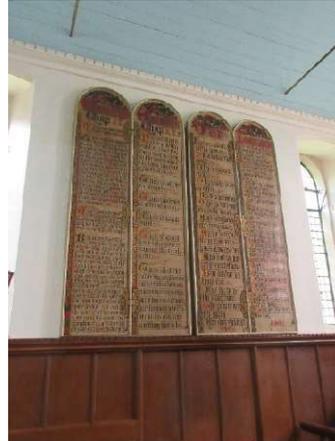
78. Three phase intake at the basement stair with a neat modern fuse and main switch with submain to Hall.  
Age estimated at 40 years.  
The installation has been altered several times and the different parts now vary in condition.
79. A periodic inspection 2017, report not seen. New test report now due. See Addendum
80. Church wiring is simple. Two rows of pendant lights (now warm colour LED lamps) in the Nave and Balcony. A cold light spot on a truss lighting the Crucifix, four cold light floods upright the Chancel. Metal and white plastic sockets at the front of the Nave, in the Office and Vestry. Pyro wiring on the longitudinal beams and down the plaster in the SE corner.

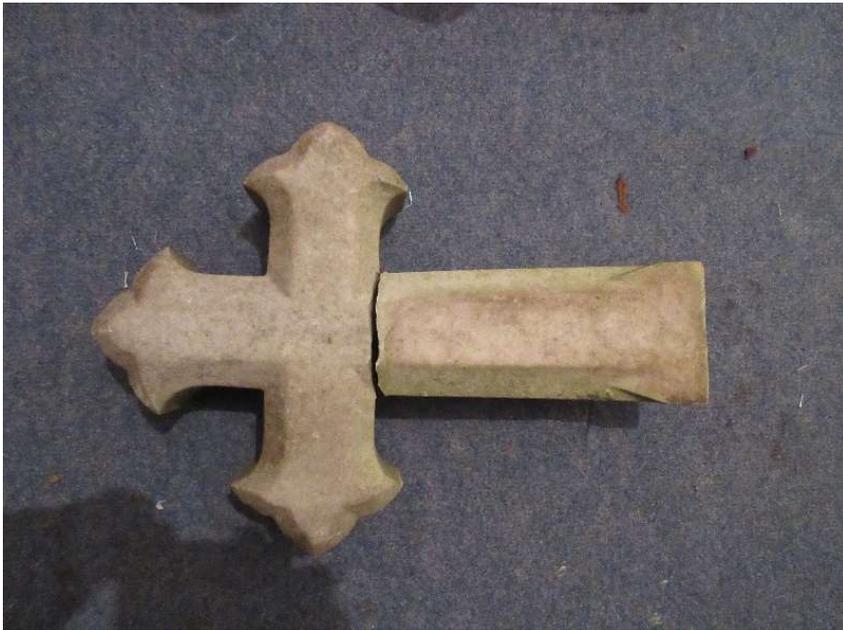
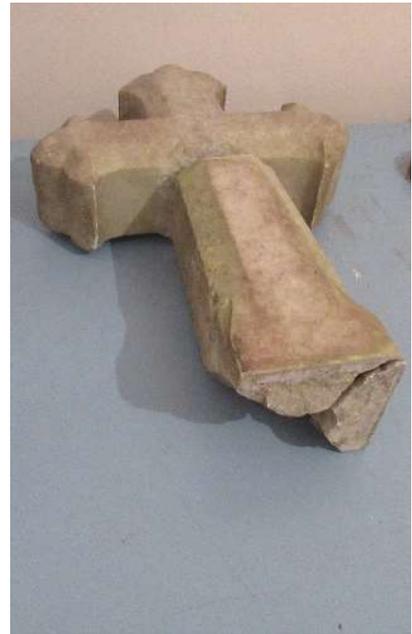
1885 monument

98. A photograph shows it was once surrounded by grave markers in a low fence, all now removed. A modern brick kerb is now just unsightly loose bricks. In 2006 an application for faculty for a new chain surround was refused.  
A listed monument ought to be in good repair so it is time to raise funds and reopen discussion with the authorities on repairing the finial and lettering and on releveling the monument on a new foundation, without reinstating the named graves.

112. Thorough repair of the 1885 listed monument is overdue.

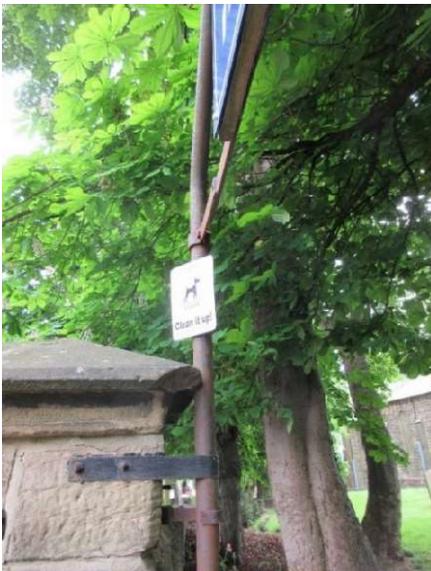
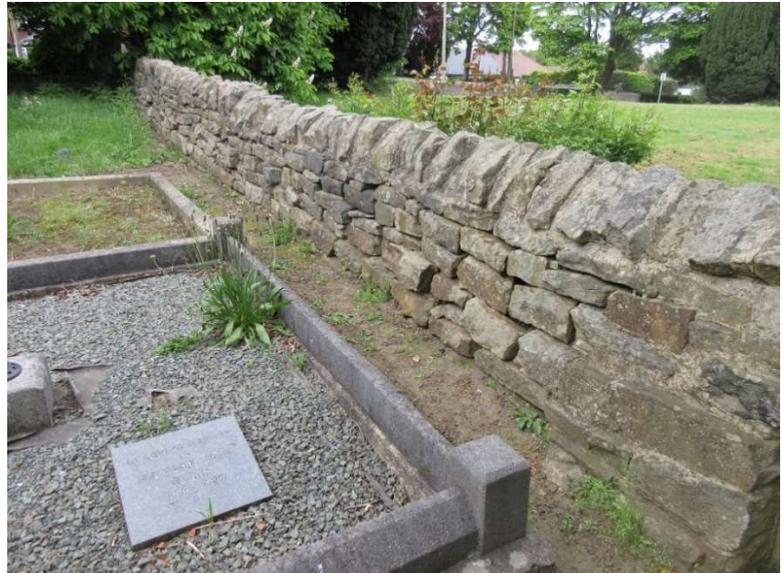
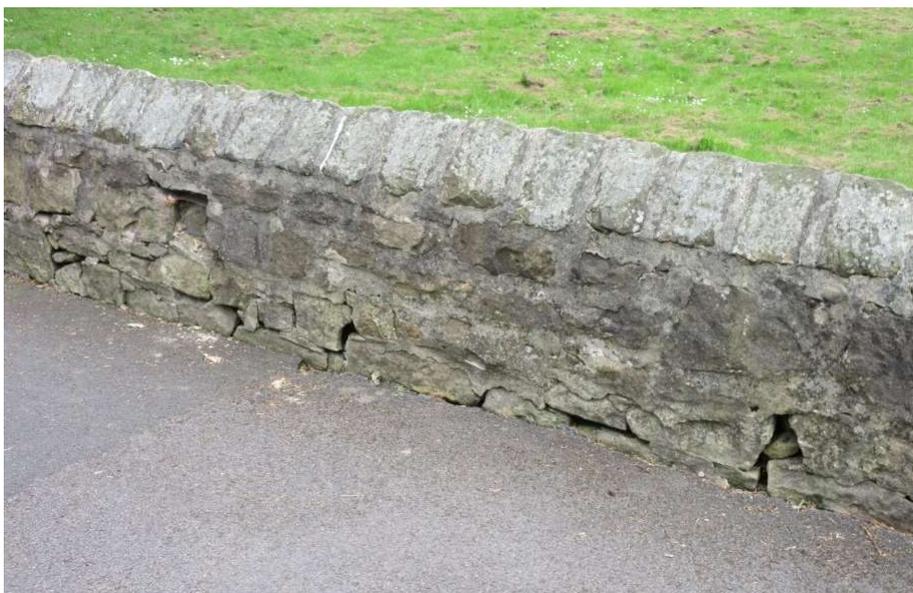
103. Further W the wall is lower but parts are poor with some missing stones.

104. The E boundary wall retains the churchyard high above adjoining house gardens. A small gated opening has been formed through it to a neighbour's garden. Many self seed saplings along the church side of the wall should be removed before they become large enough to damage the wall. Much of the E wall and all of the S wall is too overgrown to judge its condition.

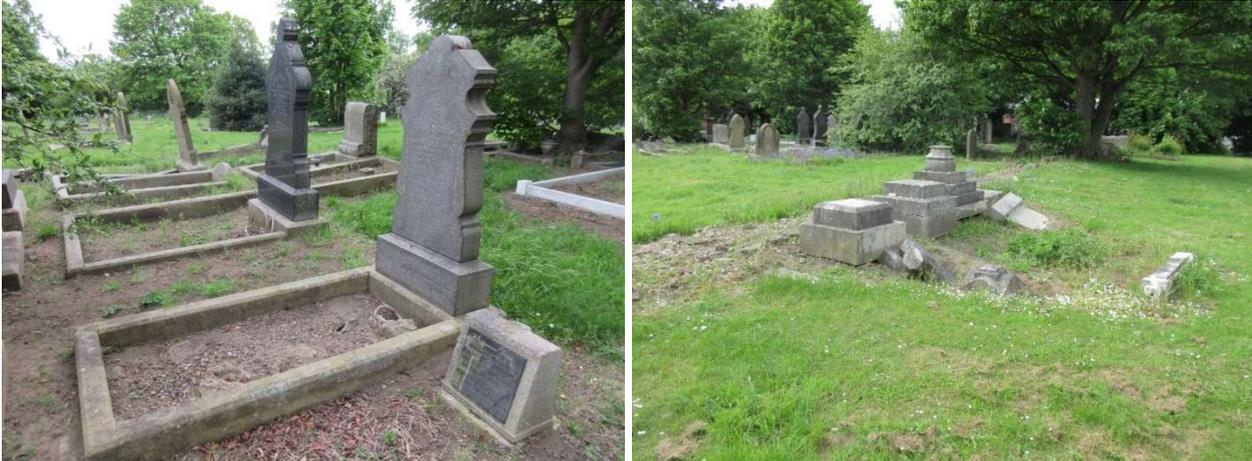
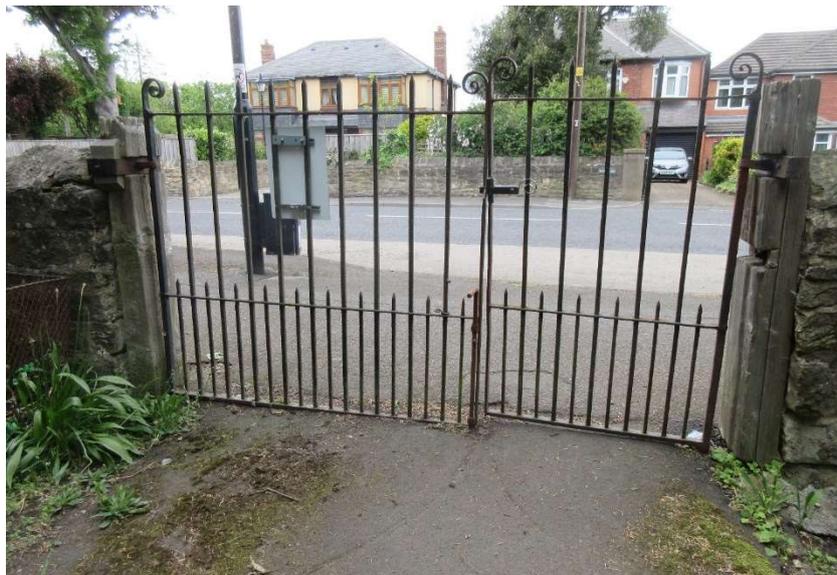
A large recent printed sign on wooden stiffeners on rusting steel tubing over the gate piers.

107. The W churchyard remains open for family burials. Parts of its low stone wall retain the highway verges outside. A pair of rusty iron gates in the N wall hang on heavy softwood posts, decayed at top and bottom but still stable.
