St MICHAEL SULGRAVE

Washington

QUINQUENNIAL REPORT

3 August 2023

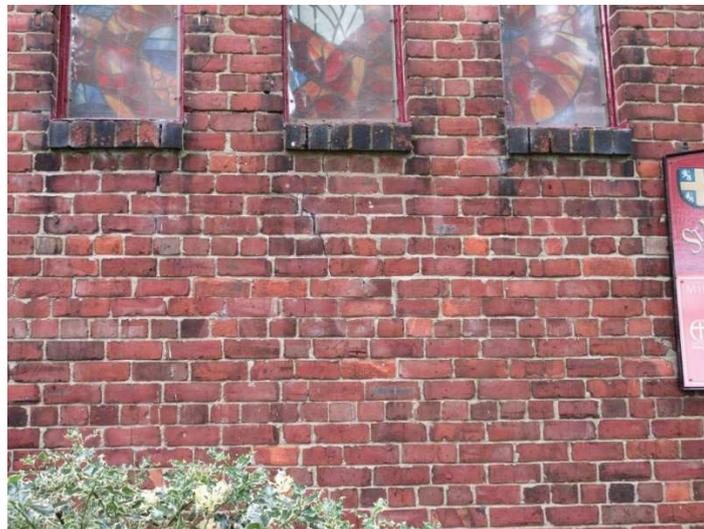
17. The church walls are solid brick with a low plinth and tall buttresses. The offshot appears cavity brickwork. Modern struck cement pointing over the original lime mortar. Very slight loss of pointing especially in
 - the wetter plinths
 - the top of the Nave NE buttress
 - around the Nave NE pipe
 - joints in the tops of three S Nave buttresses (with minor plants)

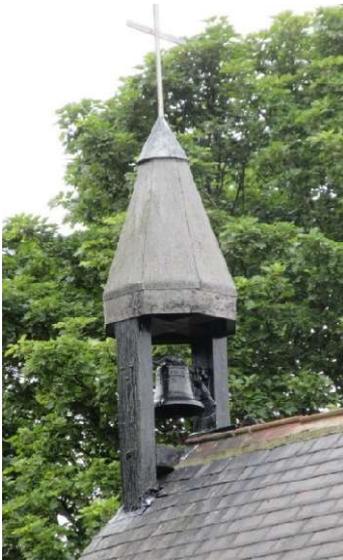
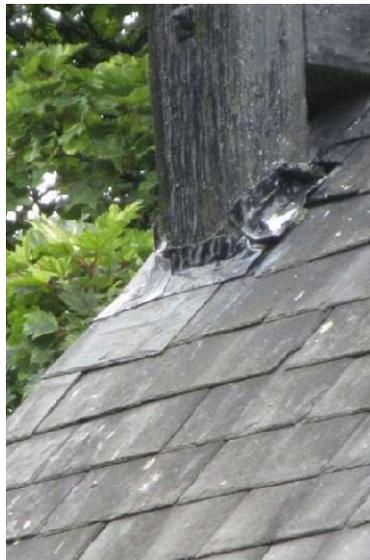
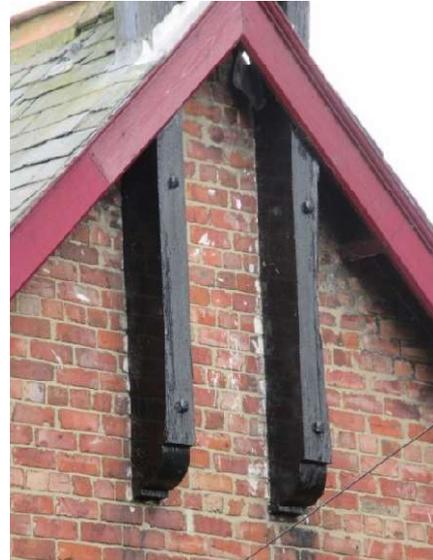
23. Two stout timber posts bolted to the W gable brickwork support an octagonal timber spirelet covered in Nuralite sheeting with a cross on a metal cap. The painted timbers look sound without close access.

24. A single bell hangs between the posts. Its rope used to pass through the slates but is now missing, leaving an open weathered hole.
25. Painted flashband weatherings between the slates and bell posts have limited life.

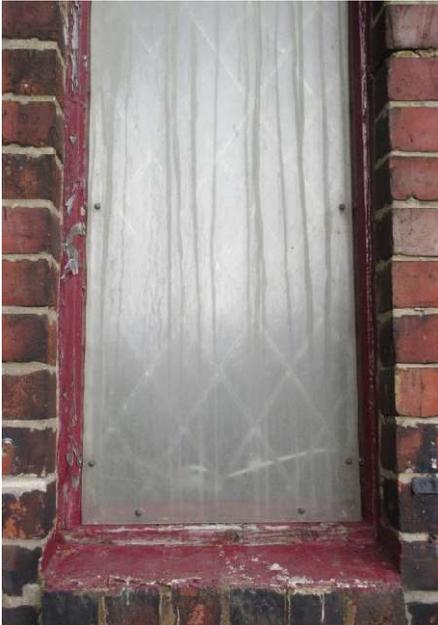
Typical S Nave

27. Slow corrosion of a small iron cross at the E end of the ridge continues and cannot practically be stopped. It leans slightly to N. If it falls it should be replaced in stainless steel.
28. Painted gable bargeboards and eave fascias good.
29. The only doors are the pair at the offshot. They are sound raised panel doors with steel sheets outside. Paint sound. The offshot windows are painted vertical sliding sashes in rebates and apparently sound though fixed shut.
30. The church window frames are painted timber in brick rebates. Generally fair but paint breaks down at S and W sides. Rot at one W end cill. The windows cannot be fully painted without removing the protection.

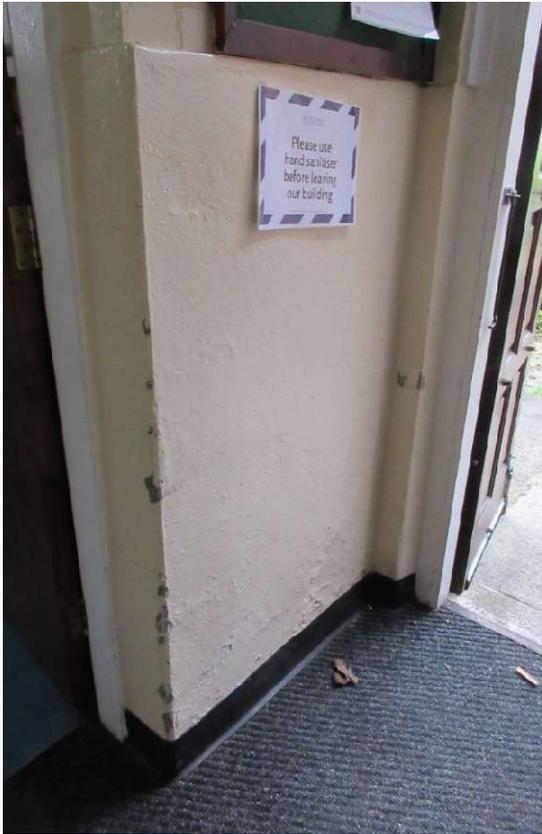
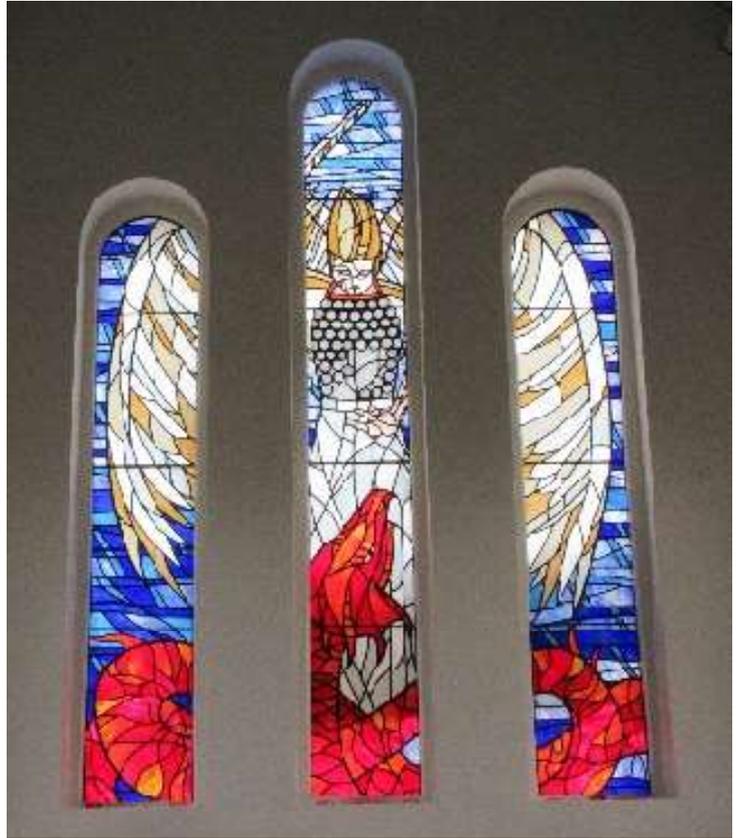
39. Some plaster at the Chancel N and E walls remains hollow. Otherwise the plaster is in good condition. A dado strip planted on the plaster below the cills may mask a joint between waterproof render and upper plaster. The dark stained rood beam and cross stand out in contrast to the cream paint.
40. A colourful church interior. French and sky blue painted roof boards, cream walls, blue chancel carpet, bright blue chairs. Cobwebs in all parts begin to be noticeable.
41. Minor low level damage in the Lobby where the walls are painted brick above painted render.

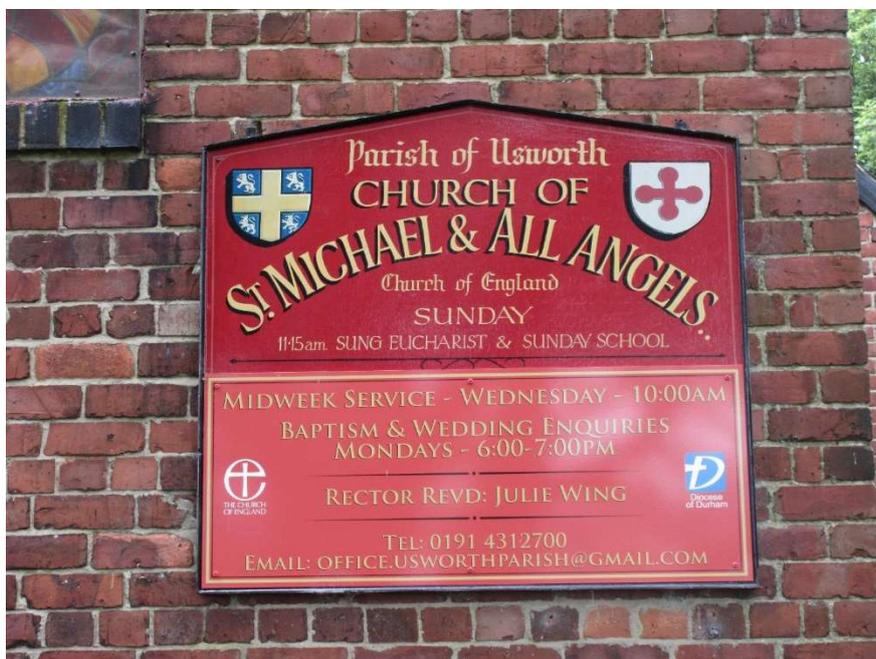
78. Painted signs fixed to the Chancel gable (with a new section) and on the offshot gable.
