**QUINQUENNIAL INSPECTION REPORT
OF
WASHINGTON, HOLY TRINITY**

**DIOCESE OF DURHAM
ARCHDEACONRY OF SUNDERLAND
DEANERY OF CHESTER-LE-STREET AND HAUGHTON –LE-SKERNE**

**INSPECTION OF CHURCHES MEASURE 1955
CARE OF CHURCHES & ECCLESIASTICAL JURISDICTION MEASURE 1991
March 2022**

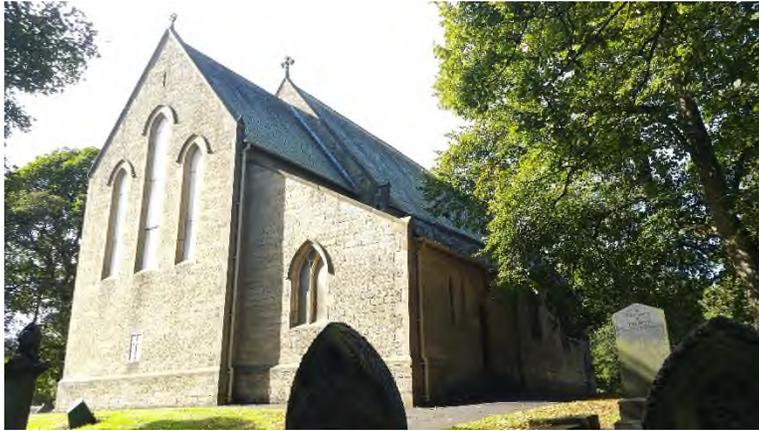
- **Choir Vestry:**

Welsh slate looks ok as do the lead flashings up the head and the abutments. Watertable to E end looks ok. Organ loft Westmoreland slating with tingles some replacements I think it is all sound. Ridge flashing in new lead against the nave looks good. W abutment mortar over lead ok. E abutment rather heavy handed looking mortar pointing over probably lead. Looks like there is some silicon type pointing to the watertable.

Recommendation: none

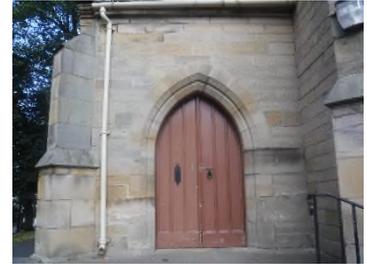
North side – Gully looks blocked.

South side – OK.

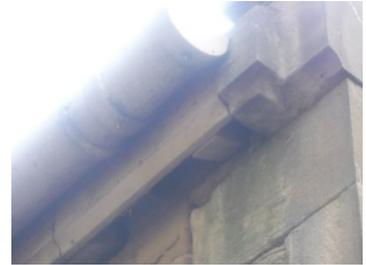
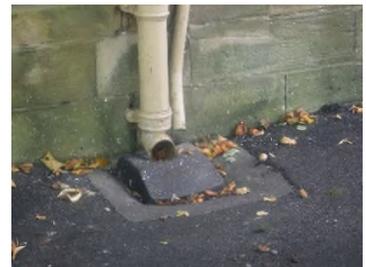
Organ Loft:

Generally ok apart from the gulley has a domestic plastic top and it is not keeping the leaves away and it is blocked by the look of it.

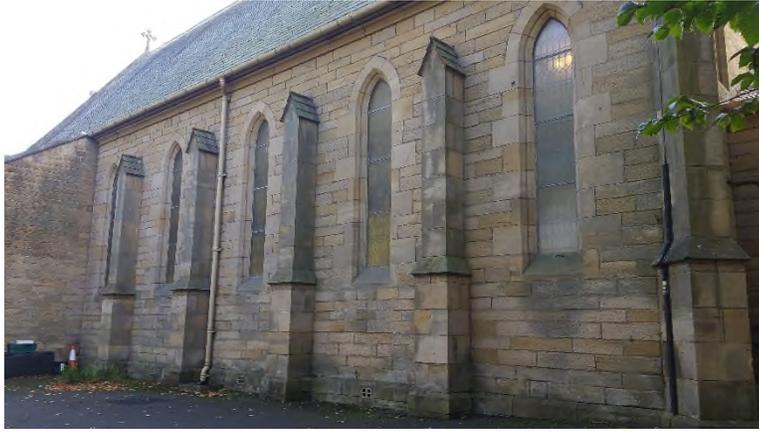
North side

– Partially enclosed by the organ loft, small area to the E of that above the choir vestry rather rough stone work but it will do, it has got a flat timber fascia at this point. This has the more original narrow pointing shows that on the S side it is fat ribbon pointing horrible, but the walling is all generally sound as are the buttresses.

Recommendation: none

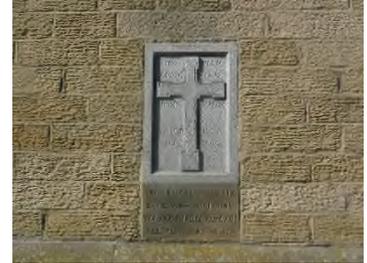
- **Chancel:**

South side – Upper part matches the nave but the majority of the wall is in random rubble and badly smeared with pointing and a couple of eroded stones at the bottom but generally sound. Cotoneaster up against this so can't see behind that very well, there is some erosion I think.

East side – Perhaps open joint to the watertable on the S slope maybe the same on the N mirrored. Slight open joint underneath the apex of the watertable, walling is all sound with some minor open joints below the plinth but don't need attention.

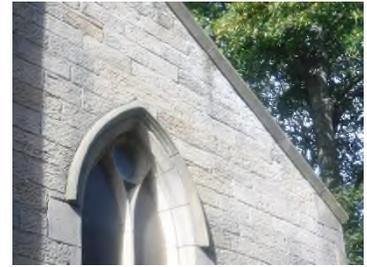
North side – Has had a patched in crack at the junction almost at the junction to the organ loft, walling itself is generally ok.

Recommendation: repoint watertable joints

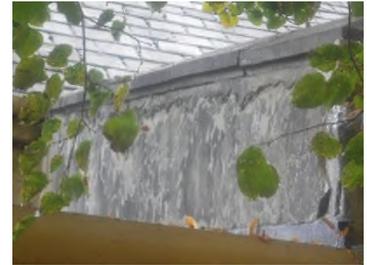
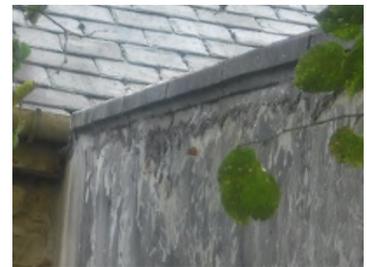
West side – Watertable joint is ok, wall has got slight open jointing at higher level but ok, a few stones above the plinth eroded but ok and the plinth itself has got some open joints.

Recommendation: rerender walling, repoint watertables, general tidy up

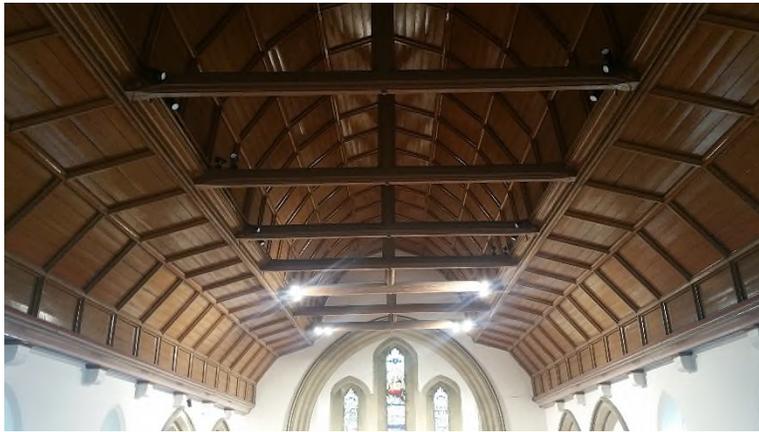
7.5.1 ROOF TIMBERS

ten bay trussed roof in the nave, all of the trusses appear ok.

The organ loft trusses are principal rafters holding up purlins and the middle, at the ridge has been affected by damp in the past, I think that is probably because of a flashing failure which has been remedied. Same design in the clergy vestry no apparent defect.

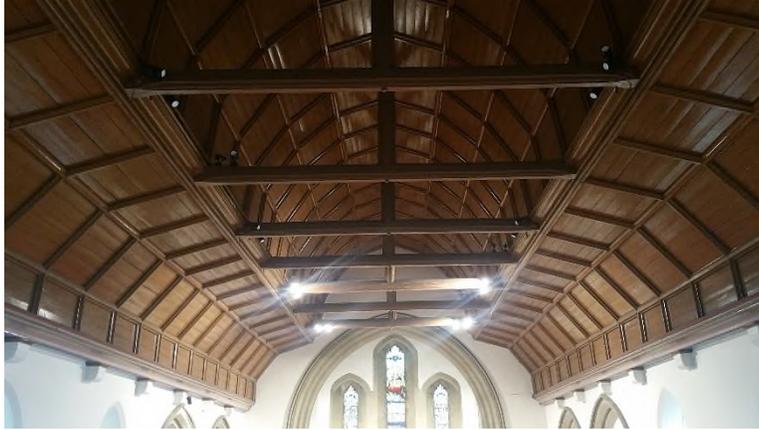
The nave has a wagon style roof faceted boarded ceiling with ribs at upper and lower level, The decoration colour and gloss finish doesn't contribute to the recent reorder.

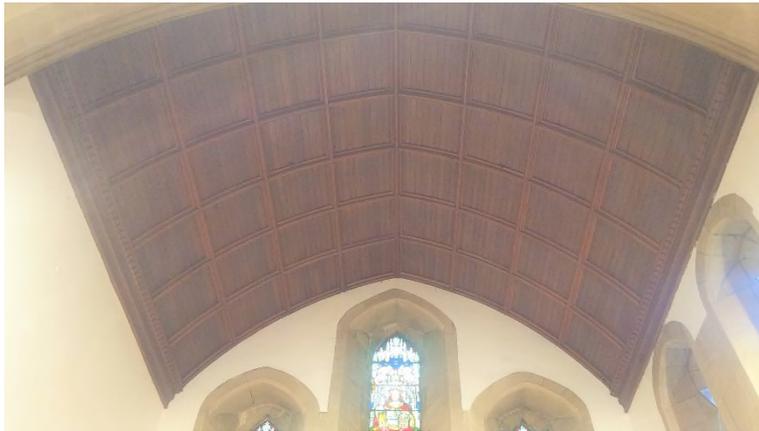
The chancel has curved lancet style roof with ribs and timber boarding, no water marking, it looks like the original finish and it is very good compared with the nave

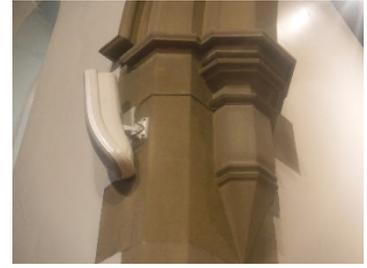
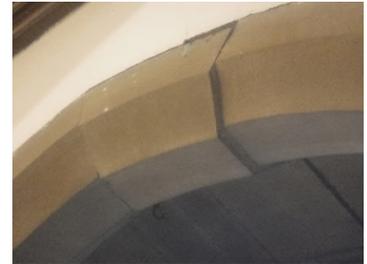
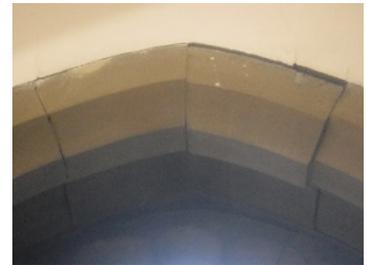
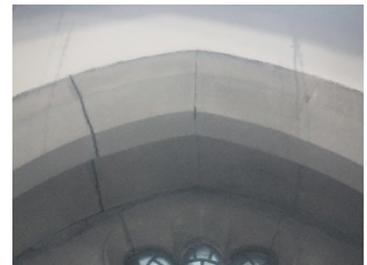
S arcade to the office

Slight fracture to the arch stone closest to the E but hairline is just an easing, the other arch is ok, and down to the ground the arches look sound.

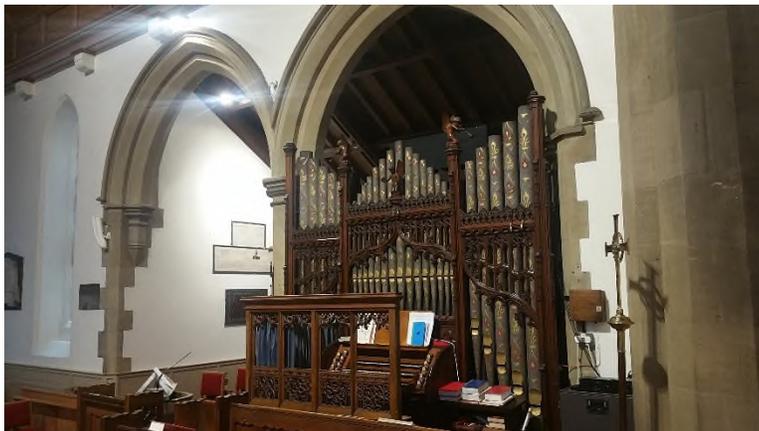
North side

The eastern most, that is above the organ, has got approximately 5mm openings to those that are below the corbel and that is the obvious thing there is a bit of load coming down on that corbel to effect the arch, there is some slight drop out of mortar and those could be going into the organ pipes, it is also taking a load from the mid rafter on the lean-to roof on the opposite side.

N organ loft W window- keystone dropped in two stages. Point up the gap in the wall and keep monitored.

Recommendation: N organ loft W window- keystone dropped in two stages. Point up the gap in the wall and keep monitored.

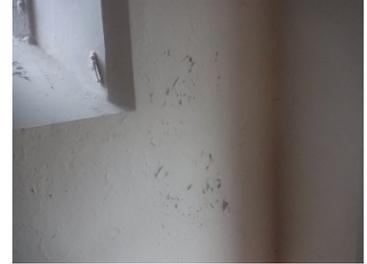
E The building has been redecorated as a result of the 2016 works. There is some cracking to the decoration disappointingly it looks like both, shrinkage on plaster and also flaking, the flaking is mostly within the window reveals so it would be worth checking the records for the paint type used and previous images to understand what is occurring here. The plaster is all ok though it does have some hairline cracks.

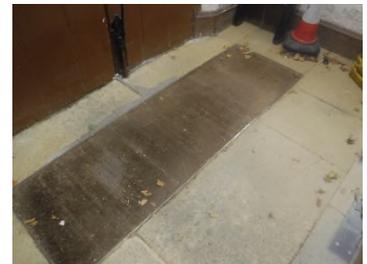
D **General** - The floor level in the nave was reduced back to its original levels as part of the 2016 works and the solid pew platforms were infilled with suspended beam and blockwork and whilst there are some slight lines it is all ok.

Porch vestibule – Some open joints in the paving slight trip hazard of the galvanised edge to the mat well itself which is worn out now and could do with being renewed.

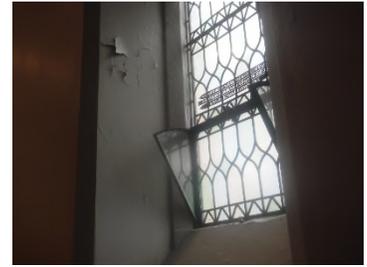
- D This is achieved by opening doors and the ventilators to the glass- if they work.

Recommendation: check vent operation

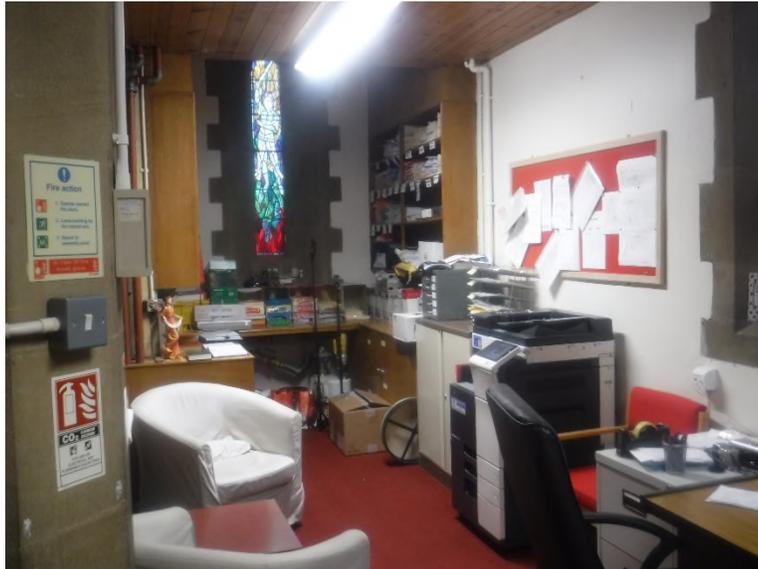
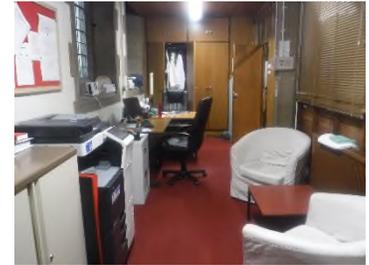
E Office:

This is a former Lady Chapel, has a mezzanine floor installed to create a boiler room above, not inspected. The room forms an office and is full to the brim. The room also contains a gas meter and vestments.

Recommendation: reorganise

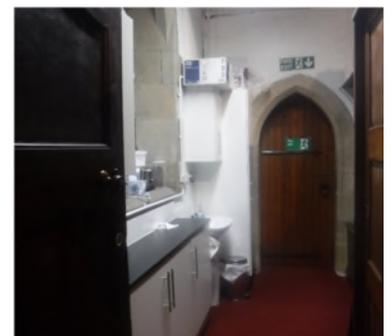
Organ space – Organ contained behind timber boarding and sliding door that contains vestments, the room also has some shallow kitchen fittings and a sink with no obvious signs of hot water it only has cold.

Recommendation: none

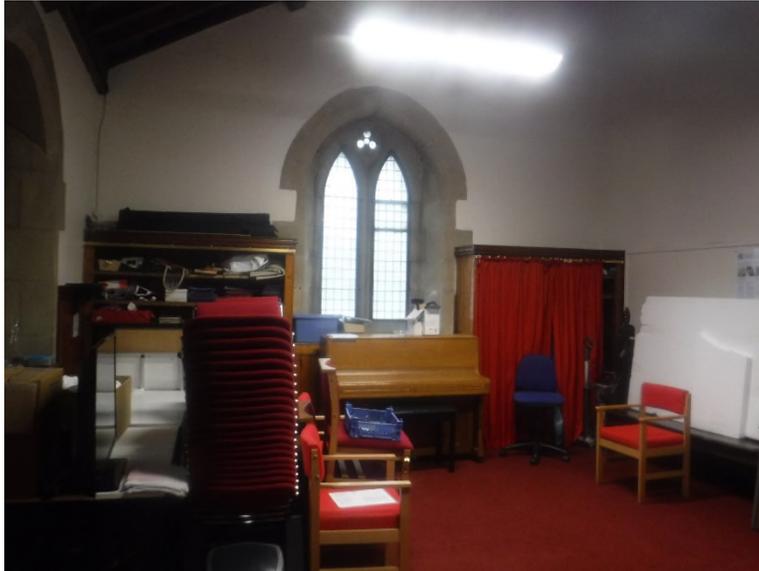
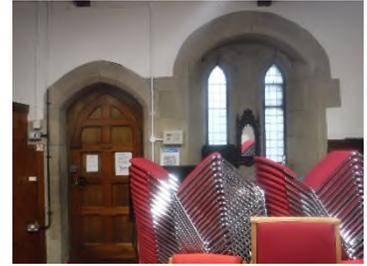
- **Clergy Vestry:**

The room is really just a storage room now, it has chairs, packed up tables and an old bench and a piano, used for choir practice I guess. It doesn't feel as warm as it should in here though it does have a radiator.

Recommendation: -

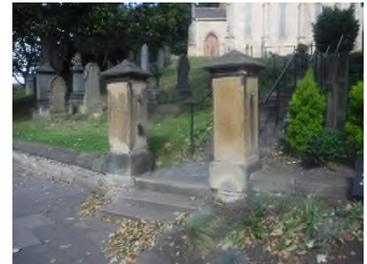
West side – Double gateway.

Steps continue to be buckled a little at the lower stage and there are open joints. The gates don't open as they are rusted up. To the N side of this the low wall is cracking in a couple of places.

Recommendation: Consider repairs to gates. Point up steps. Point up open joints to walling.

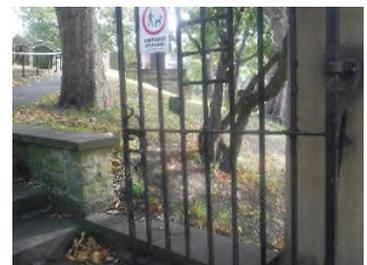
North side

Low wall retaining the sloping churchyard and there are many open joints to it at low level. To the NE end is a pillared entrance without gates. Paths are tarmac and ok.
